Christchurch City Council

English Park Lighting Towers

Detailed Engineering Evaluation

Quantitative Assessment Report

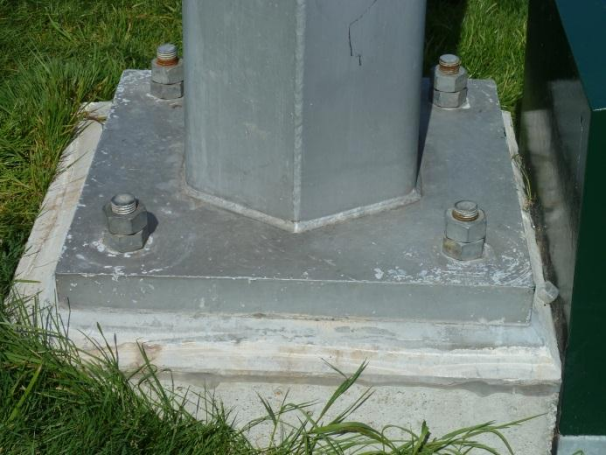
4.	Base plate with threaded bolts fixed to the existing concrete footings

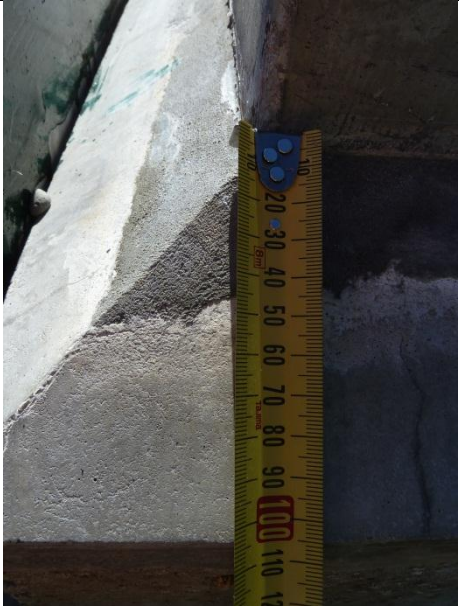
13.	Existing concrete footing

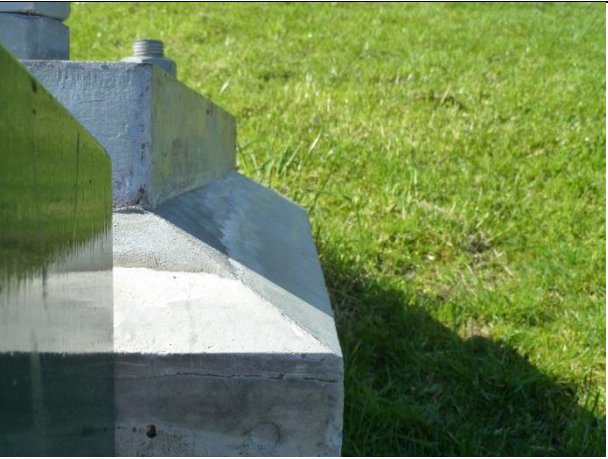
14.	Existing concrete footing

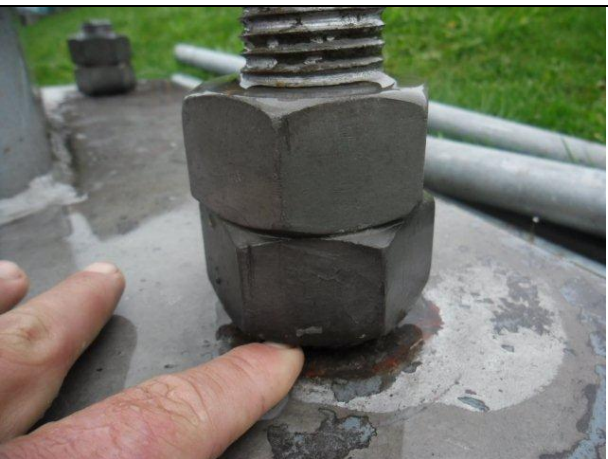
We note that elongation of the M36 threaded rods was observed with approximately 5mm of separation between the threaded rod nut and steel base plate following the M6.3 Christchurch earthquake on 22 February 2011. The threaded rod nuts have since been retightened by City Care. Refer to Appendix 1 for photographs of the threaded rods before and after retightening.

15.	Elongation of the 36mm threaded rods, observed following M6.3 Christchurch earthquake

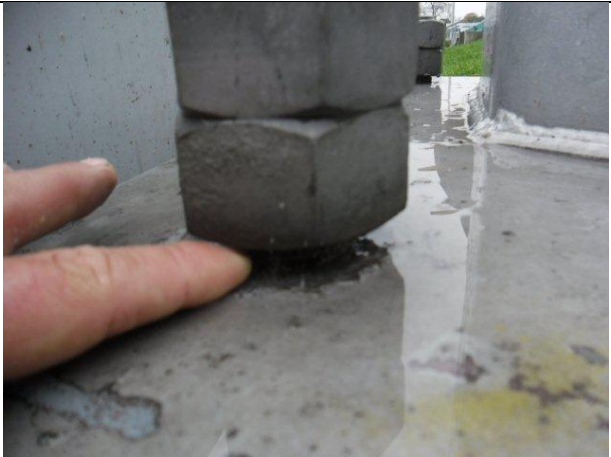
16.	Elongation of the 36mm threaded rods, observed following M6.3 Christchurch earthquake
