Dwelling
PRO 3525 001
Detailed Engineering Evaluation
Qualitative Report
Version Final

42 Exeter Street

Christchurch City Council

Date
17th May 2013

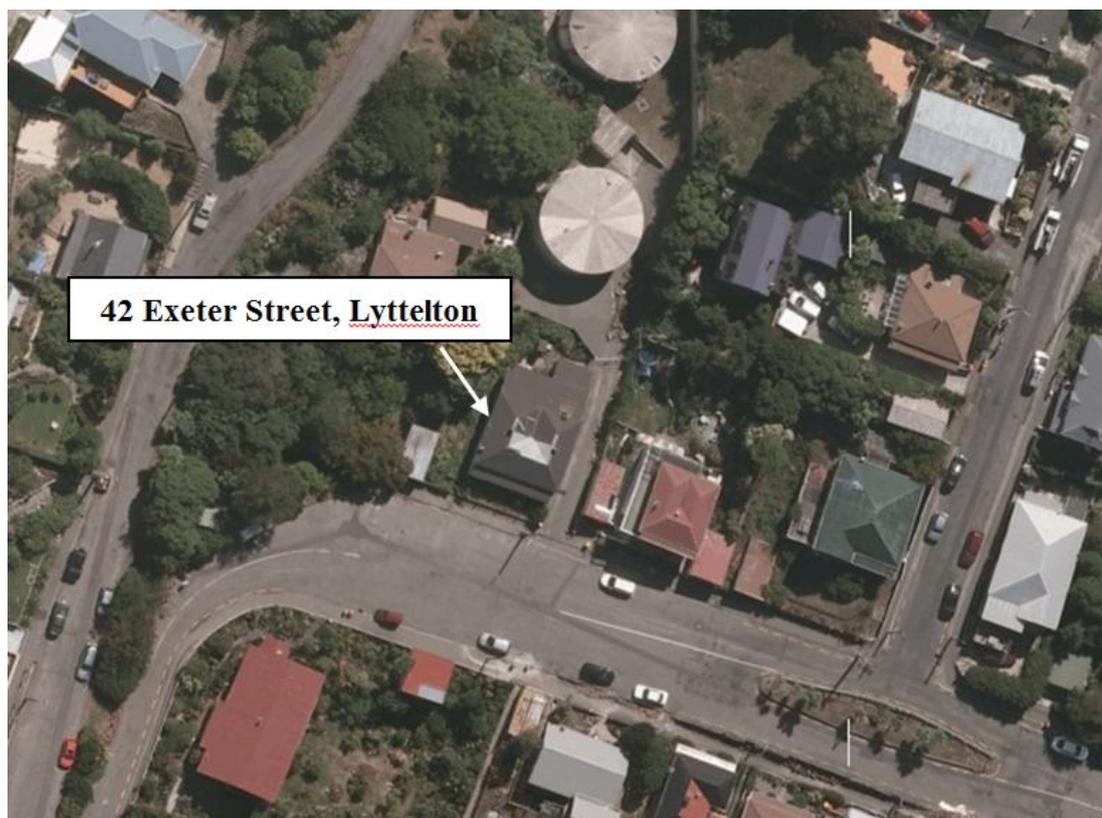
Figure 3 Post February 2011 Earthquake Aerial Photography ²

Aerial photography taken following the 22 February 2011 earthquake shows minor signs of liquefaction in road corridors near the site, as shown in Figure 3.

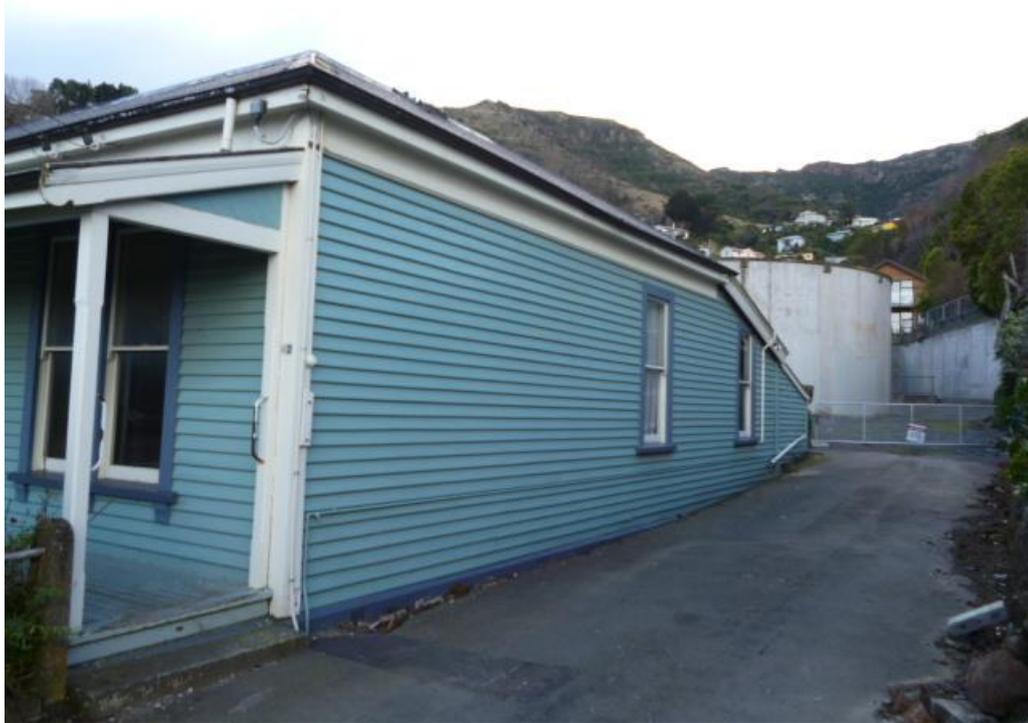
Photograph 1 Eastern elevation.

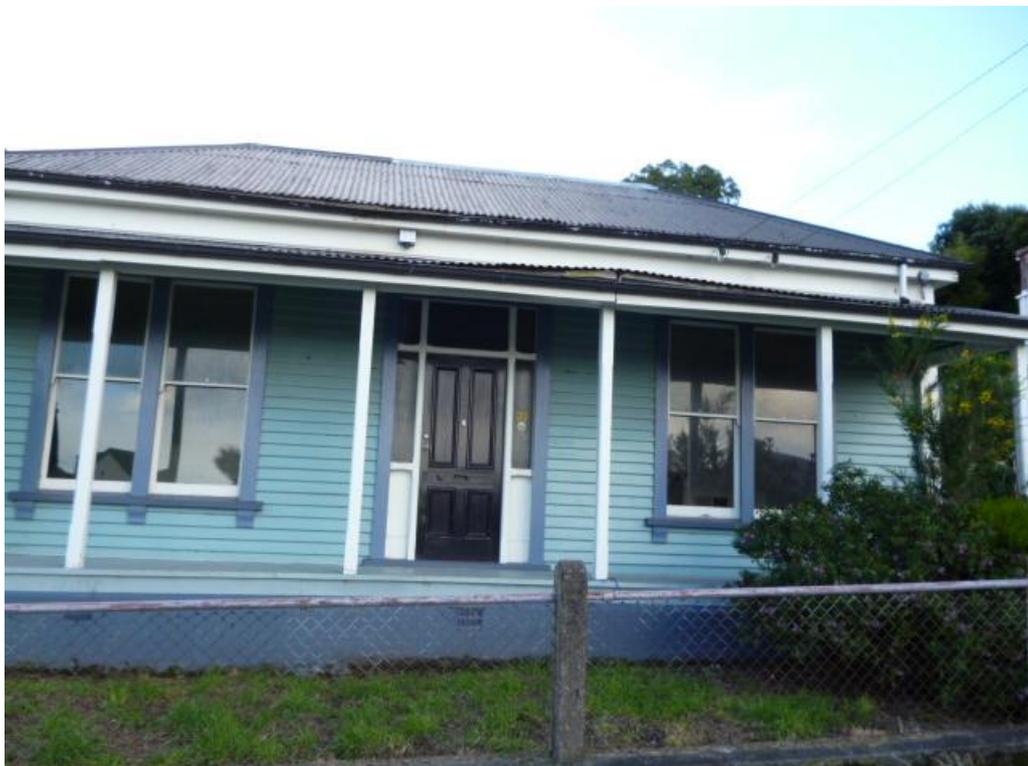
Photograph 2 Southern elevation.

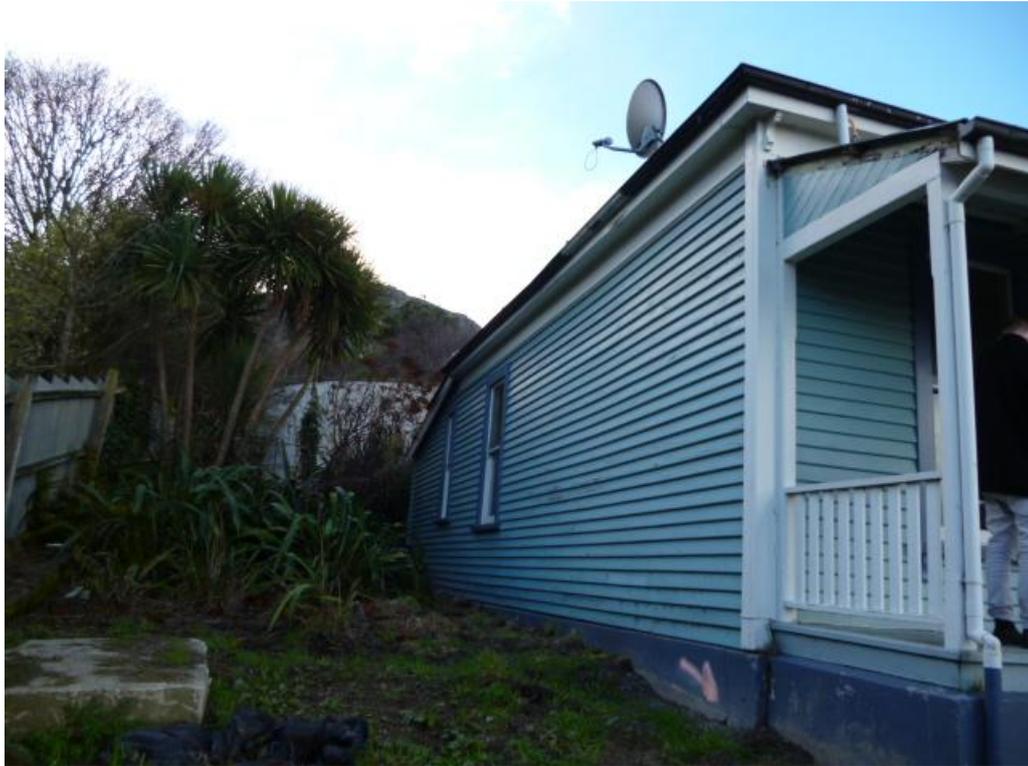
Photograph 3 Western elevation.

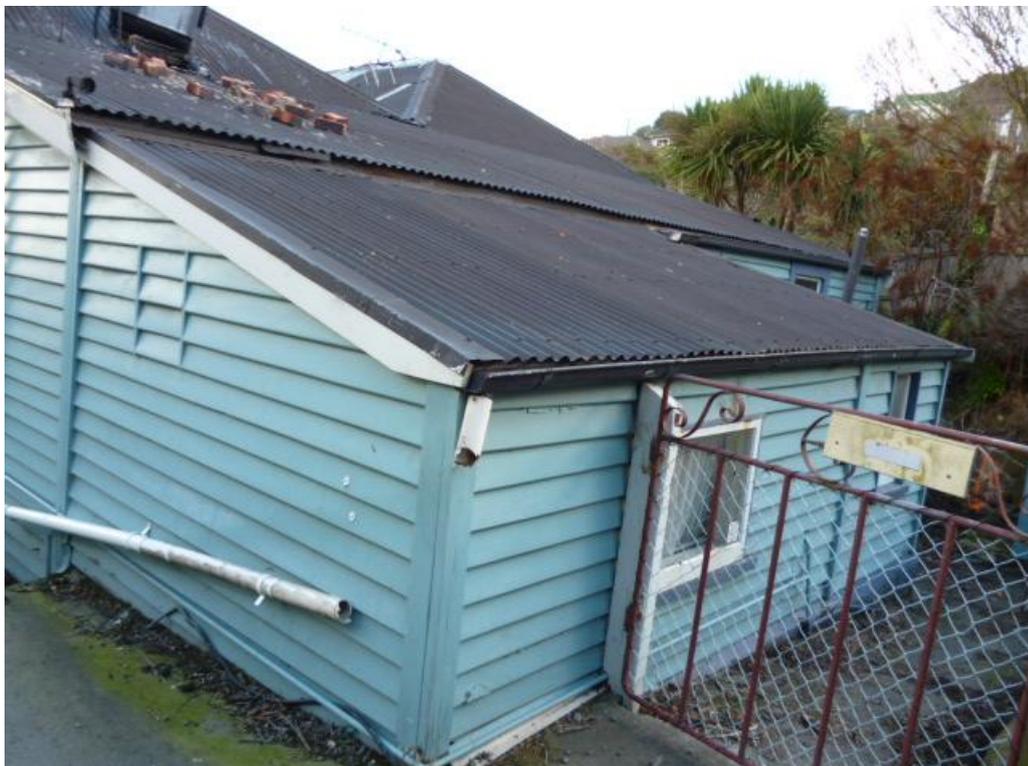
There may have been damage to the chimneys as a result of the earthquake. These have now been intentionally collapsed, either as a necessity or precaution. Subsequently, the flue masonry, which has been dropped on itself, has pushed out plasterboard wall cladding and fireplace mantels.

Photograph 4 Southern elevation and collapsed chimney.

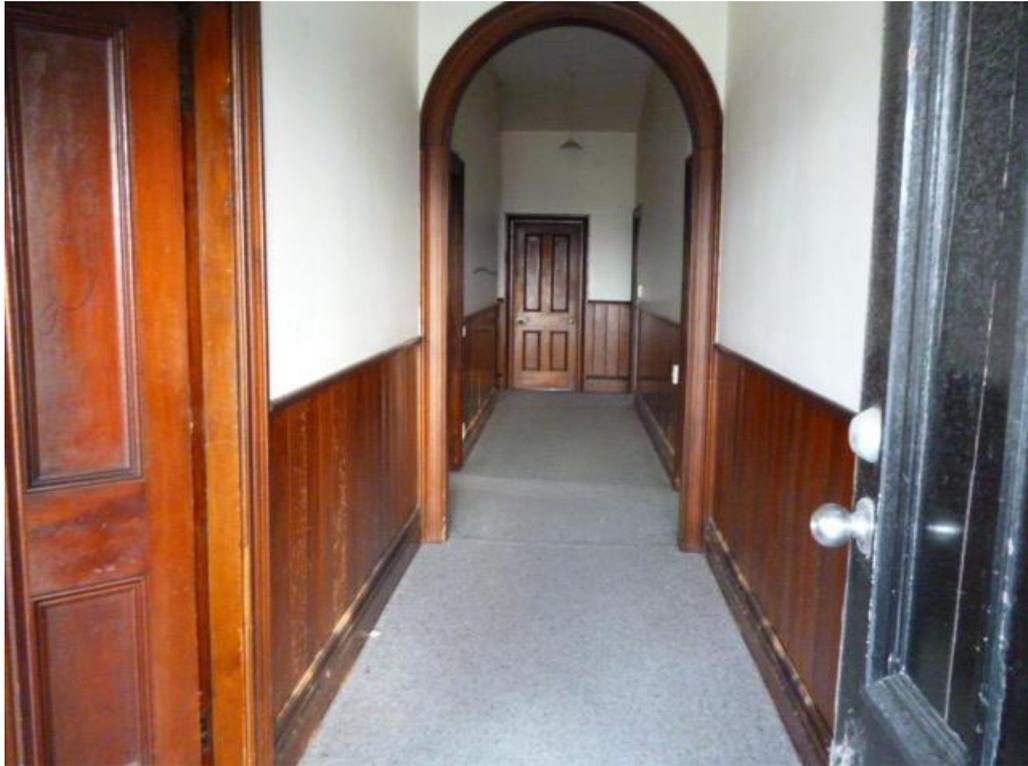
Cracking was noted to the internal plasterboard linings in several locations throughout the building and on the perimeter strip footing (see photographs 5 to 13).

Photograph 5 Hallway.

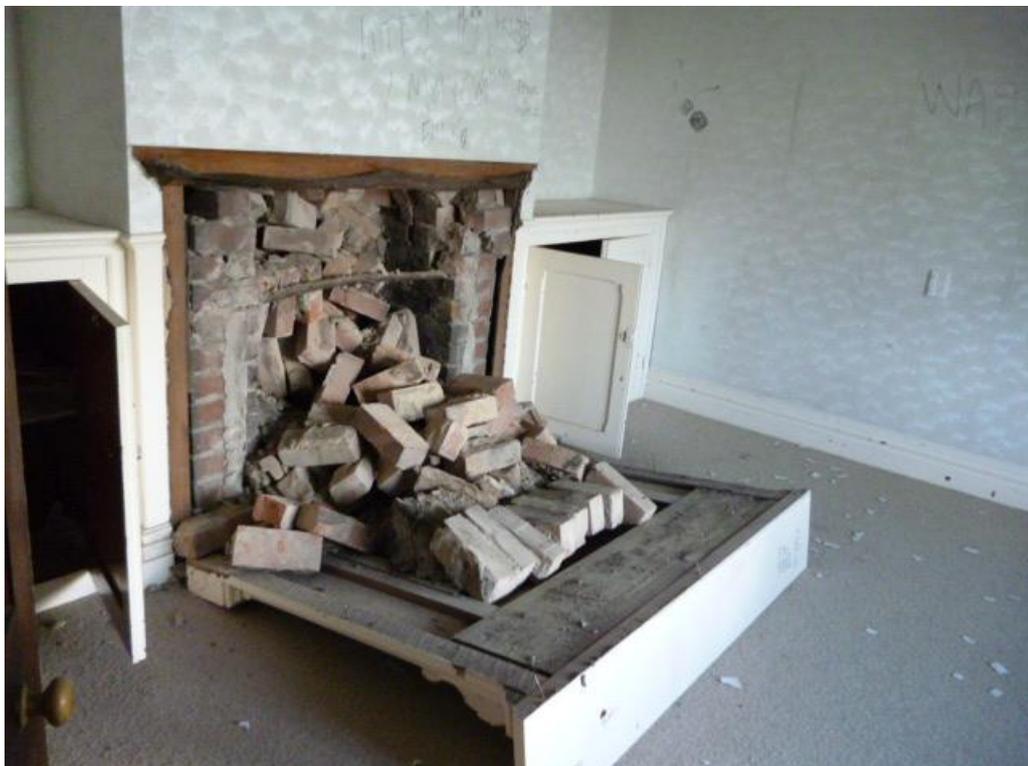
Photograph 6 Collapsed fireplace mantel.

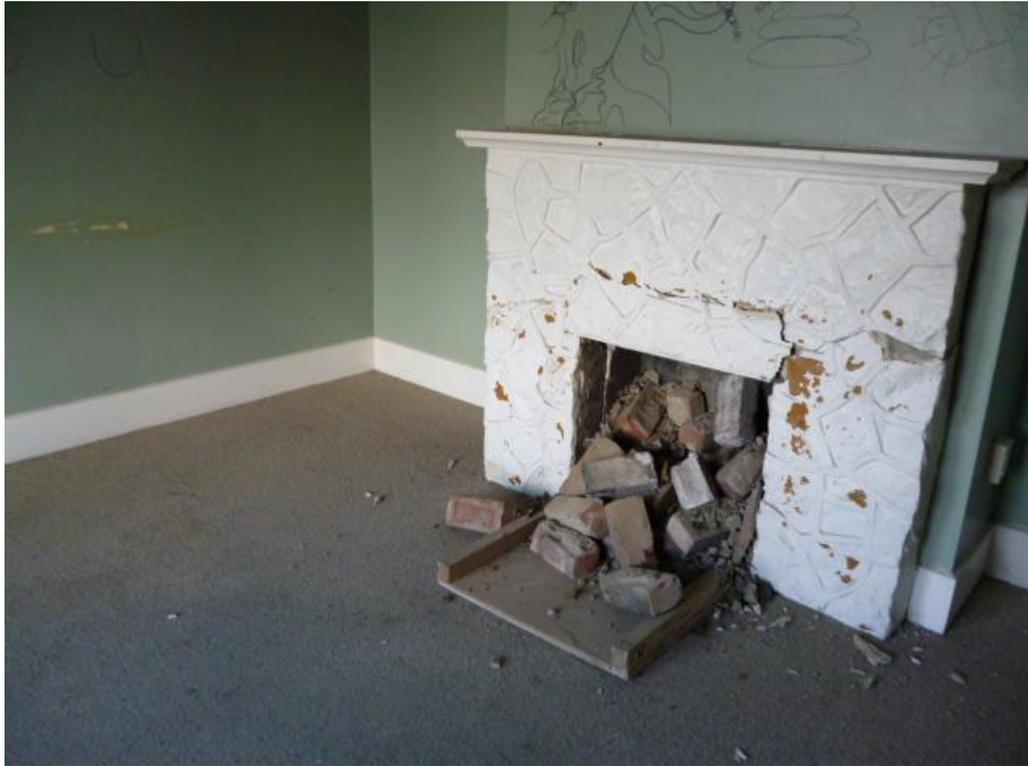
Photograph 7 Collapsed fireplace mantel.

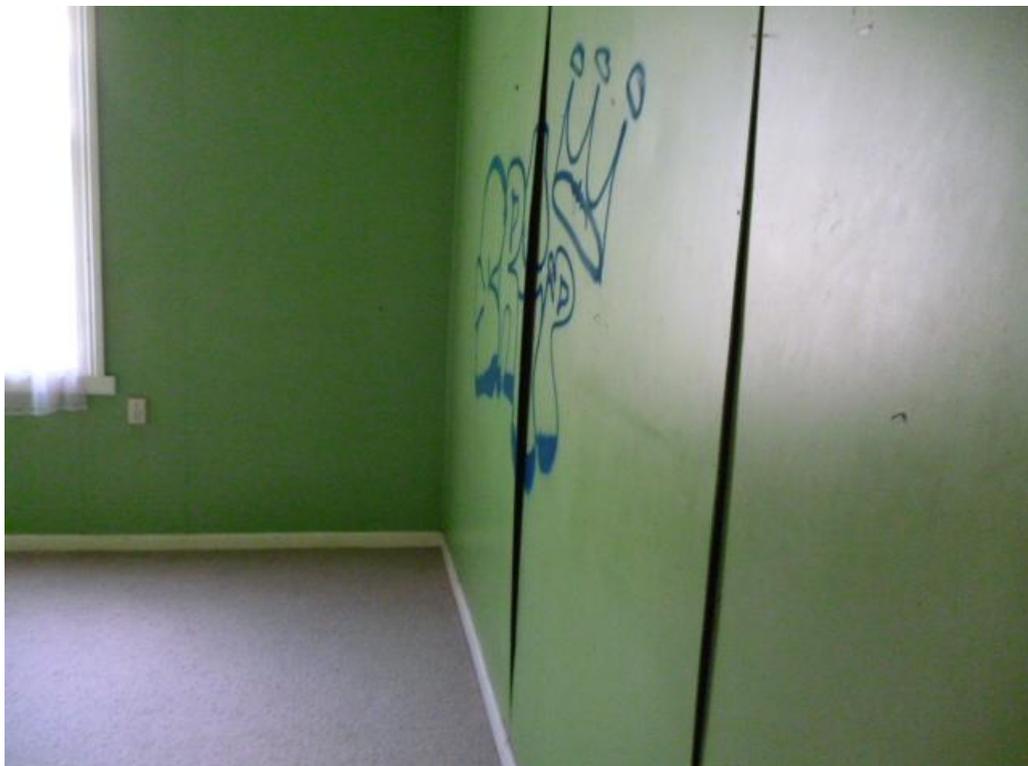
Photograph 8 Displaced plasterboard.

Level of repair/strengthening required:	<input type="text" value="minor structural"/>	Describe:	<input type="text" value="Re-attach displaced plasterboard"/>
Building Consent required:	<input type="text" value="no"/>	Describe:	<input type="text"/>
Interim occupancy recommendations:	<input type="text" value="full occupancy"/>	Describe:	<input type="text"/>

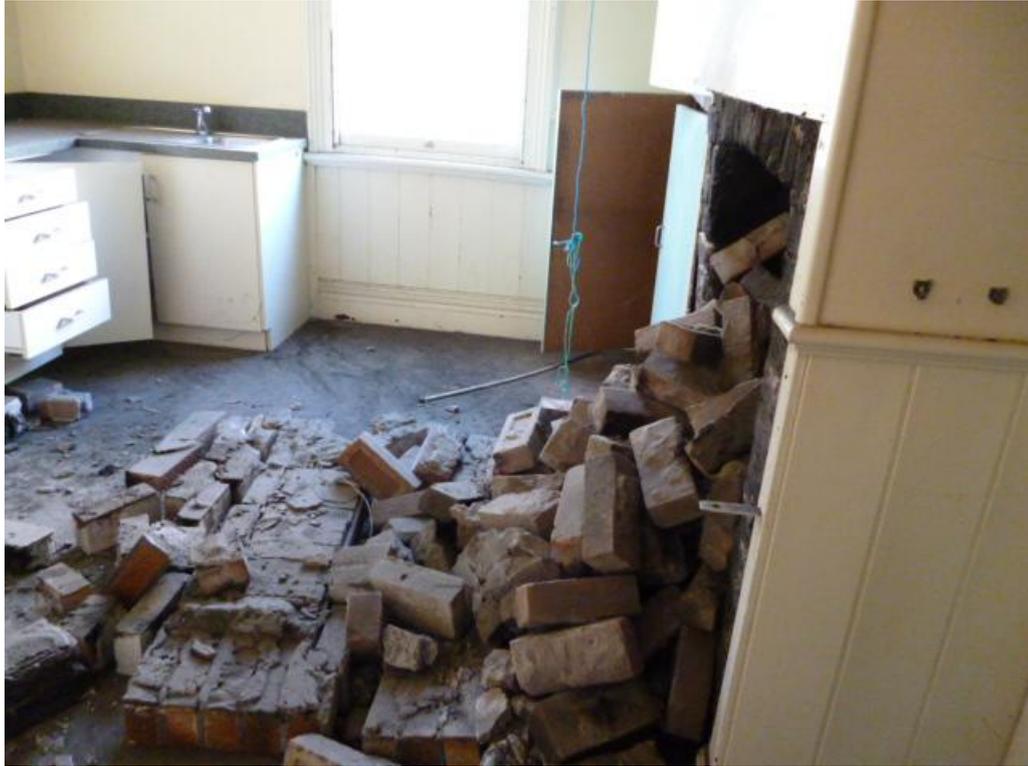
Photograph 9 Kitchen and collapsed chimney and fireplace

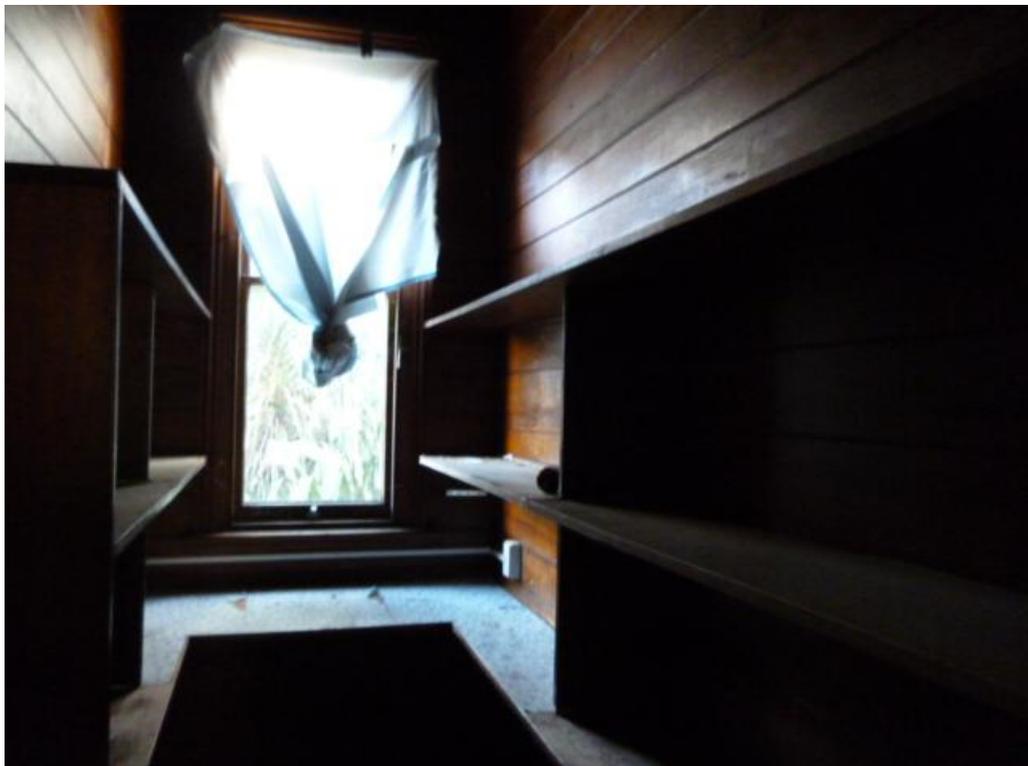
Photograph 10 Pantry

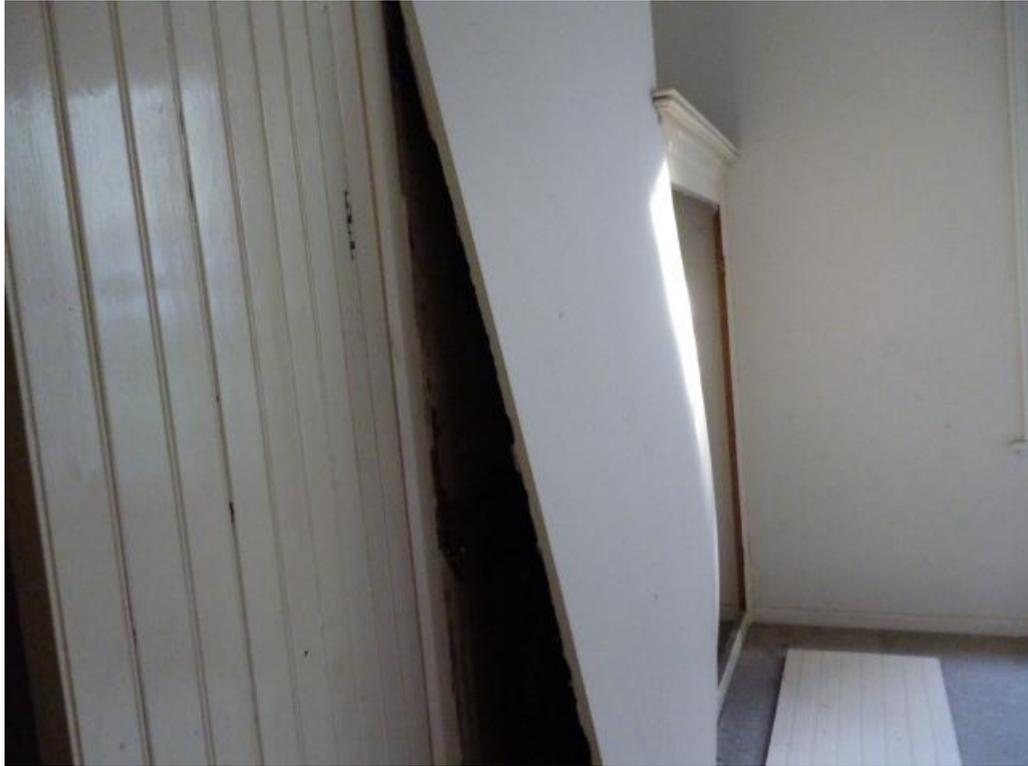
Photograph 11 Displaced plasterboard
