Ferrier Park Toilets

PRK 0224 BLDG 001 EQ2

Detailed Engineering Evaluation

Quantitative Assessment Report

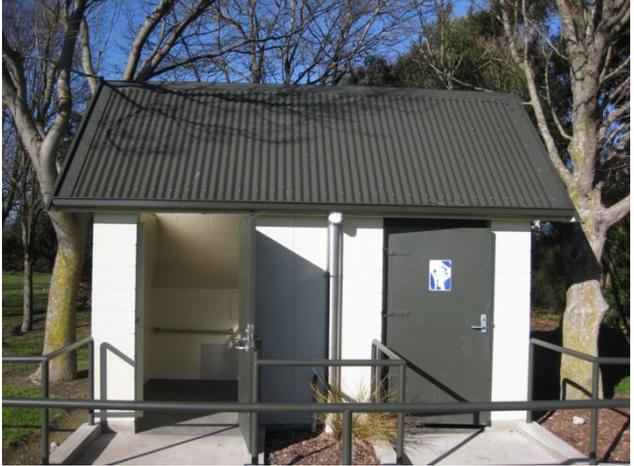
Site Name		
No.	Item description	Photo
General		
1.	Northern view of building

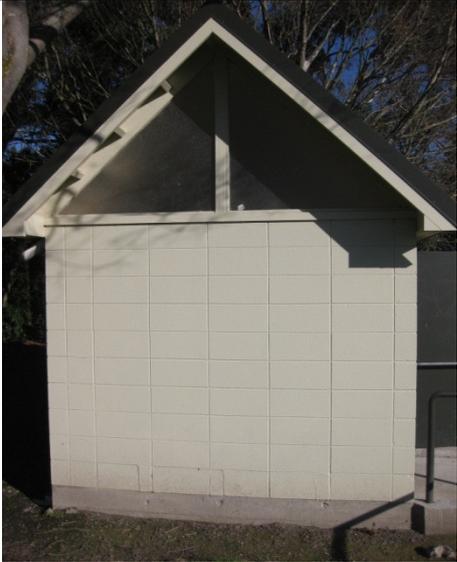
2.	Eastern view of building

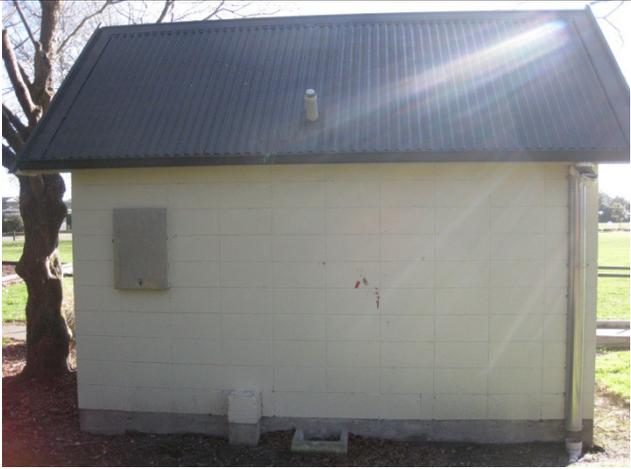
3.	Southern view of building

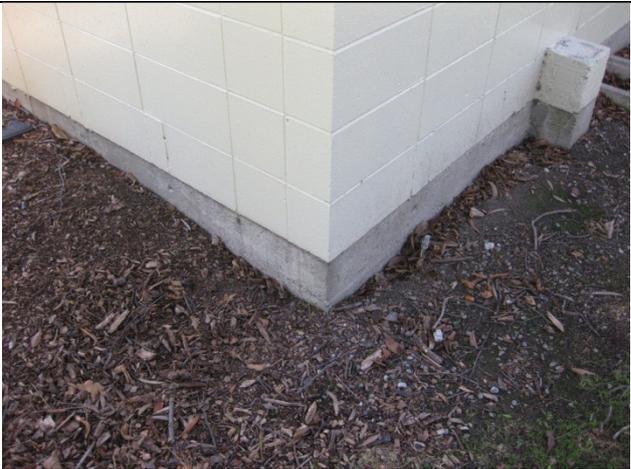
A photograph showing the southern view of a small, single-story building. The building has a dark grey corrugated metal roof and light-colored, possibly white or cream, block walls. A small white vent pipe is visible on the roof. The building is situated outdoors with trees and a grassy area in the background.
4.	Slab on ground foundations

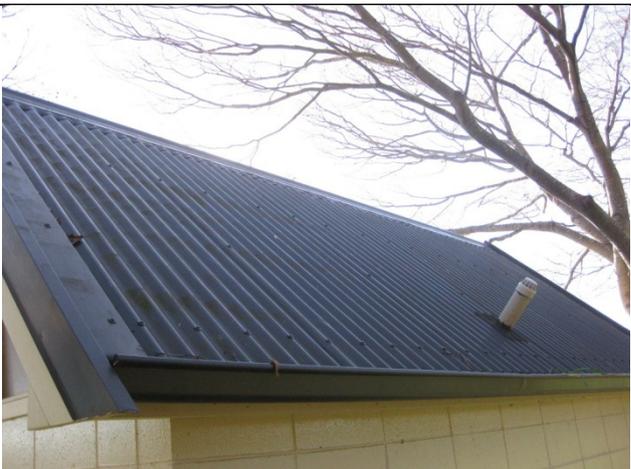
A close-up photograph of the corner of the building's foundation. The foundation is a concrete slab on ground, showing a slight overhang. The walls are made of light-colored blocks. The ground around the foundation is covered with dry leaves and some debris.
5.	Corrugated iron roof

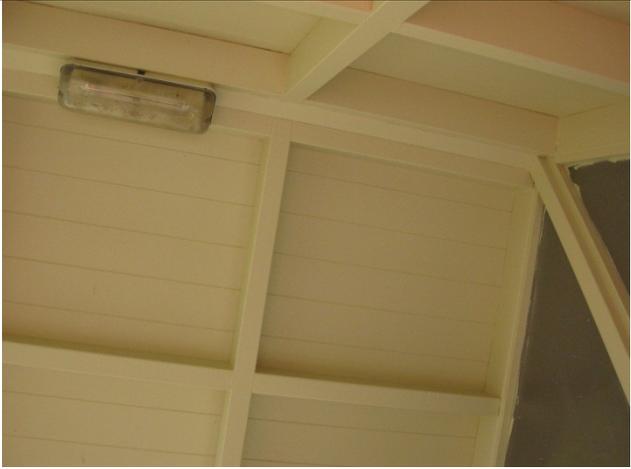
6.	Timber framed roof (sarking - no ceiling)

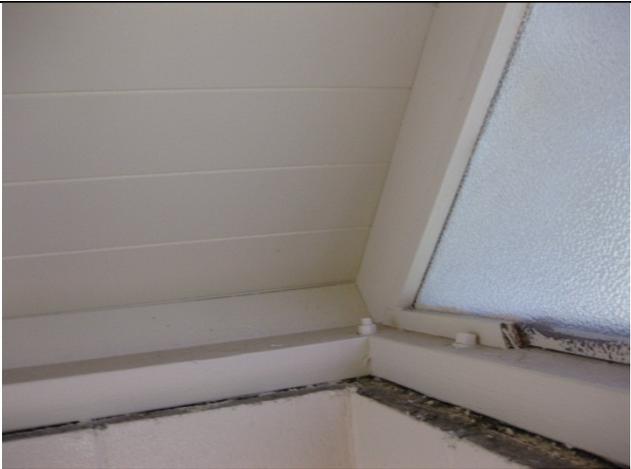
7.	Top plate on blockwork

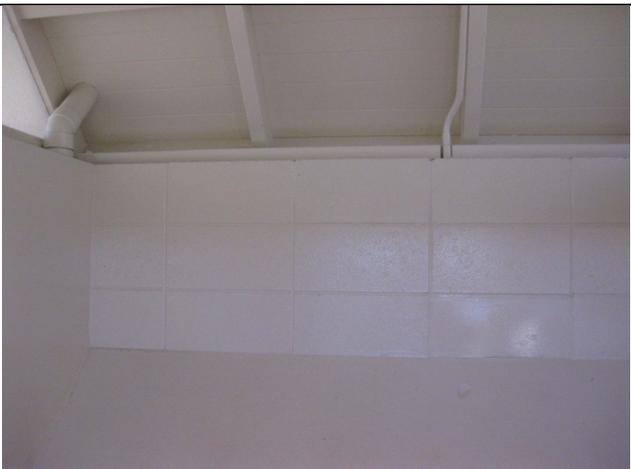
8.	Wall roof junction

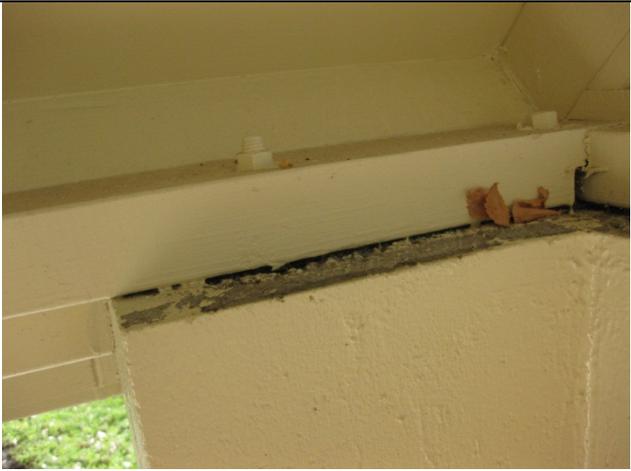
9.	Hold down bolts
