Pavillion / Toilet Ferrymead Park
PRK 2628 BLDG 001
Detailed Engineering Evaluation
Qualitative Report
Version Final

50 Ferrymead Park Drive, Ferrymead

Christchurch City Council

Date
17th May 2013

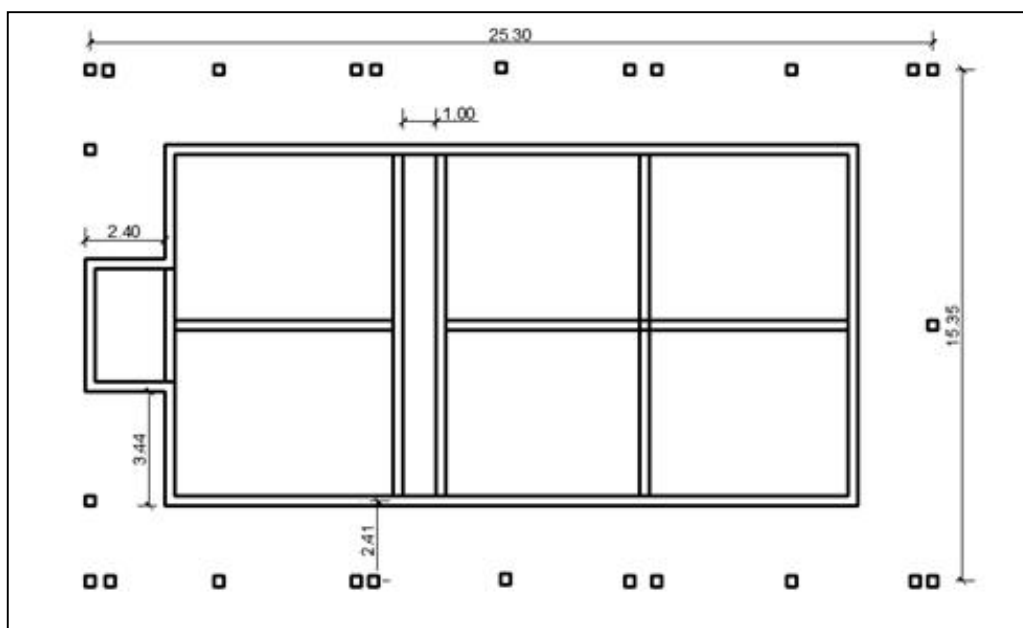
Figure 2 Plan Sketch Showing Key Structural Elements

The structure is found on a concrete slab on grade and it is assumed to have strip footings. The foundations support concrete masonry walls which rise to 2.4m internally and 0.8m high on the exterior elevations. Each of these masonry walls has timber framed walls built on top which support a timber roof structure. All timber walls are clad with plywood.

The roof is timber framed and is covered by a plywood ceiling. Rafters and purlins have adequate bracing to provide a diaphragm for the building. The roof extends further than the walls forming a veranda around the exterior of the building. This is supported by 170 x 170 mm timber columns on its outer edge.

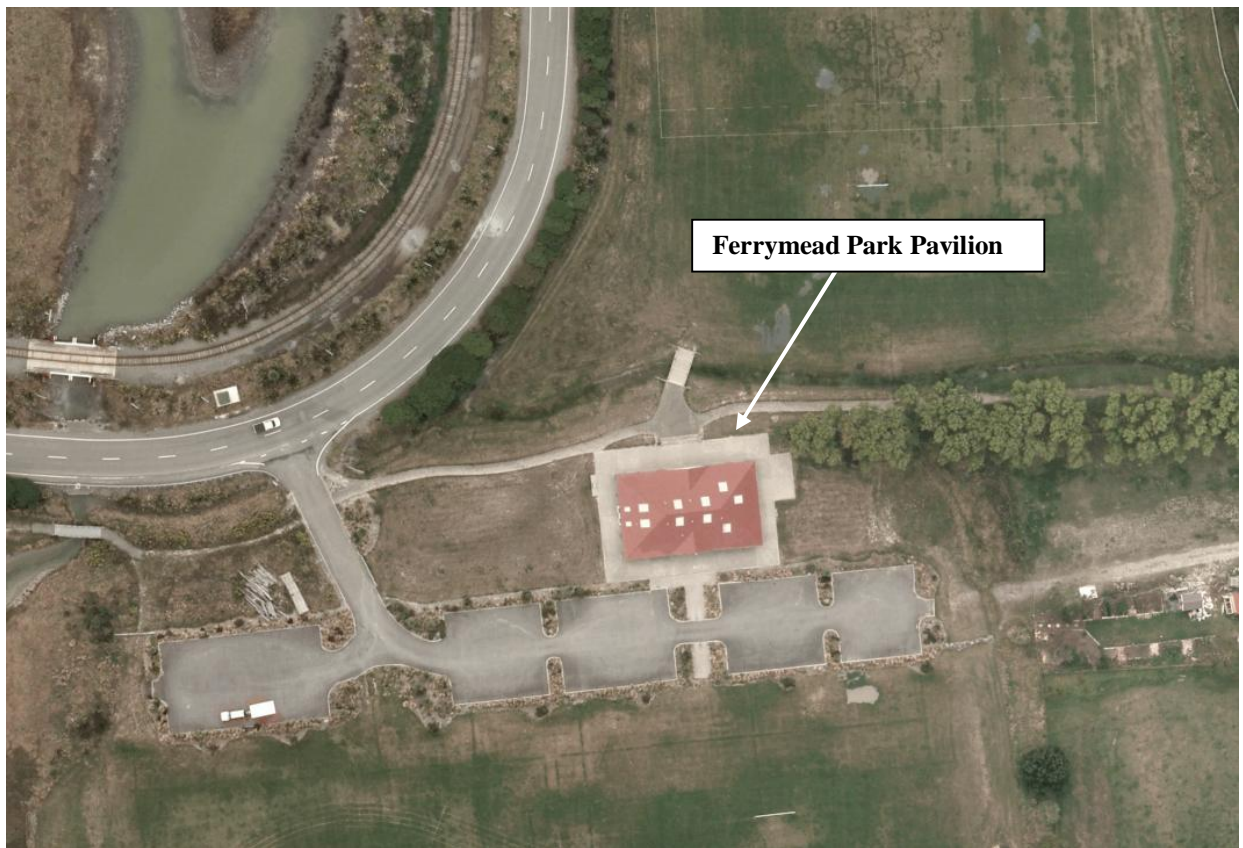
Figure 3 Post February 2011 Earthquake Aerial Photography ²

Aerial photography taken following the 22 February 2011 earthquake shows no signs of liquefaction outside the building footprint, but minor evidence is visible to the north of the building, as shown in Figure 3.

Due to the relative paucity of location-specific ground information, and location of the site, it is recommended that intrusive investigation comprising at least one piezocone CPT be conducted. This will allow a more comprehensive liquefaction and/or ground condition assessment to be carried out, and result in the recommended soil class being better defined.

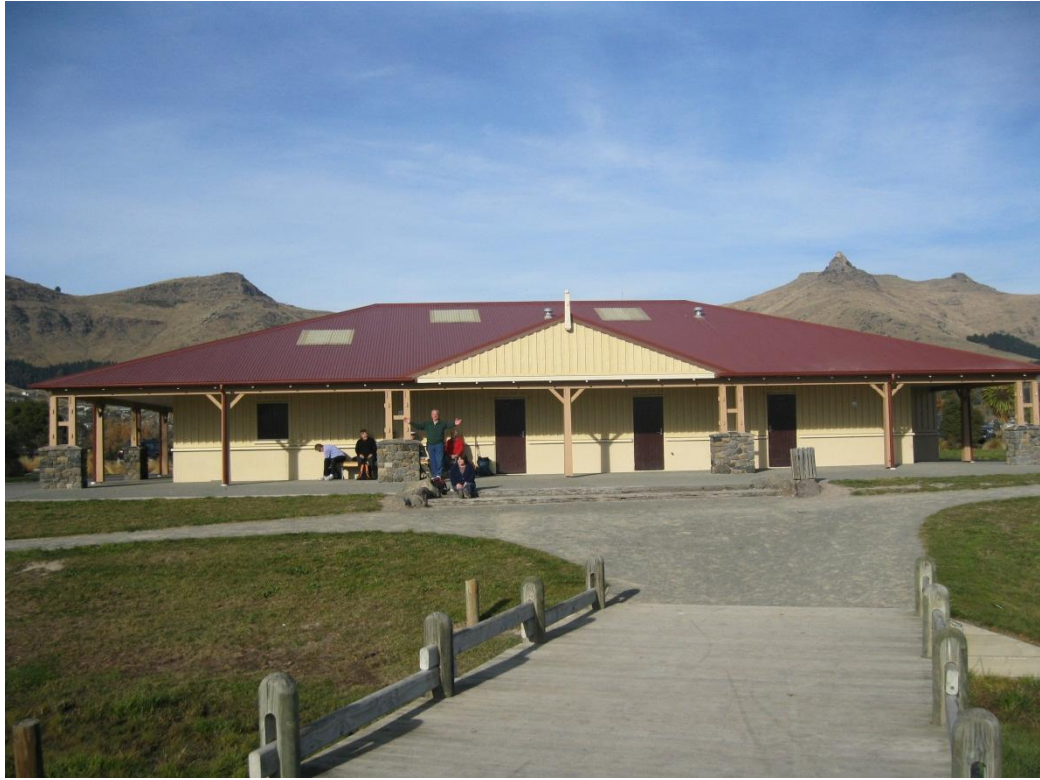
Photograph 1 North elevation.

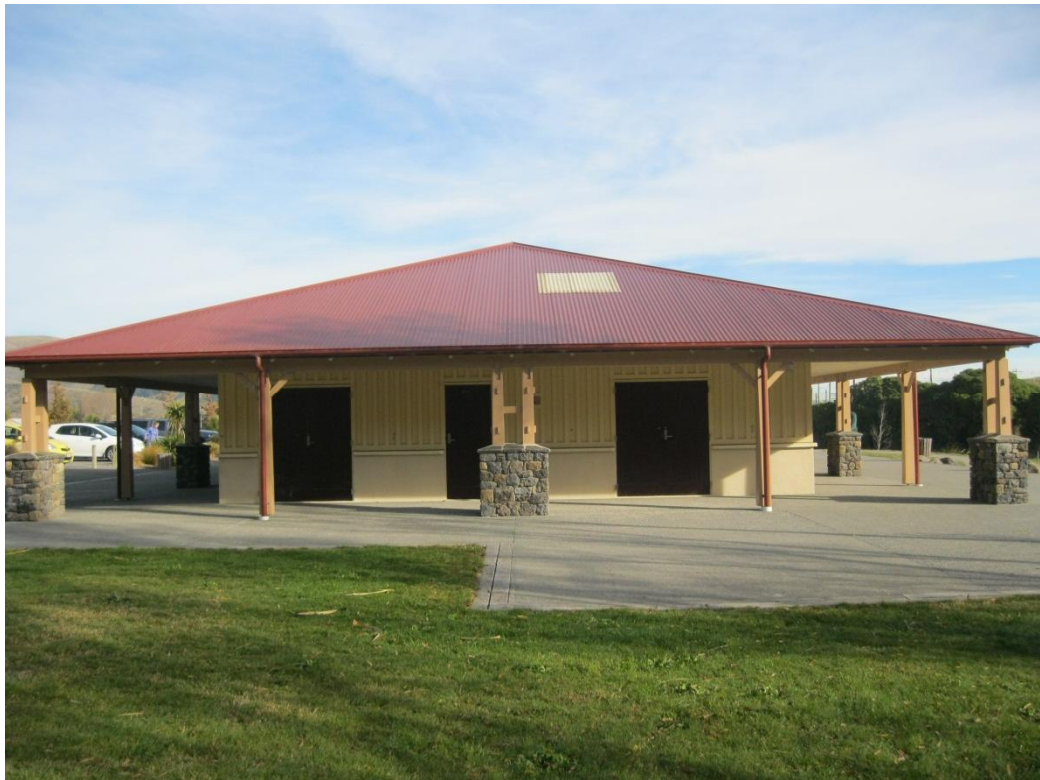
Photograph 2 East Elevation.

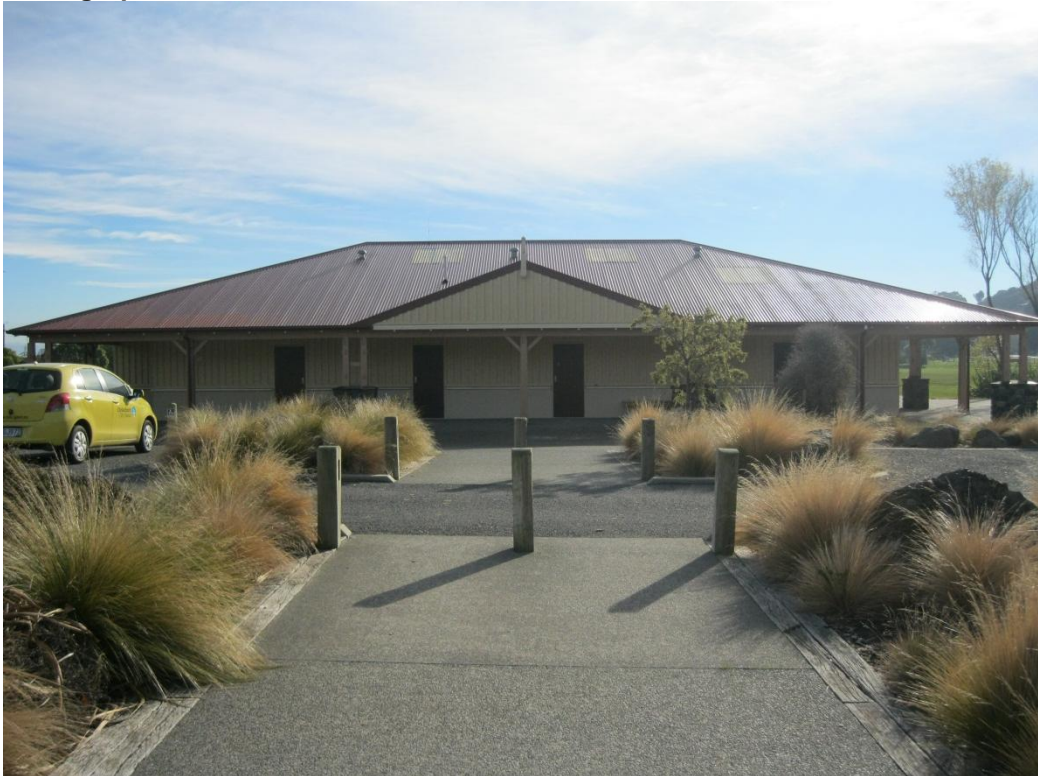
Photograph 3 South Elevation.

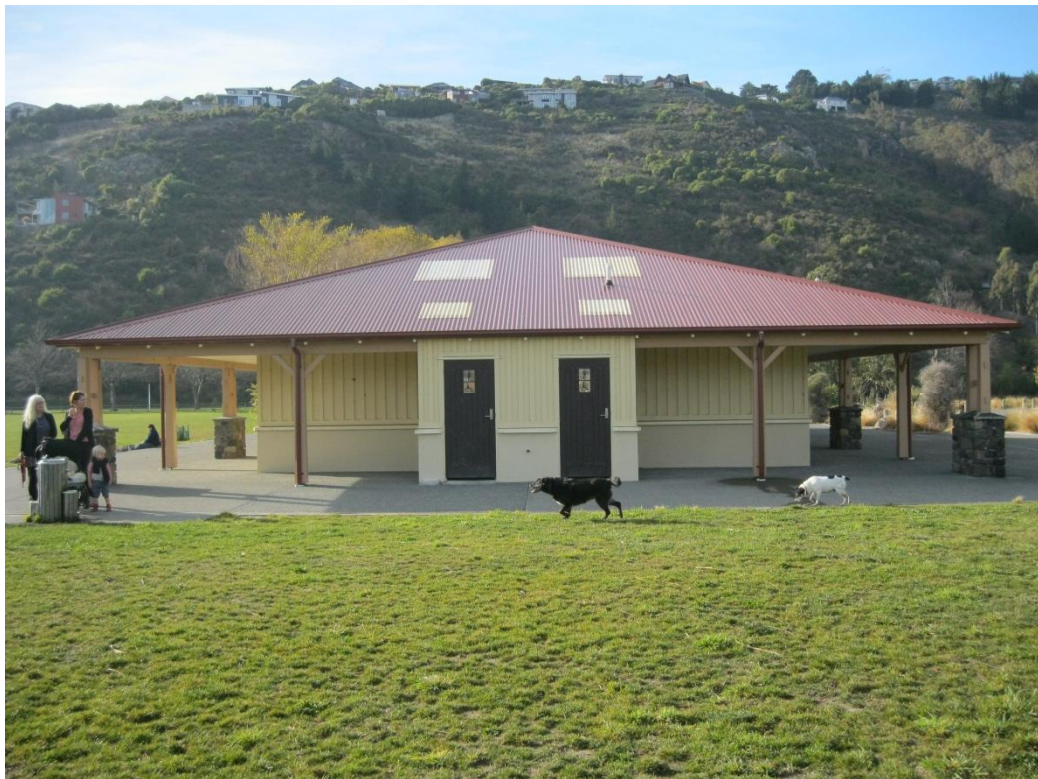
Photograph 4 West Elevation.

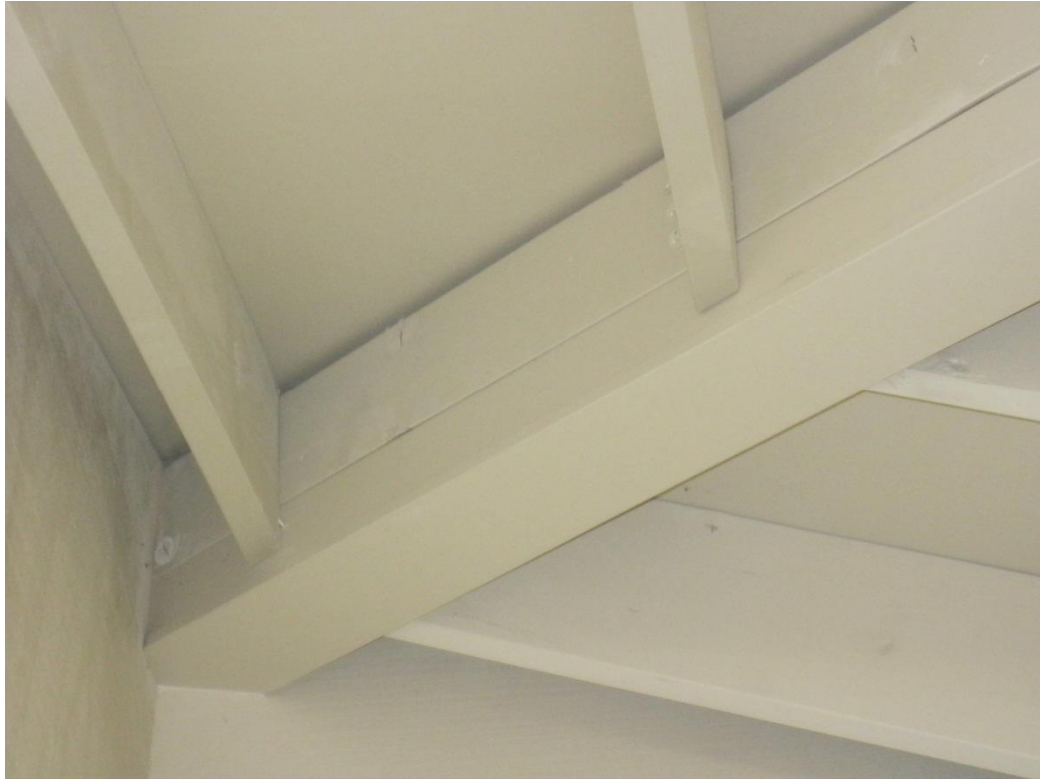
Photograph 5 Roof structure.

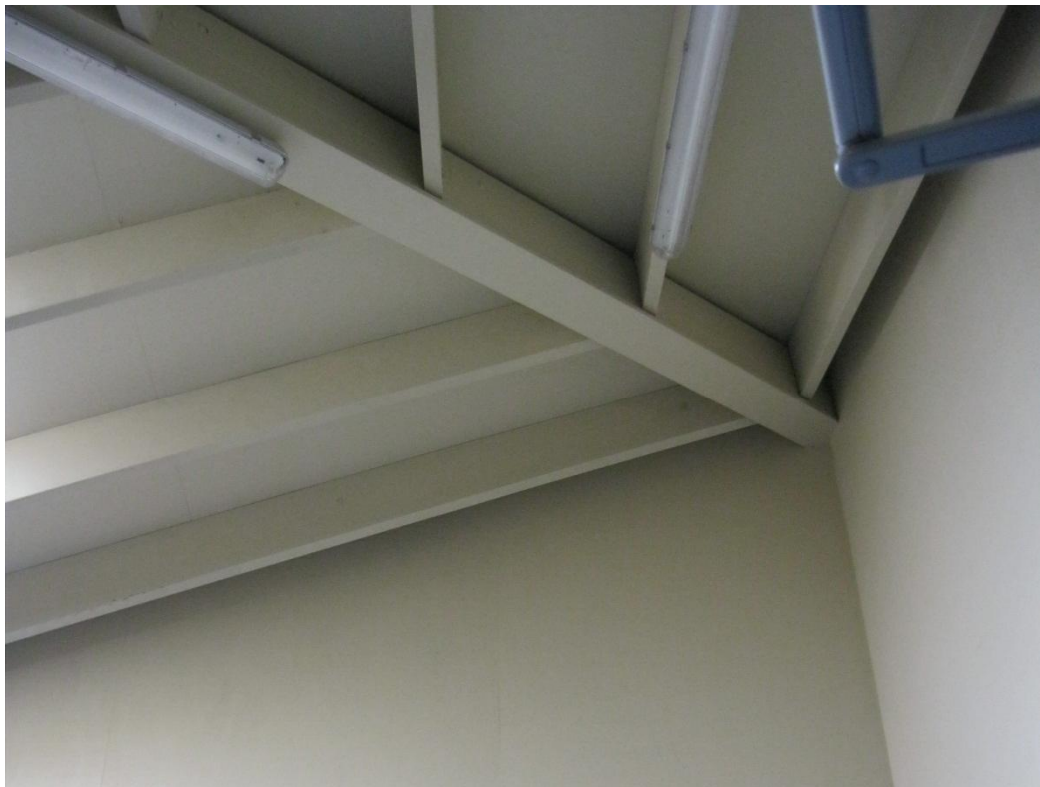
Photograph 6 Roof structure.

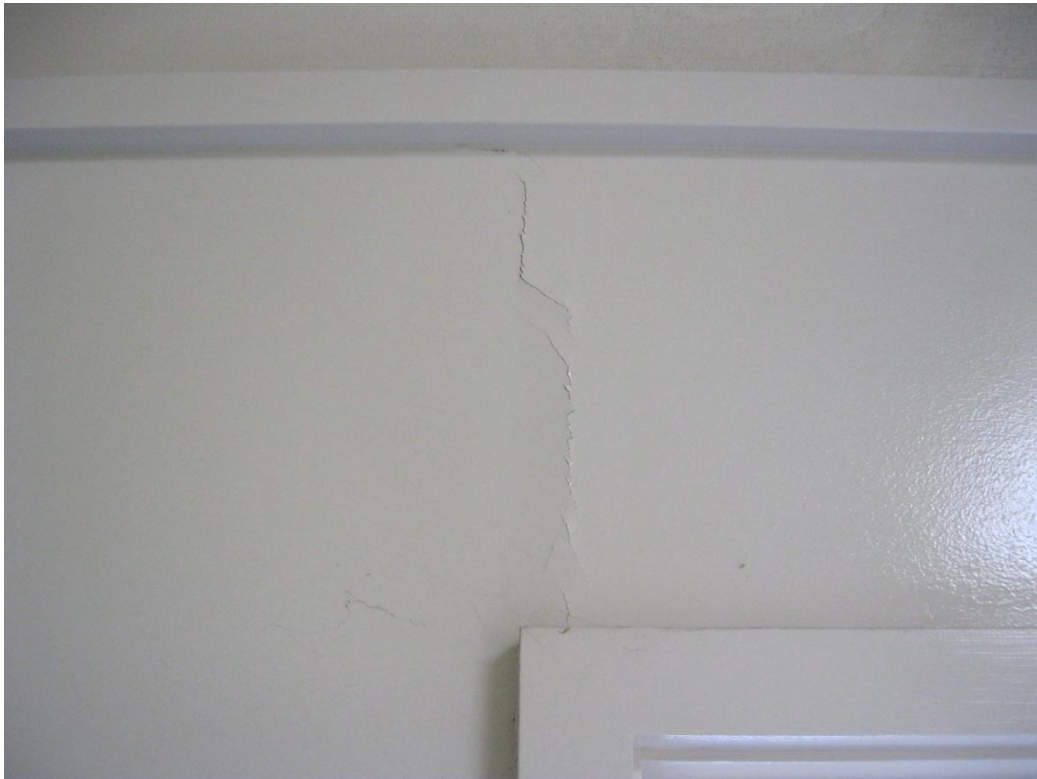
- Loose stone veneer around the base of the columns.
- ~ 10 mm openings between the paving slabs.
- Paint flaking on the interior of the building.

Photograph 7 Flaking of paint work.

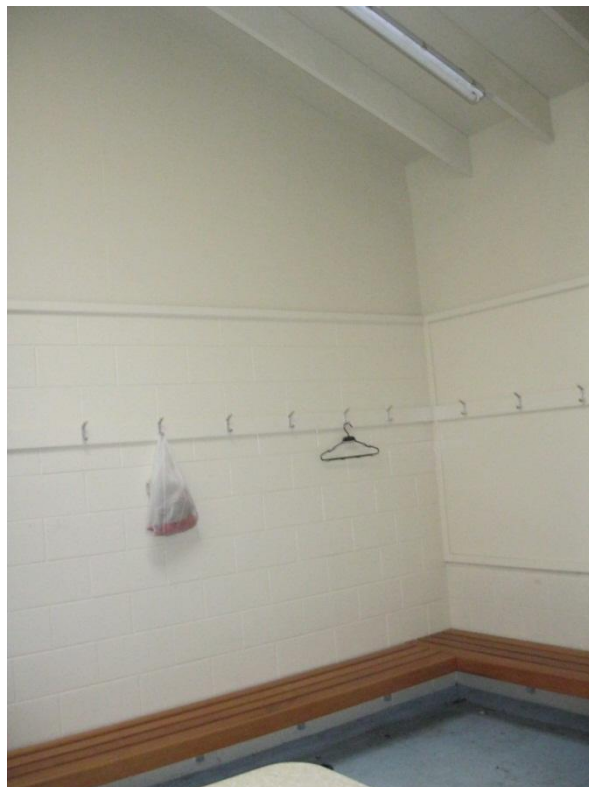
Photograph 8 Timber and masonry Interior wall.

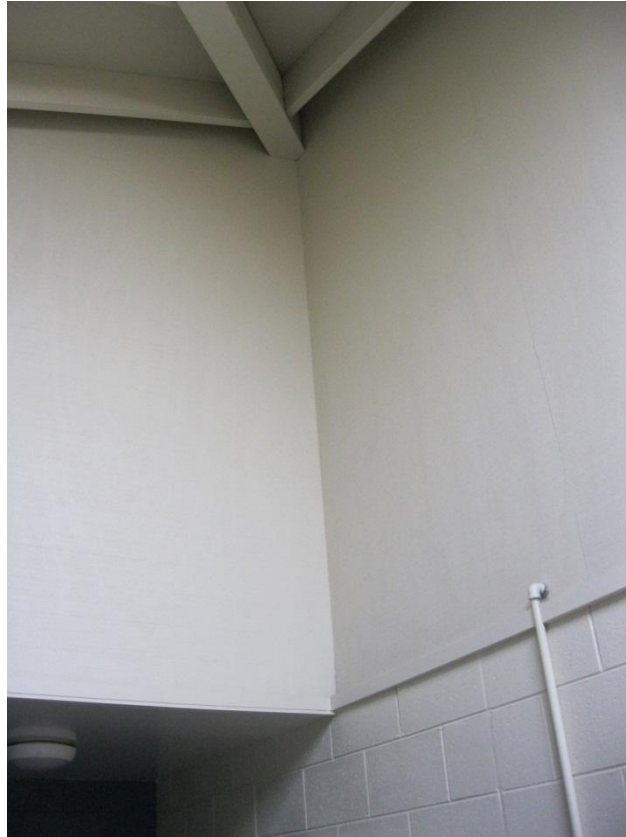
Photograph 9 Timber and masonry interior wall.
