**Fletcher Place  
Housing Complex  
PRO 0230**

**Detailed Engineering Evaluation  
Quantitative Assessment Report**

# **Fletcher Place Housing Complex Quantitative Assessment Report**

**Fletcher Place, Riccarton, Christchurch**

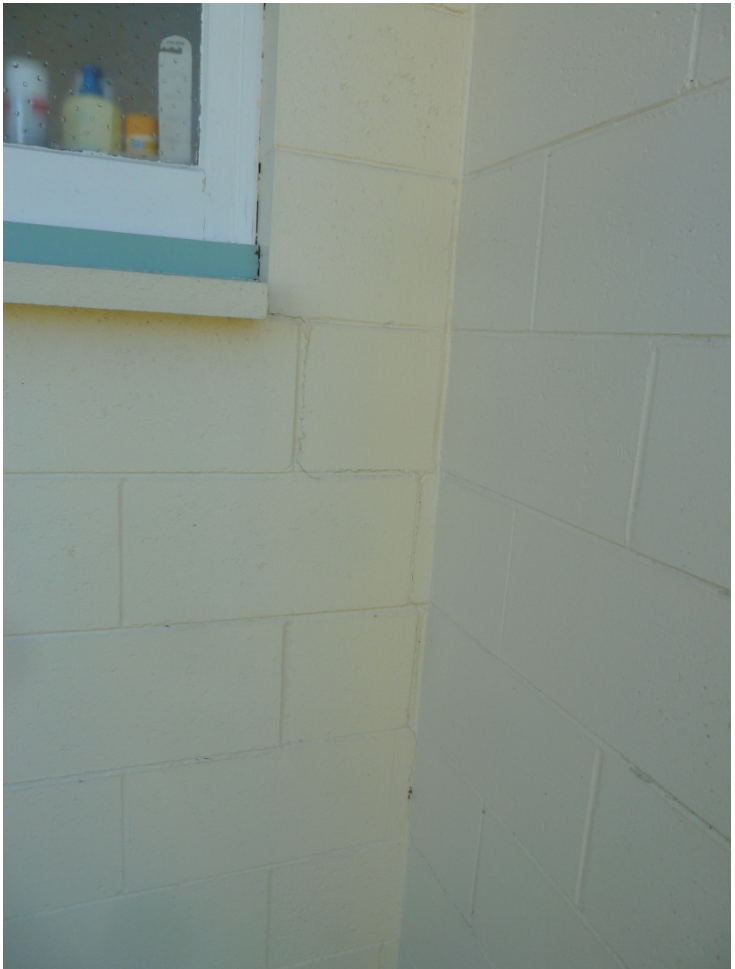
Minimal stepped cracking in the concrete block and brick veneer exterior cladding mortar joints was observed on some of the units.

A photograph showing the interior of a floor void. Several white PVC pipes are visible, some with blue tape. The void is lined with brown insulation material. The floor below is covered with orange plastic sheeting.
Residential Units - Damage		
10.	Typical stepped cracking of block veneer

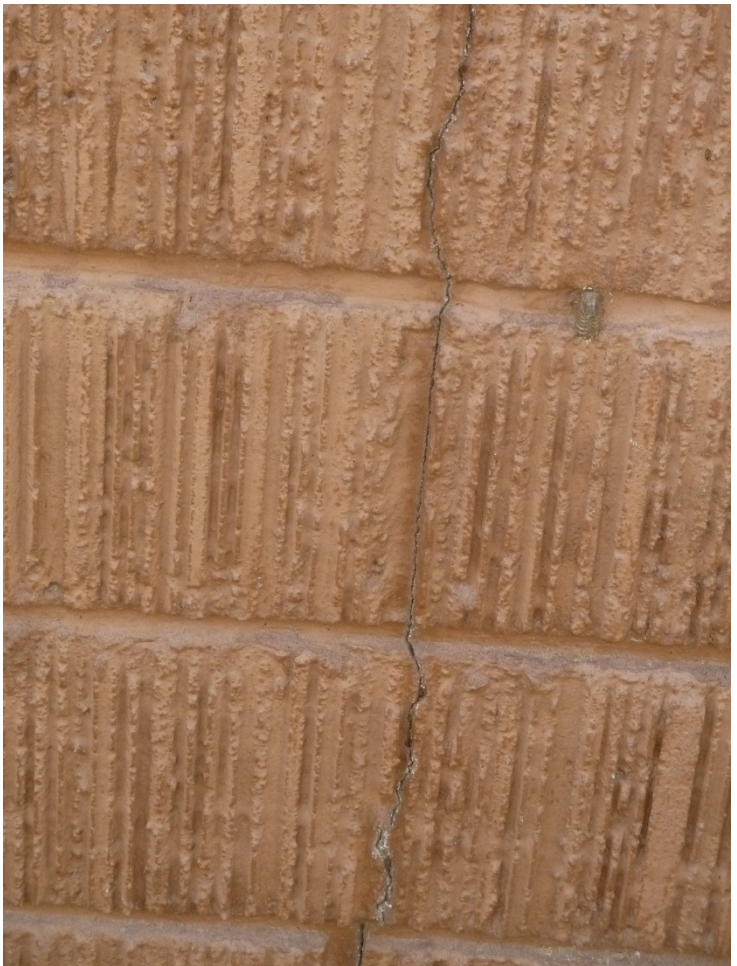
A photograph showing a section of red brick veneer. The bricks are laid in a standard running bond pattern with light-colored mortar. A vertical crack is visible, extending through several courses of bricks. The crack is located near the top of the frame, where it meets a white horizontal surface, possibly a window sill or a ledge. The lighting is bright, casting shadows that emphasize the texture of the bricks and the depth of the crack.
<p>12.</p>	<p>Typical cracking of brick veneer</p>

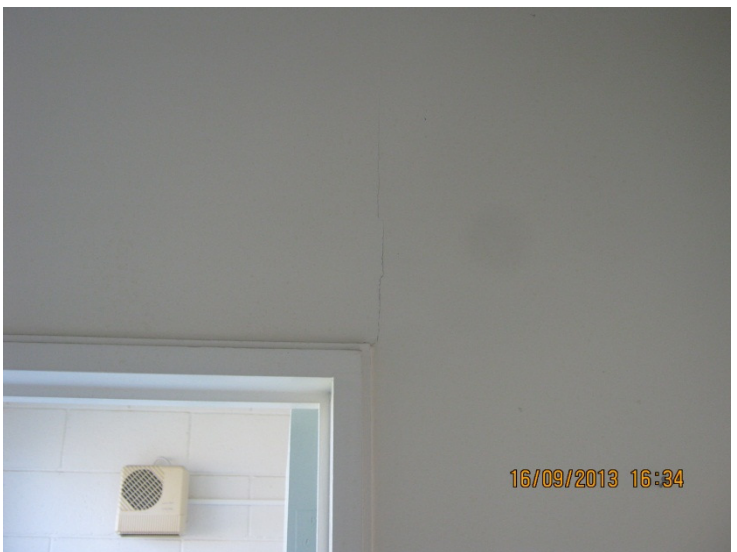
Minimal cracking of plasterboard ceiling diaphragms and wall linings was observed in the units. This form of damage is common throughout the units.

13.	Typical cracking of gib linings

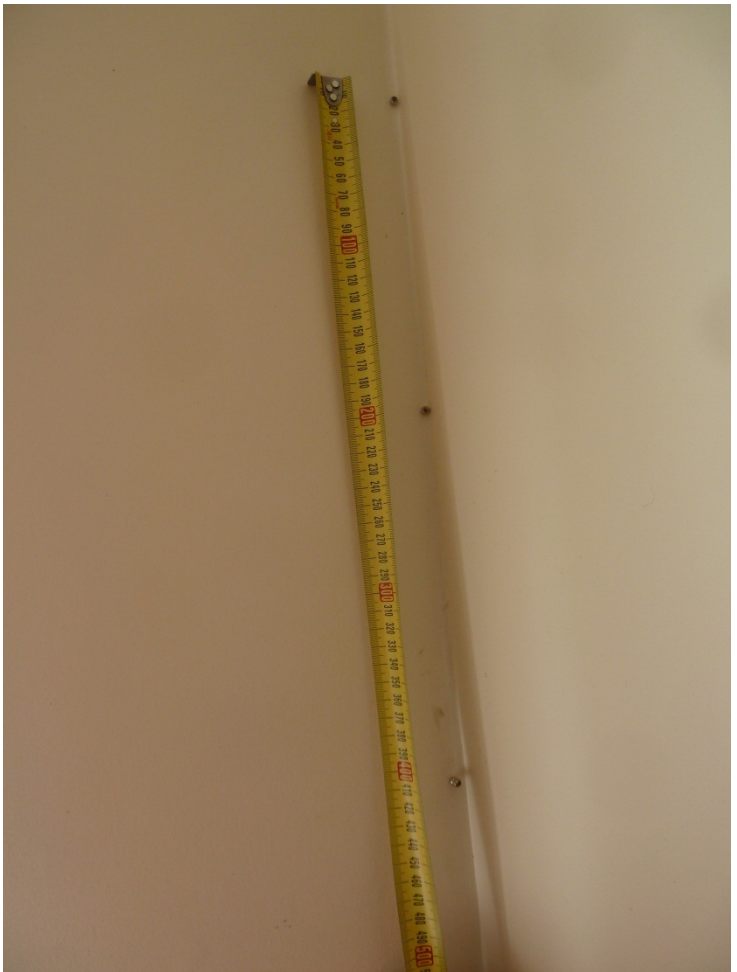
Increasing the number of nails in the plasterboard will not significantly improve the strength of the buildings.

14.	Typical spacing of interior lining fixings

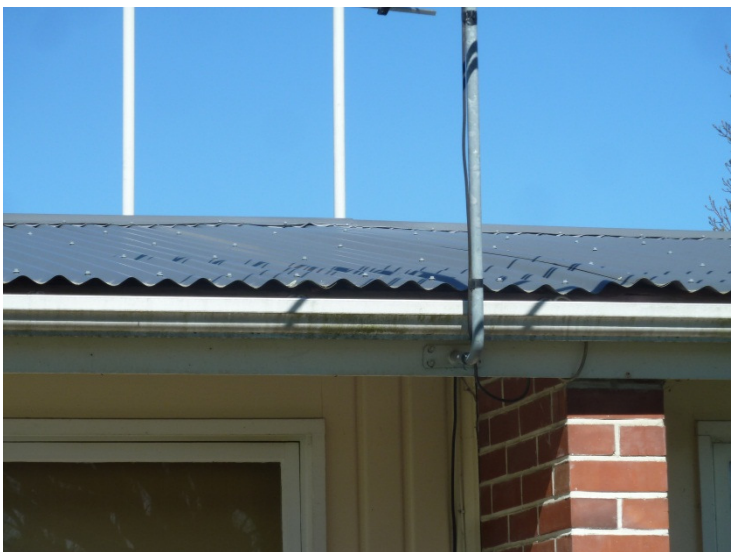
The roofline has been damaged between Unit 10 and 11, where a fire wall may have been subject to differential settlement and movement of the wall during earthquake actions (photo 15).

15.	The roofline between Unit 10 and 11 shows some upward movement along the line of the firewall

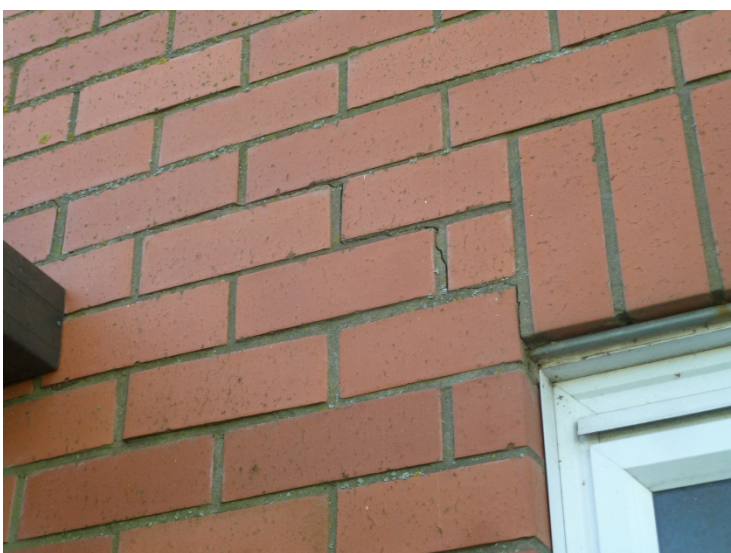
<p>20.</p>	<p>Typical cracking of brick veneer</p>

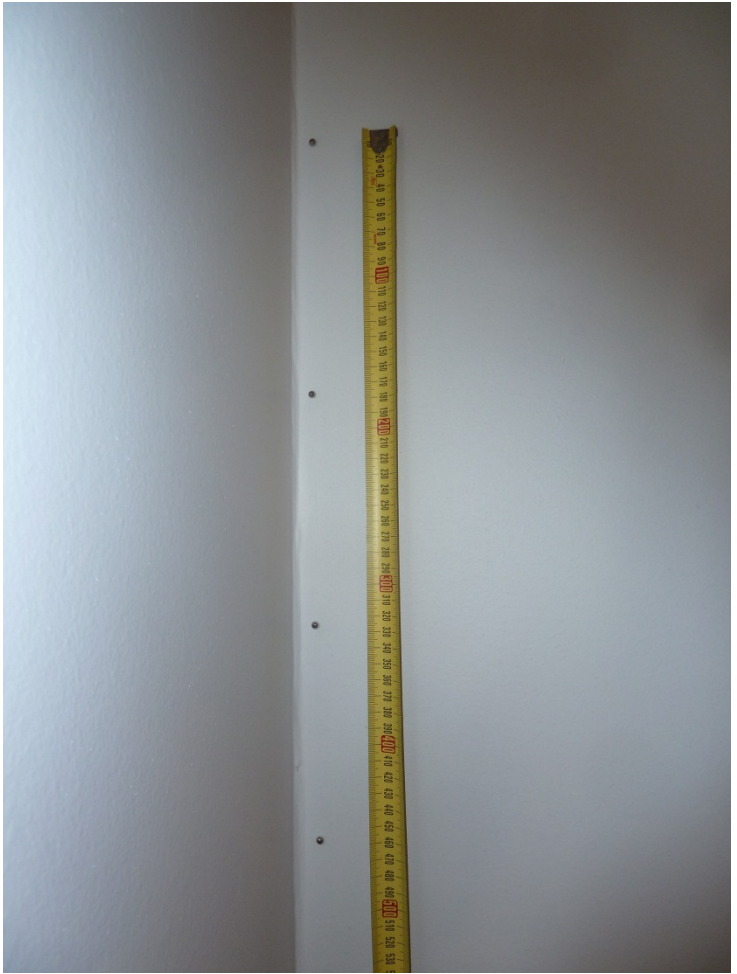
<p>21.</p>	<p>Typical spacing of interior lining fixings</p>
