Fred Price Courts Housing Complex BE 1323

**Detailed Engineering Evaluation
Quantitative Assessment Report**

**76 Palmers Road, North Beach,
Christchurch**

Date: 30 April 2013
Reference: 6-QC128.00

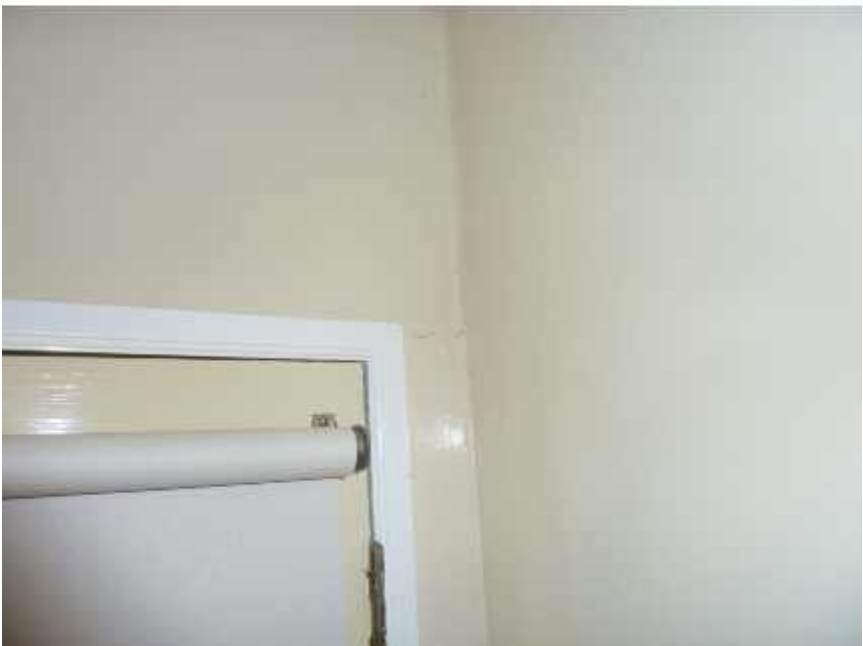
10.	Typical Internal Lining Damage

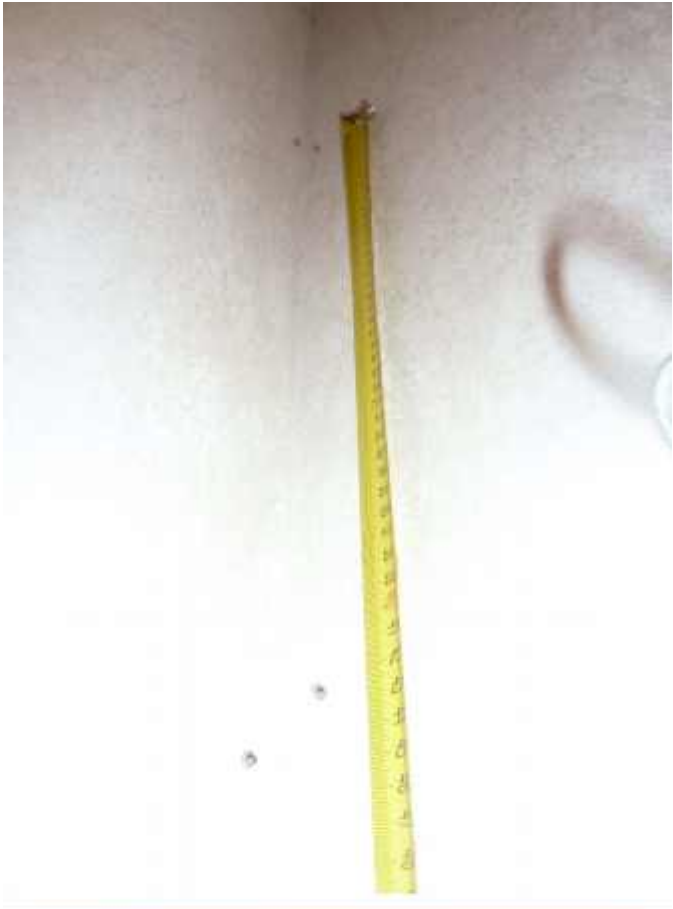
The spacing of GIB nails was checked in several locations throughout the site. This showed some locations had nail spacing of up to 450mm which is inadequate for bracing purposes. Due to the non-intrusive nature of the original survey, many other connection details could not be ascertained.

14.	450mm GIB Nail Spacing (Unit 32)

- Check GIB nail spacing in all units and remediate as necessary.
- Strengthening options be developed to increase the seismic capacity of the buildings to at least 67%NBS.
- Investigate which units have piles.
- More level survey data will be required to assist the damage assessment for insurance.

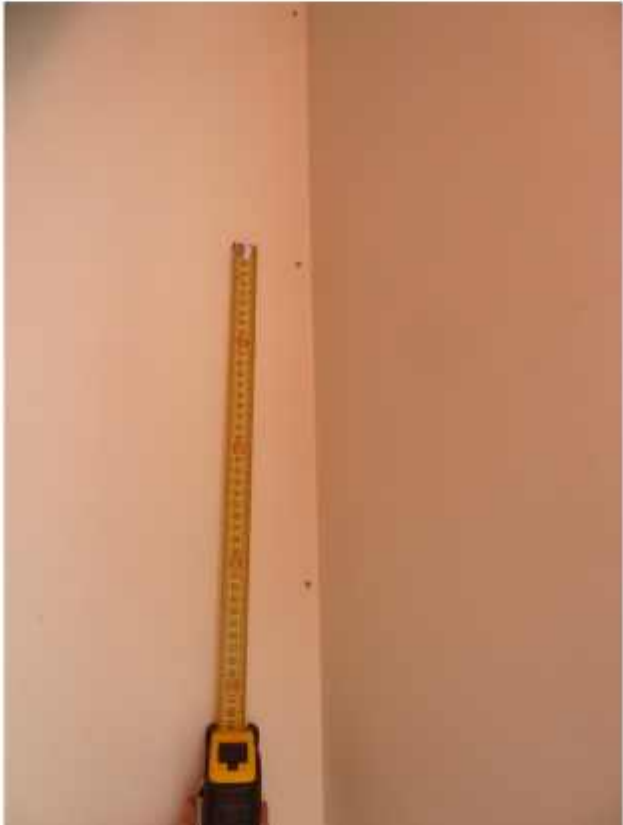
15.	300mm GIB Nail Spacing (Unit 1)

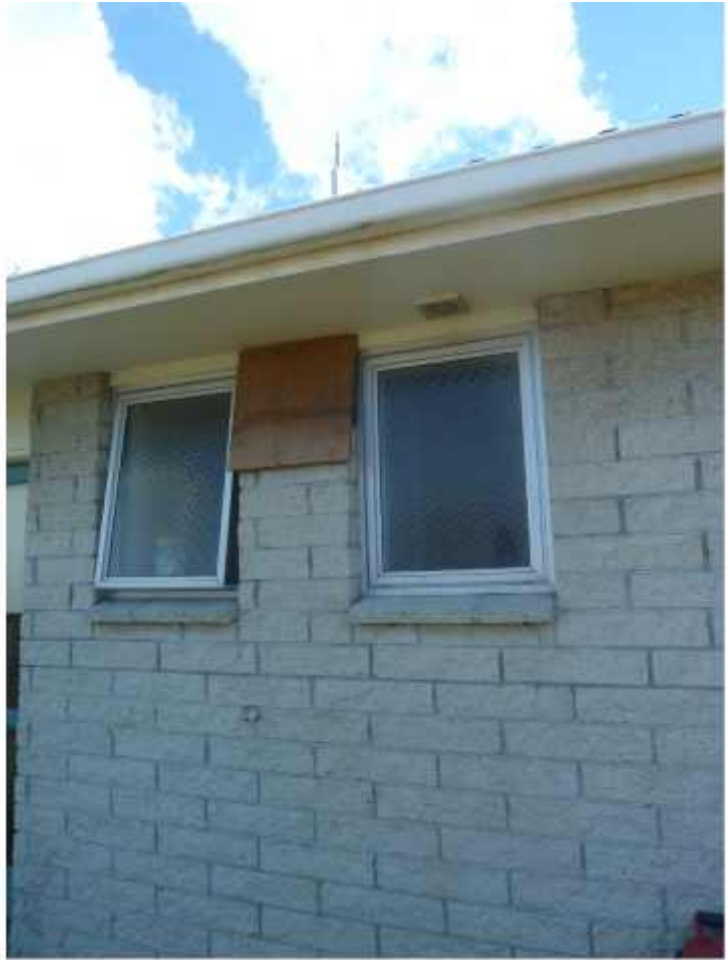
18.	Veneer removed and covered

- Veneer ties checked for adequacy and corrosion.

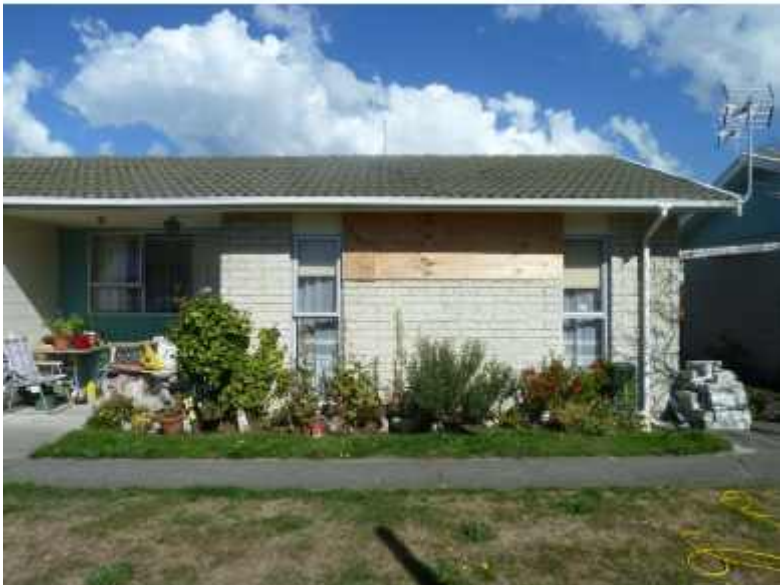
19.	Veneer removed and covered -Unit 37

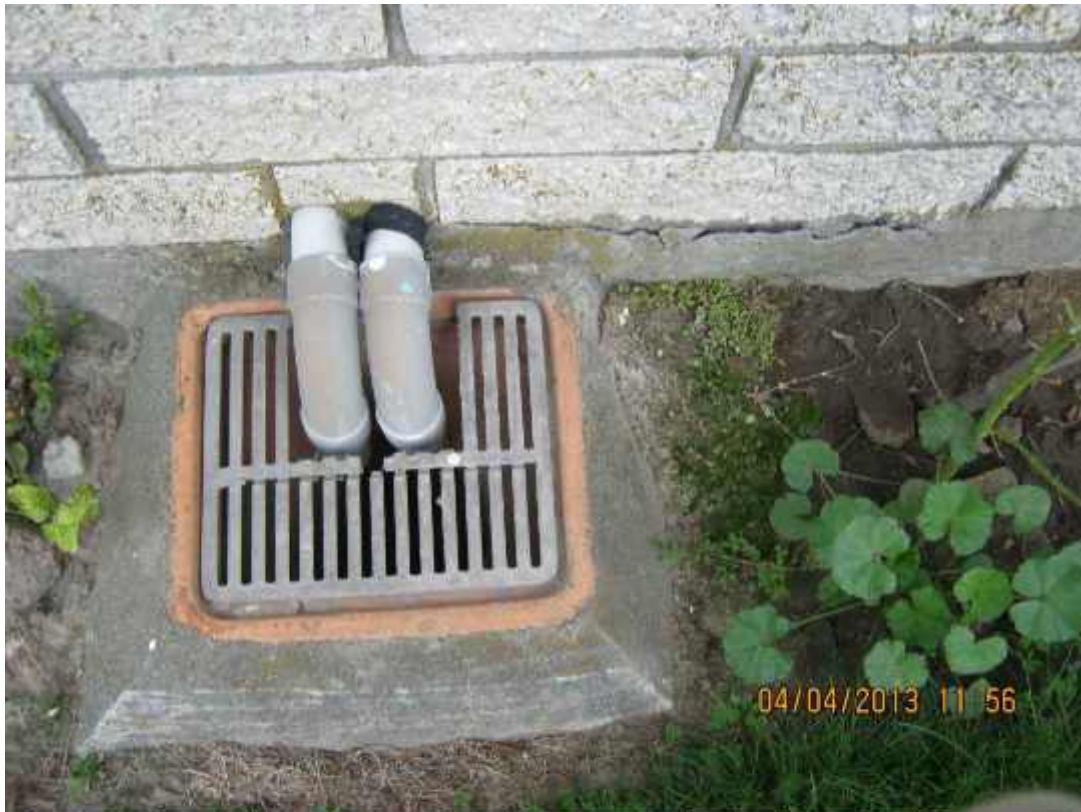
Photograph 1: Spalling of concrete from the perimeter footing observed on the western side of Unit 2.

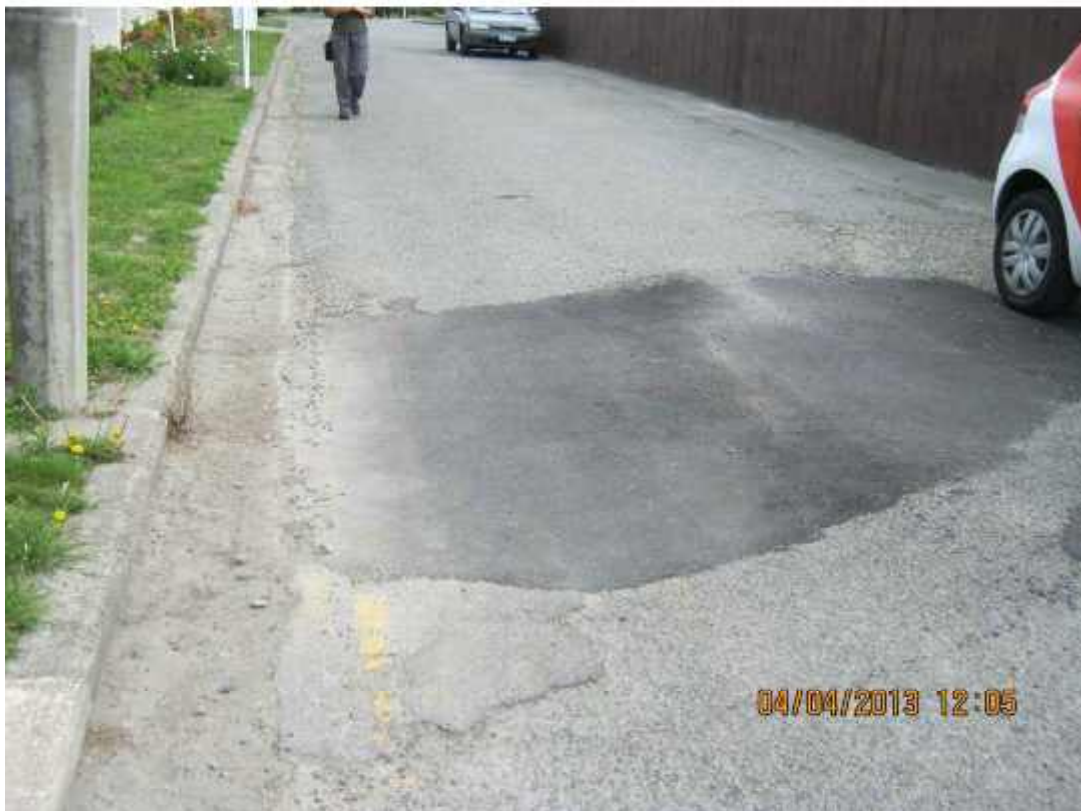
Photograph 2: View of driveway surface in poor condition, north of Units 1-6.

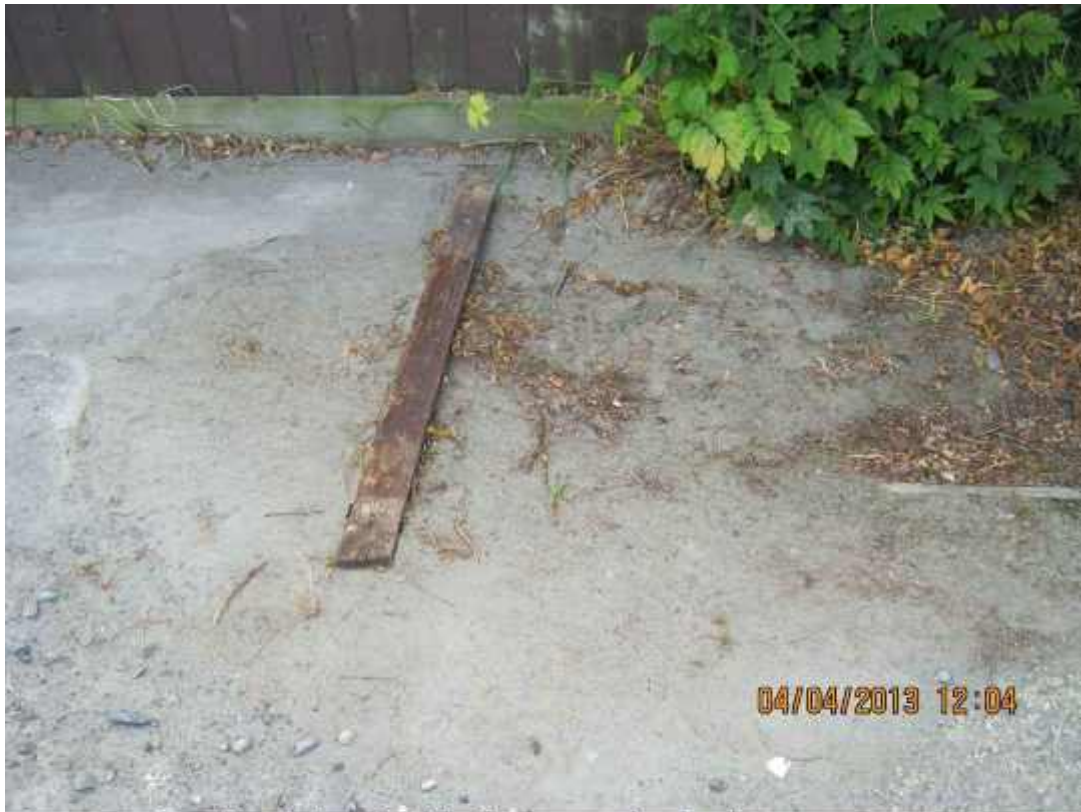
Photograph 3: Observed sand boil in driveway, north of Units 1-6.

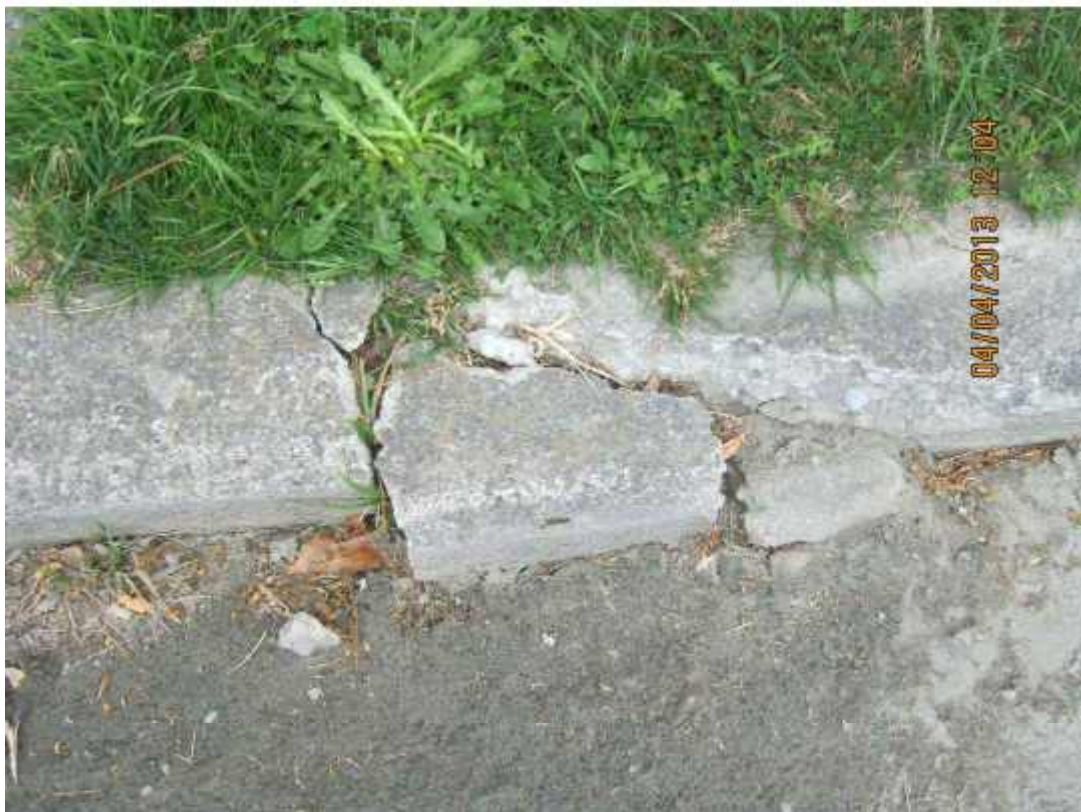
Photograph 4: View of large cracks and broken sections of kerbing, north of Units 1-6 .

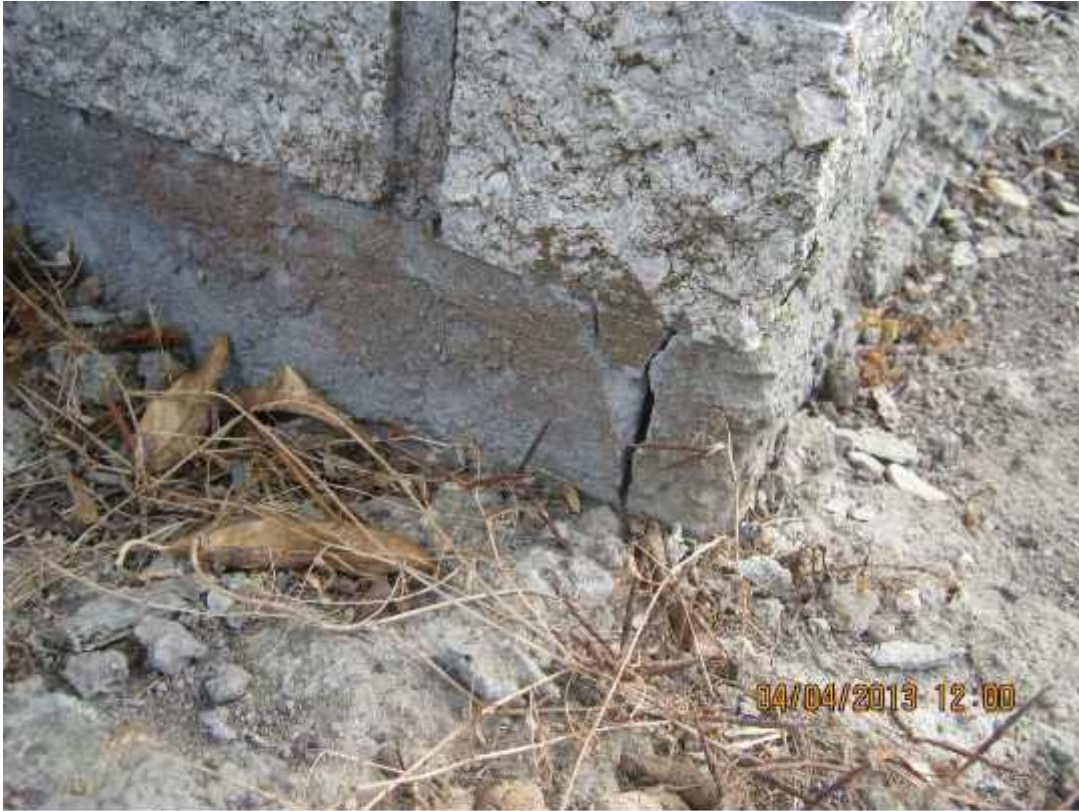
Photograph 5: View of cracking (5mm wide) observed in the footing in the southeast corner of Unit 1.

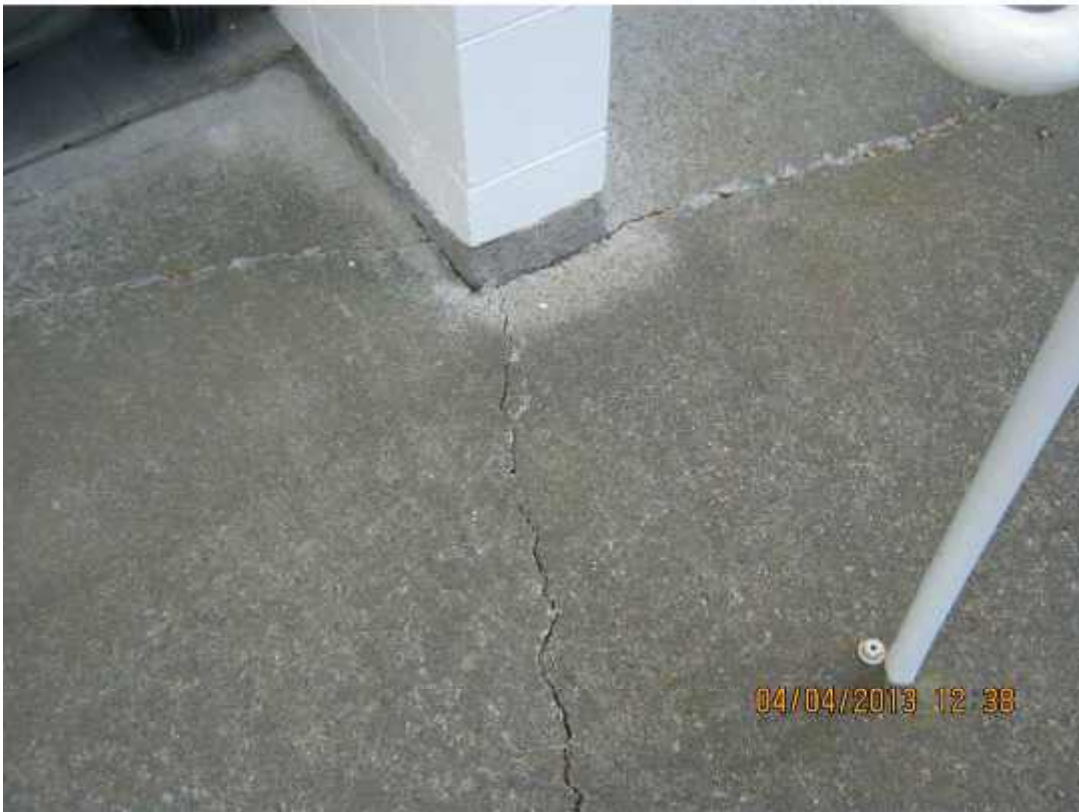
Photograph 6: View of large cracks up to 5mm wide and 1.5m long, observed in the front porch slabs of most units.

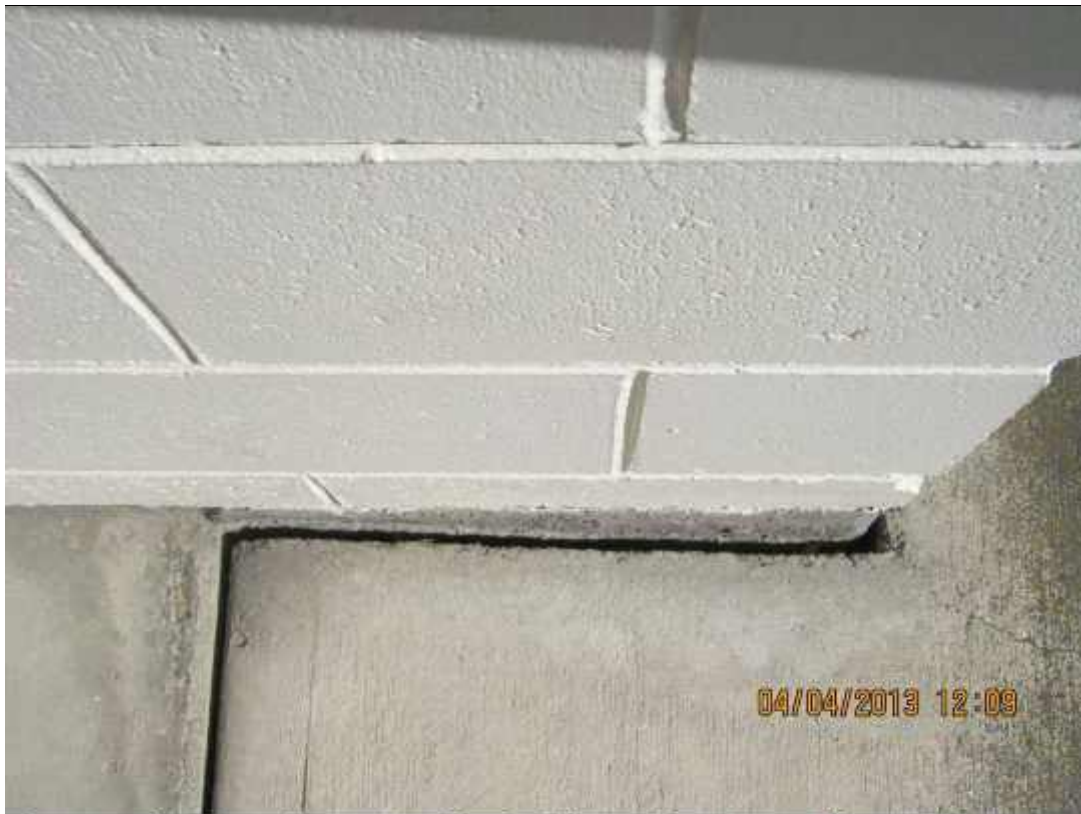
Photograph 7: View of separation of porch slab away from Party wall footing (by approximately 20mm) observed along the northern side of Unit 32.

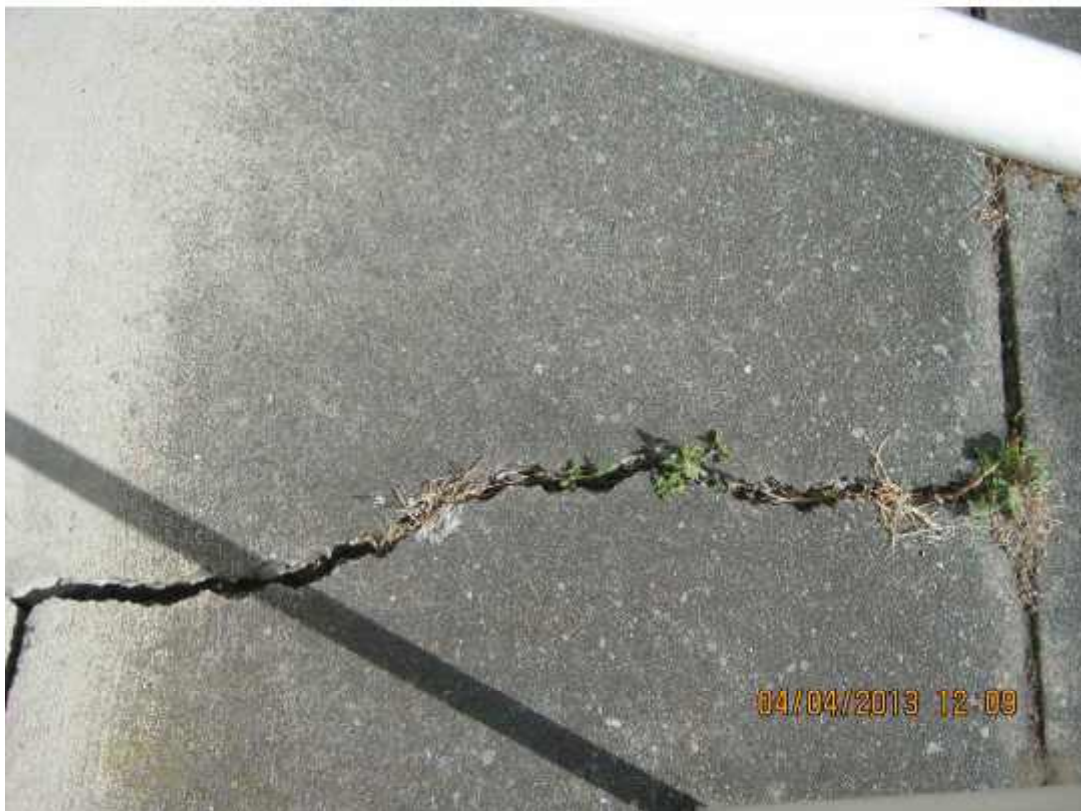
Photograph 8: View of crack in slab (approximately 1m long and 20mm wide) observed along the northern side of Unit 32.

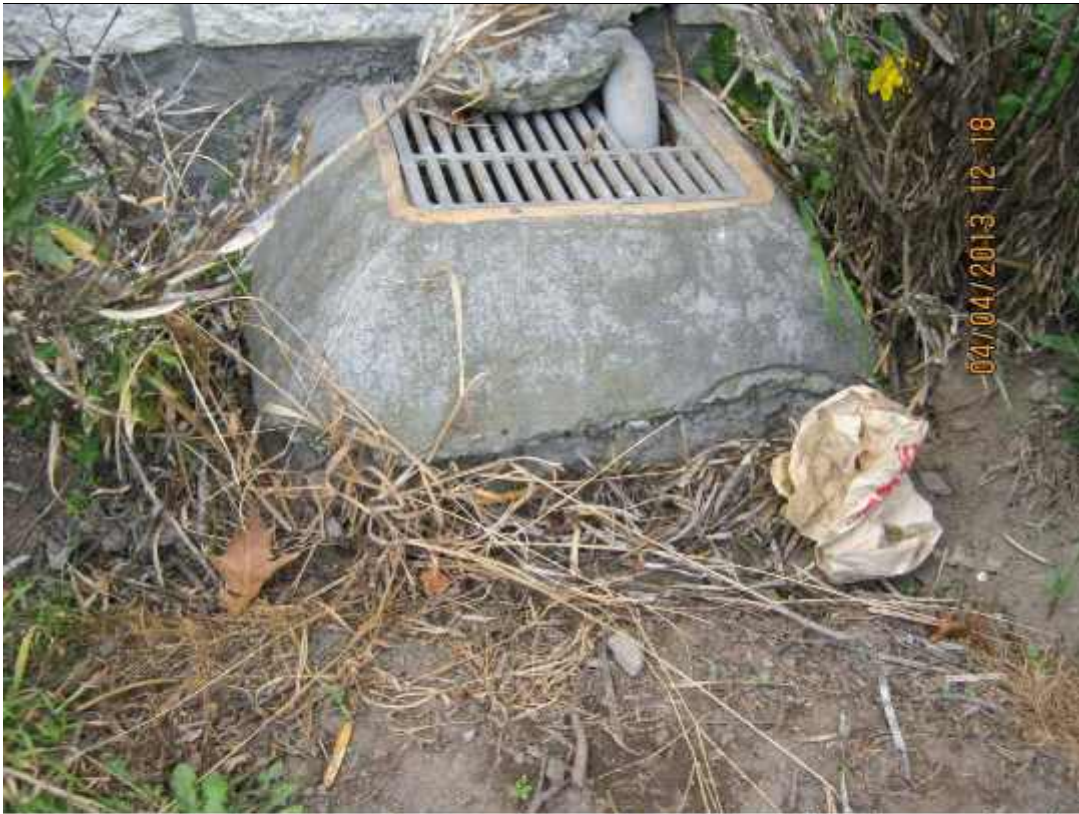
Photograph 9: View of exposed concrete observed around drain where the ground may have settled, at the northeastern corner of Unit 34.

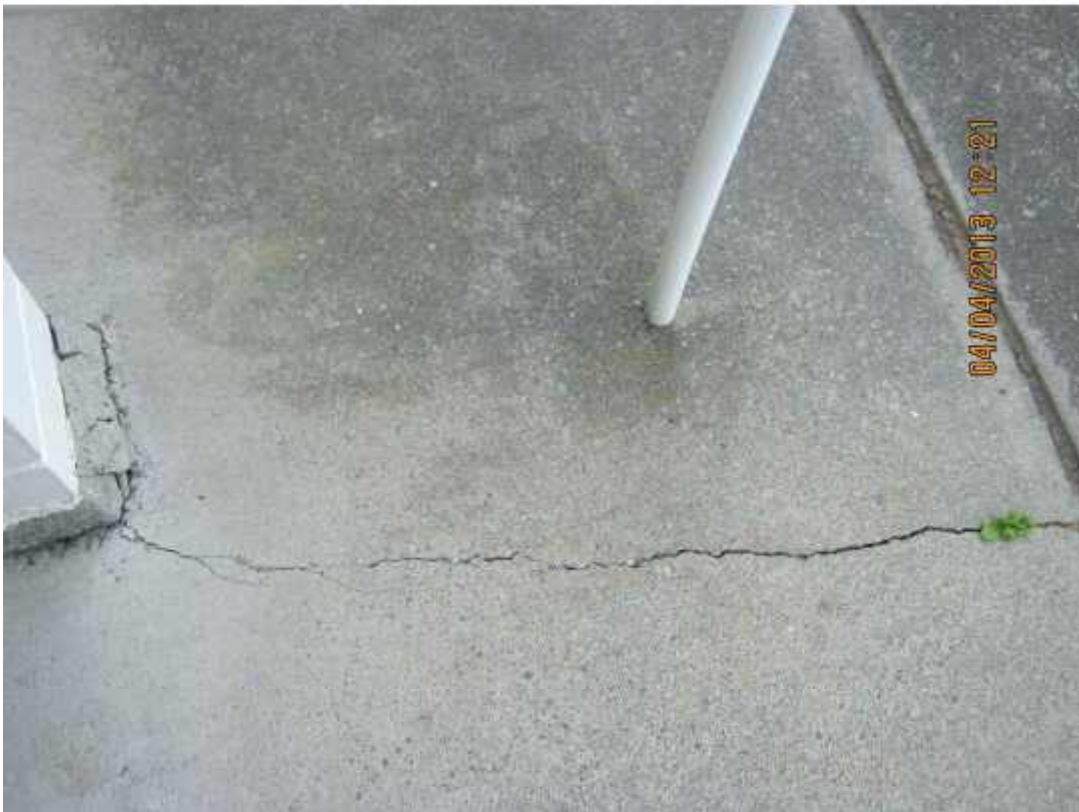
Photograph 10: View of cracking of porch slab (5mm wide x 1m long) and spalling of Party wall footing concrete observed on the northern side of Units 35 and 36.

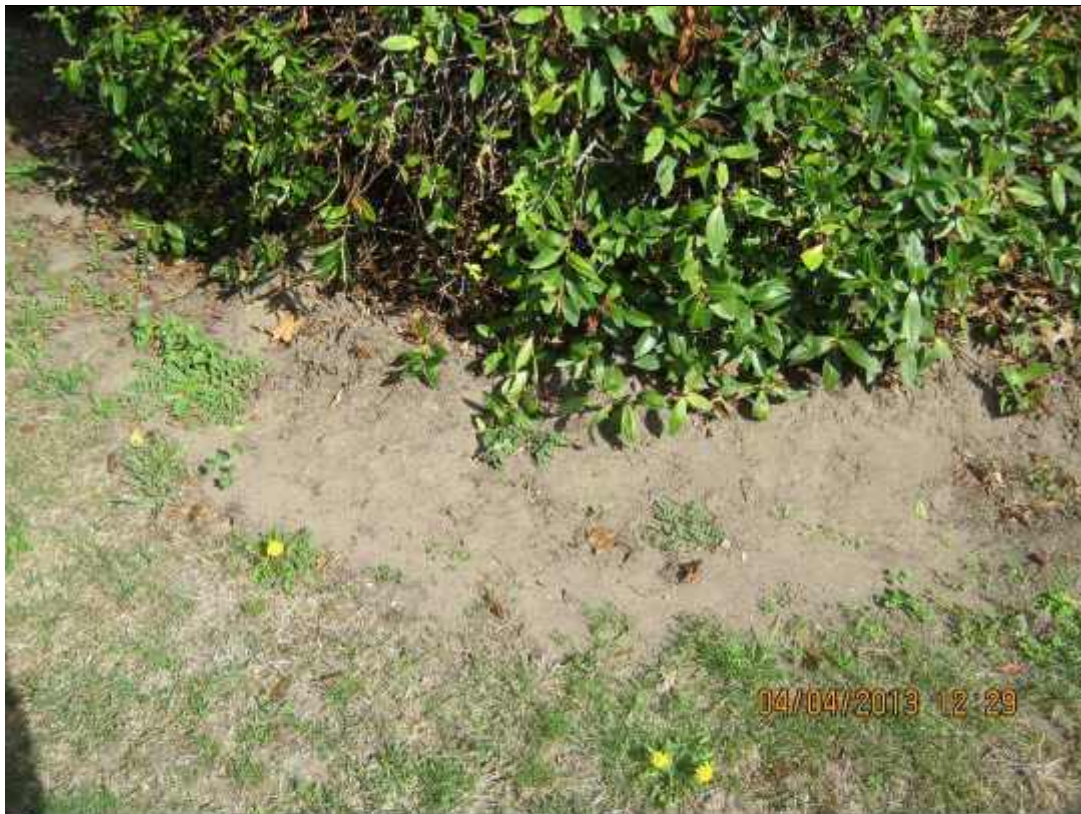
Photograph 11: View of sand boil observed in southwestern corner of site.

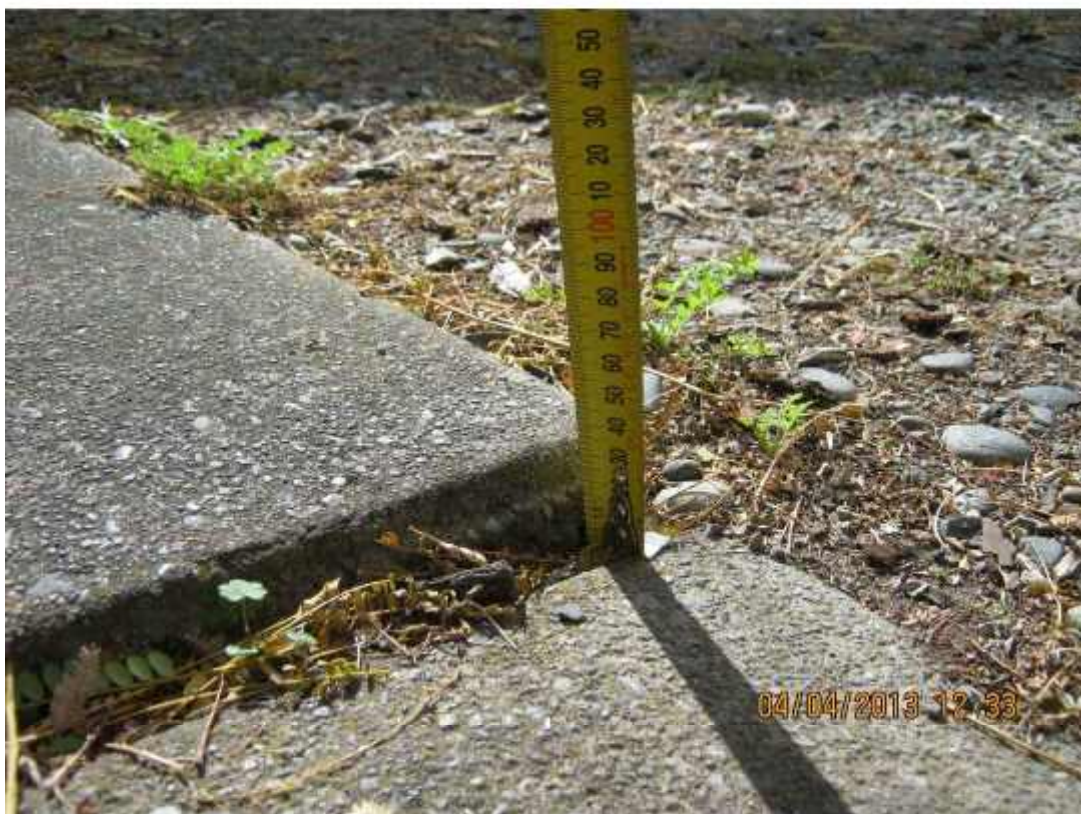
Photograph 12: View of surface evidence of up to 40mm of differential settlement observed in the footpaths in the western half of the complex.

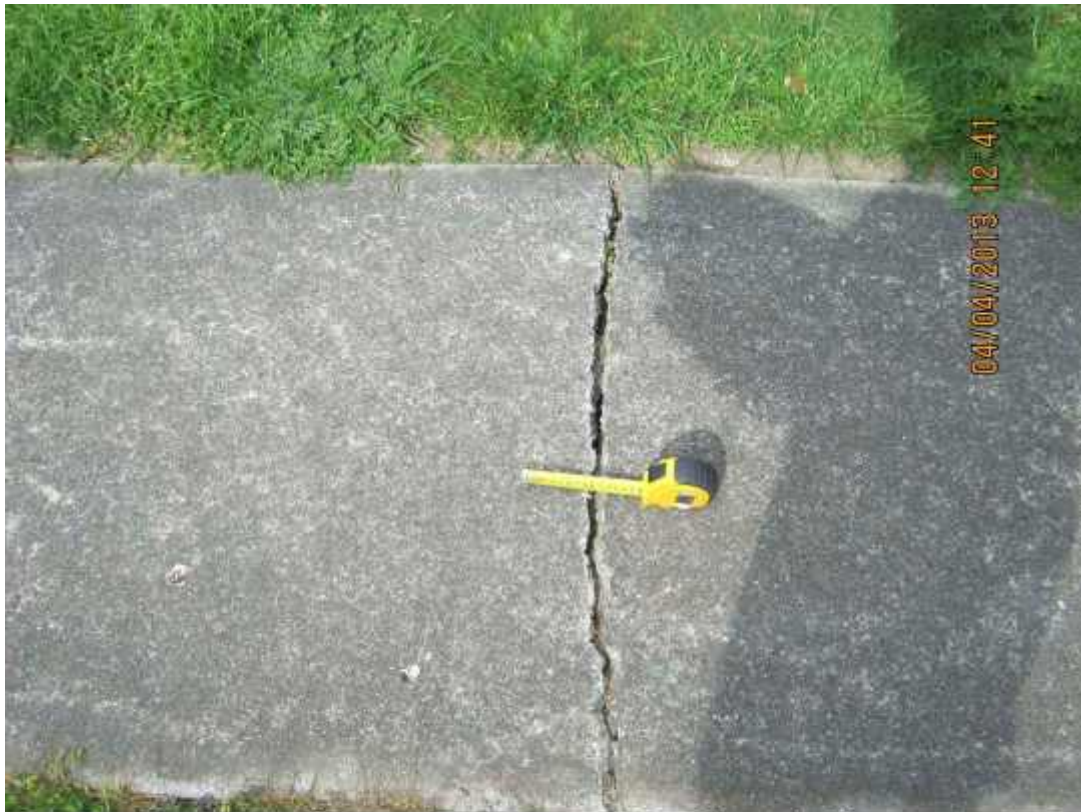
Photograph 13: View of large crack across entire width of footpath slab, east of Units 21 and 22, indicating differential settlement.

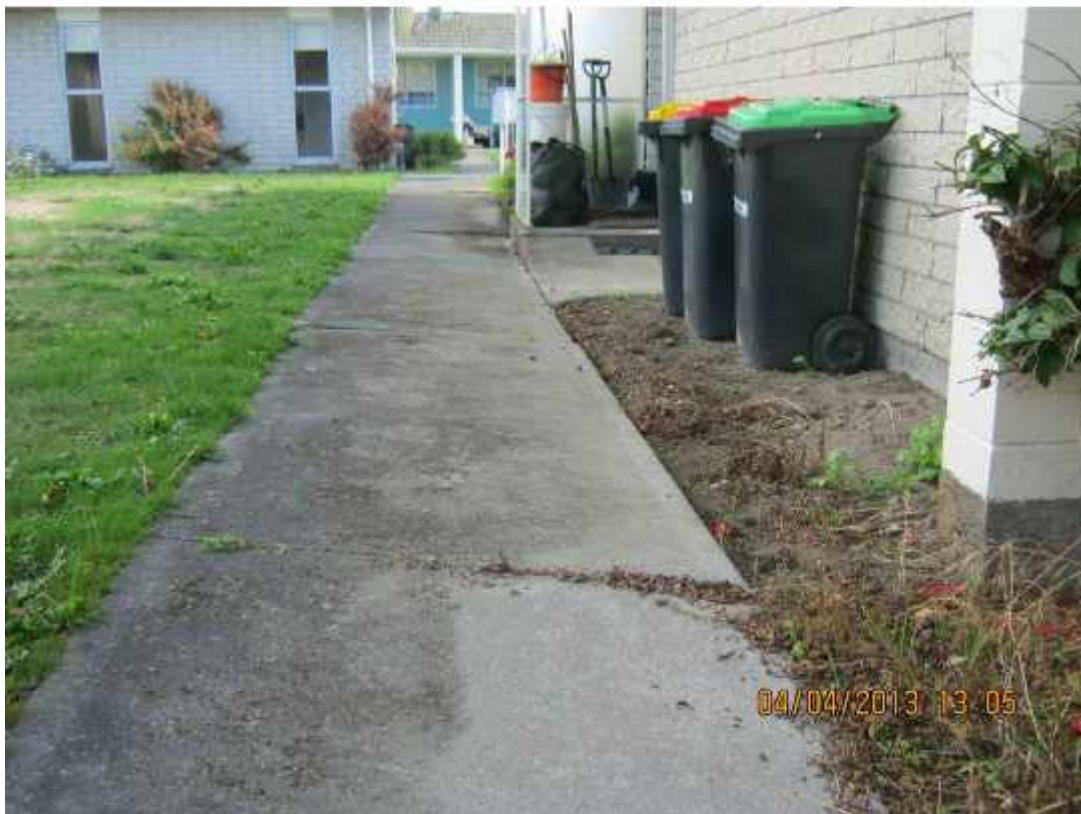
Photograph 14: View of footpath slab (approximately 10m long) along the southern side of Units 9 and 10 that appeared to have undergone differential settlement (up to 40mm) as a result of liquefaction and now slopes in a northerly direction towards the structure.

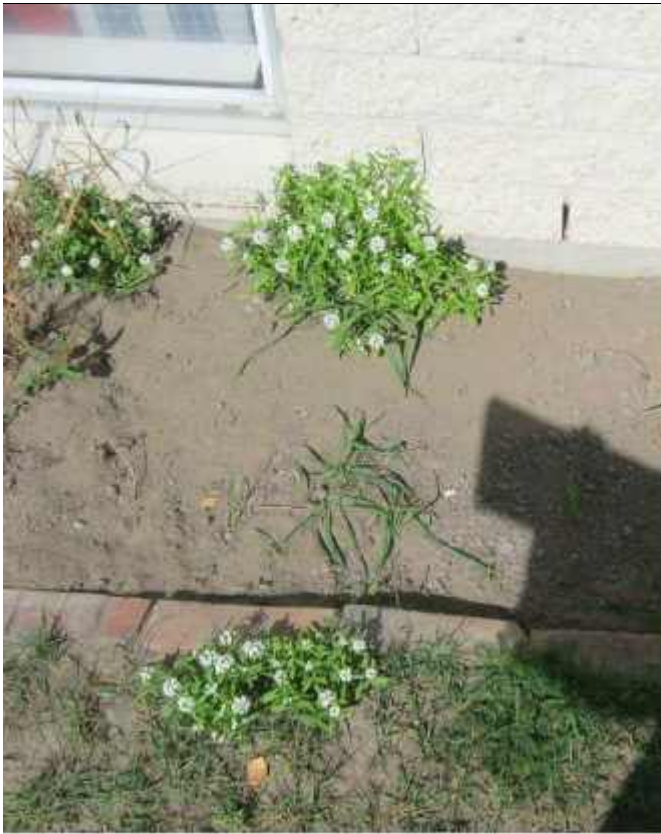
Photograph 15: View of possible ejected liquefied material observed in the flower beds surrounding the residential units.

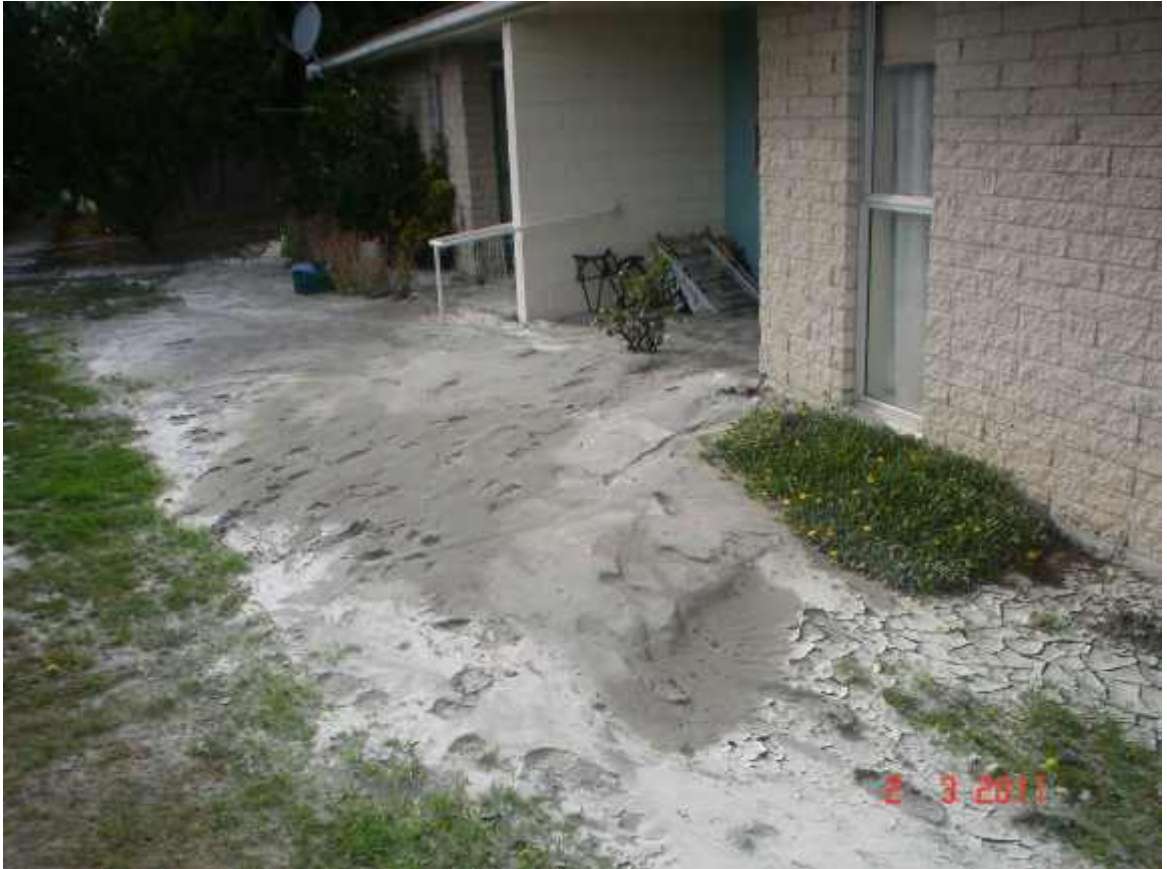
Photograph 17: View of ejected liquefied material (Photograph taken in March 2011).

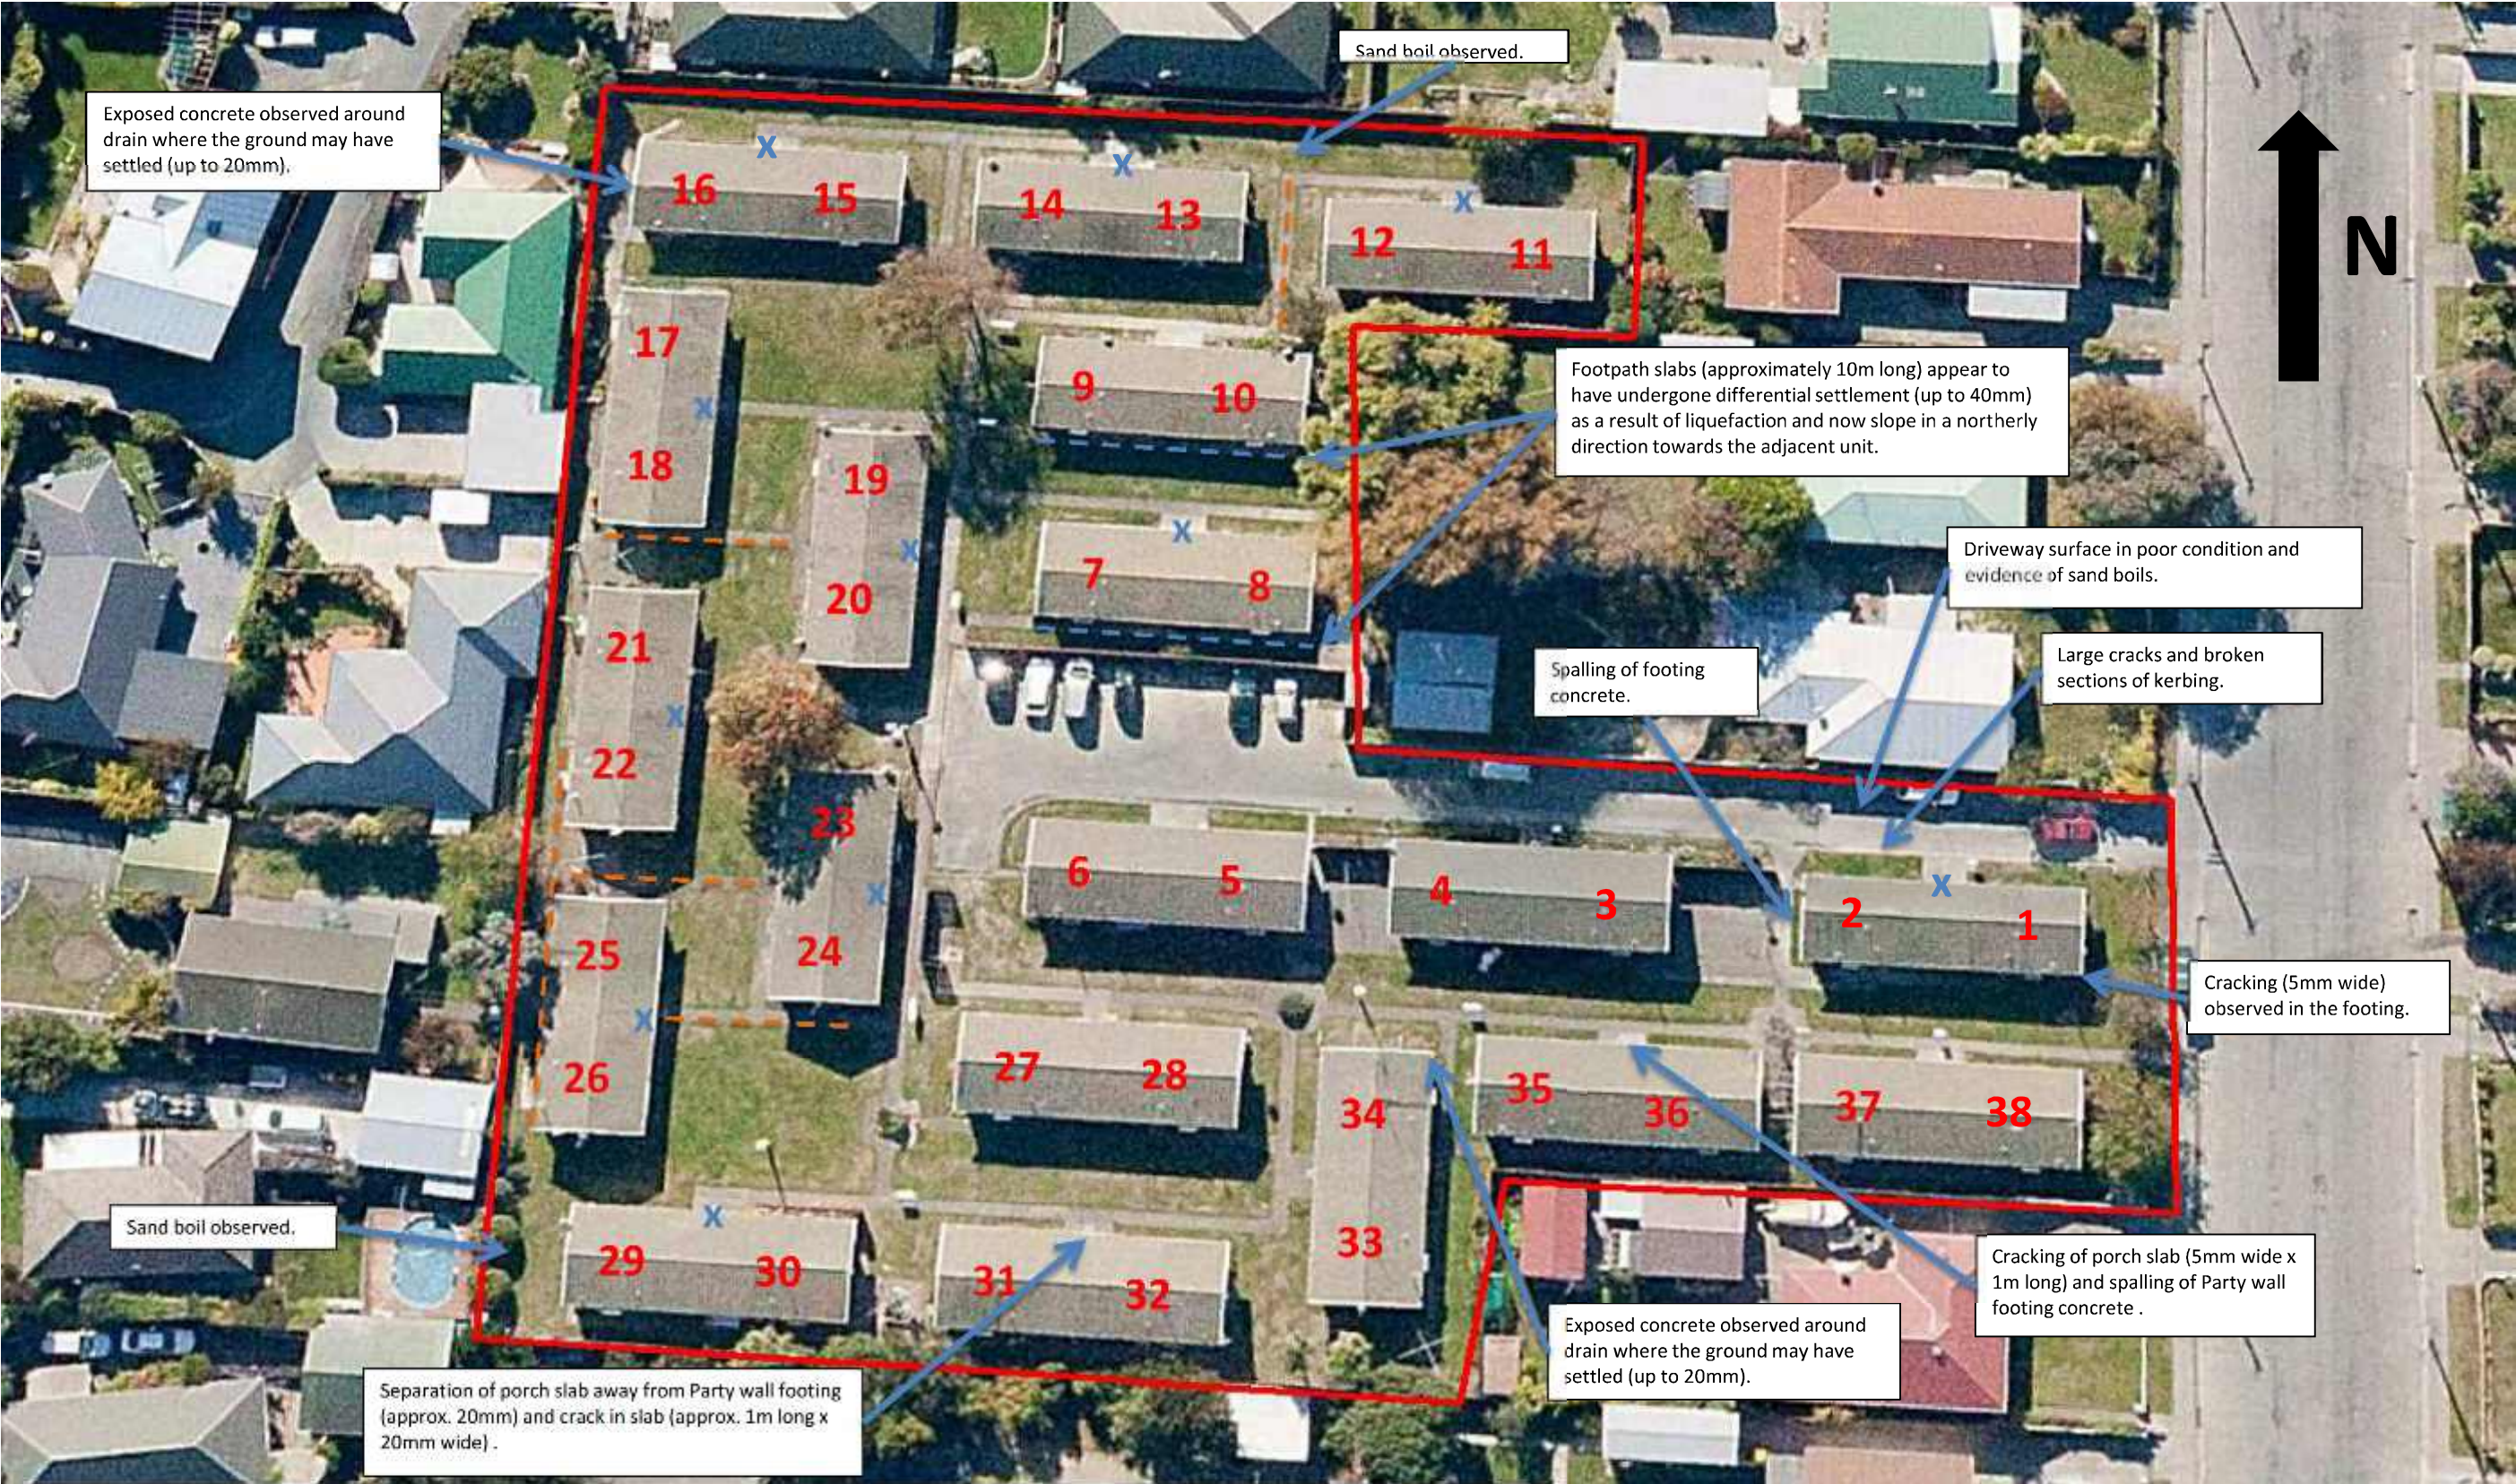
Appendix C: Walkover Inspection Plan

1-38: Residential Unit Numbers
X: Large cracks up to 5mm wide and 1.5m long in the front porch slabs, emanating from the Party wall footings.
---: Damaged footpaths - unlevel (up to 40 mm) and large cracking across slab width.
