**GF Allan Courts
Housing Complex
PRO 1453**

**Detailed Engineering Evaluation
Quantitative Assessment Report**

GF Allan Courts Housing Complex Quantitative Assessment Report

30 Wiggins Street, Sumner,

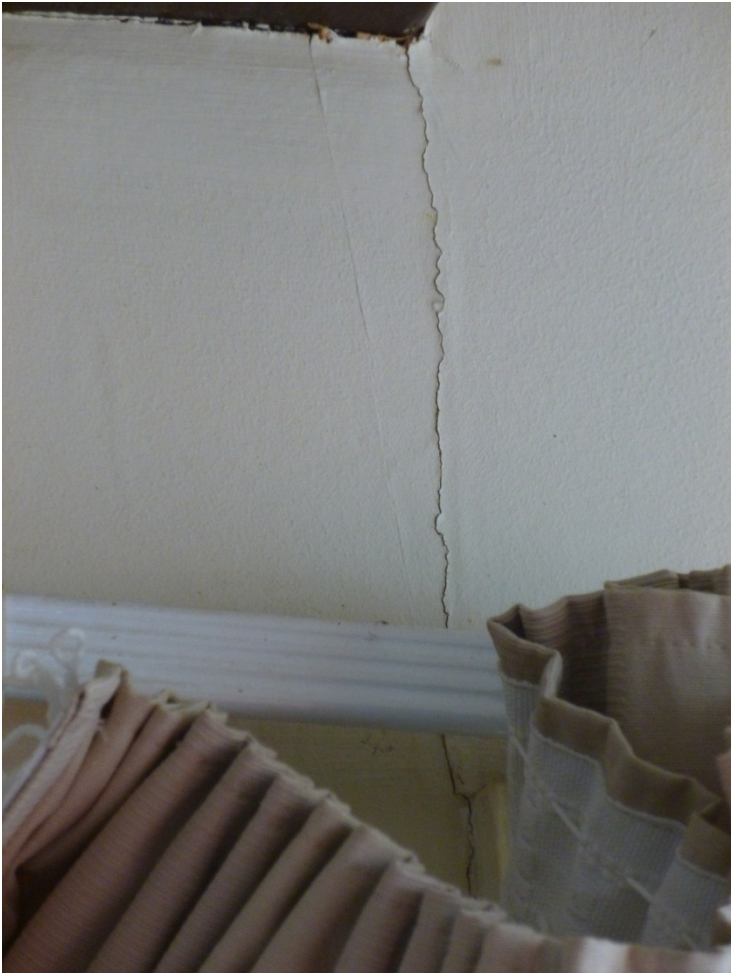
Vertical cracking of the plaster board was noted in some units (photo 8). This damage was most notable in Unit 1 but still very minor. Some hairline cracks were noted between the ceiling and walls in some units (photo 9).

| <p>8.</p> | <p>Typical vertical cracking above windows</p> | A photograph showing a vertical crack in a white wall. The crack runs from the top edge of a window frame down towards the middle of the wall. The wall surface is slightly textured. In the foreground, there are some brown, corrugated objects, possibly insulation or debris, partially obscuring the bottom of the window frame. |

- Veneer at height (gable ends) have the veneer ties checked.
- Cosmetic repairs be undertaken as required.
- Strengthening schemes be developed to increase seismic capacity of all blocks to 67%NBS.
- Additional weight in the roof space be removed, in particular, the concrete header tanks.

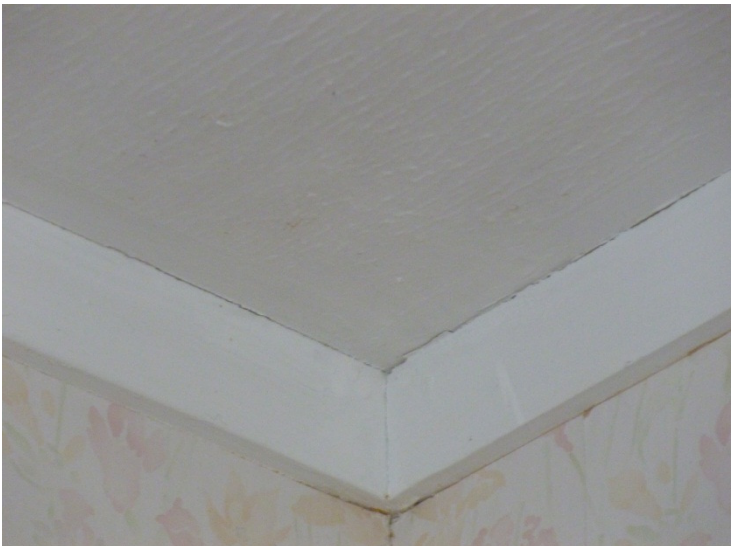
| <p>9.</p> | <p>Typical separation cracking between ceiling and walls</p> | A photograph showing a corner where a white ceiling meets a wall. There is a clear gap or separation between the ceiling and the wall, with some cracking visible along the joint. The wall below the ceiling has a floral patterned wallpaper. |

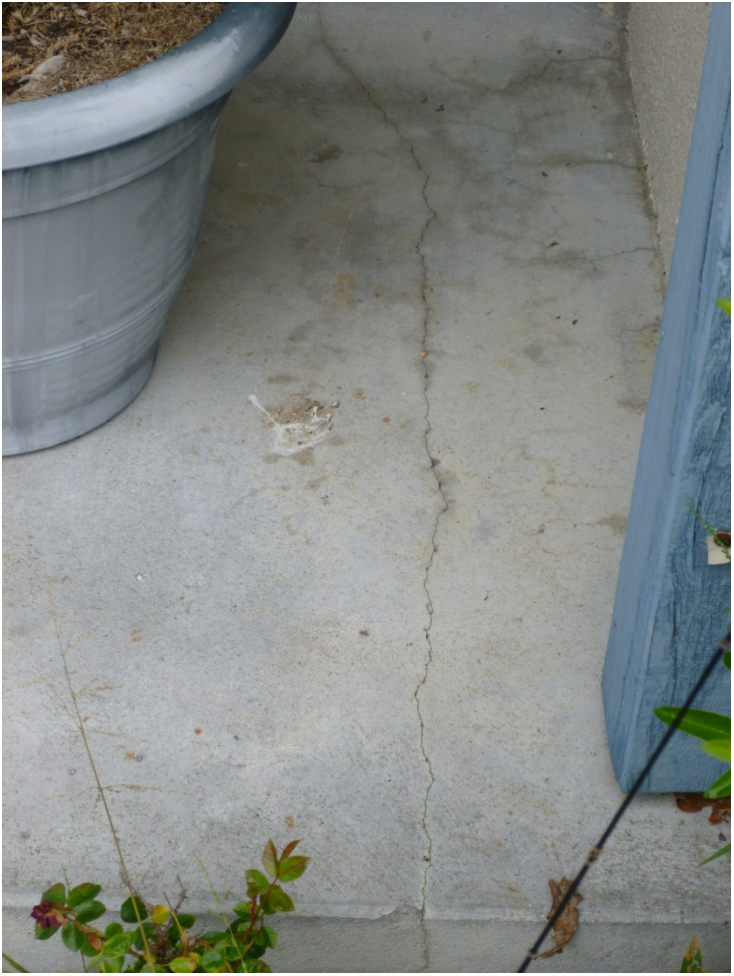
Cracking in porches was noted outside Units 1 and 4 (photo 12).

| <p>12.</p> | <p>Typical crack in porch</p> | |

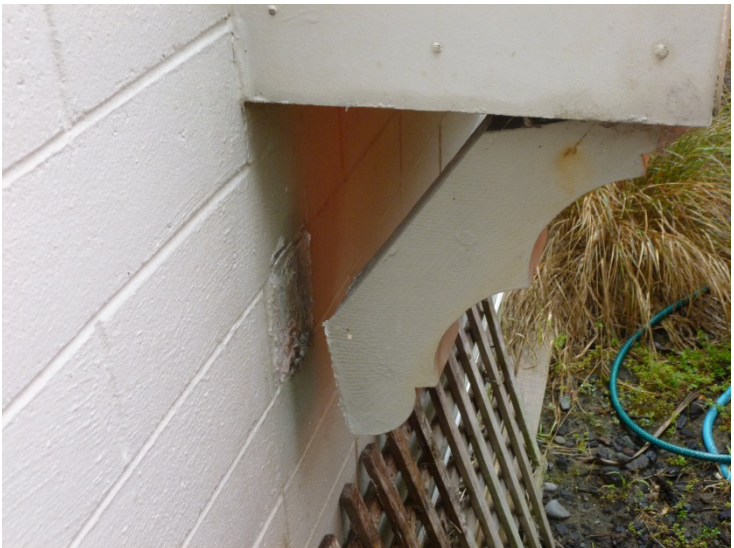
It was noted that the window ‘supports’ detailing at the ends of the blocks have loosened and detached (photo 13).

| <p>13.</p> | <p>Detachment of non-structural window supports</p> | |
