**Gloucester Courts Blocks B & C**  
**BU 2373-002 EQ2, BU 2373-003 EQ2**  
Detailed Engineering Evaluation  
Quantitative Report  
Version FINAL

254 Gloucester Street, Christchurch

Christchurch City Council

**Date**  
14/11/2012

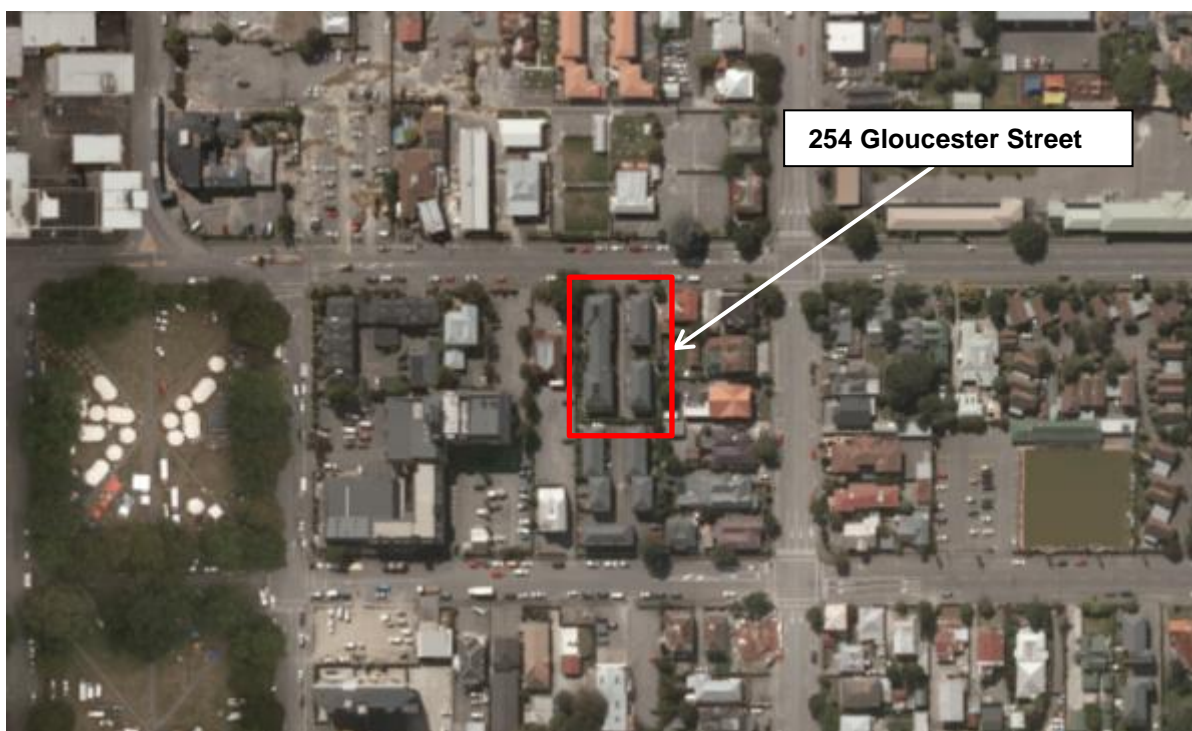
**Figure 8 Post February 2011 Earthquake Aerial Photography**

Aerial photography taken following the 22 February 2011 earthquake shows signs of liquefaction in adjacent properties, particularly those to the northwest across Gloucester Street (see Figure 8). However, little to no effect can be observed on the site itself.

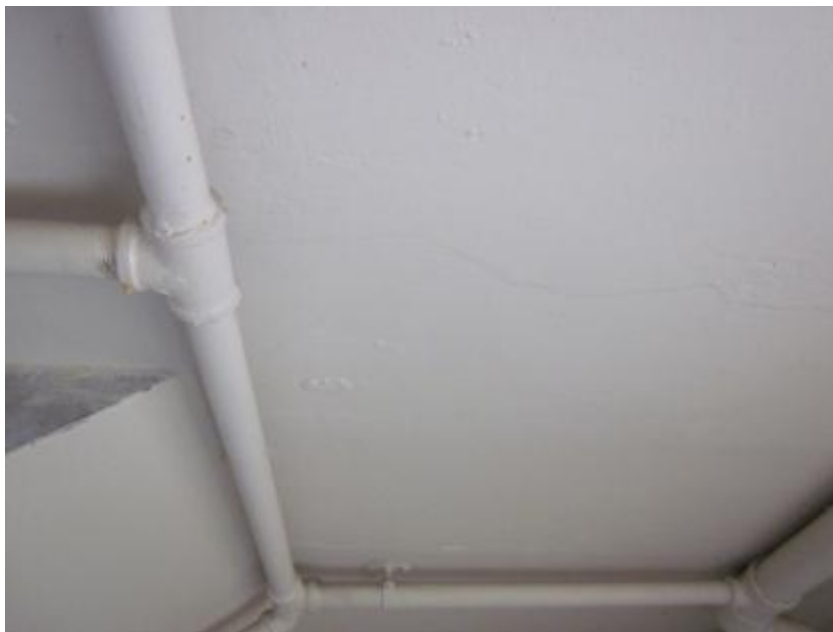
- ▶ Minor cracks were observed in walls above the exterior doors.
- ▶ Minor cracks were observed in the first floor slab near the staircase.

It is believed that the cracks mentioned above are due to localised stresses in the floors and walls during earthquake shaking.

Photograph 9 Minor cracks to the wall above the exterior door

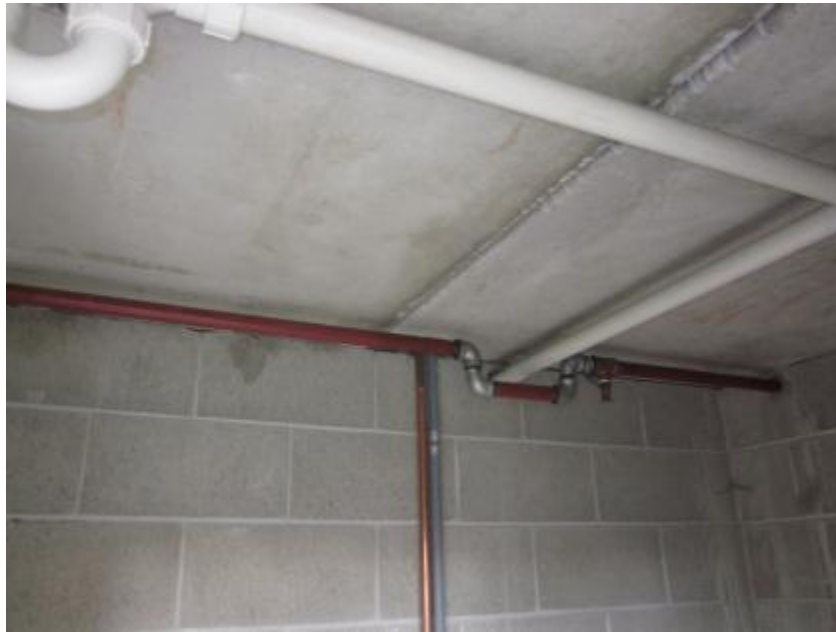
Photograph 10 Minor cracks at 1<sup>st</sup> floor slab near the staircase.
