# **Glue Place Housing Complex PRO 1097**

**Detailed Engineering Evaluation  
Quantitative Assessment Report**

**Glue Place, Hoon Hay, Christchurch  
8024**

Date: August 2013  
Reference: 6-QC346.00  
Status: Final

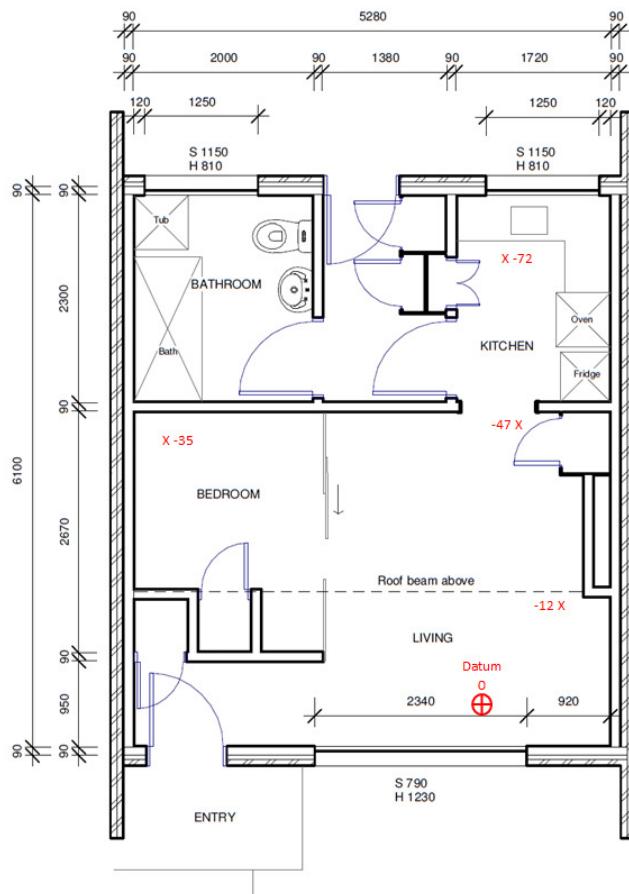
Figure 7: Results of laser level survey from unit 17

All floor slopes assessed, with the exception of unit 17, were less than the 5mm/m limitation set out in the MBIE guidelines [6]. Unit 17 has a slope of 14mm/m.

The results of the level survey show that the floor in unit 17 is 72mm out of level. This indicates the possibility of ground settlement. This unit showed no more damage than the other units internally. The doors and windows in the unit had been planed prior to the earthquake indicating that the displacement is likely to be historical. Foundation damage consistent with this movement is shown in photo 11.

It is recommended that unit 17 is re-levelled and cosmetic repair works to cracks in walls and foundations are undertaken.

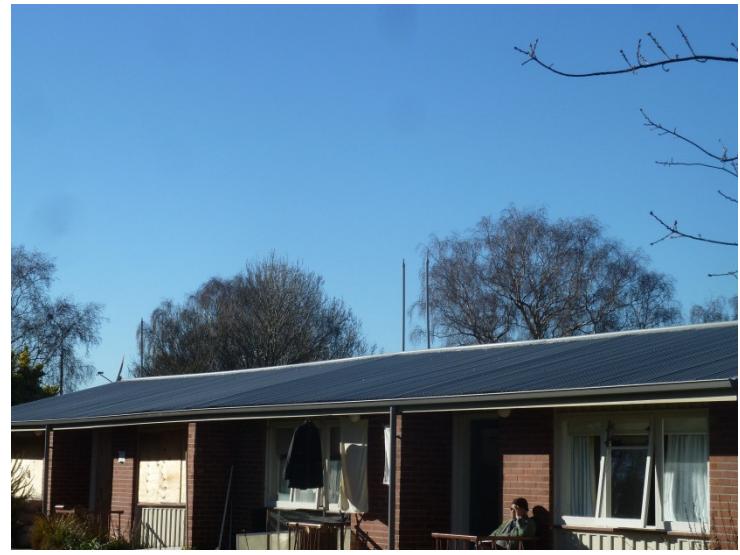
Damage to the roof cladding due to movement of the fire walls (photo 3) was observed in all units.

3	Damage to the roof cladding due to movement of fire wall relative to the rest of the structure.

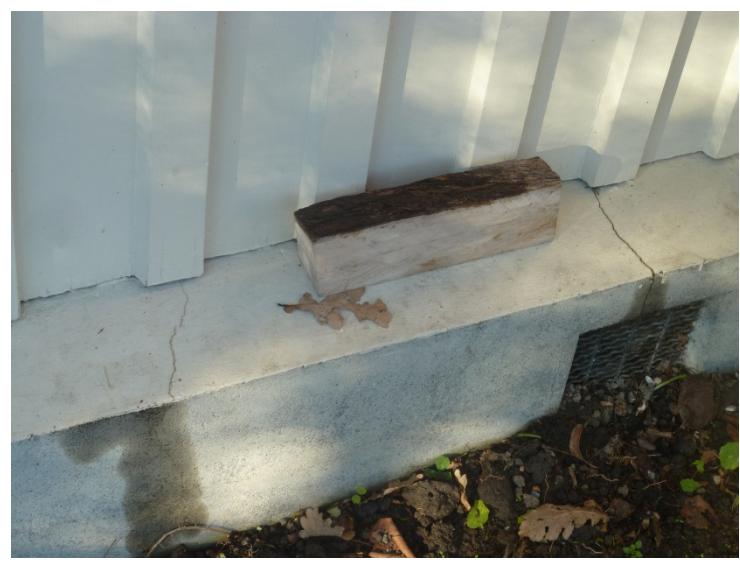
Minor cracking (less than 1mm) in the concrete perimeter foundation walls (photo 4). This damage was common throughout all the units.

4	Cracking in concrete foundations (all units)

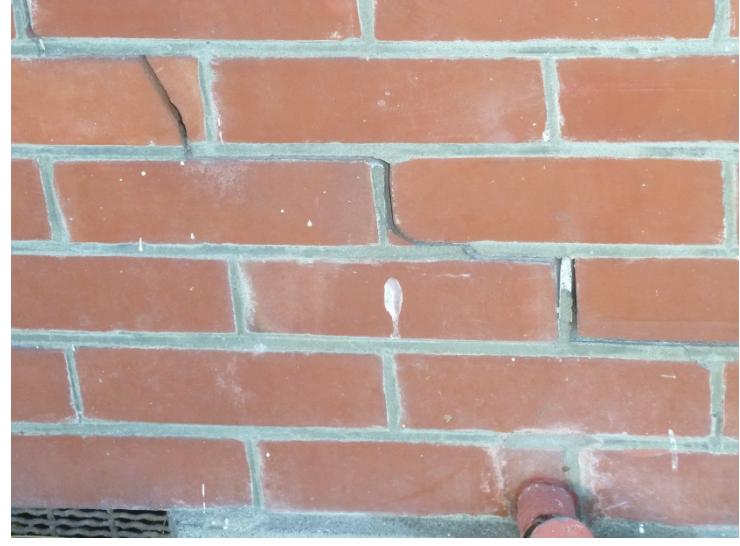
Minor step cracking in the brick veneers was observed throughout all the units (photo 5).

5	Stepped cracking seen in exterior brick veneer cladding (most units)

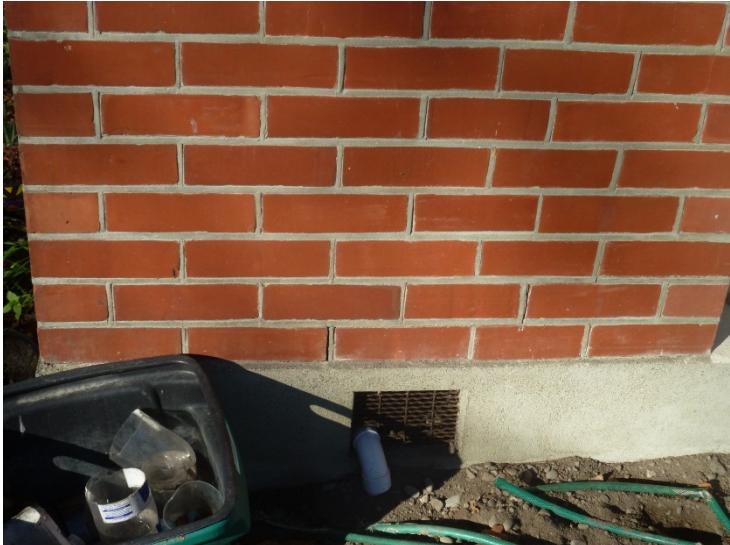
6	Loose and cracked mortar between brick cladding common (most units)

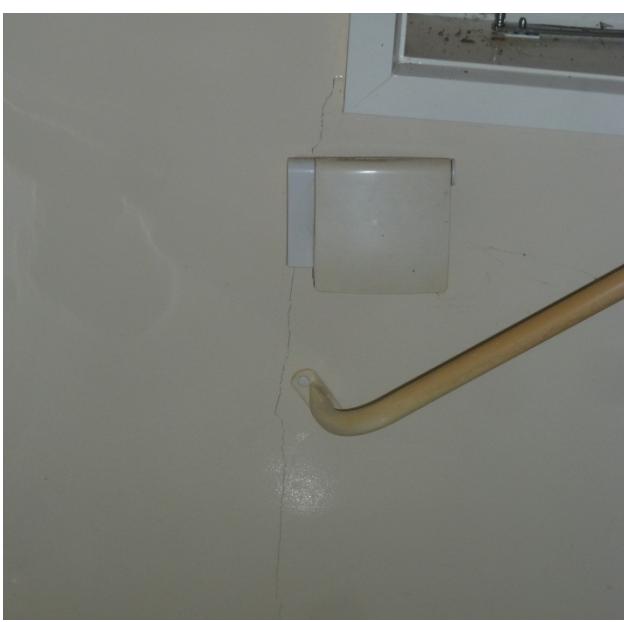
7	Cracking from corner of window (several units)

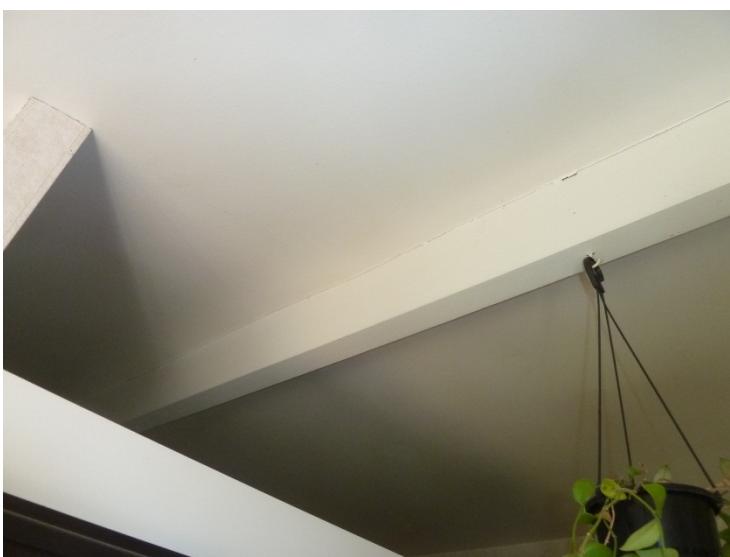
8	Cracking where beam meets ceiling cladding (most units)

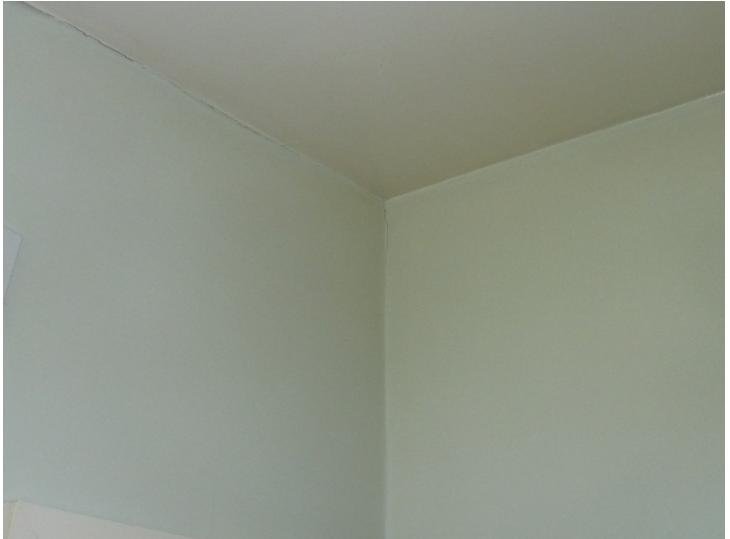
9	Cracking between GIB ceiling and wall linings (most units)

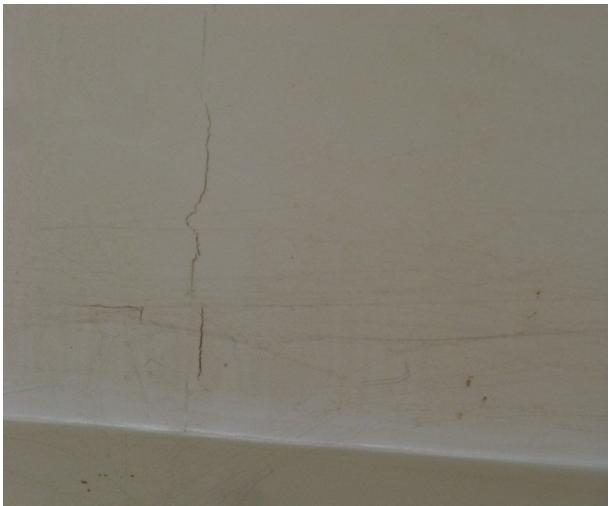
Minor cracking to the GIB wall linings was observed in most units, especially above window and door openings.

10	Cracking where GIB wall linings joins (some units)

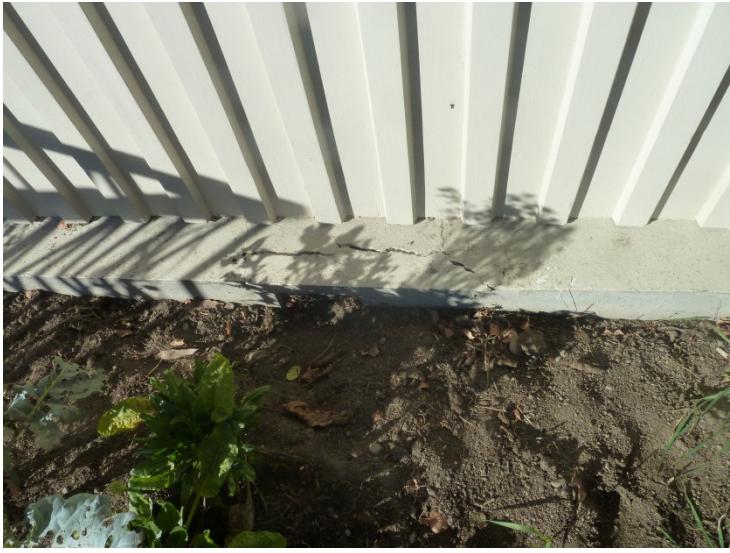
In the June 2013 site visit it was noted that the ground on the opposite side of the fence adjacent to unit 17 was about half a metre lower. This suggests that the unit may have been placed on fill to level the section. Settlement of this fill would be consistent with the levels found in this unit. Hand augers as part of a geotechnical site investigation could confirm the presence of fill.

11	Foundation damage unit 17
