**Governors Bay Pool Structures  
Detailed Engineering Evaluation  
Quantitative Report**

Christchurch City Council

Date: August 2012  
Reference: 6-QUCCC.61  
Status: Final

Governors Bay Pool Structures  
BU 3569-002 EQ2 and PRK 3569 BLDG 007 EQ2

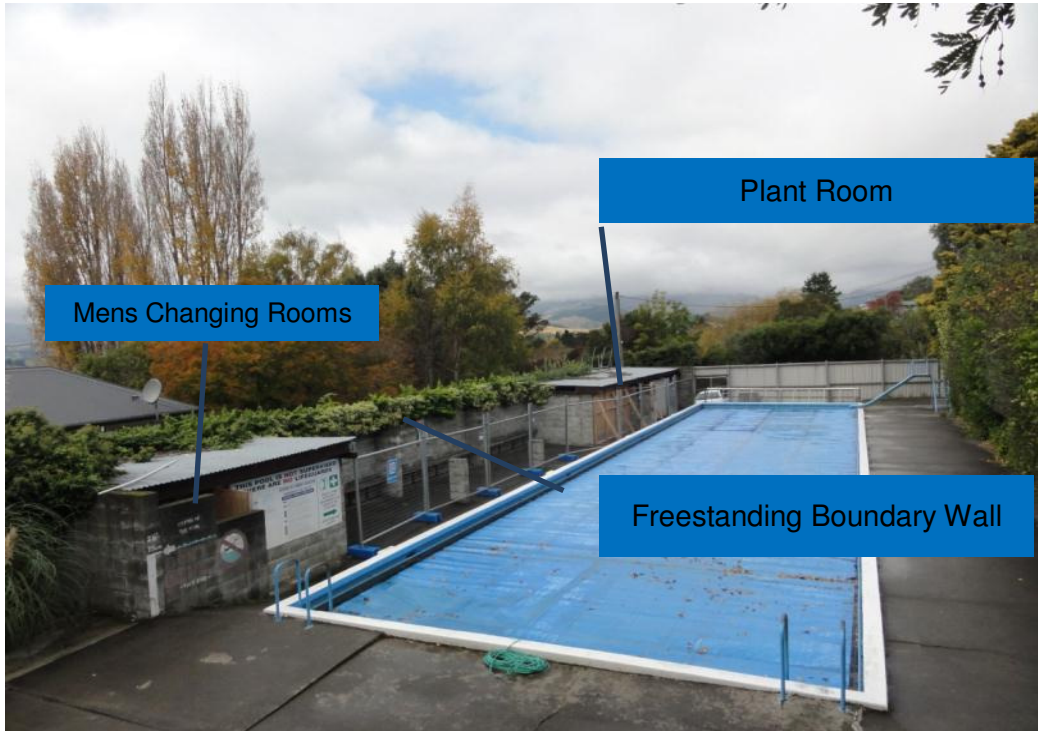
Photo 1: General photo of the structures

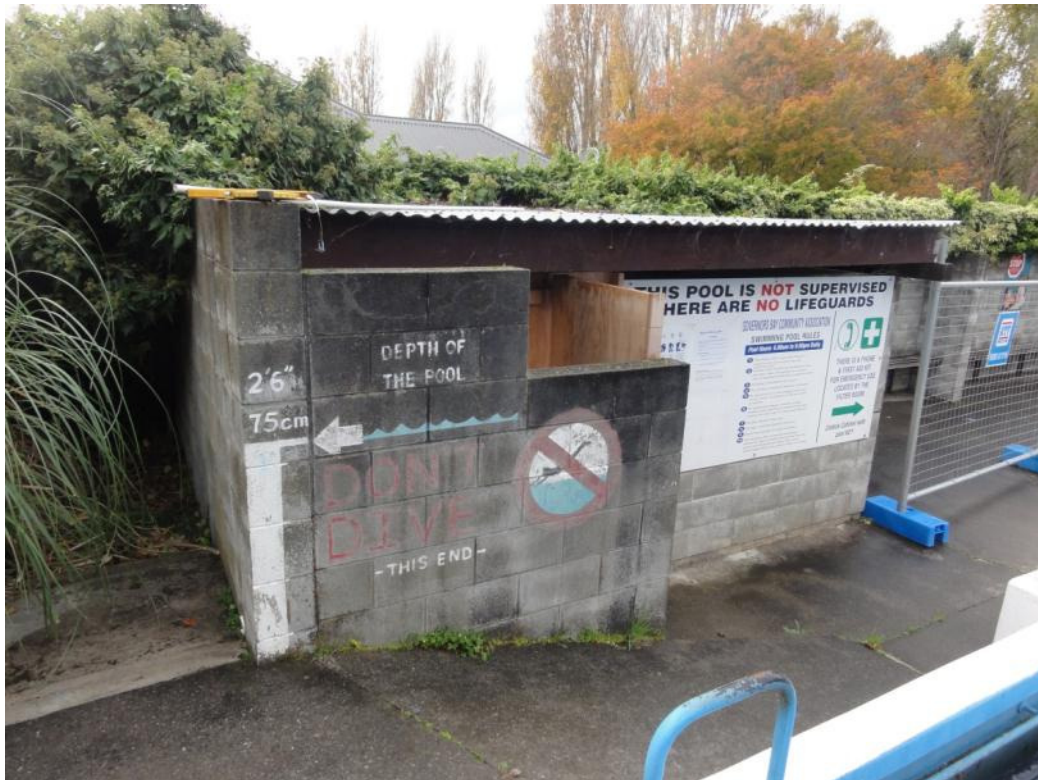
Photo 2: Mens Changing Rooms general photo

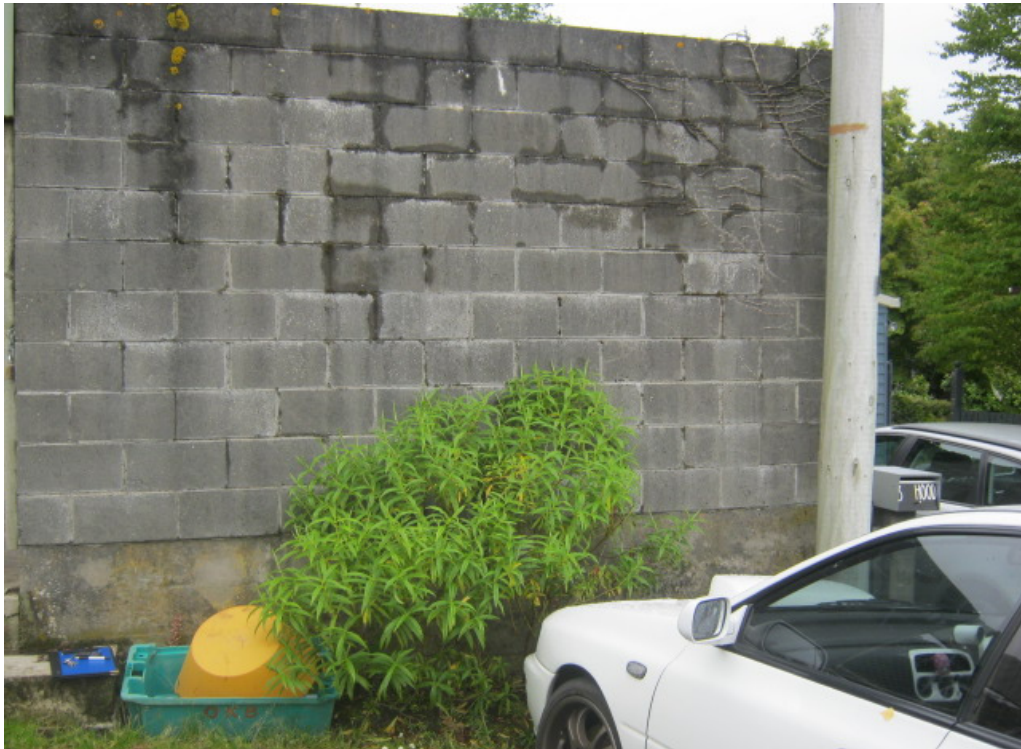
**Photo 3: Plant Room side wall (prior to propping)**

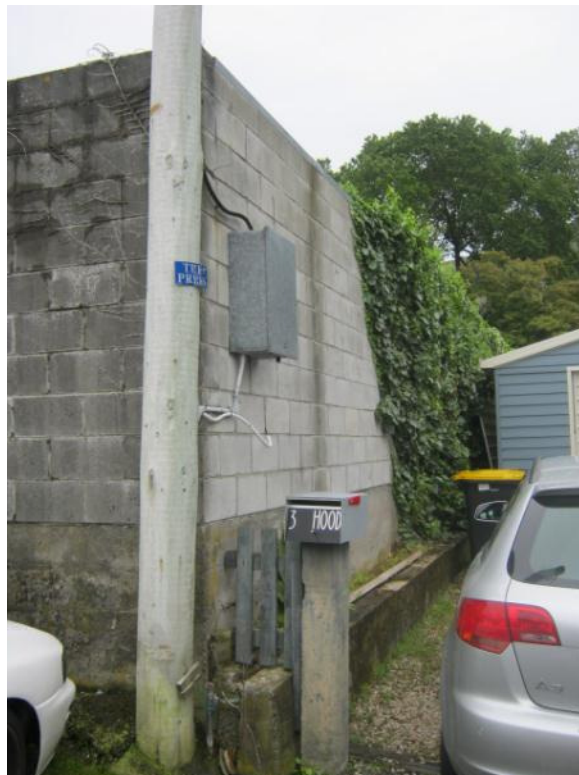
**Photo 4: Plant Room back wall (prior to propping)**

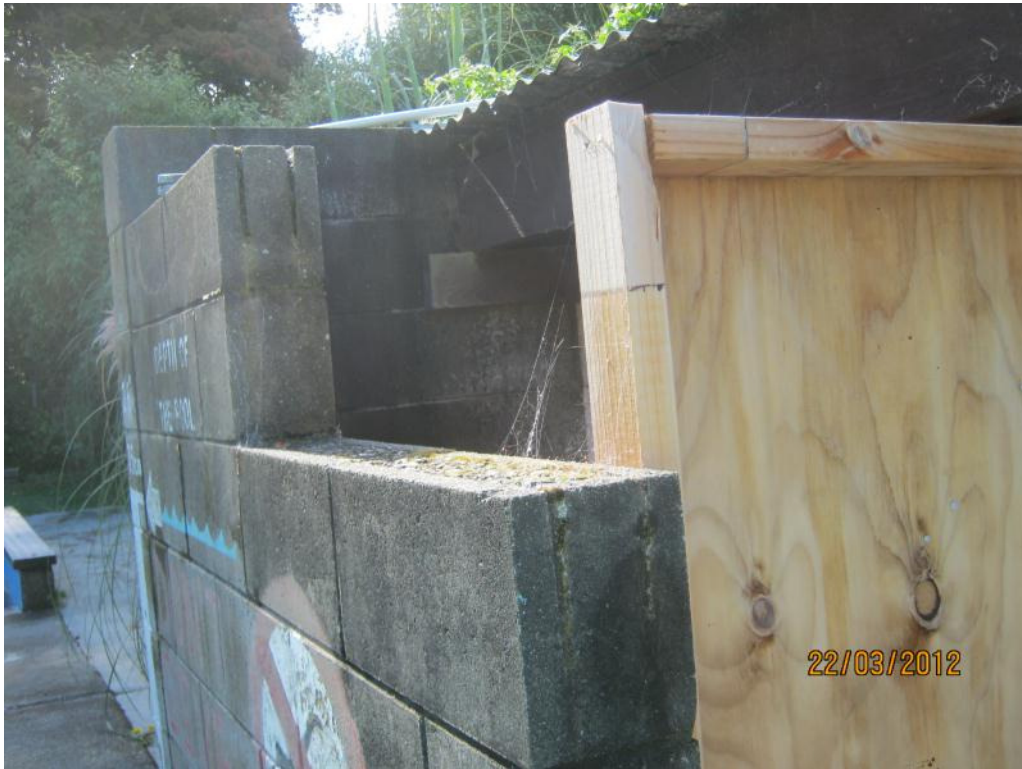
**Photo 5: Mens Changing Rooms front corner**

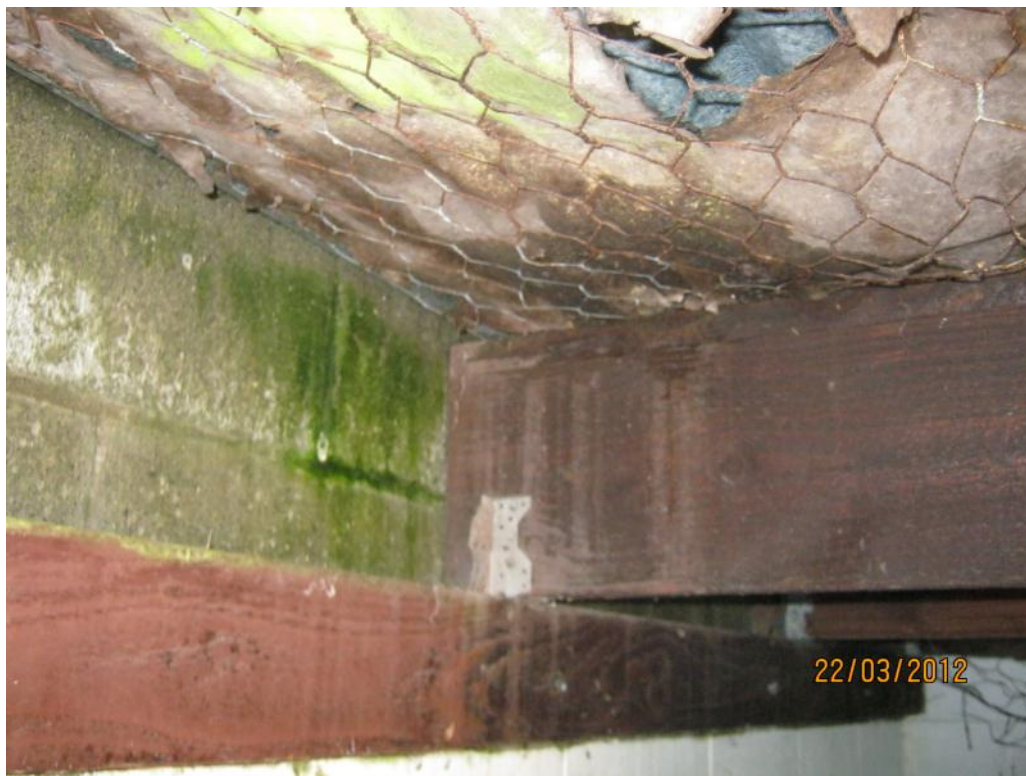
**Photo 6: Mens Changing Rooms timber roof purlins and wall plate**

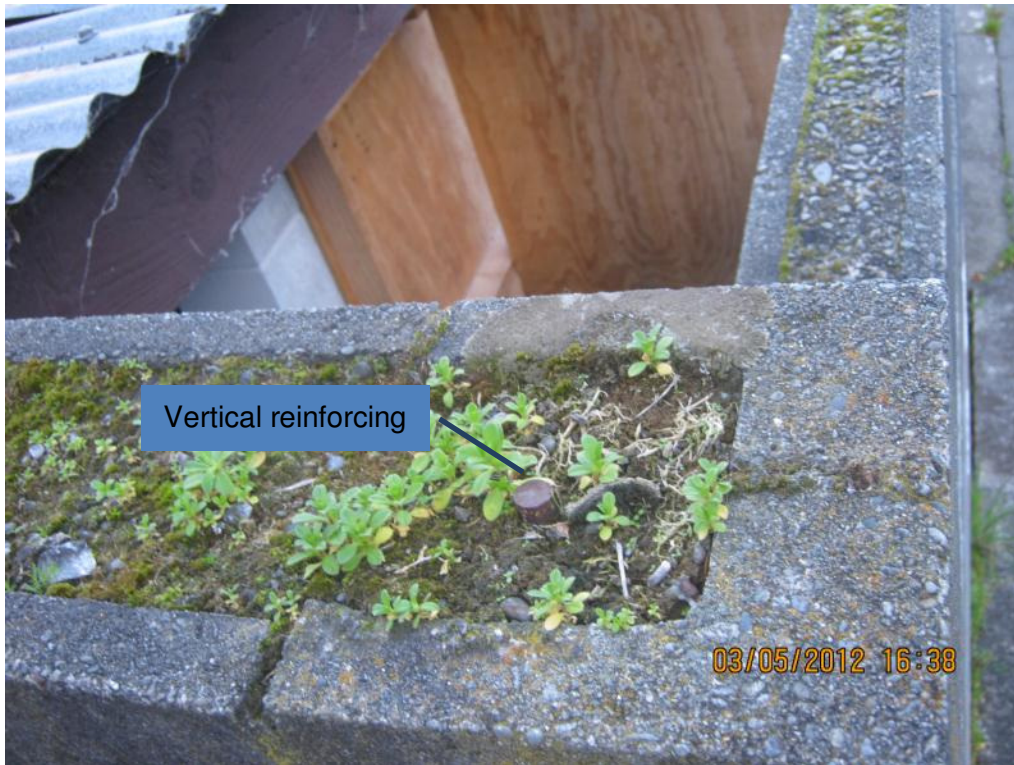
Photo 7: Mens Changing Rooms - front corner bond beam and vertical rebar

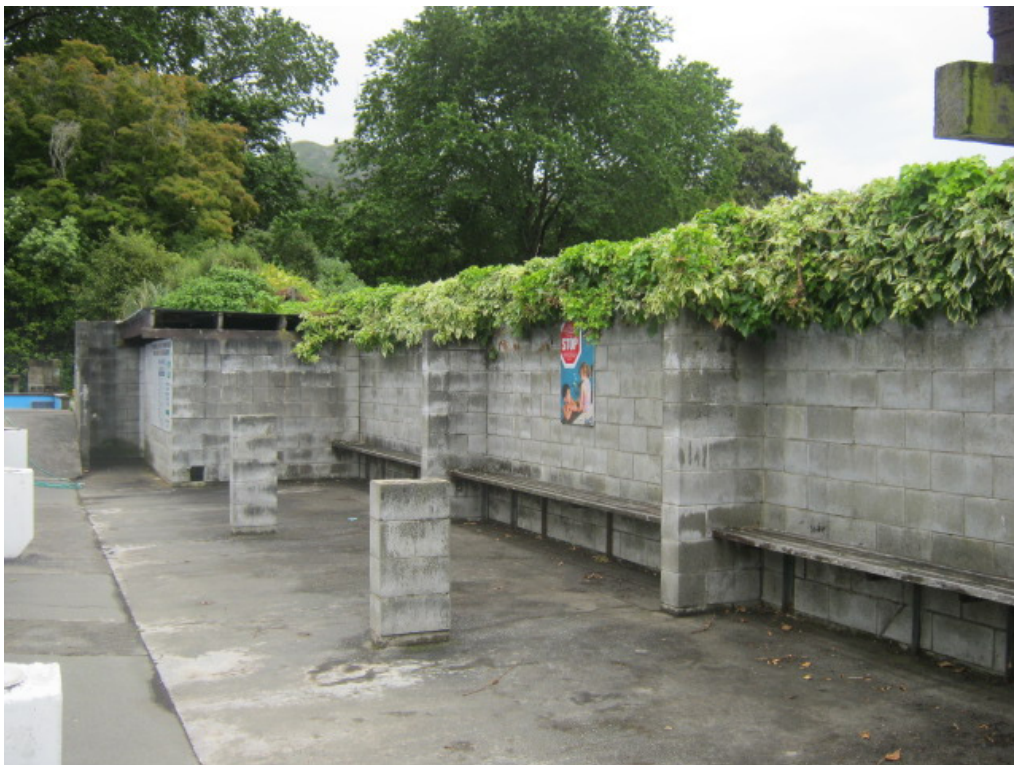
Photo 8: Freestanding boundary wall and Mens Changing Rooms (prior to propping)

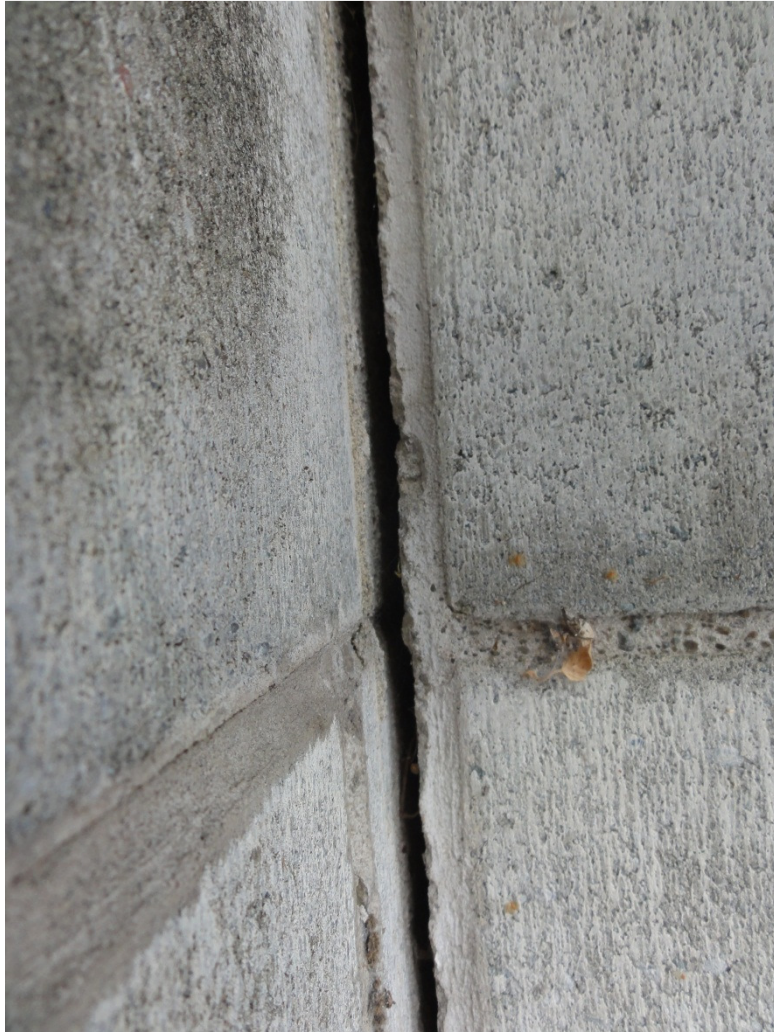
The damage noted was several displacement cracks in the reinforced partially grouted block walls of the Plant Room building, up to 10mm width, particularly at wall joint locations, and the separation of the masonry wall/fence from the block piers.

Our inspection noted that a number of walls did not appear to have been built integrally with the end return walls. The now-demolished Plant Room wall was likely one of these. Consequently, the top bond beams may not span between return walls, requiring the wall to transmit seismic load by out-of-plane flexure. Our assessment of the seismic load distribution has been based on this feature and the actual extent of this will need to be confirmed in any future strengthening proposal. Similarly the block boundary wall piers may not be fully engaged with the wall compromising the strength of this wall.

**Photo 9: Separation of pier and block boundary wall.**

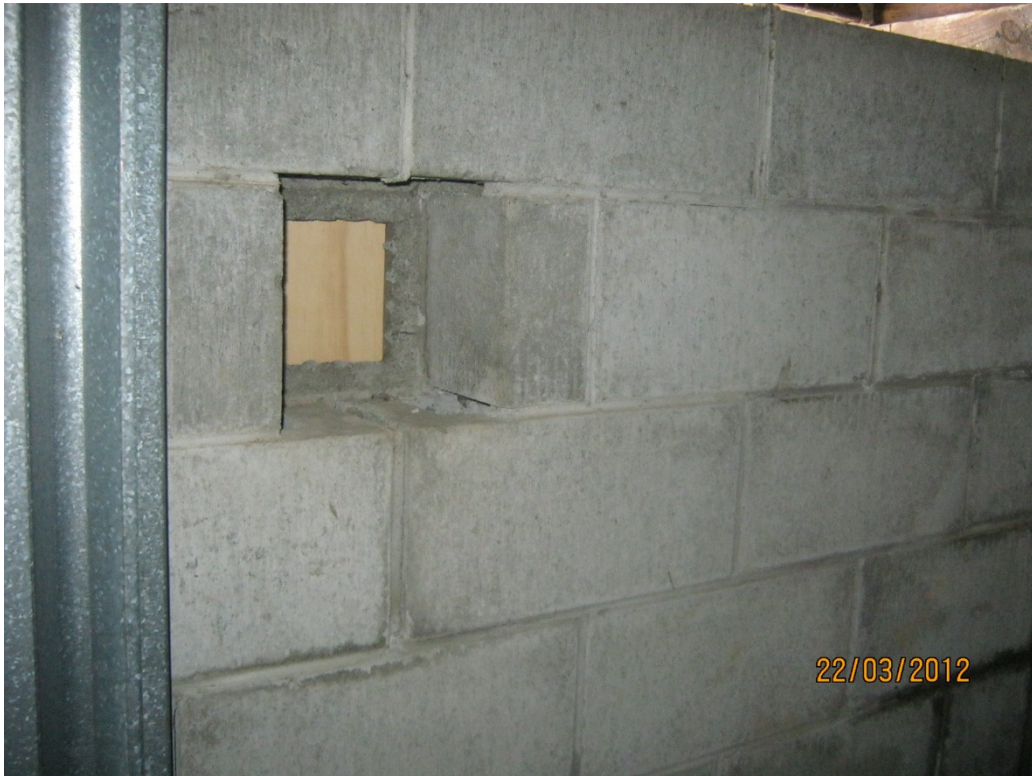
Photo 10: Plant Room – opening in block wall

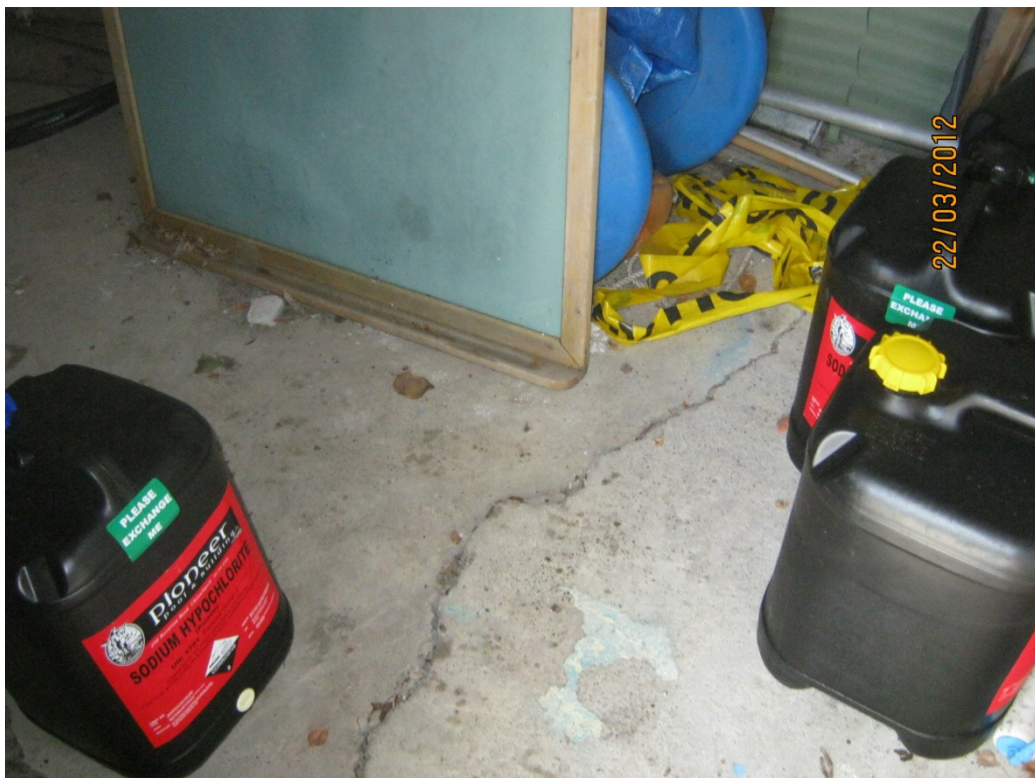
No displacements of the foundations or cracks in the footings were observed, but intrusive investigations and level surveys have not been undertaken. There is a large differential settlement crack in the Plant Room building floor slab. This crack was reported by the pool caretaker to have existed for some time before the recent seismic activity. The nearby diagonal wall crack may be related to this differential ground settlement and not seismic related.

Photo 11: Plant Room – crack in floor (non-seismic damage)

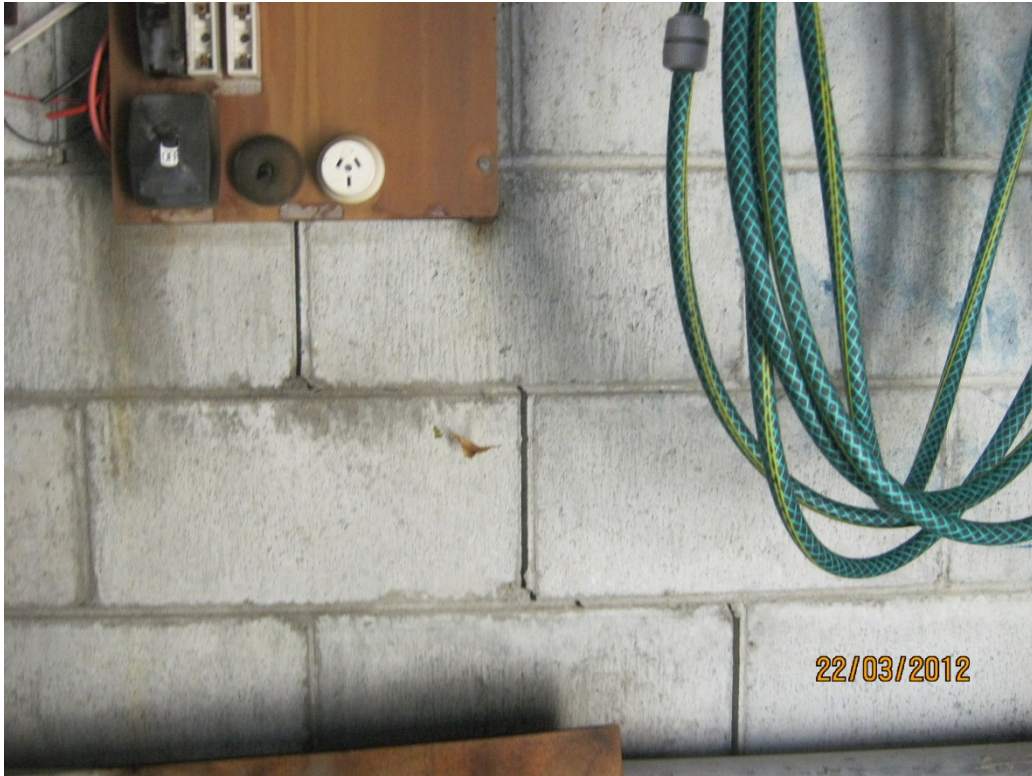
**Photo 12: Pool Plant Room - block wall opening crack**

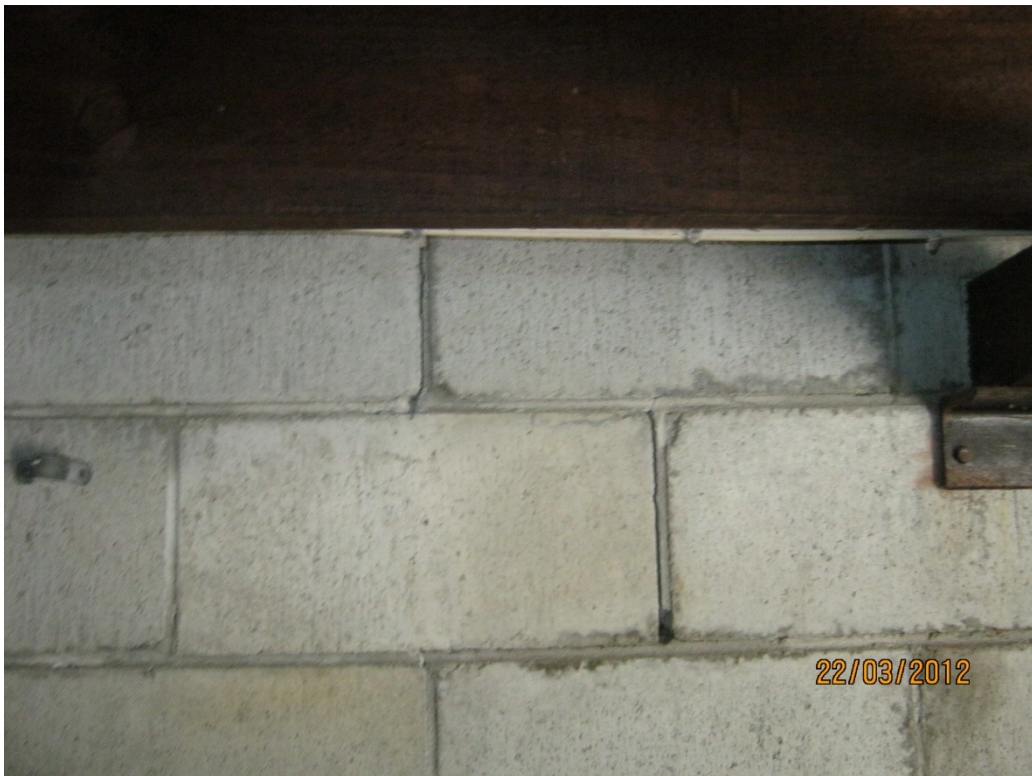
**Photo 13: Pool Plant Room block wall opening crack**

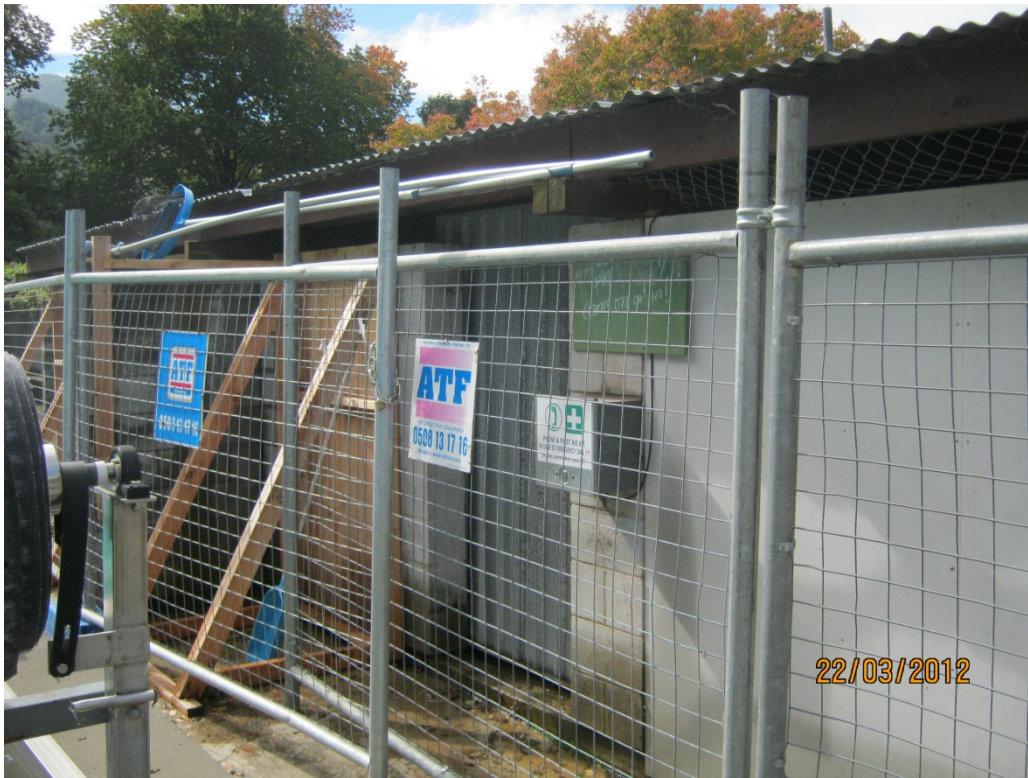
Photo 14: Pool Plant Room block wall propping

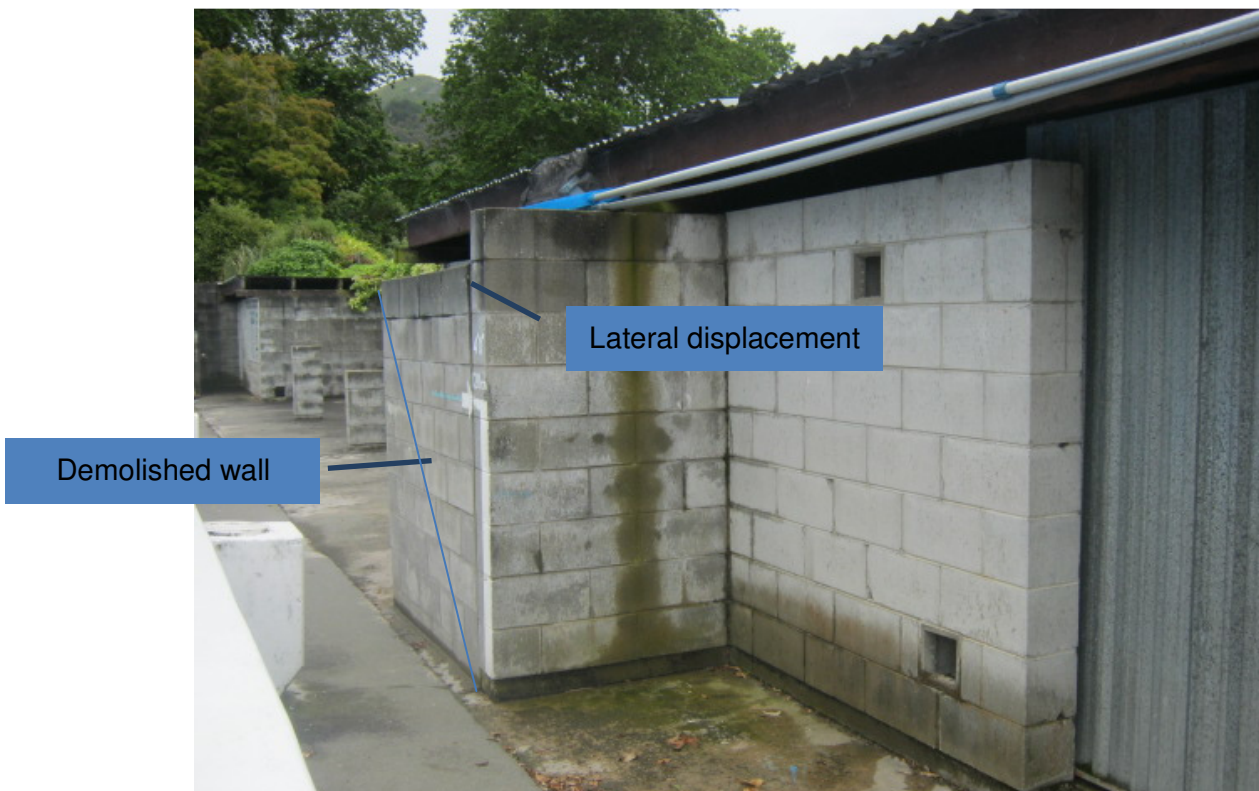
Photo 15: Similar photo as photo 14 – prior to wall demolition and propping

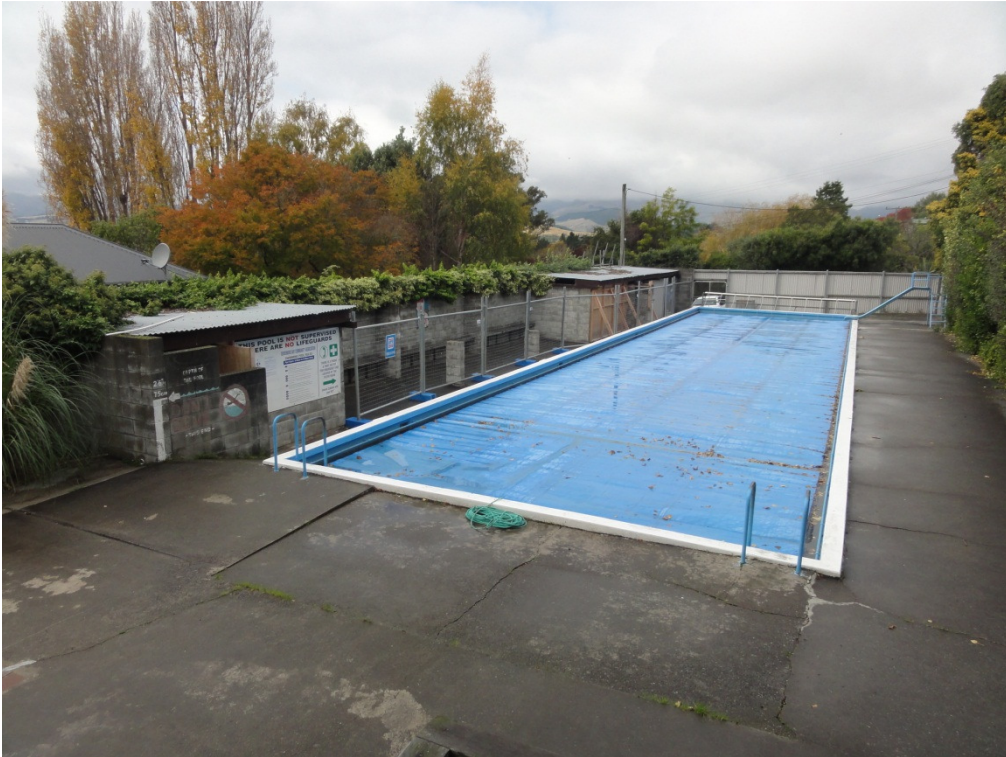
**Photo 1.** Pool service building on left, with concrete block wall on boundary. Note site slopes gently to far back left (SE)

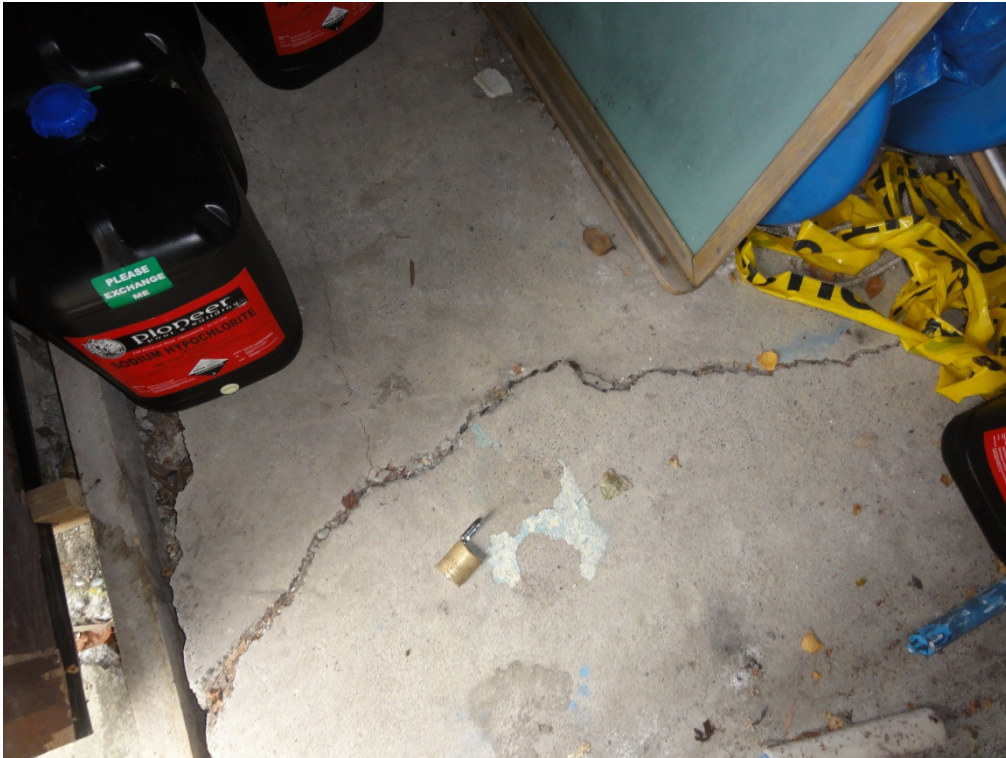
however no level survey has been completed. There was some differential settlement noted on paths around the pool. Discussions with the pool caretaker indicate cracking in the storeroom floor slab and paths was existing prior to the September 2010 earthquake.

**Photo 2.** Store room floor slab cracking

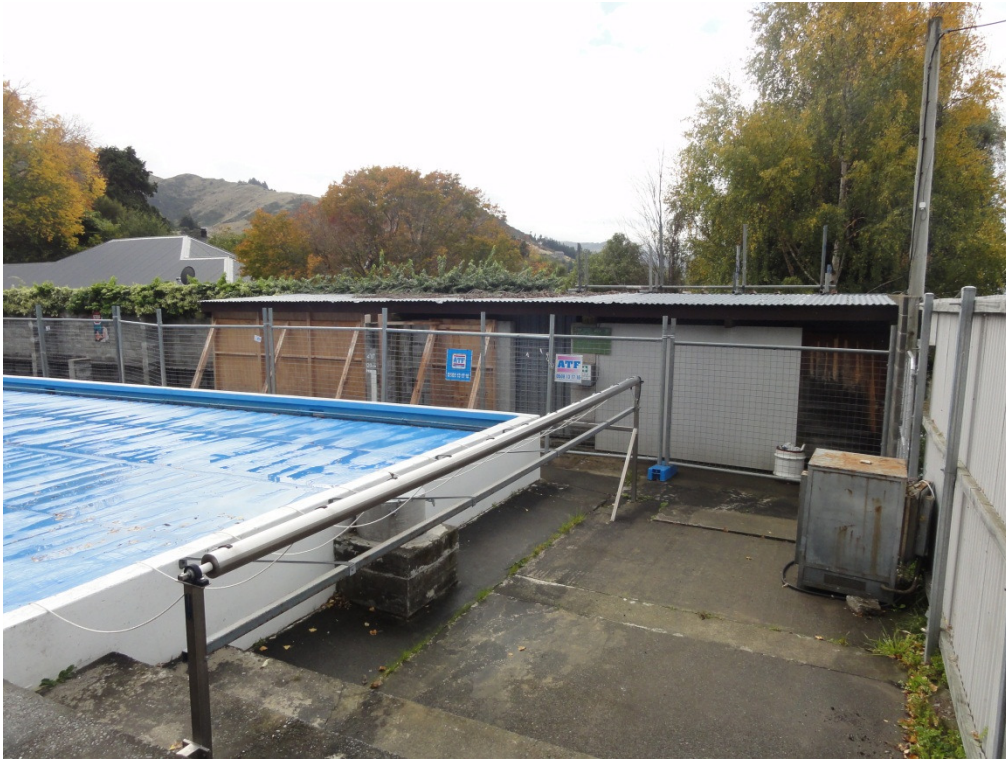
**Photo 3** Extensive propping of building. Paving slabs around pool tilted.

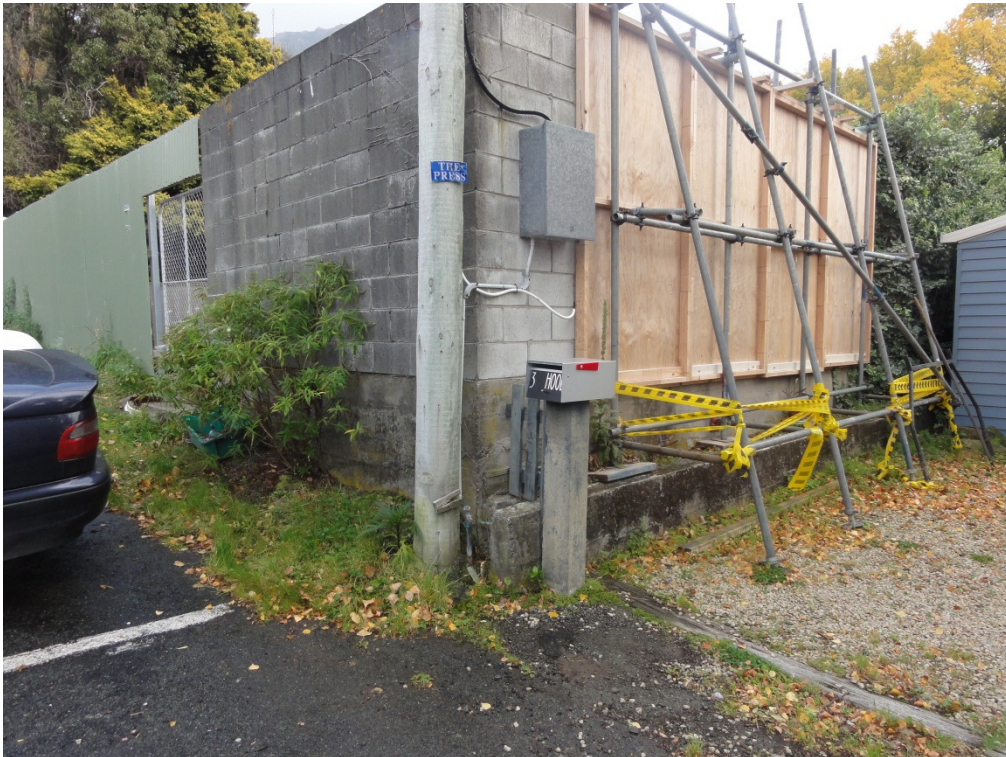
**Photo 4.** Blockwork on SE corner of building at back of storeroom propped.
