**Gowerton Place  
Housing Complex  
PRO 0678**

**Detailed Engineering Evaluation  
Quantitative Assessment Report**

## **Quantitative Assessment Report**

**Gowerton Place, Richmond,  
Christchurch 8013**

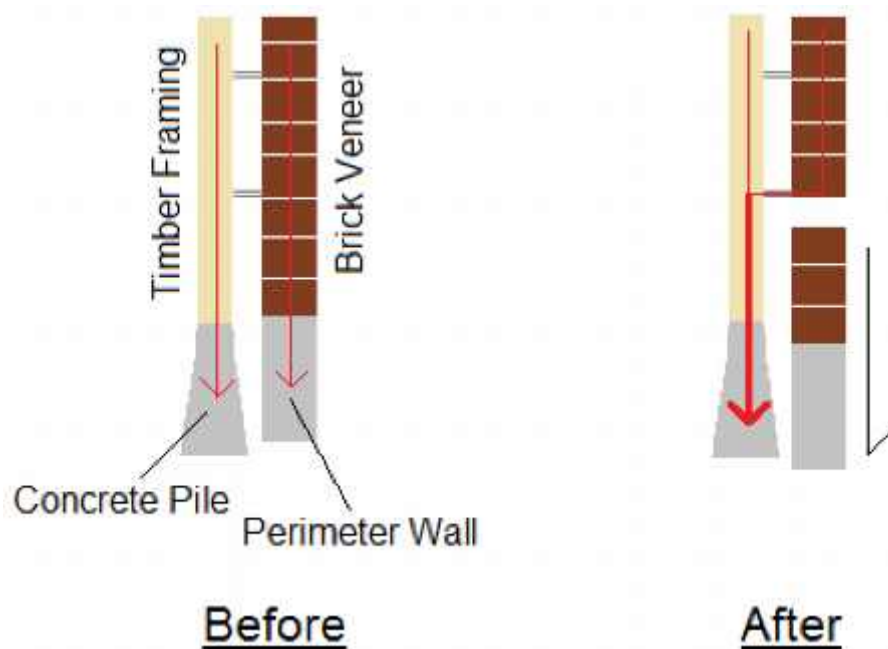
A major cause of damage in these units was due to settlement of the perimeter wall, upon which the brick cladding is supported. Settlement of these footings relative to the concrete piles within the footing has caused the load path to shift as the veneers become supported by the wire veneer ties, as shown in Figure 7. This has caused splitting in the mortar joints up to 20mm wide. This change in load path increases the load on the timber framing and has already resulted in increased damage; this was observed to have worsened between the visits by Opus engineers in 2011 and 2013. It is expected that this will cause continued damage to the units unless repaired.

Figure 7: Example of damage due to relative settlement of the perimeter wall.

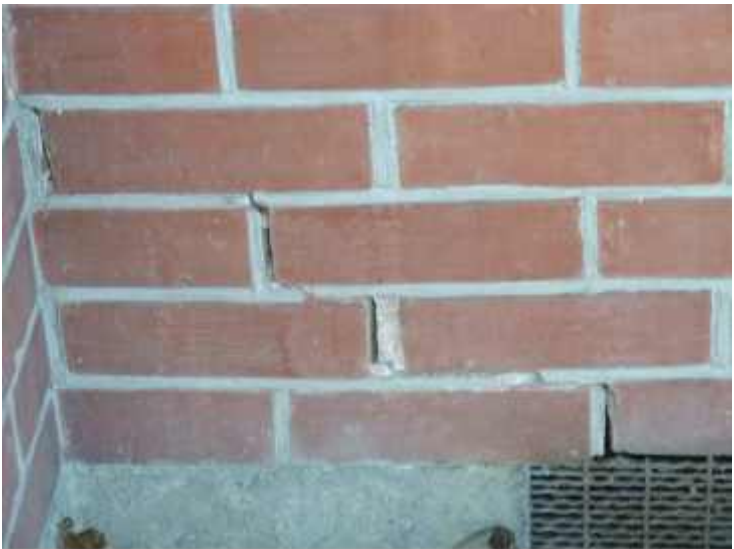
Stepped cracking of the mortar joints and through the brick veneer exterior cladding was observed on most units (photos 6-13). Units 24-27 and 28-31 appear to have suffered the most cracking to their brick veneer cladding. This damage is due to shear failure, differential settlement and the foundation damage explained in section 5.2.

9	Typical stepped cracking of brick veneer

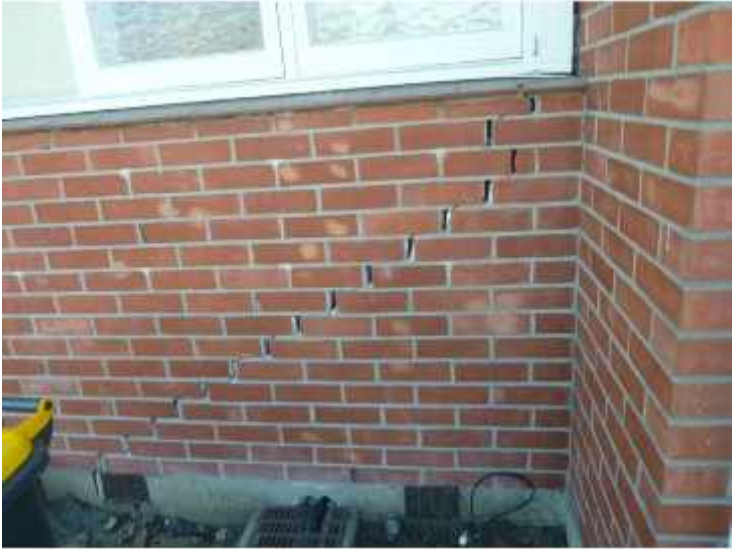
10	Typical stepped cracking of brick veneer

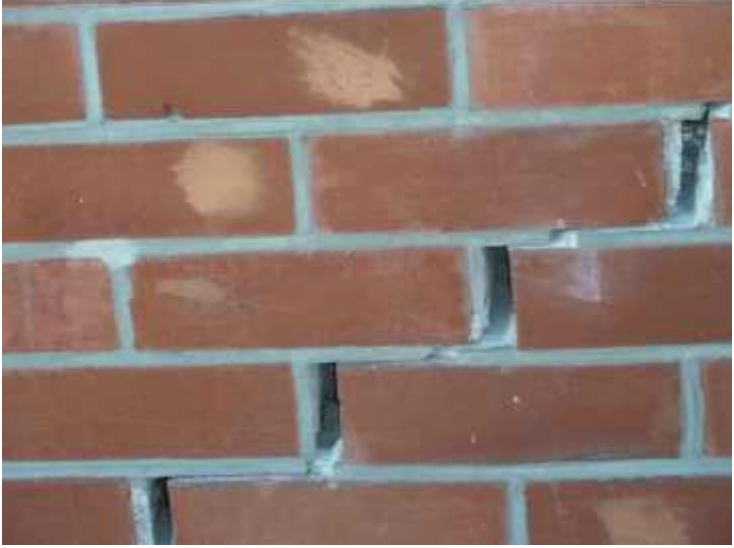
11	Typical stepped cracking of brick veneer

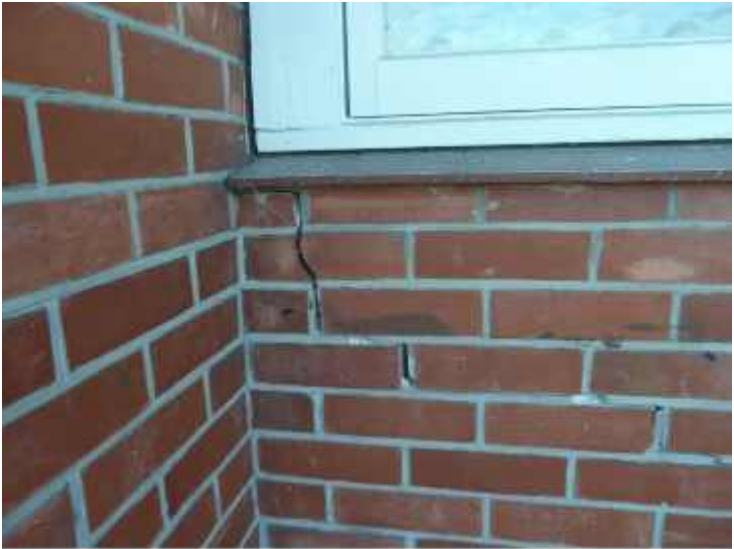
12	Typical cracking of brick veneer

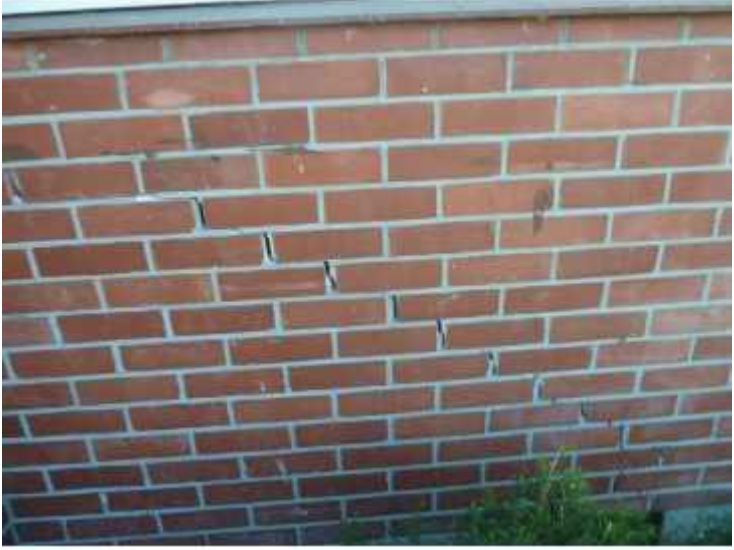
13	Typical stepped cracking of brick veneer

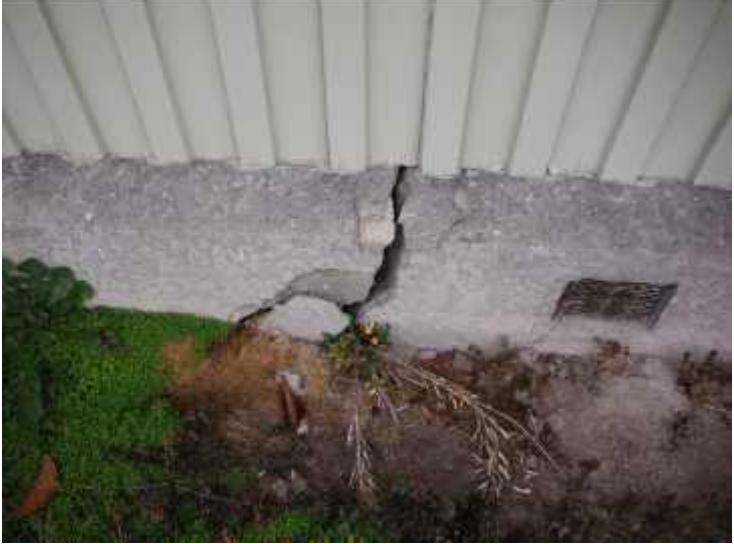
Many of the residential blocks have areas along their length where 0.1-1 mm wide cracks can be observed on the concrete perimeter foundation wall. In some locations cracking exceeds 40mm and are observed as being severe in nature (photos 14-17). Access to view the timber subfloor framing was limited to a visual assessment through a floor access hatch in unit 9.

14	Severe cracking of concrete perimeter foundation wall

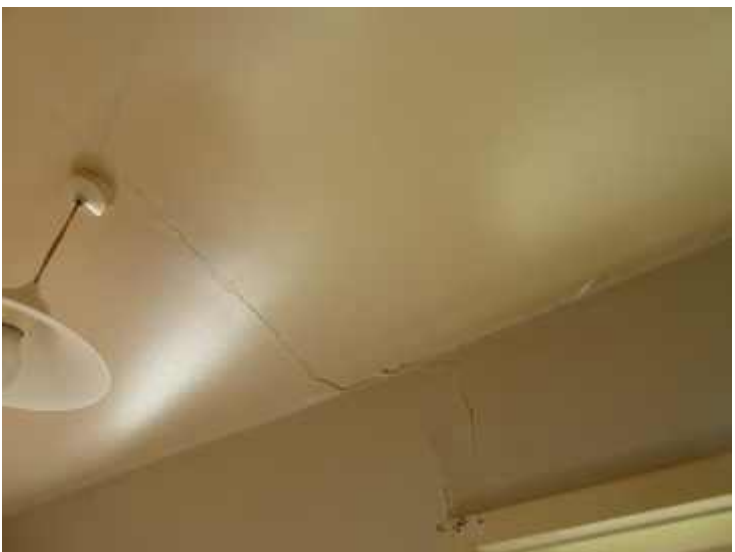
Some cracking of GIB ceiling diaphragms and wall linings was observed in many of the units, typically at the joint between two panels (photos 19-21). This was consistent throughout all the units visited.

21	Typical cracking of GIB ceiling and wall lining

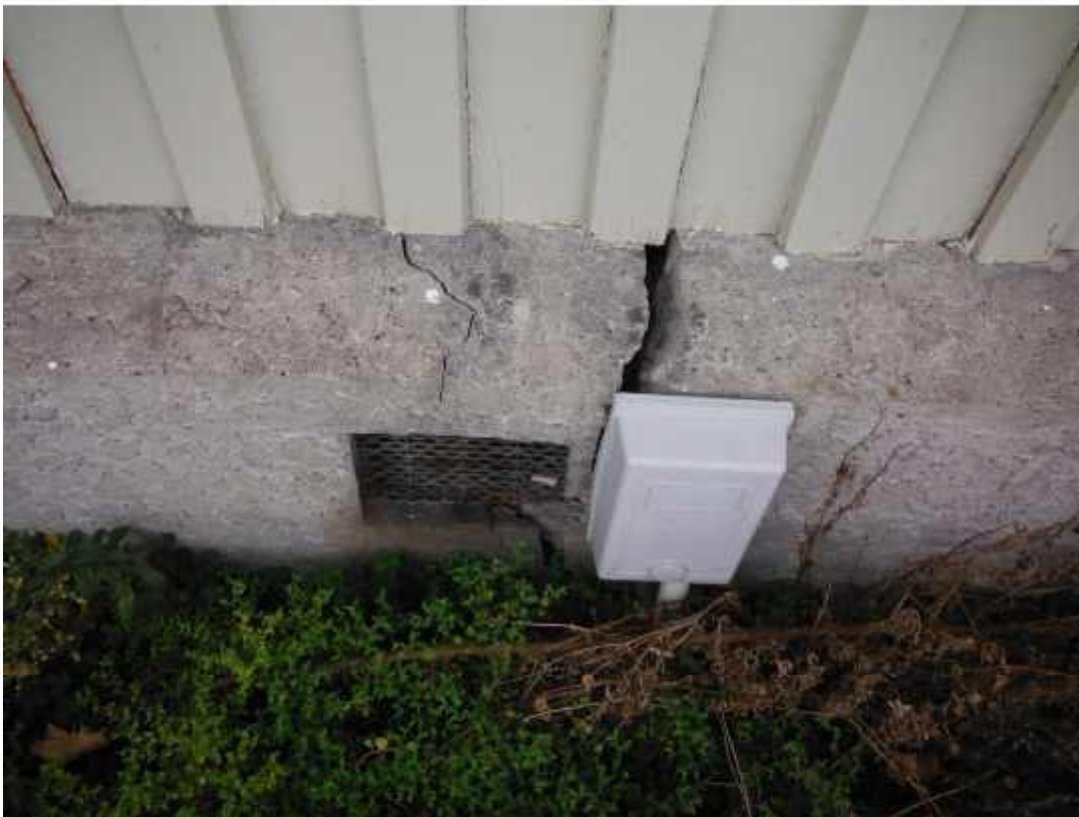
**Photograph 3:** Observed crack (approximately 4 mm wide) in footing, south-eastern side of Unit 18.

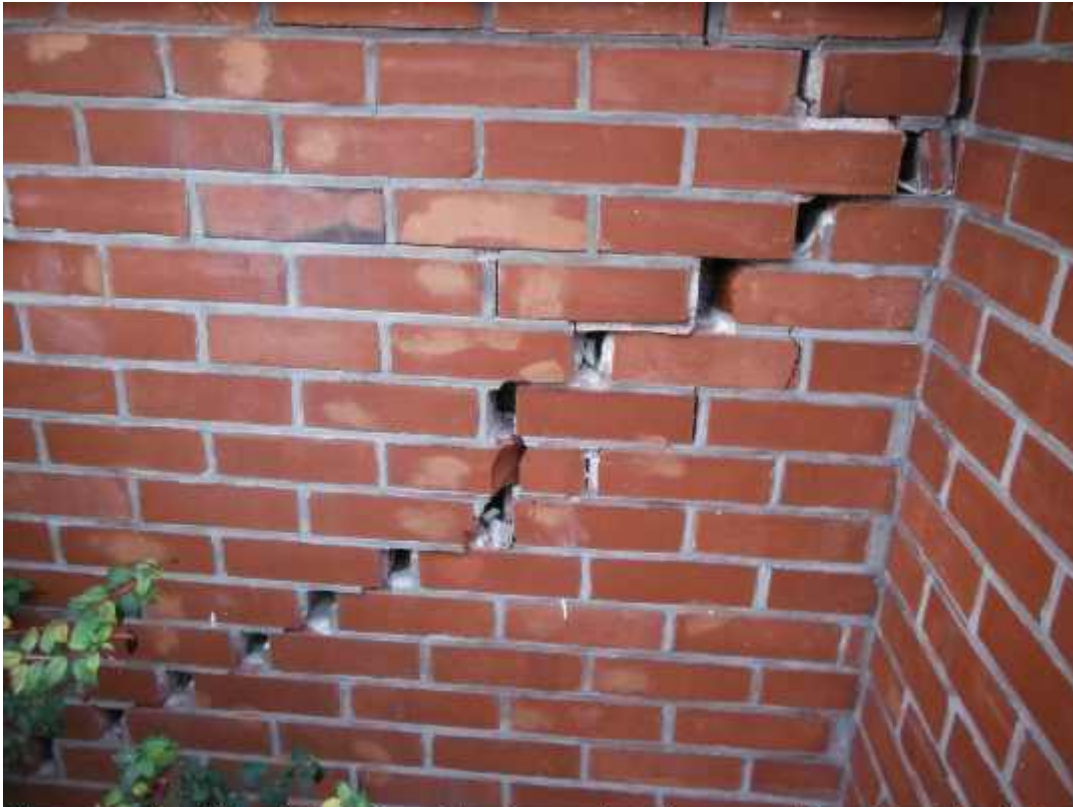
**Photograph 4:** Large crack (approximately 30 mm wide) observed in footing, north-western side of Unit 21.

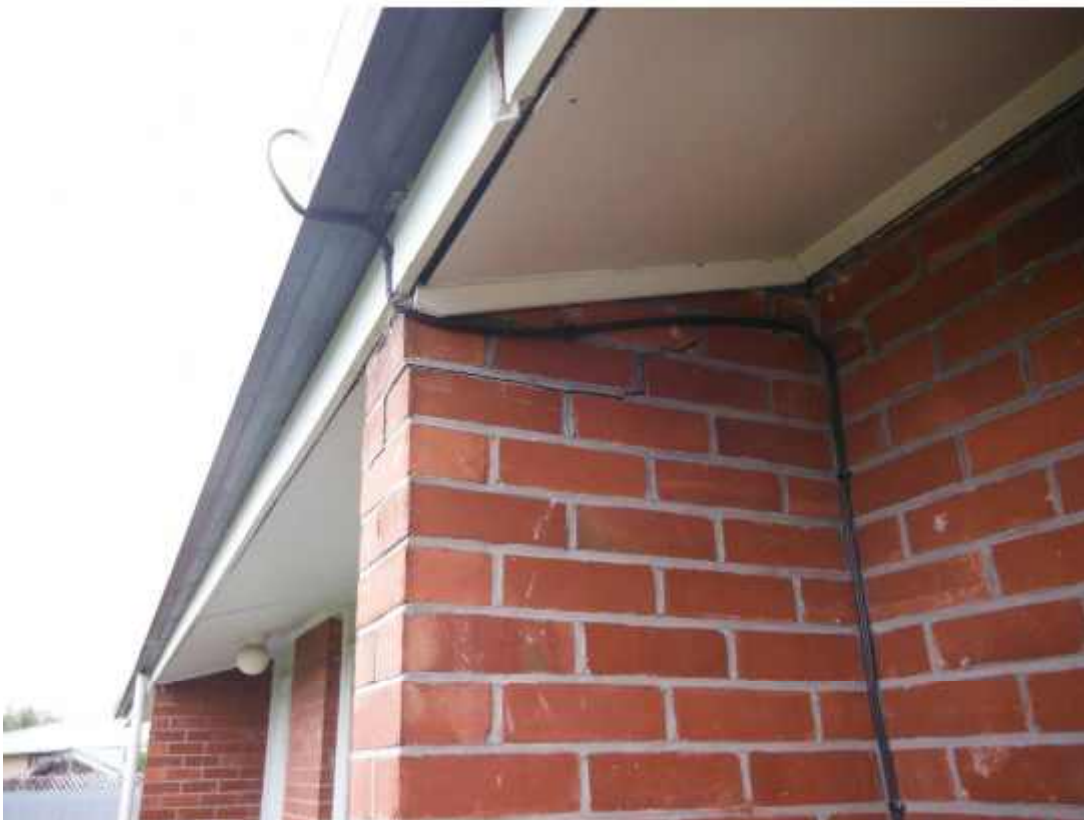
**Photograph 5:** View of stepped cracking (approximately 40 mm wide and 2 m long) observed in the brick veneer in the southeast corner of Unit 22.

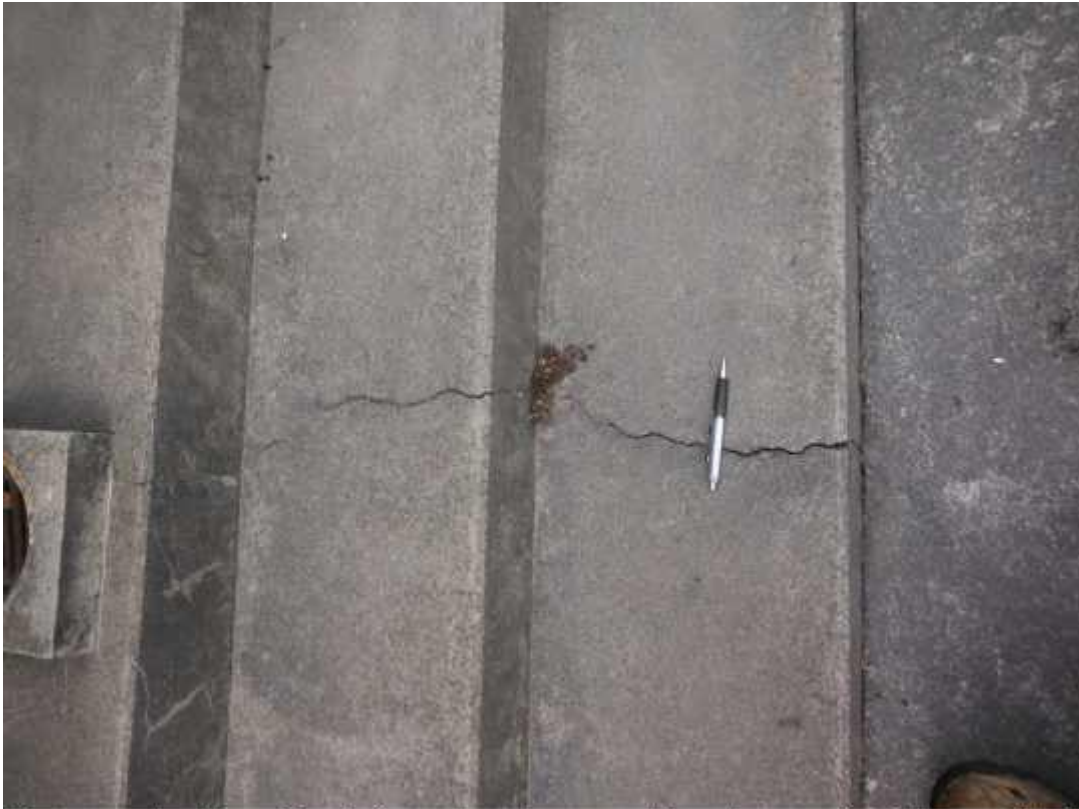
**Photograph 6:** View of cracking in the party walls (approximately 4 mm wide and 500 mm long) between Units 21 and 22.

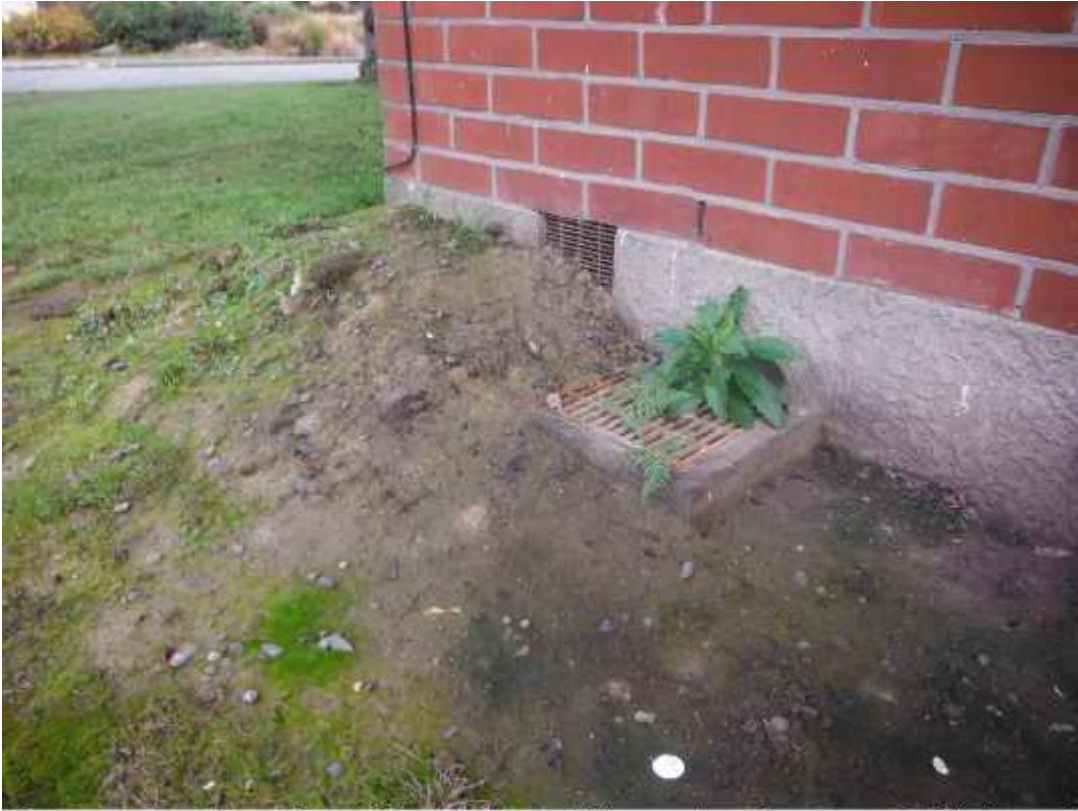
**Photograph 8:** View of exposed concrete observed around drain where the ground may have settled (up to 60 mm) at the southern corner of Unit 11.
