Christchurch City Council
PRK_0348_BLDG_014 EQ2
Boat Shed
The Groynes, 182 Johns Road

QUALITATIVE ASSESSMENT REPORT

- Rev B
- 23 May 2013

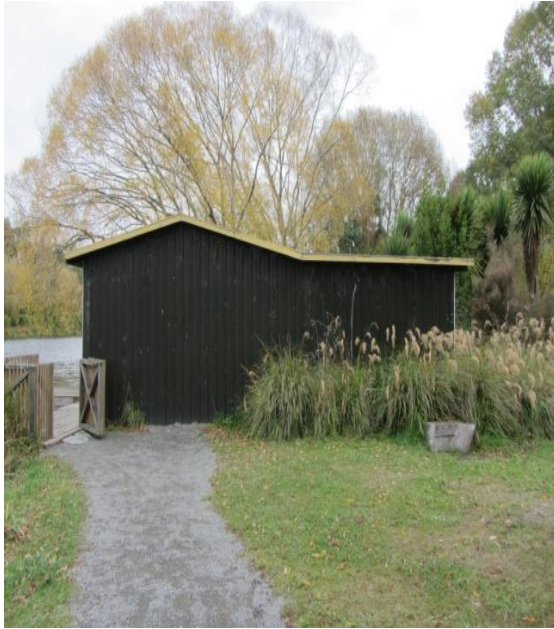
Photo 1: East Elevation

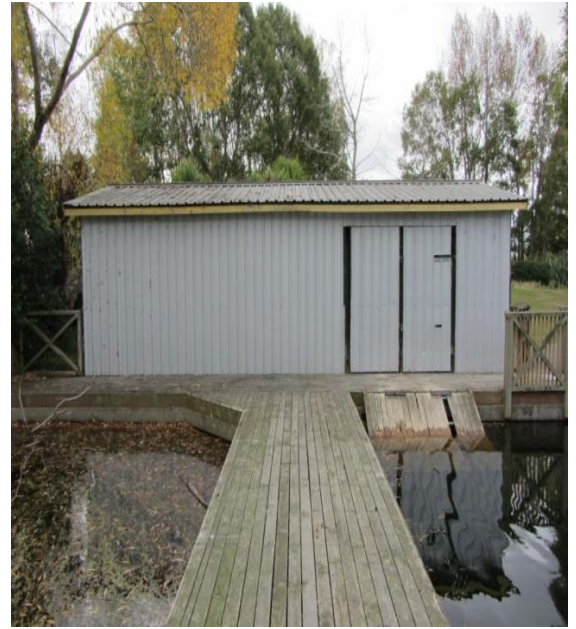
Photo 2: South Elevation

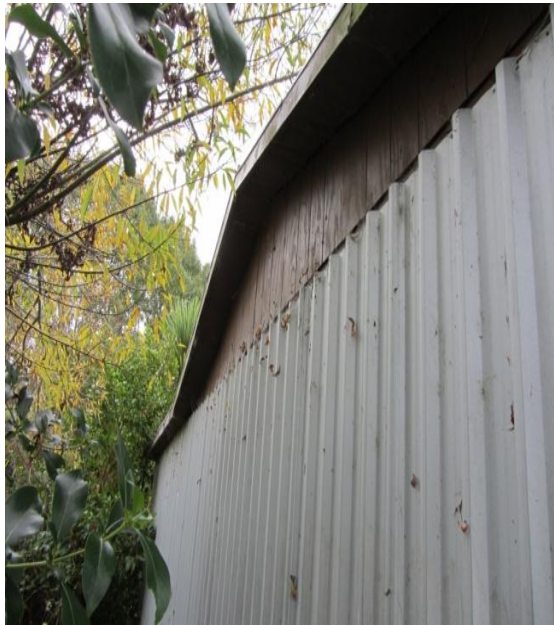
Photo 3: West Elevation

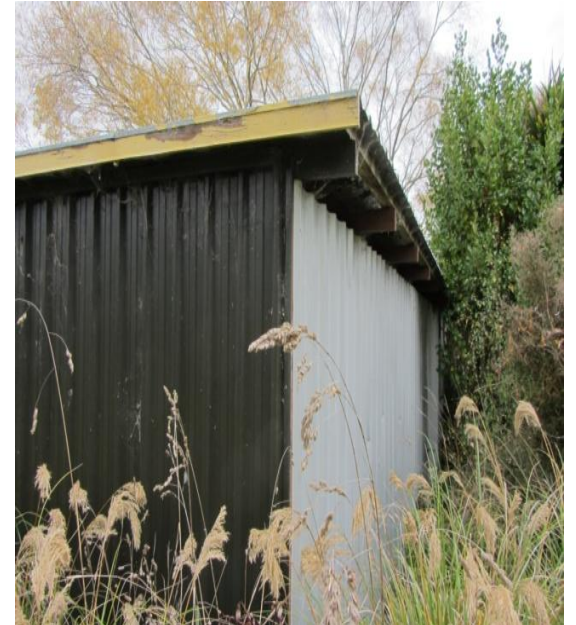
Photo 4: North Elevation

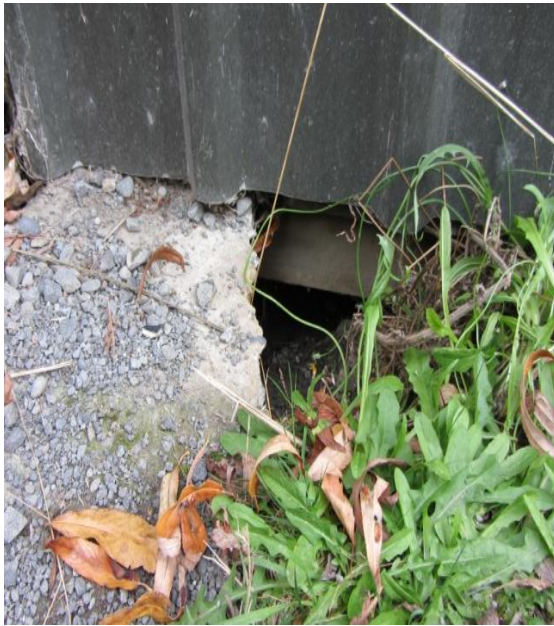
Photo 5: View of timber framed foundation

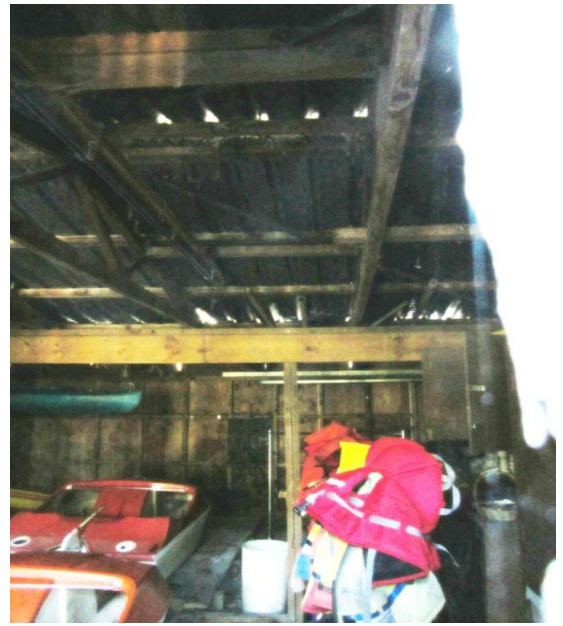
Photo 6: Interior view showing roof truss and steel bracing
