**Christchurch City Council**  
PRK\_0348\_BLDG\_018 EQ2  
Kimihiia Toilet block  
The Groynes, 182 Johns Road

QUALITATIVE ASSESSMENT REPORT  
FINAL

- Rev B
- 09 November 2012

Sinclair Knight Merz  
142 Sherborne Street  
Saint Albans  
PO Box 21011, Edgware  
Christchurch, New Zealand  
Tel: +64 3 940 4900  
Fax: +64 3 940 4901  
Web: [www.skmconsulting.com](http://www.skmconsulting.com)

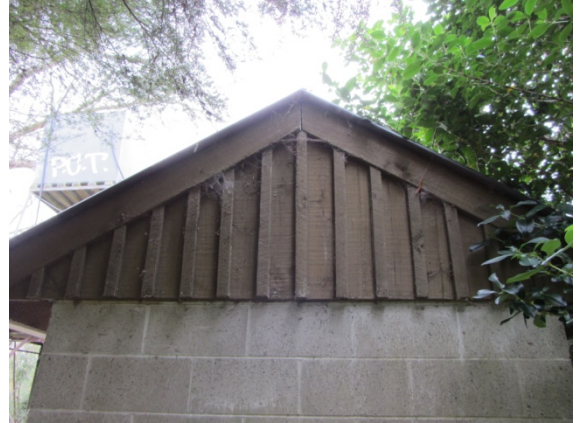
Photo 10: West elevation of roof

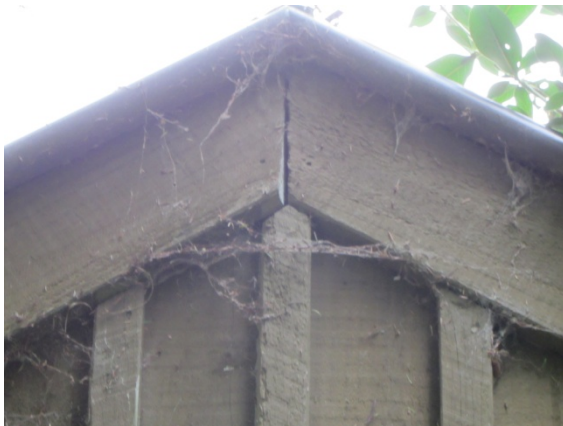
- 1) The rafter on the west side of the building does not sit in plane.
- 2) The concrete pavement in front of the building (North Side) has cracked. Width of the crack is 10-15mm.
- 3) Separation between the concrete pavement and the concrete foundation.

These damages are unlikely to be a result of the earthquakes. Photos of the above damage can be found in Appendix 1 – Photos.

Photo 11: Close up view of photo 10 showing the buckled rafter at the apex

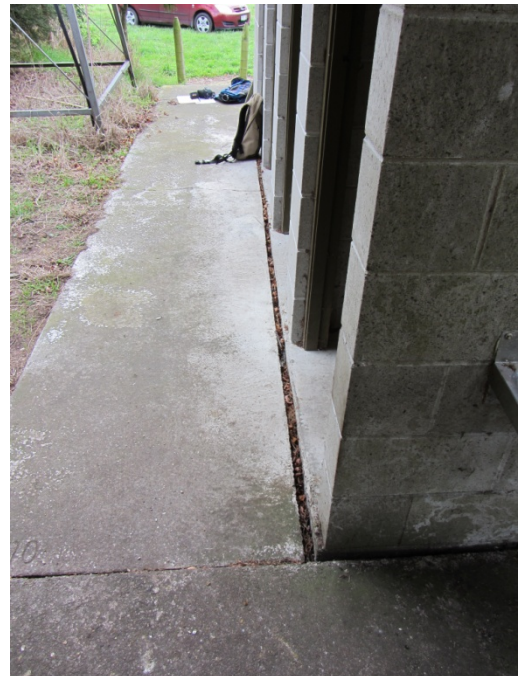
Photo 12: Pavement in front of the toilet block showing the separation away from the structure.

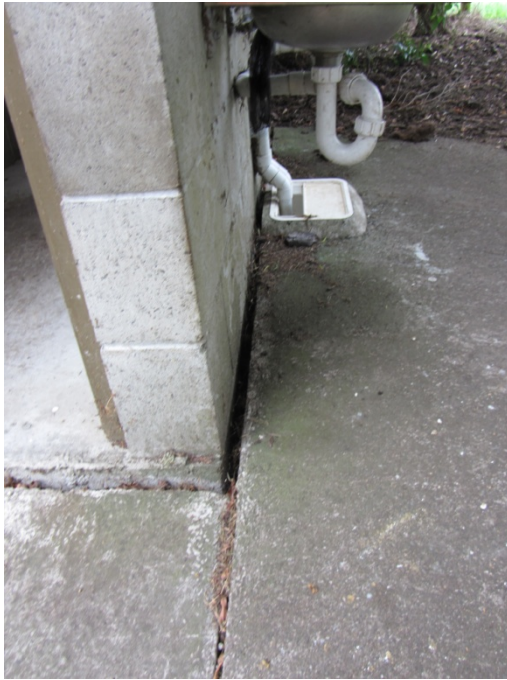
Photo 13: Pavement on the west elevation showing separation away from the structure

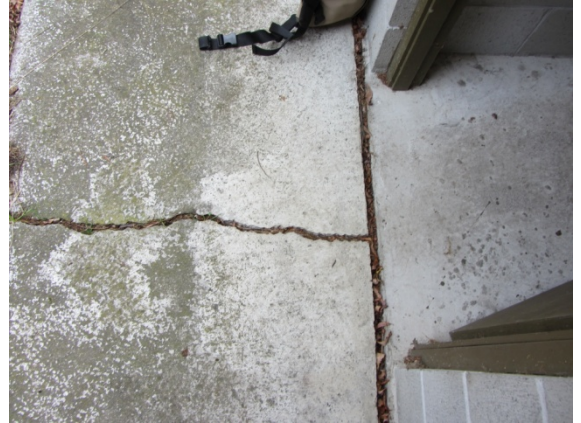
Photo 14: Cracking in pavement in front of the toilet block

<b>Recommendations</b>		Level of repair/strengthening required: minor non-structural	Describe: Grouting of crack
Building Consent required: no		Interim occupancy recommendations: full occupancy	Describe: _____
Along	Assessed %NBS before: _____	100%	Qualitative Assessment carried out this includes the NZSEEE IEP - refer to SKM report If IEP not used, please detail assessment methodology: _____
	Assessed %NBS after: _____	100%	
Across	Assessed %NBS before: _____	100%	
	Assessed %NBS after: _____	100%
