CHRISTCHURCH CITY COUNCIL
PRK_0348_BLDG_009 EQ2
The Groynes – Kiosk
182 Johns Road

QUALITATIVE ASSESSMENT REPORT
FINAL

- Rev B
- 05 December 2012

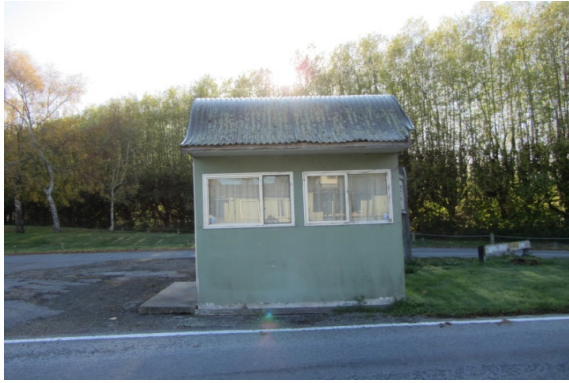
Photo 1: West Elevation

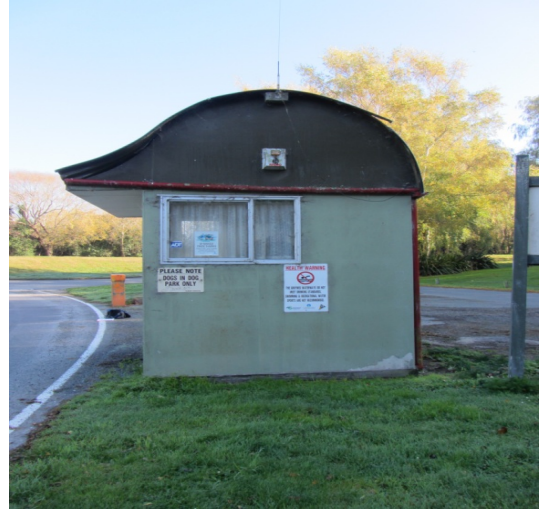
Photo 2: South Elevation

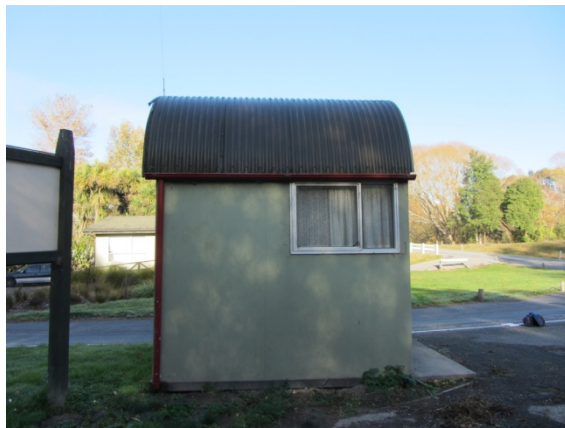
Photo 3: East Elevation

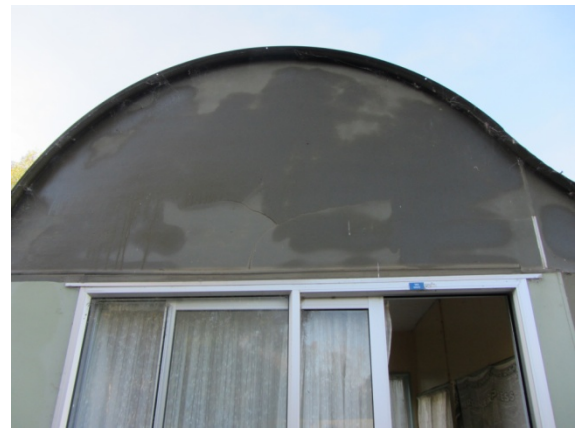
- 1) No visual evidence of settlement was noted at this site. Therefore a level survey is not required at this stage of assessment.
- 2) Damage present to the cladding above the north door. This damage appears to be a result of something impacting on the building and therefore is not a result of the earthquake (PHOTO 4 & 5)
- 3) Minor hairline cracking present to the cladding panels on the north face (PHOTO'S 6-10)

Photo 4: Damage to Cladding above North Door

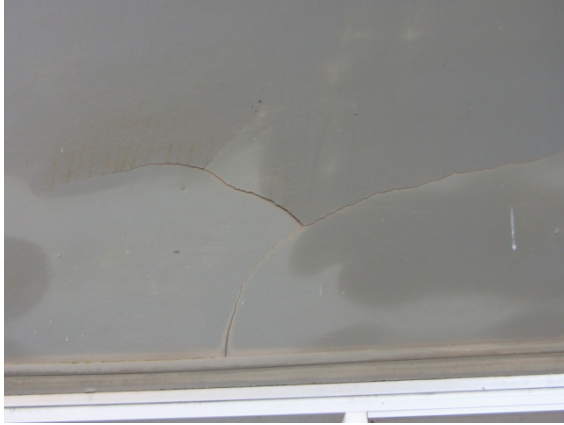
Photo 5: Close Up of Photo 4

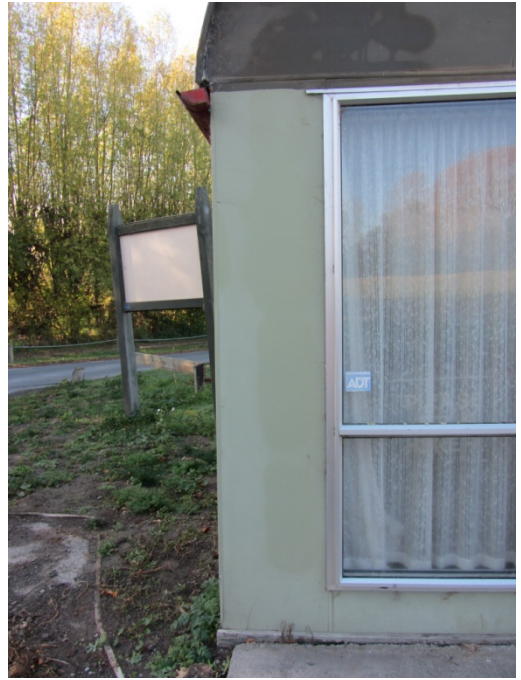
Photo 6: Hairline Cracking to Cladding on the North Wall

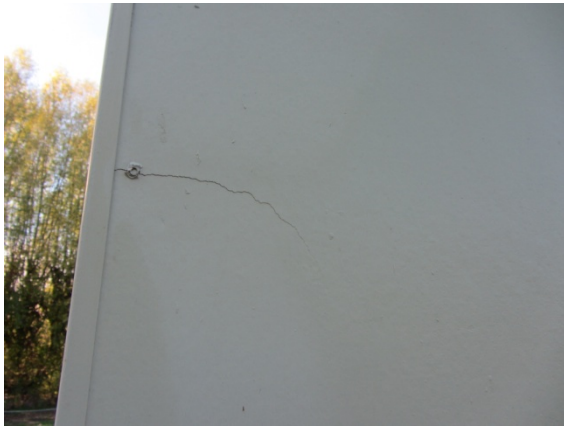
Photo 7: Cracking to Cladding Panel in NE Corner

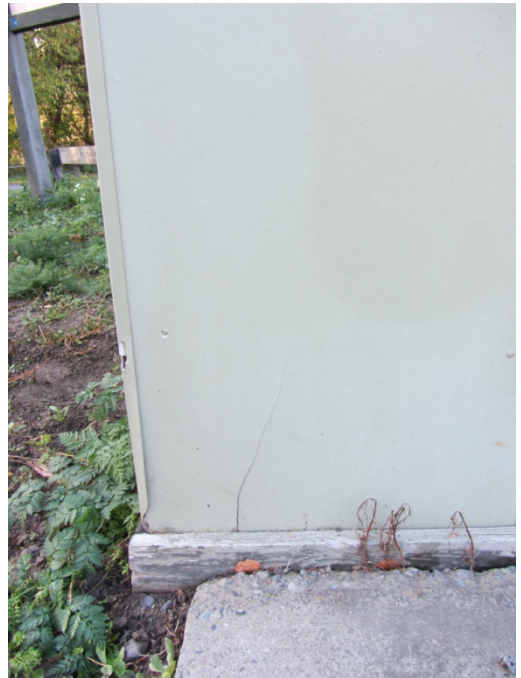
Photo 8: Cracking to Cladding Panel in NE Corner

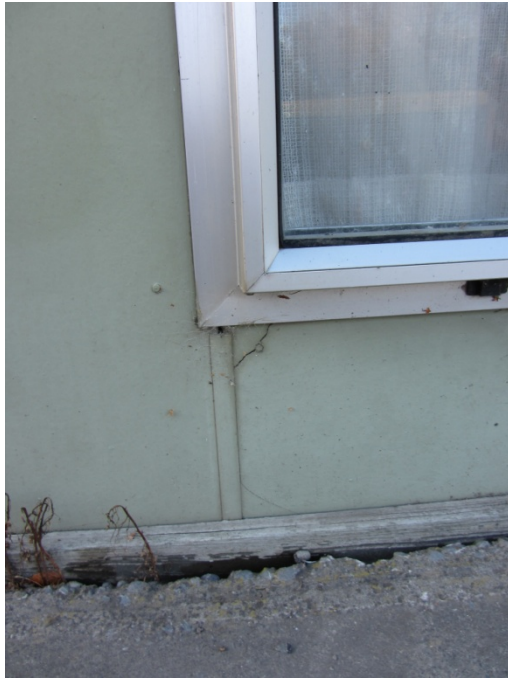
Photo 9: Hairline Cracking to Cladding Panel under North Door

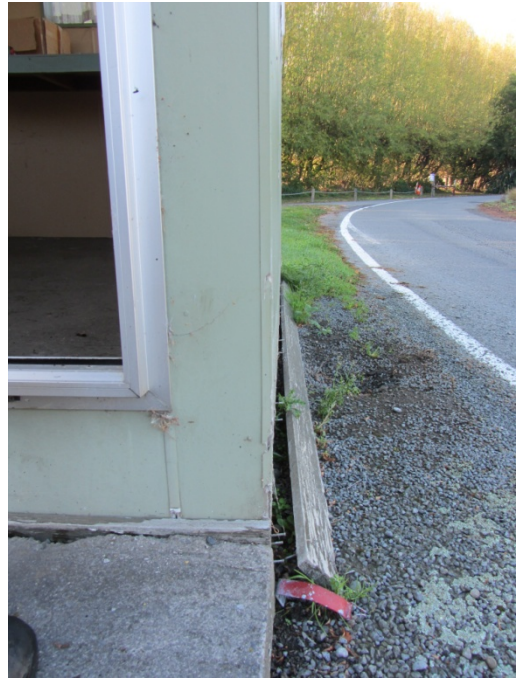
Photo 10: Hairline Cracking to Cladding Panel in NW Corner

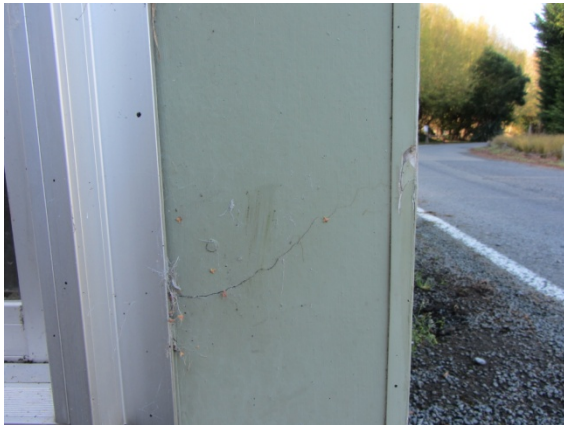
Photo 11: Close Up of Photo 10
