Christchurch City Council
PRK_0348_BLDG_013 EQ2
Main Shop and Mobile Shop
The Groynes, 182 Johns Road

QUALITATIVE ASSESSMENT REPORT

- Rev B
- 23 May 2013

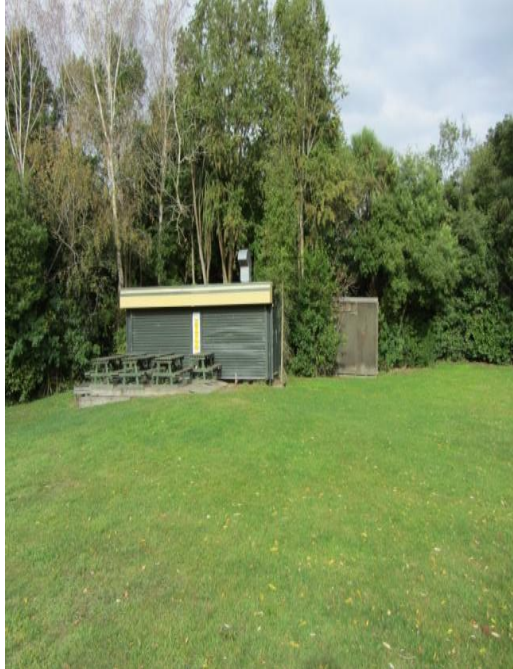
Photo 1: Overall View

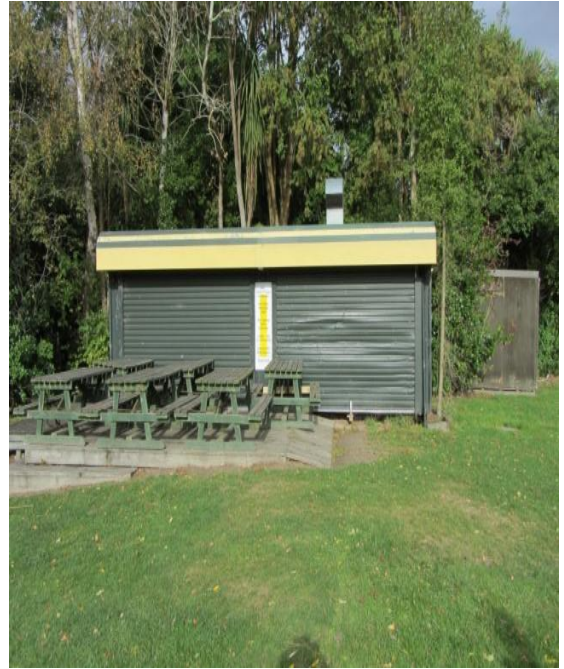
Photo 2: North Elevation

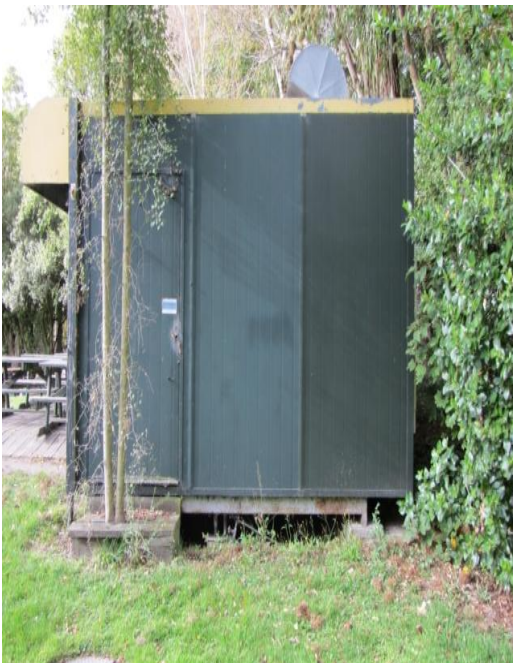
Photo 3: West Elevation

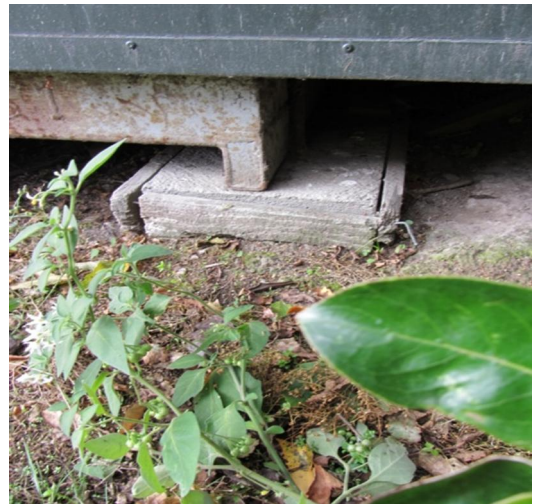
Photo 4: Building sitting on concrete footing

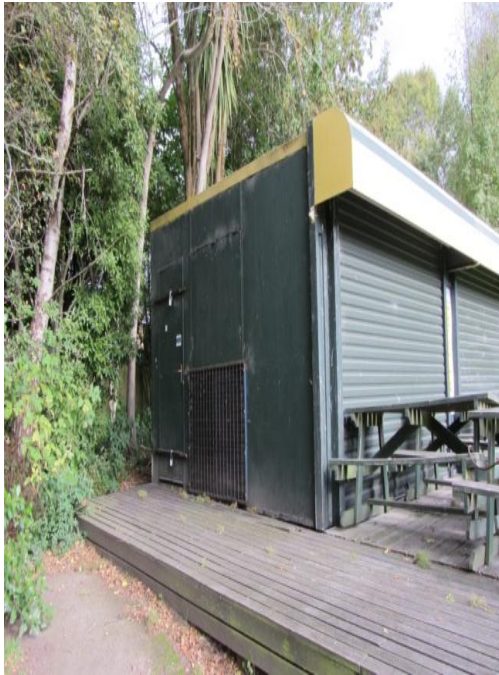
Photo 9: East Elevation

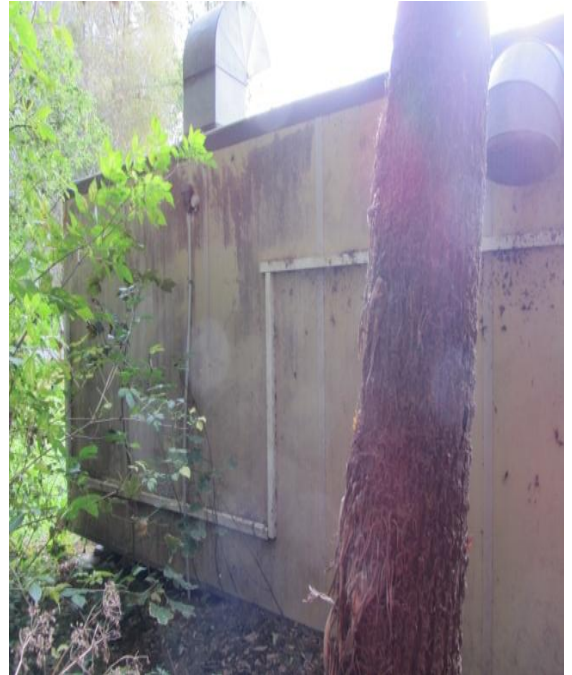
Photo 10: South Elevation 1

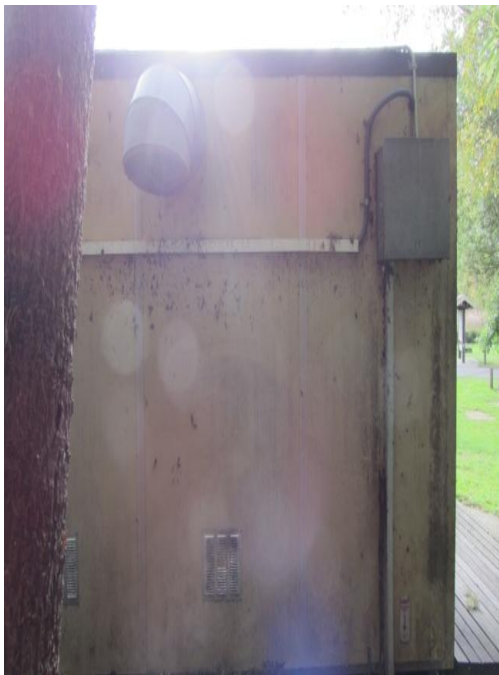
Photo 11: South Elevation 2
