Christchurch City Council
PRK_0348_BLDG_003 EQ2
Toilets No 1 Ground West
The Groynes, 182 Johns Road

QUALITATIVE ASSESSMENT REPORT

- Rev B
- 21 November 2012

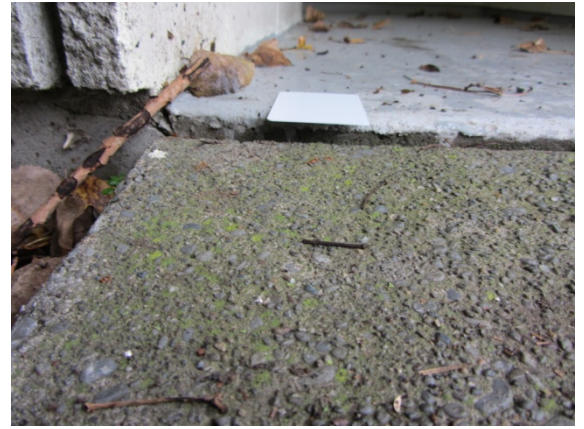
- 1) The sump at the back of the building (west side) has displaced away from the building
- 2) Pavement has separated further from the structure and has cracks

Photo 14: Separation between pavement and toilet entrance

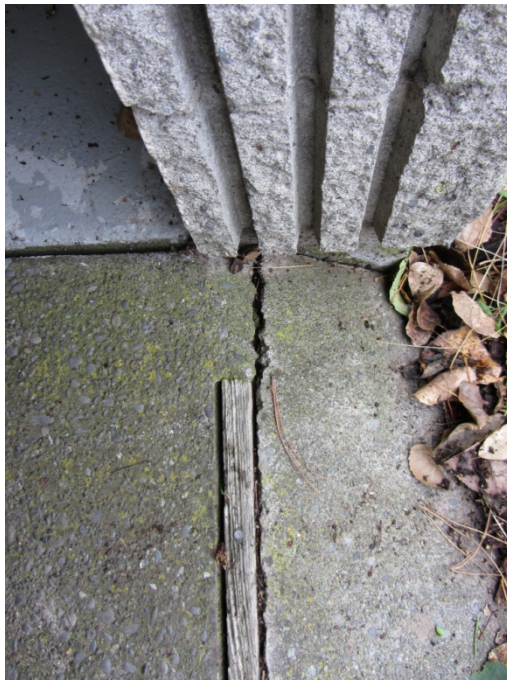
Photo 15: Cracking in the pavement

Recommendations		Level of repair/strengthening required: minor non-structural	Describe: Grouting of crack
Building Consent required: no		Interim occupancy recommendations: full occupancy	Describe: _____
Along	Assessed %NBS before: 100%	%NBS from IEP below	If IEP not used, please detail assessment methodology: _____
	Assessed %NBS after: 100%		
Across	Assessed %NBS before: 100%	%NBS from IEP below	Qualitative Assessment carried out, this includes the NZSEE IEP - refer to SKM report
	Assessed %NBS after: 100%

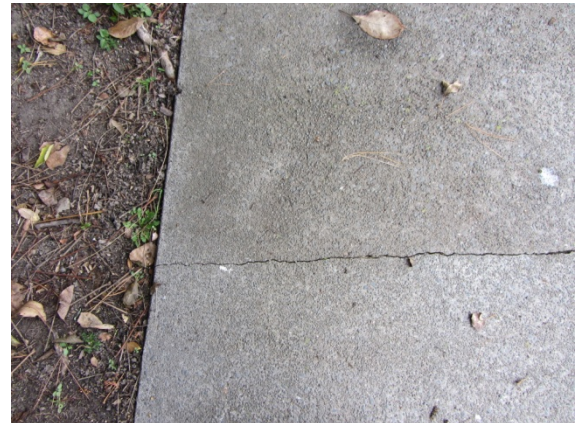
Photo 16: Cracking in the pavement

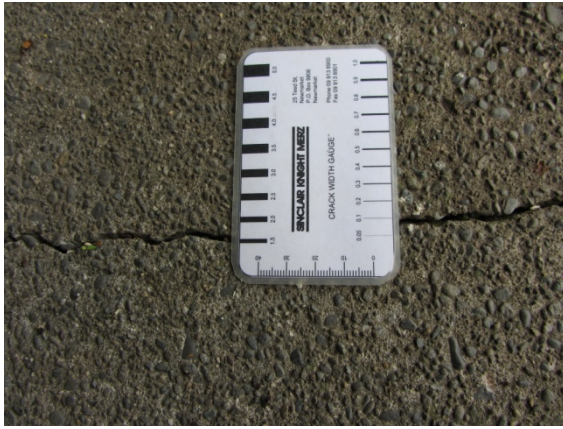
Photo 17: Close up view of crack from photo 16 showing 1.5mm wide crack

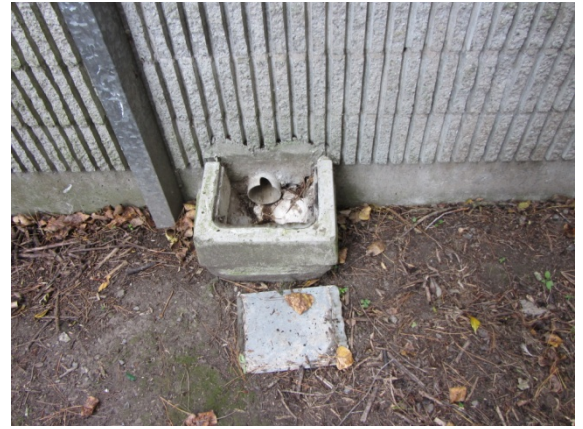
Photo 18: Sump at the back of the toilet block (west side)

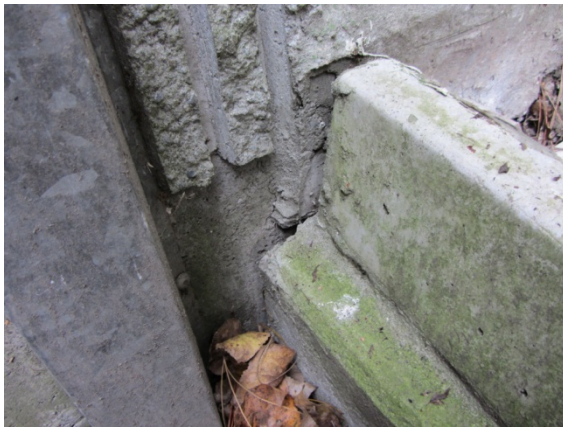
Photo 19: Separation between sump and toilet structure

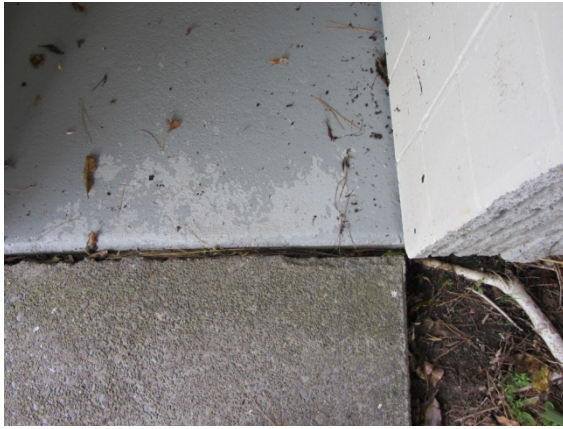
Photo 21: Separation between pavement and entrance to mens toilet

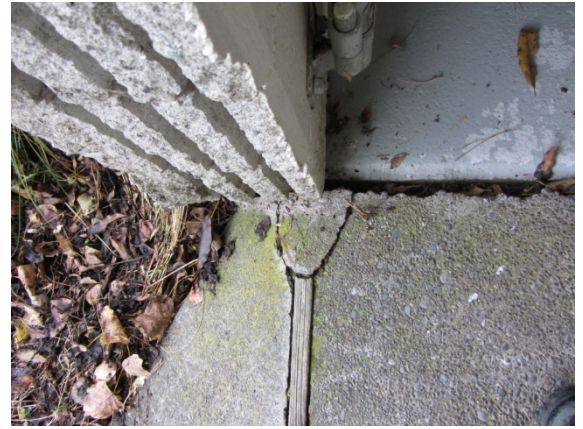
Photo 22: Cracking in the pavement at the mens toilet entrance
