PRK_0348_BLDG_008 EQ2

Toilets No 3 Ground

The Groynes, 182 Johns Road

QUALITATIVE ASSESSMENT REPORT FINAL

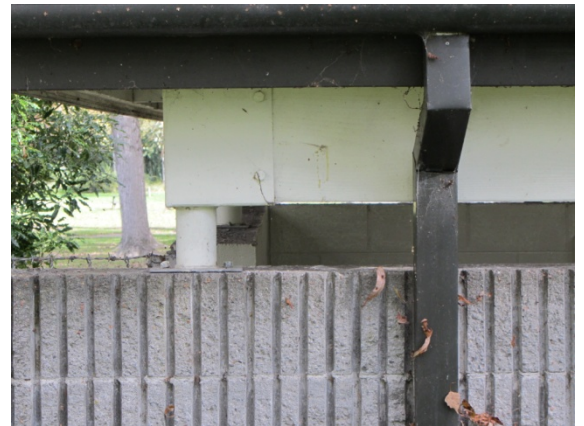
Photo 4: Exterior view of south west steel connection

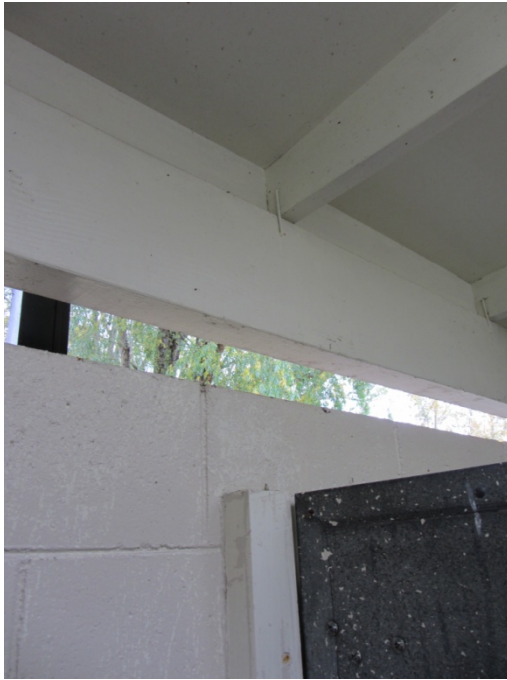
Photo 5: Interior view of timber roof frame

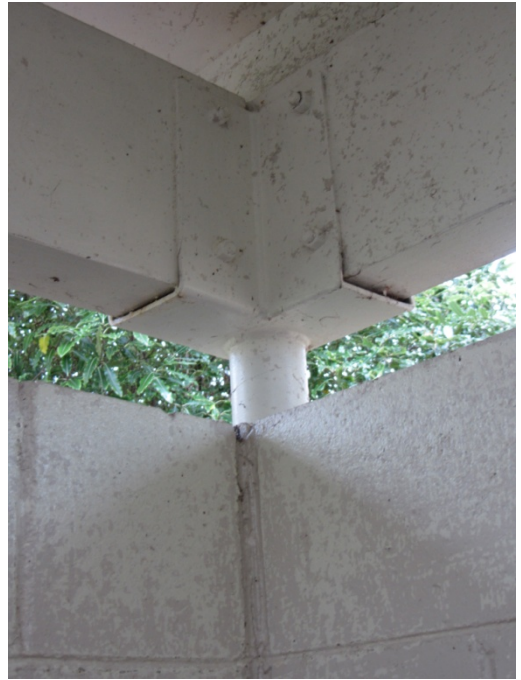
Photo 6: Interior view of steel connection

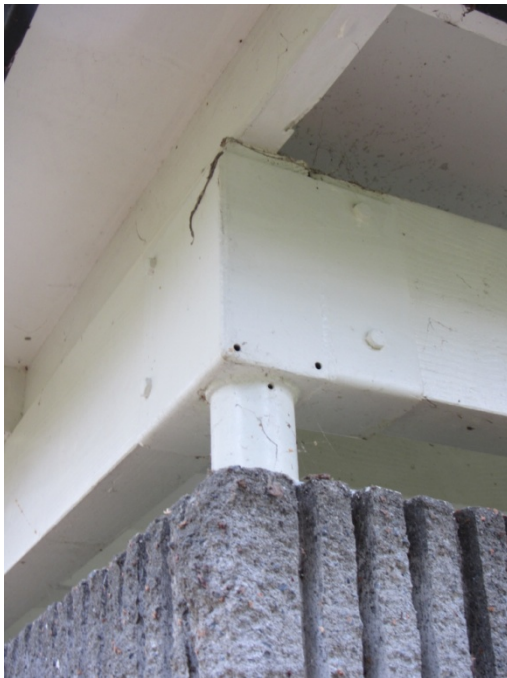
Photo 7: exterior view of connection
