CHRISTCHURCH CITY COUNCIL
PRK_0348_BLDG_016 EQ2
Storage Shed
The Groynes, 182 Johns Road

QUALITATIVE ASSESSMENT REPORT
FINAL

- Rev B
- 07 December 2012

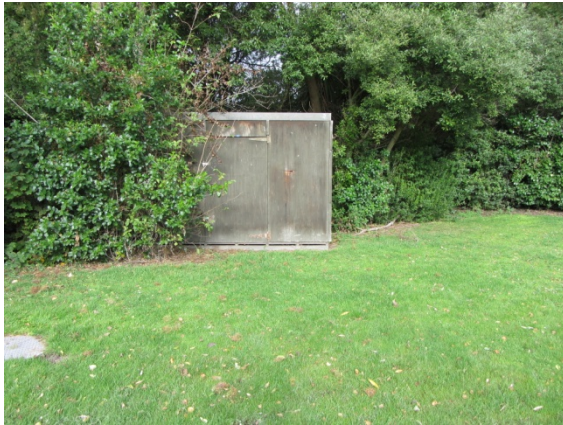
Photo 1: North Elevation.

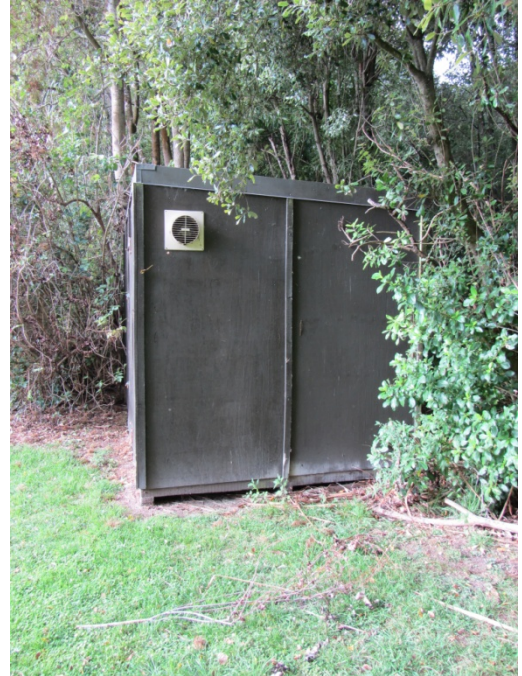
Photo 2: West Elevation

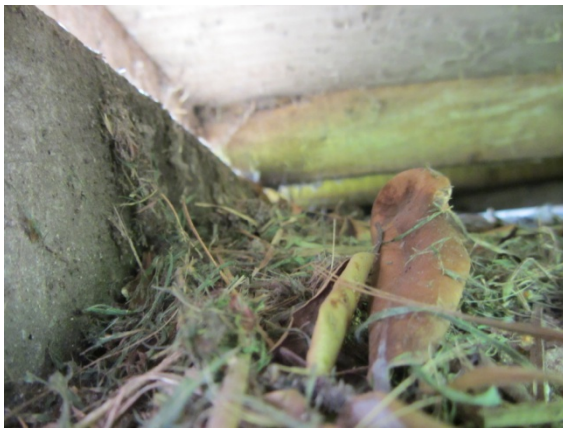
Photo 3: Underside of the building

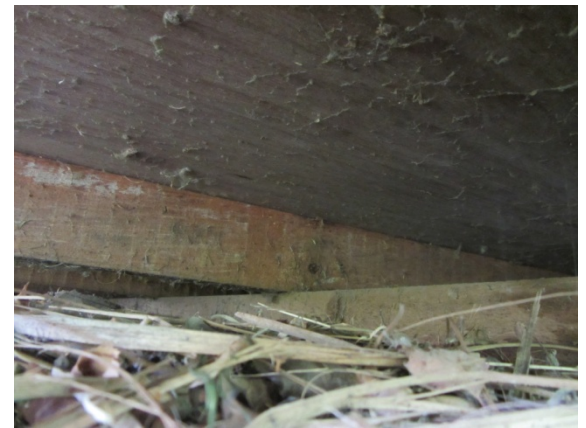
Photo 4: Underside of the building showing the timber bearers 1 of 2

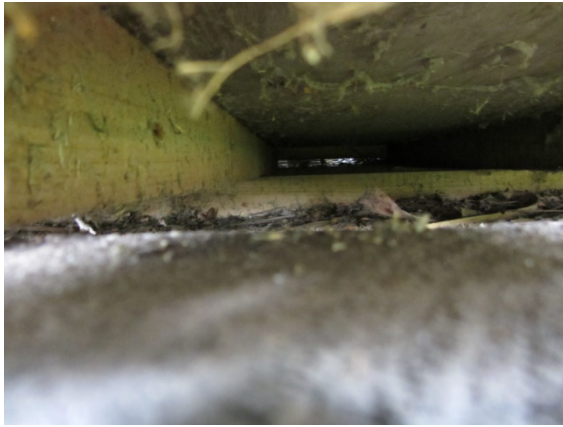
Photo 5: Underside of the building showing the timber bearers 2 of 2

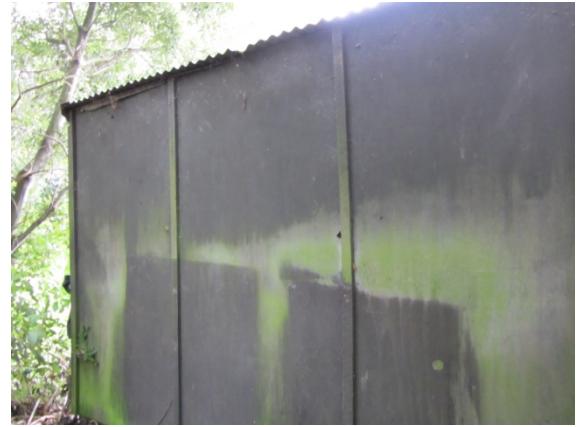
Photo 6: South Elevation

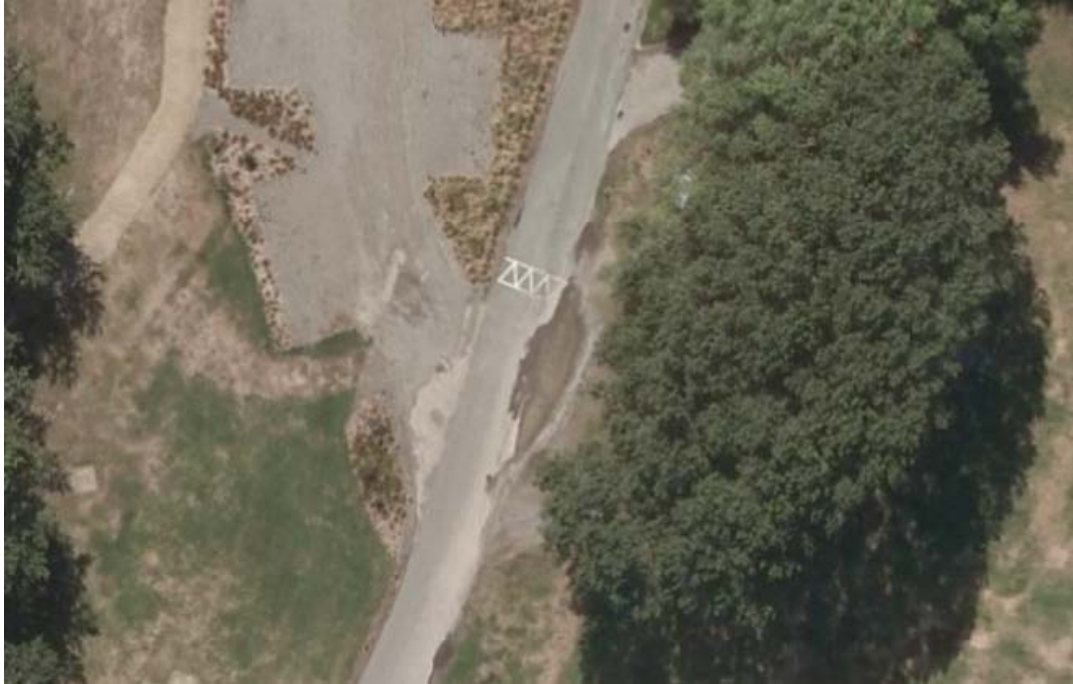
- **Figure 4 Aerial photograph showing liquefied material ejected near road way (<http://viewers.geospatial.govt.nz/>)**

The aerial photographs appears to show some evidence of liquefaction occurring on site due to the 22 February earthquake, with localised sand boils and liquefied material ejected near the road way visible in figure 4.
