**CHRISTCHURCH CITY COUNCIL**  
PRK\_0348\_BLDG\_011 EQ2  
The Groynes – Workshop & Garage  
182 Johns Road

QUALITATIVE ASSESSMENT REPORT  
FINAL

- Rev B
- 08 November 2012

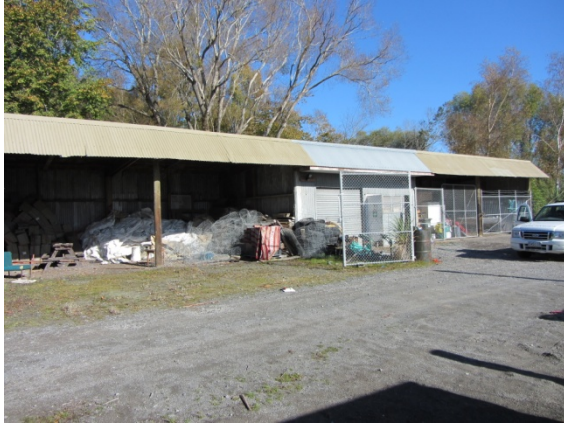
Photo 1: East Elevation

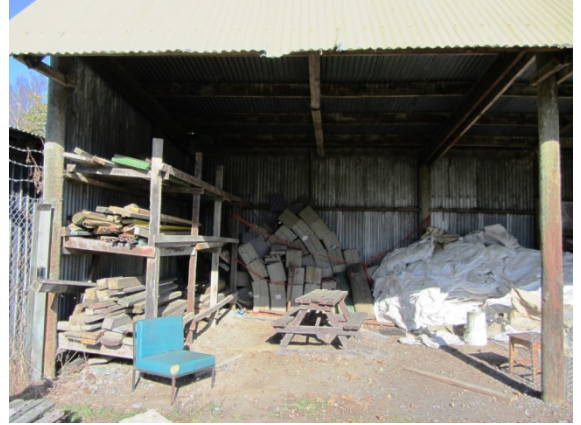
Photo 2: Close Up of Photo 1

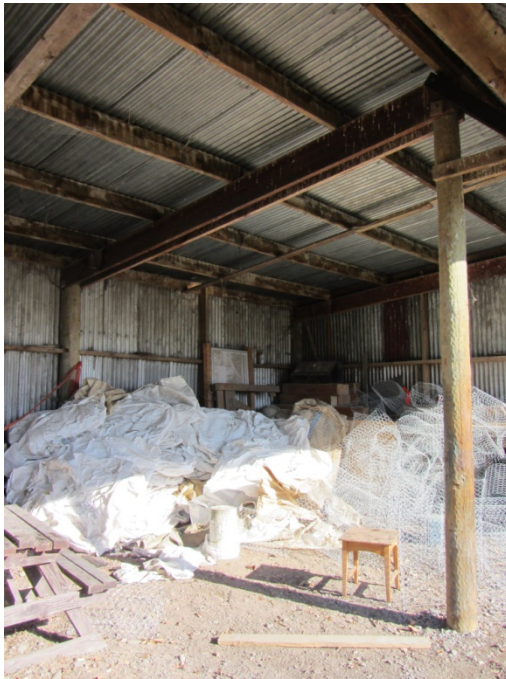
Photo 3: Internal View of Structure

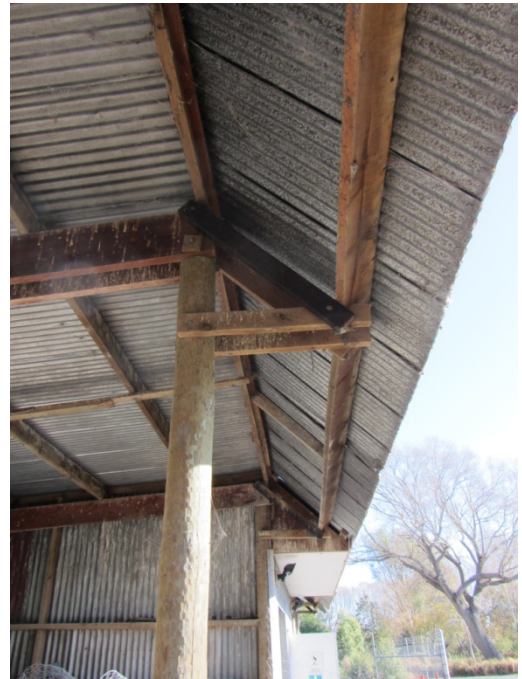
Photo 4: Structure along The Eastern Face

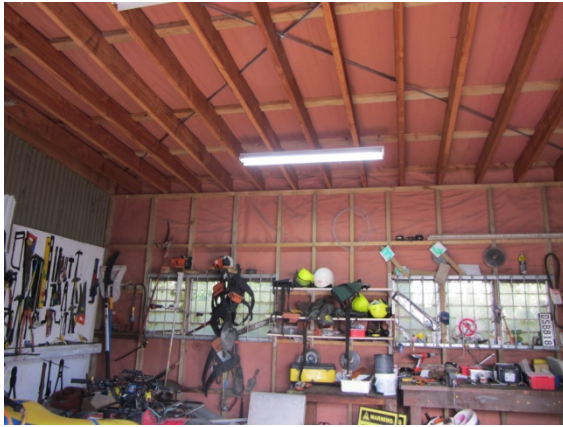
Photo 5: Internal View of Workshop
