CHRISTCHURCH CITY COUNCIL
BU 0812-002 EQ2
Guthrey Courts – Block B
72a Olliviers Road, Phillipstown

QUANTITATIVE ASSESSMENT REPORT

- Rev E
- 03 May 2013

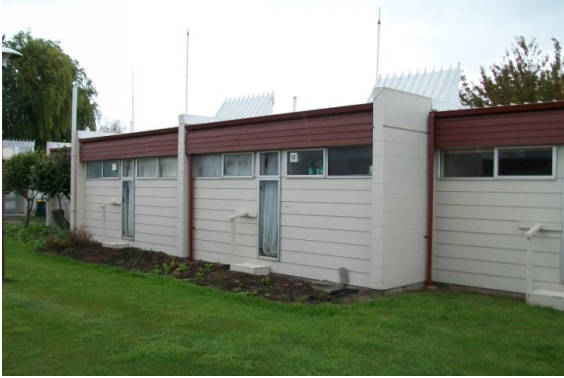
<p>Photo 1: Rear of unit block B</p>	<p>Photo 2: Horizontal and vertical cracking extending from the doorway penetrations</p>

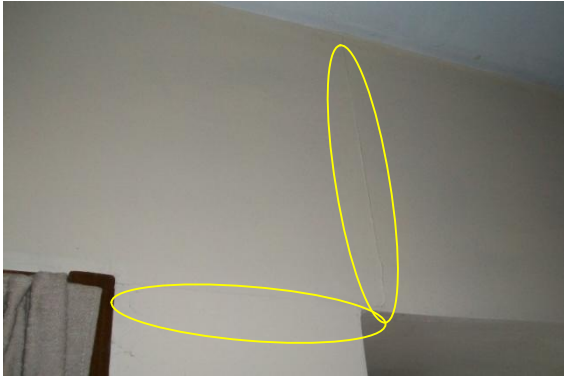
- 1) Cracking to plasterboard linings in the walls and ceilings extending from wall and ceiling penetrations such as doors and sky lights throughout
- 2) Separation along internal plasterboard joints in the walls and ceilings throughout
- 3) Gaps opening up between window frame and timber walls
- 4) Gap opening up between top of masonry wall and flashing cap on top of wall. There should have been sufficient flexibility in the flashing cap to prevent damage due to differential earthquake movement, so this defect appears to be unrelated to the recent earthquakes.

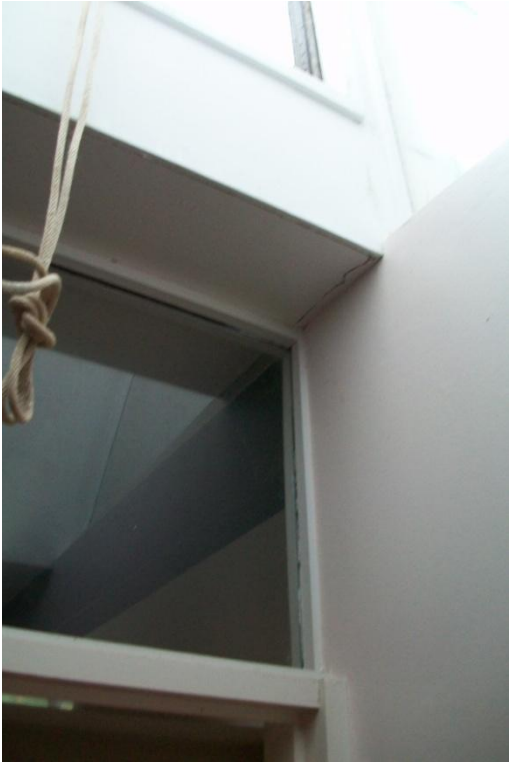
<p>Photo 3: Cracking through the plasterboard linings below the sky light</p>	<p>Photo 4: Cracking through the plasterboard linings below the sky light</p>

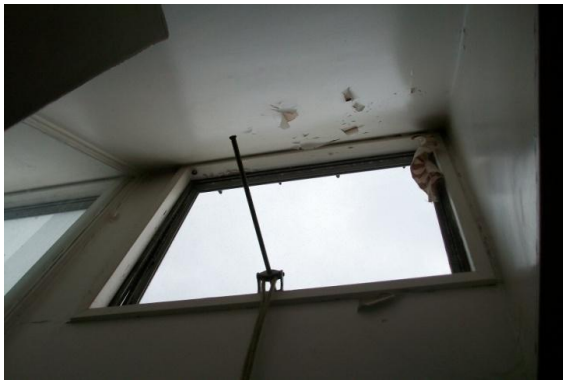
Photo 5: Moisture damage to the paint in the skylight

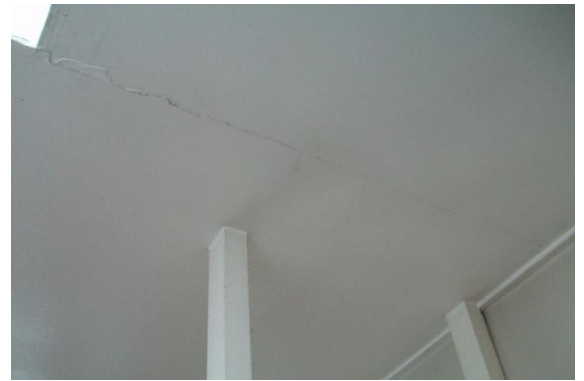
Photo 6: Separation along the ceiling lining joints extending from the skylight

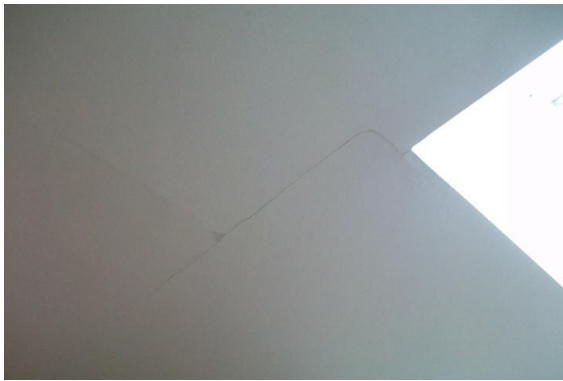
Photo 7: Separation along the

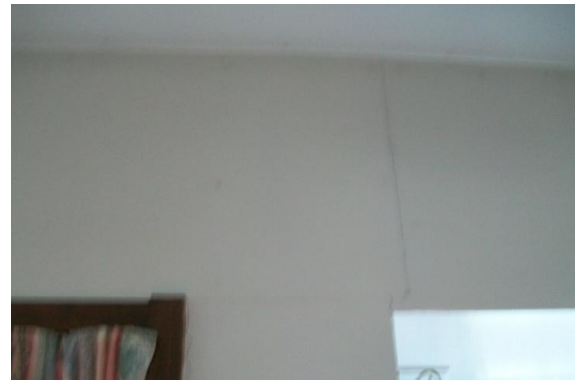
Photo 8: Separation between vertical plasterboard linings at the door penetrations

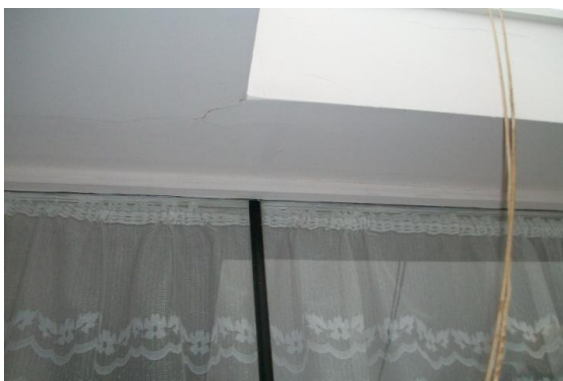
Photo 9: Separation between wall and ceiling linings

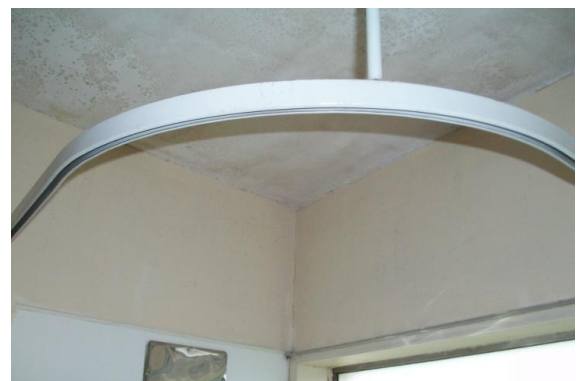
Photo 10: water damage and wall ceiling junction lining separation

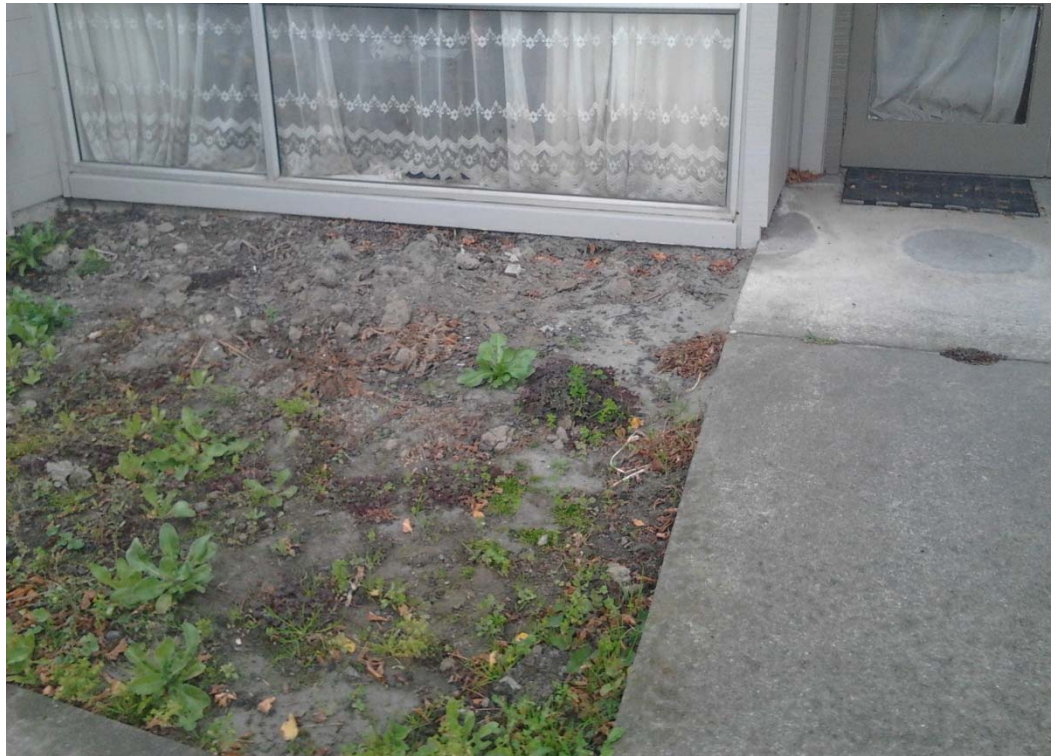
Significant land damage was observed during the external site walkover. The site had significant liquefaction during the Feb 2011 earthquake, as there was evidence of this over a year later. There were remaining sand ejecta on the site, significant ground undulations including domes in the driveway where sand boils were ejected beneath the asphalt. There was undulating grass land and settlement of footpaths. It is expected that some settlement of the structure would have occurred as a result of significant liquefaction of underlying ground.

■ **Figure 10 Remaining evidence of liquefied material ejecta**

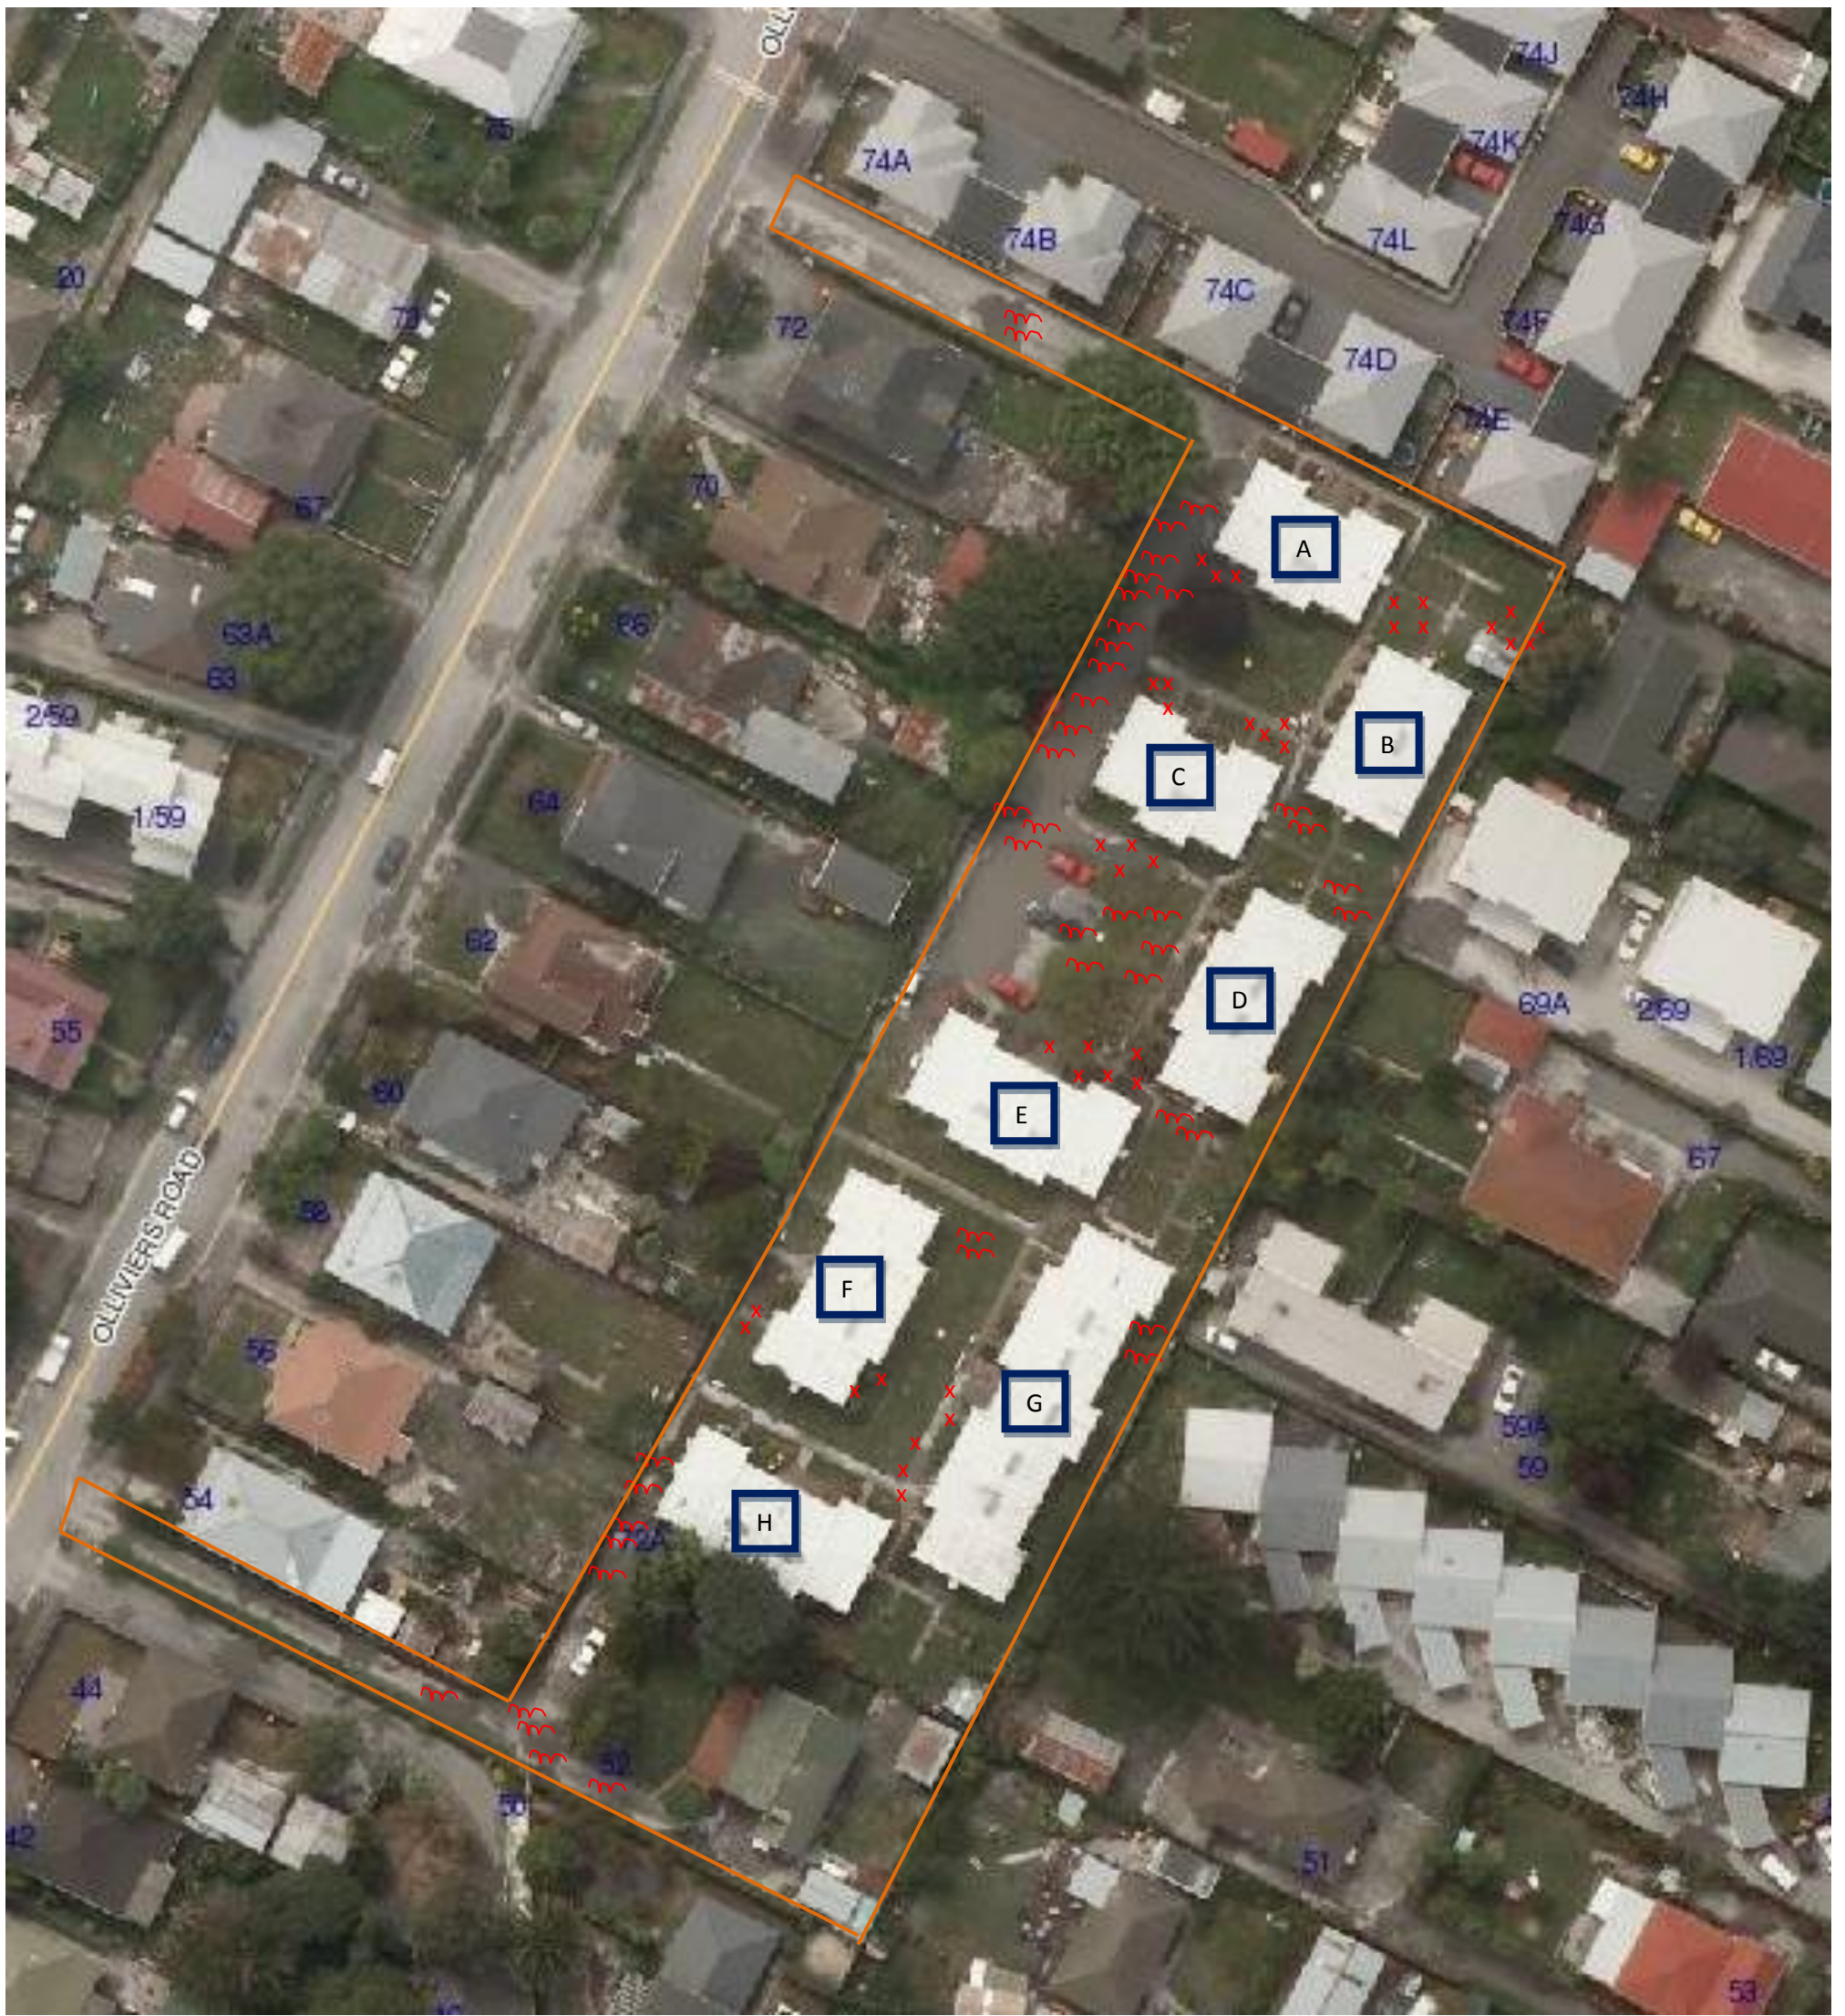
Appendix D – Site Plan showing observed land damage

Undulating Ground Observed

Ejected Silt Observed
