CHRISTCHURCH CITY COUNCIL
BU 0812-005 EQ2
Guthrey Courts – Block E
72a Olliviers Road, Phillipstown

QUANTITATIVE ASSESSMENT REPORT

- Rev E
- 03 May 2013

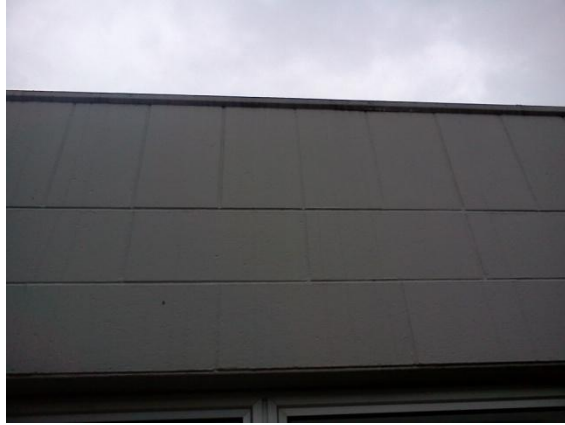
Photo 5: Masonry end walls have ring beams at top

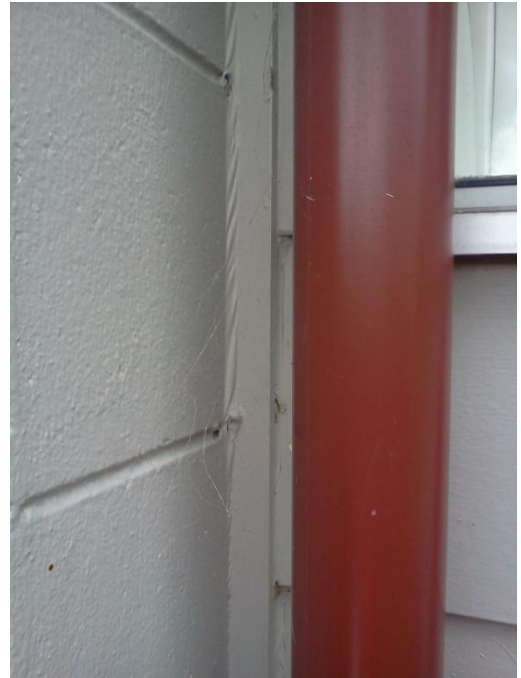
Photo 6: Paint distress along the light timber frame and masonry wall junction

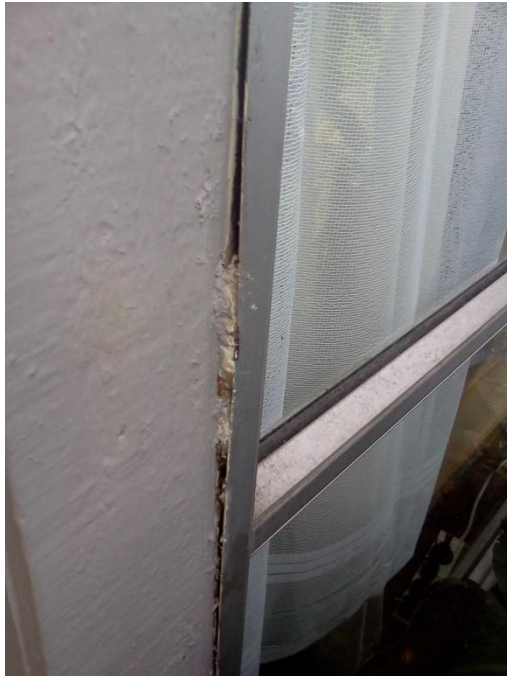
- 1) Separation along internal plasterboard joints in the walls and ceilings throughout
- 2) Cracking extending from windows and doors through the plasterboard linings
- 3) Gaps opening up between window framing and timber walls. It is unclear whether or not this gap has been caused and/or widened by earthquake activity.
- 4) Gap opening up between top of masonry wall and flashing cap on top of wall. There should have been sufficient flexibility in the flashing cap to prevent damage due to differential earthquake movement, so this defect appears to be unrelated to the recent earthquakes.

Photo 7: Separation along the window framing which appears pre existing

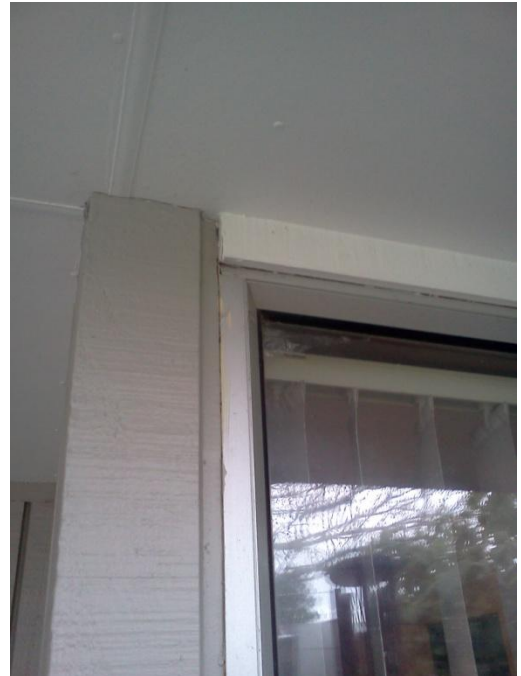
Photo 8: Minor gap opening around the aluminium window framing

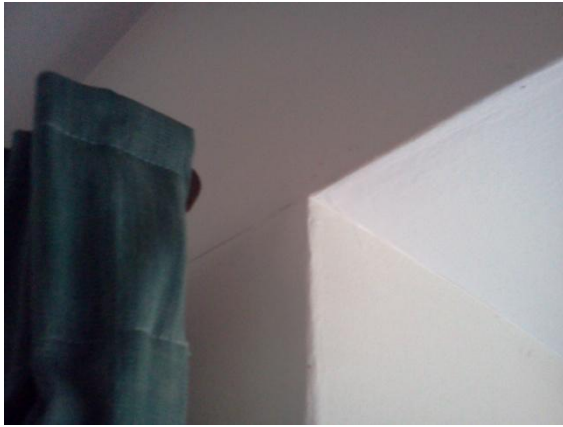
Photo 9: Horizontal cracking through the plasterboards

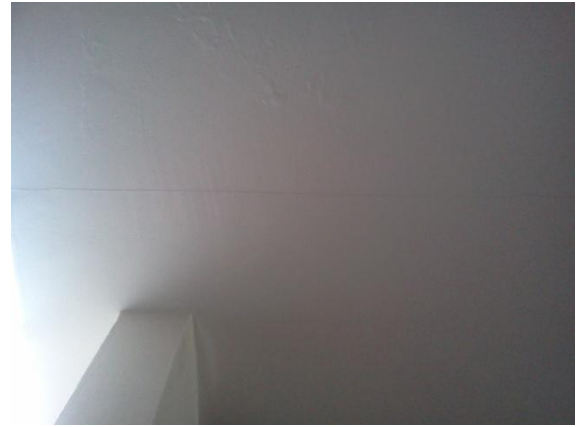
Photo 10: Separation along the plasterboard sheet joint

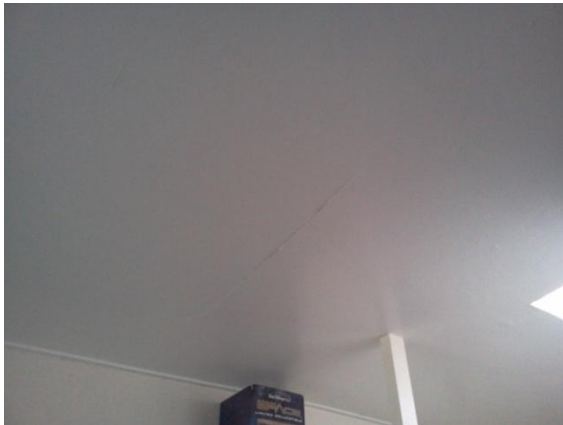
Photo 11: Separation along the plasterboard sheet joint

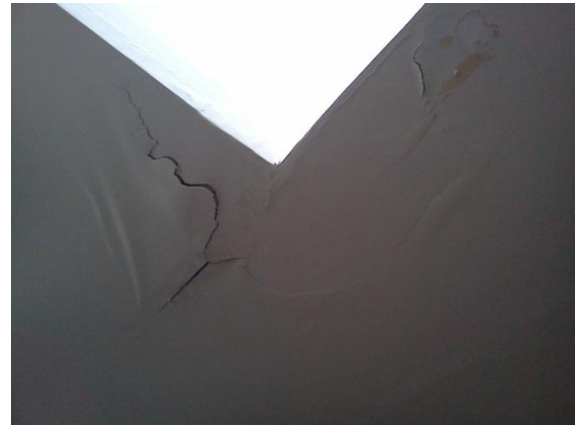
Photo 12: Damage to the ceiling lining around the base of the skylight due to moisture

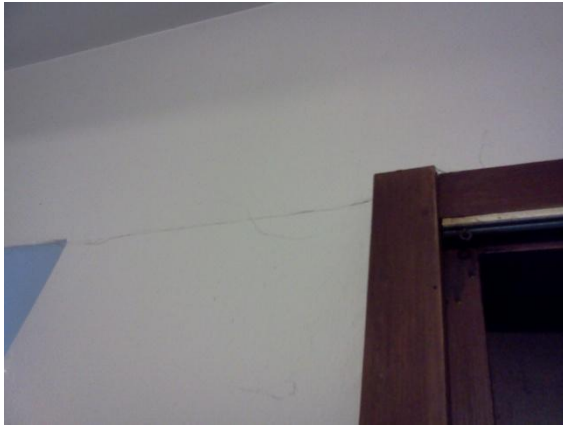
Photo 13: Horizontal cracking between wall penetrations

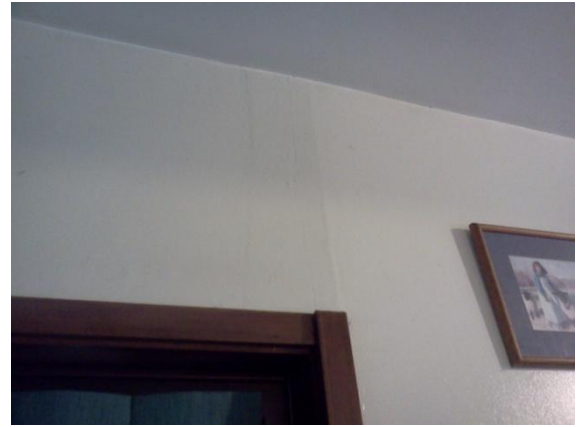
Photo 14: Vertical separation between plaster boards
