CHRISTCHURCH CITY COUNCIL
BU 0812-008 EQ2
Guthrey Courts – Block H
72a Olliviers Road, Phillipstown

QUANTITATIVE ASSESSMENT REPORT

- Rev E
- 03 May 2013

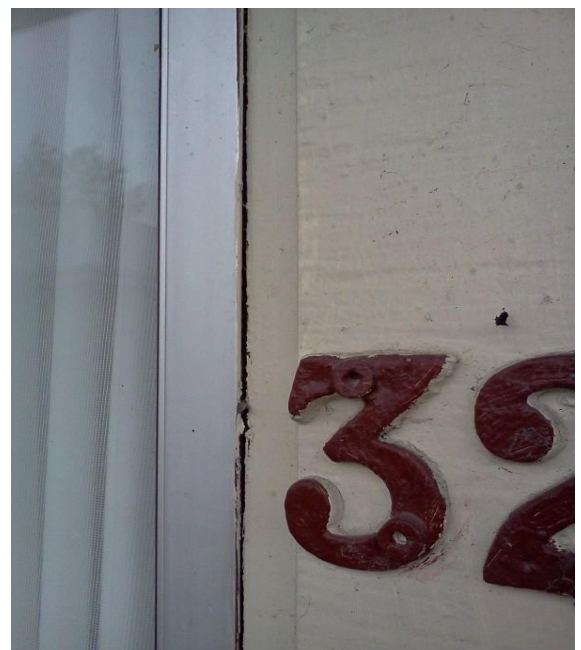
- 1) Cracking along internal plasterboard joints in the walls and ceilings throughout
- 2) Cracking along timber joints on external south walls
- 3) Gaps opening up between window frame and timber wall on the north side. It is unclear whether or not this crack has been caused and/or widened by earthquake activity.

Photo 6: Gap opening up between window frame and timber wall on the north wall of Unit 32 (typical).

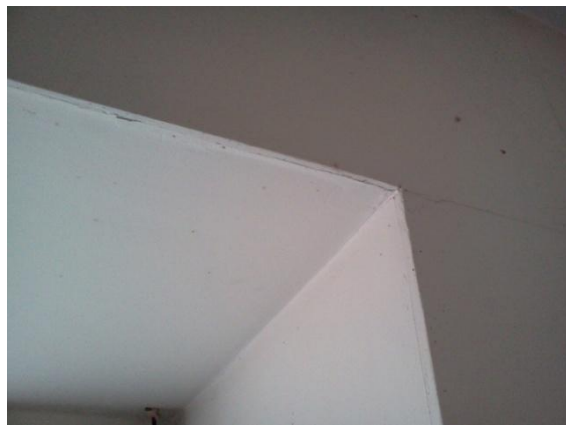
Photo 7: Cracks in internal wall lining joints.

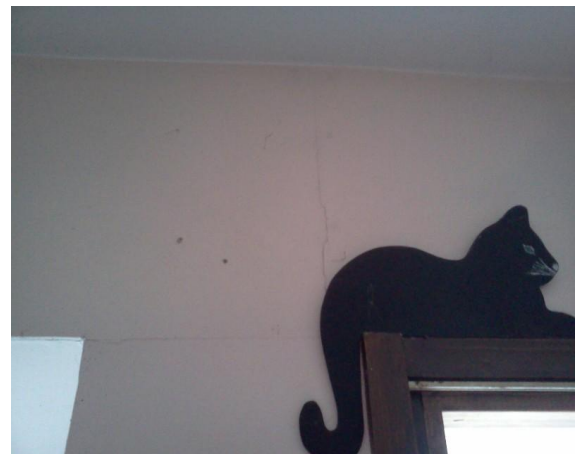
Photo 8: Cracks in internal wall lining radiating from corners.

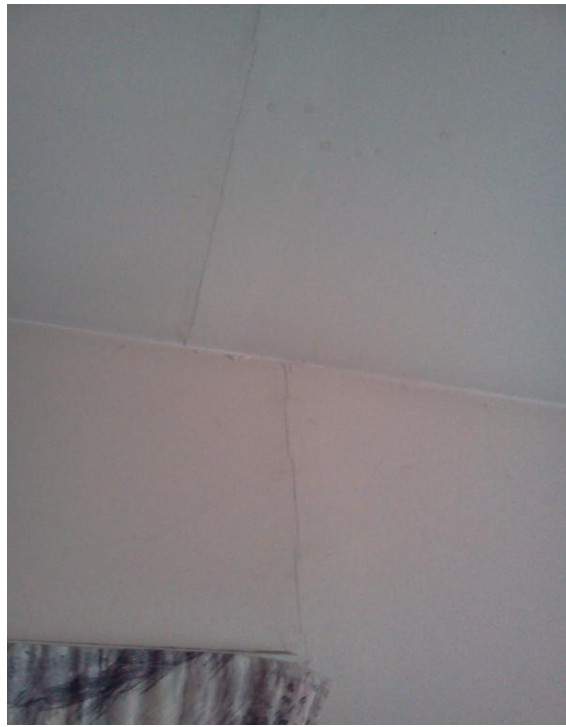
Photo 9: Cracks in internal wall and ceiling lining.

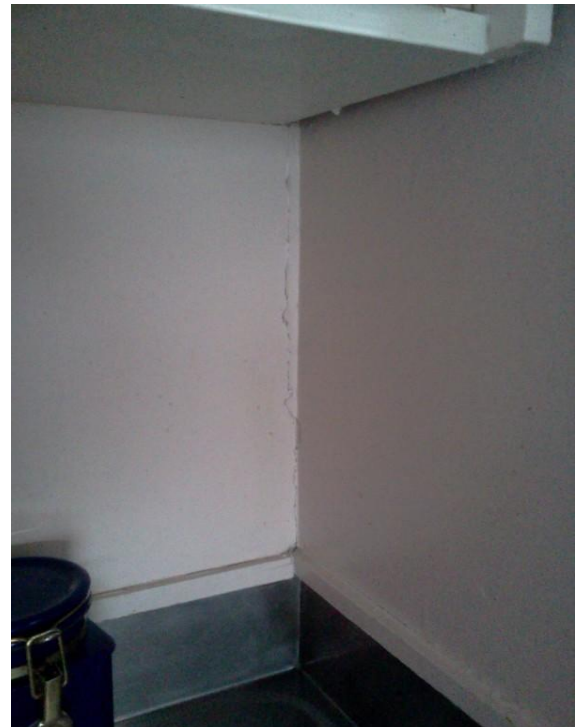
Photo 10: Cracks in wall lining and paint tearing at corners.

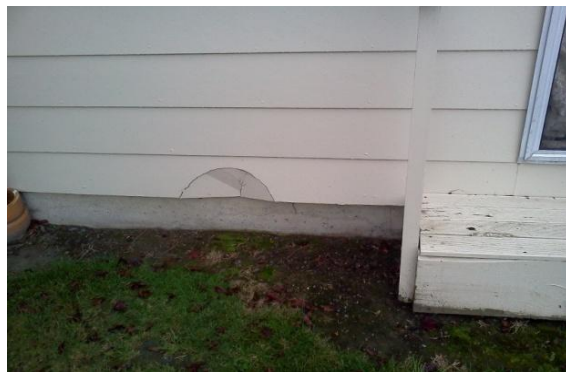
- 5) Existing defects in weatherboarding at the bottom of the south wall were noted in several locations, but the shape of the defect is consistent with impact damage rather than earthquake damage.

Photo 11: Existing weatherboard damage on South wall.

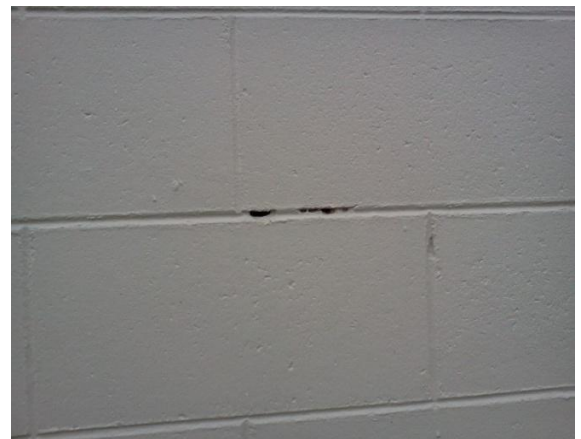
- 6) Existing gaps and voids in the pointing of block masonry on the east wall were noted, but these defects appear to pre-date the existing paint on the masonry walls and are therefore assumed to pre-date the recent earthquakes.

Photo 12: Existing low quality pointing of masonry on East wall.

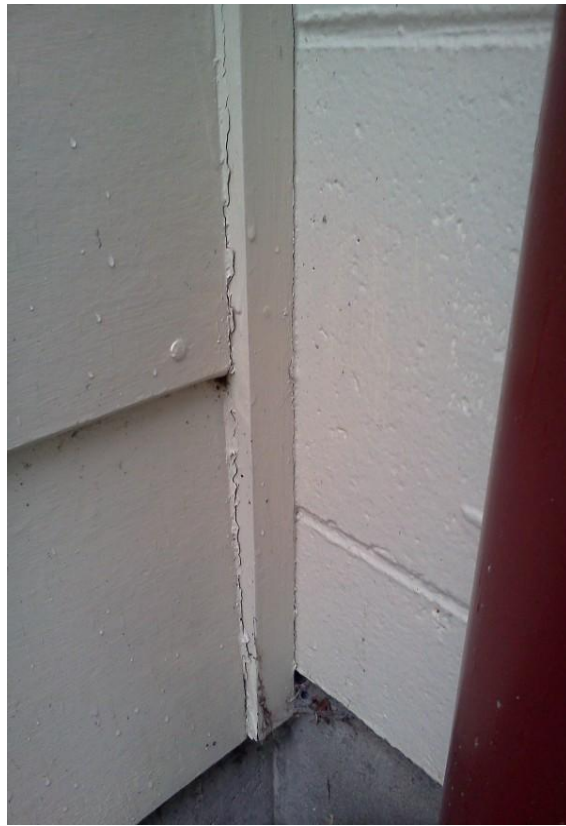
Photo 13: Cracks in external timber wall on south side in corners.

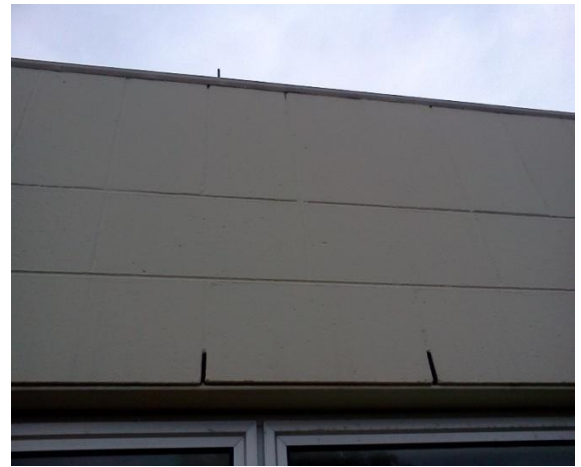
- 4) Gap opening up between top of masonry wall and flashing cap on top of wall. There should have been sufficient flexibility in the flashing cap to prevent damage due to differential earthquake movement, so this defect appears to be unrelated to the recent earthquakes.

Photo 14: Gap opening up between masonry and steel cap plate at top of masonry wall on east side (typical).

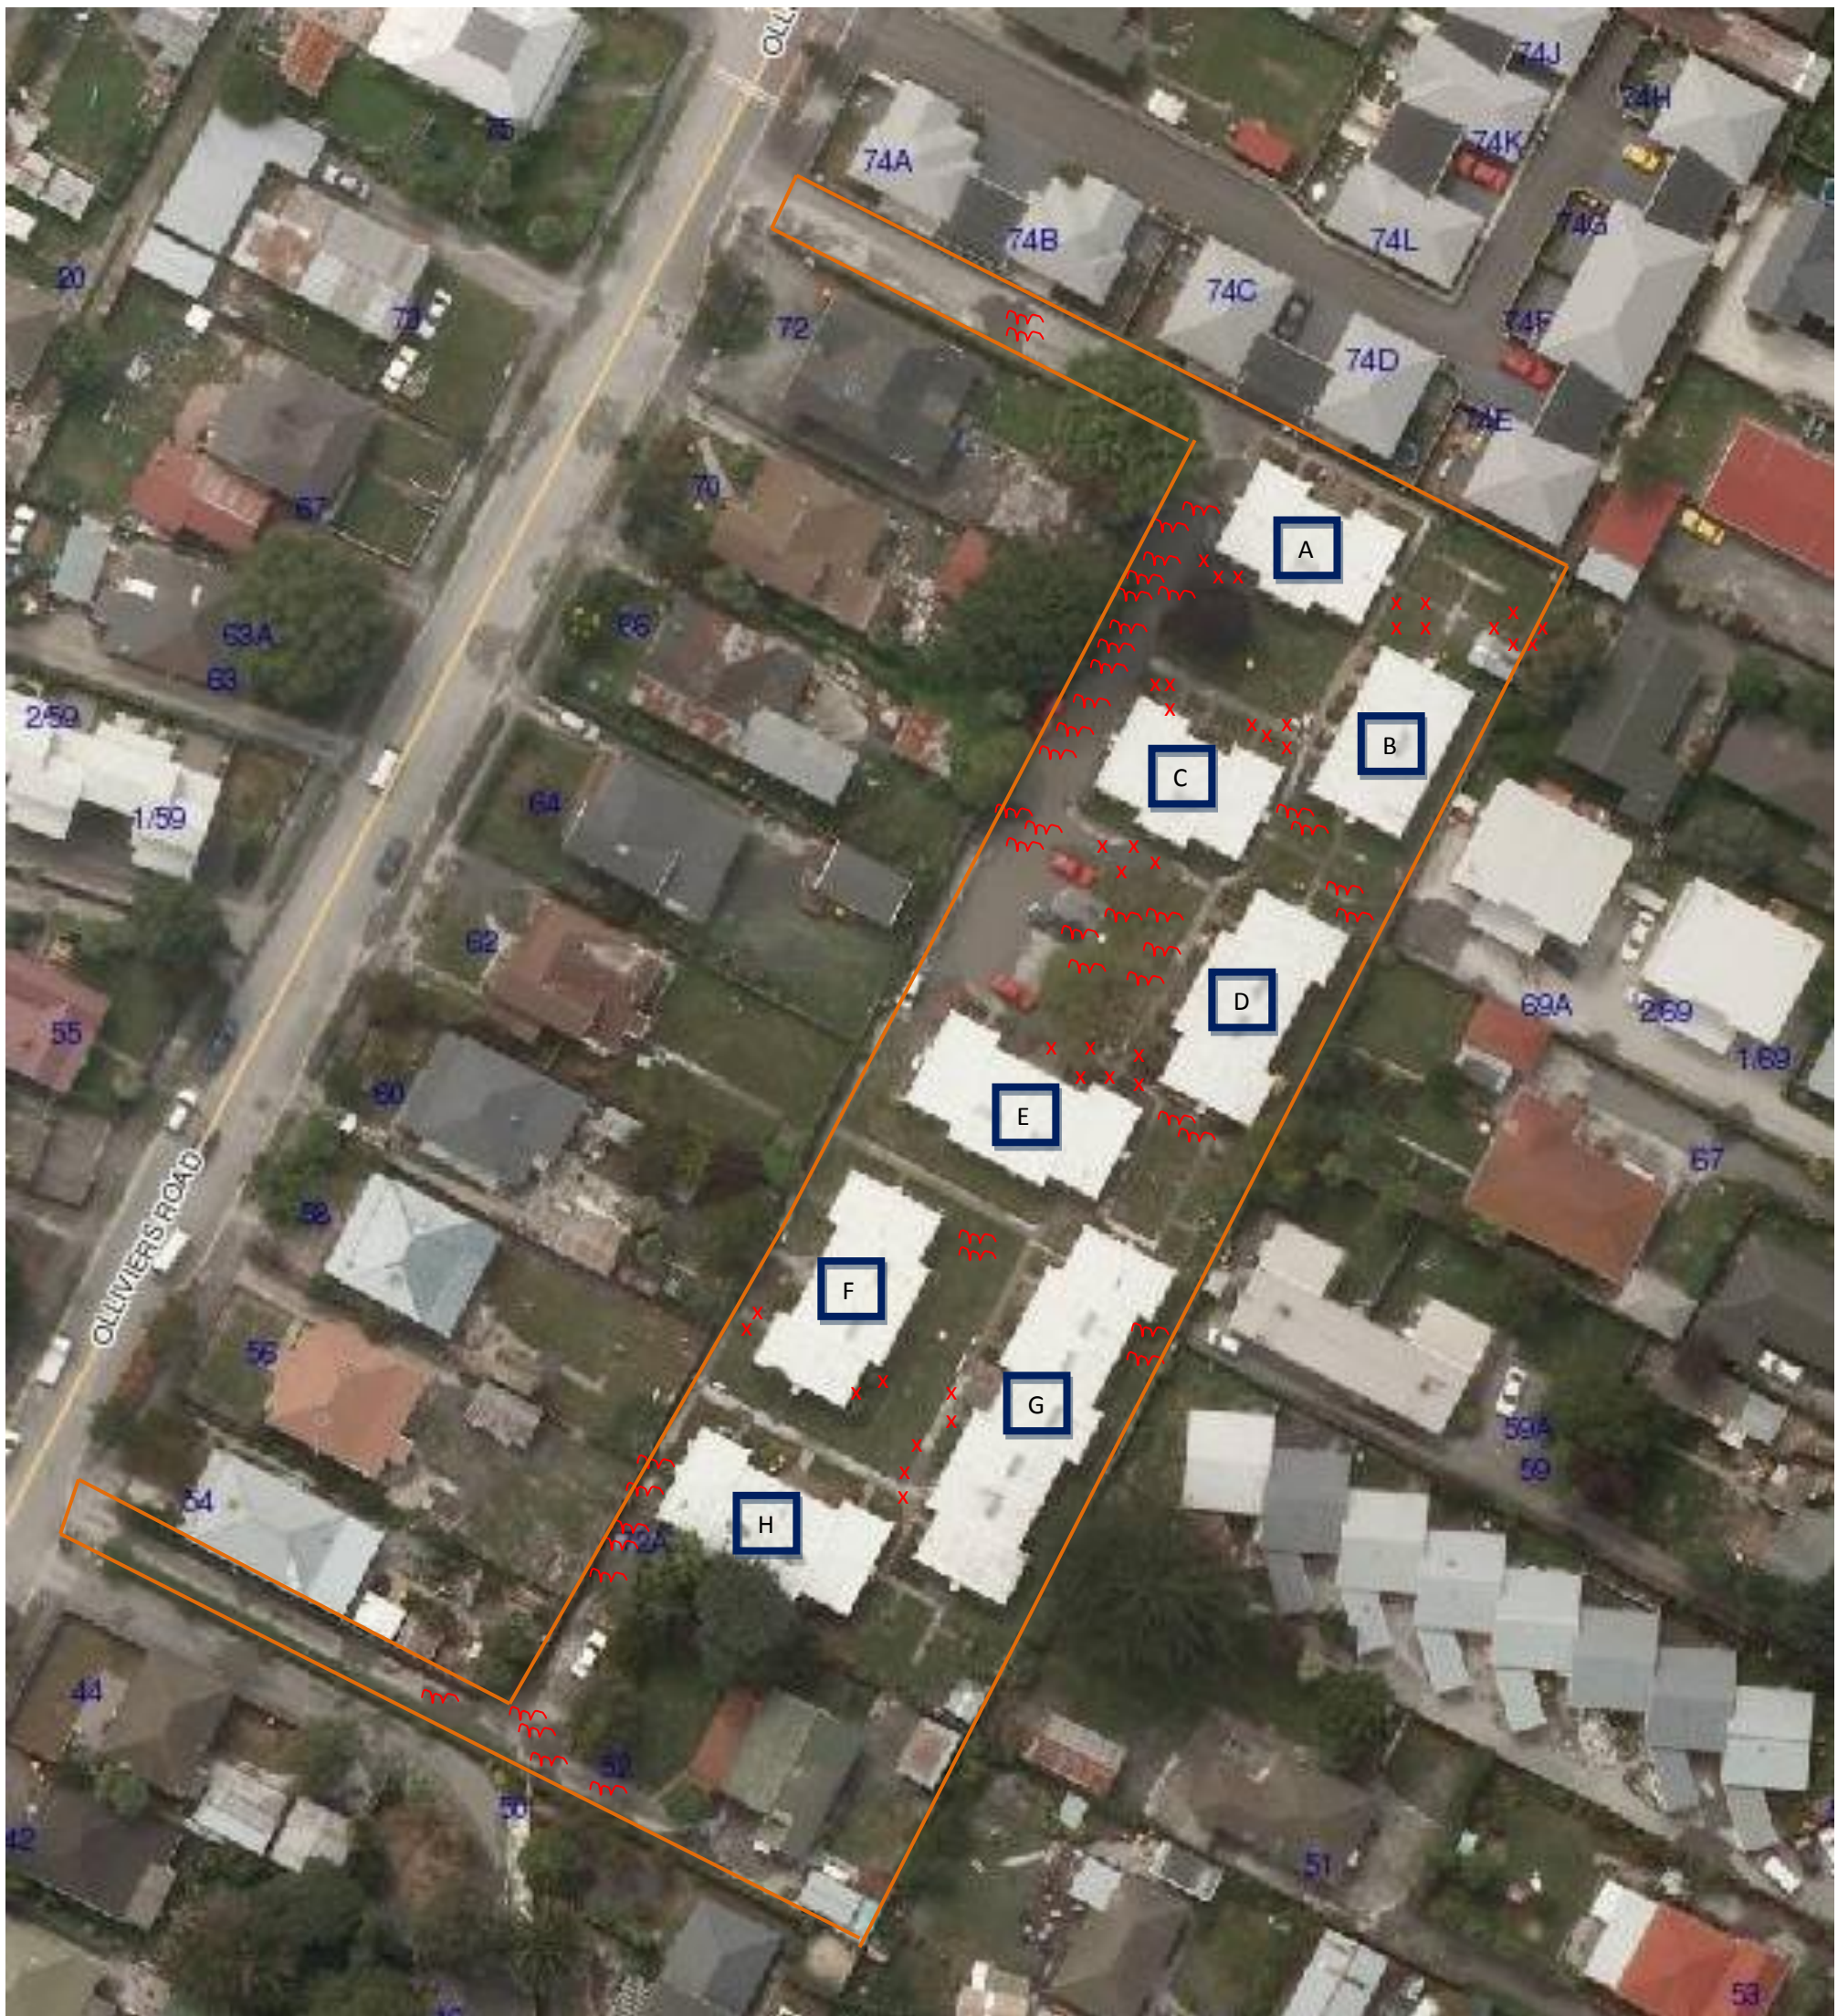
Appendix D – Site Plan showing observed land damage

Undulating Ground Observed

Ejected Silt Observed
