Haast Courts Block C
BU 0792-003 EQ2
Detailed Engineering Evaluation
Quantitative Report
Version FINAL

Units 11 to 14, 43 Haast Street, Linwood

Christchurch City Council

Date
13 November 2012

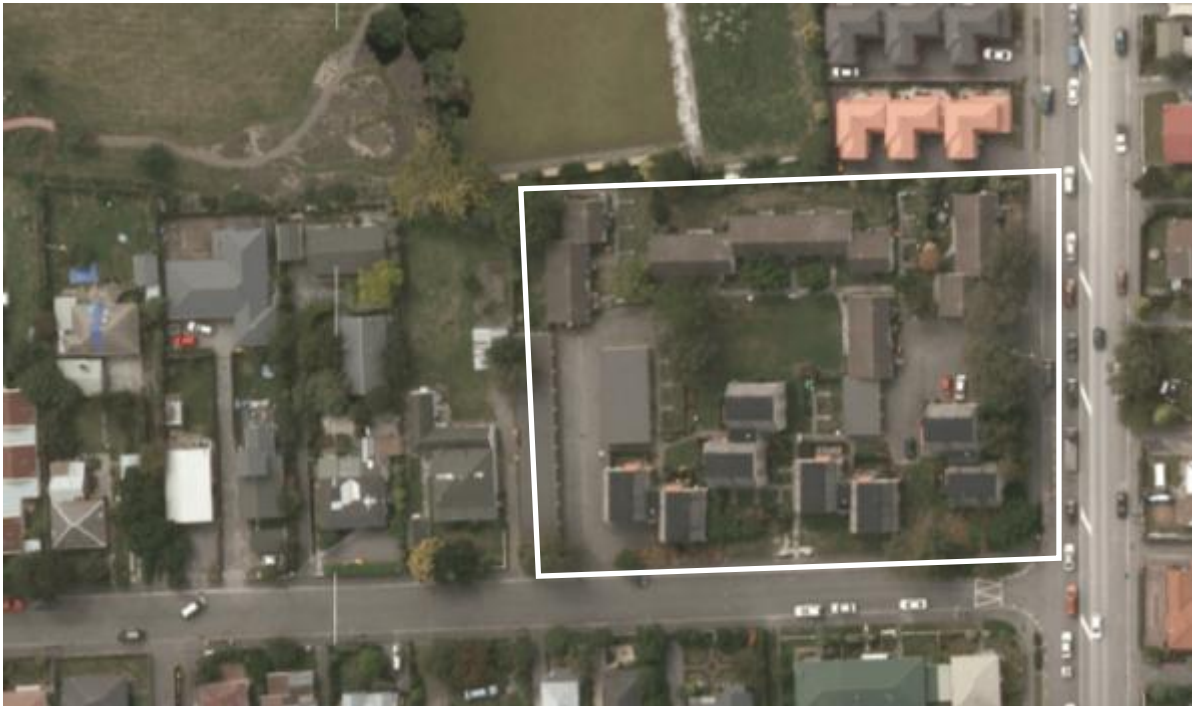
Figure 3 Post February 2011 Earthquake Aerial Photography³

Aerial photography taken following the 22 February 2011 earthquake shows no signs of liquefaction outside the building footprints or adjacent to the site, as shown in Figure 3.

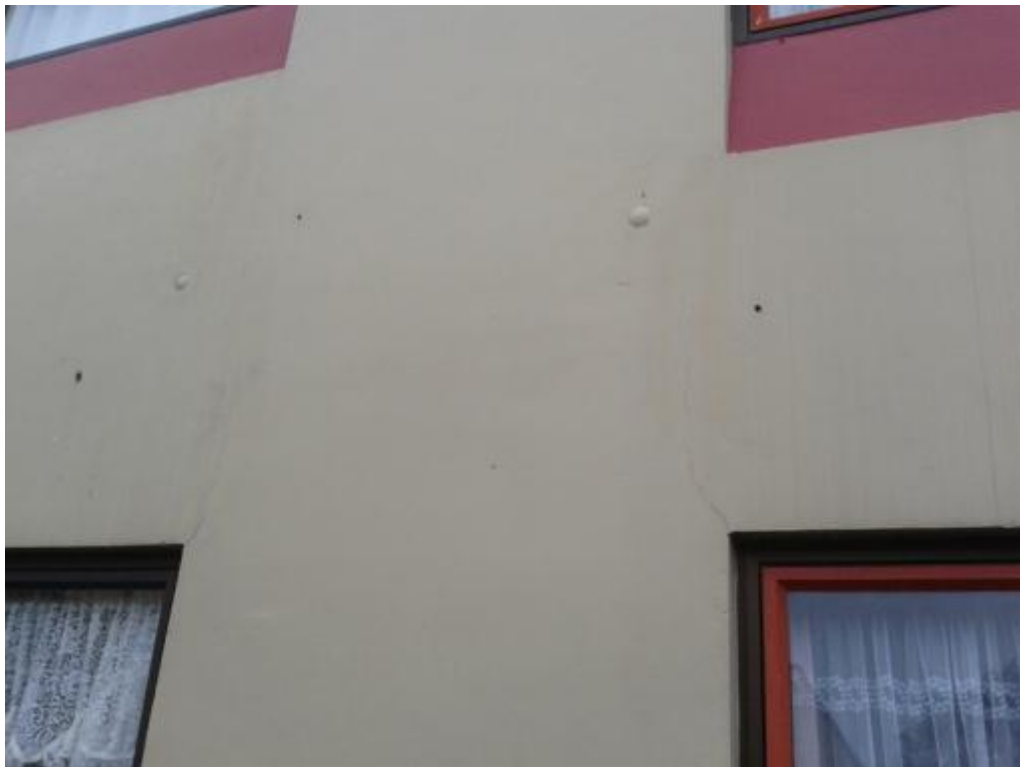
Minor cracking was noted to the exterior of the buildings. These cracks may be original shrinkage cracks that may have opened up slightly during the recent seismic activity.

Photograph 2 Cracking to exterior walls at window corners.

GHD Limited recommends that any cracking greater than 0.2mm wide to the concrete panel walls and suspended concrete floors are repaired by epoxy injection to restore the buildings to their pre-earthquake condition.

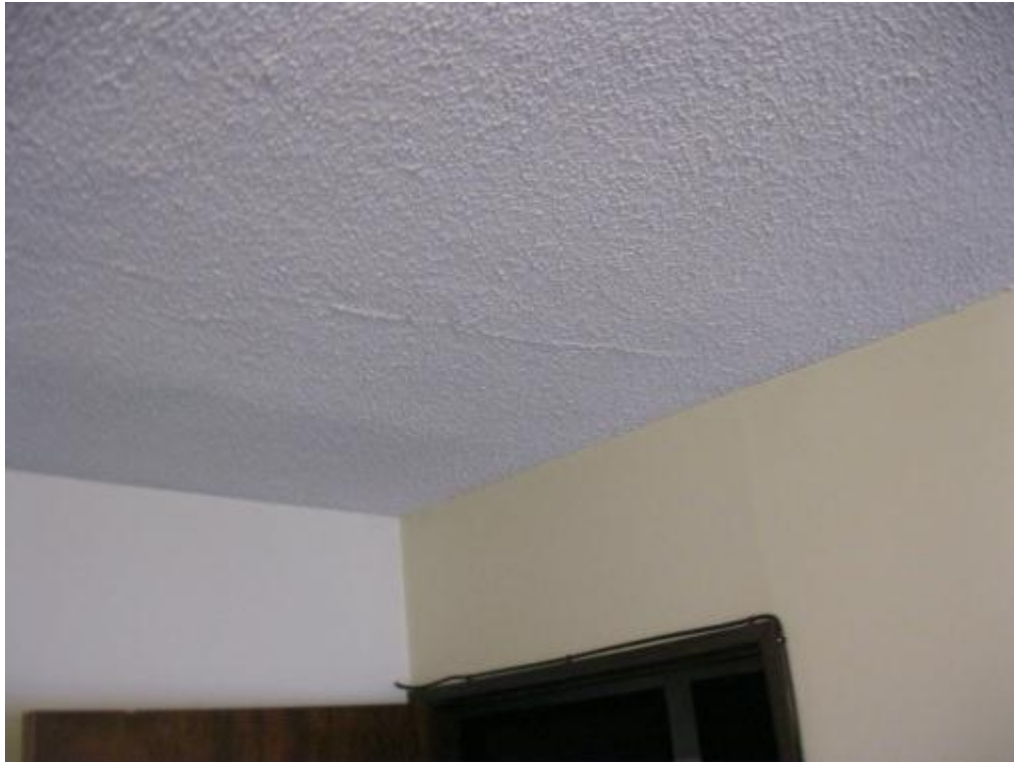
Minor cracking was evident in the asbestos plaster finish to the underside of the first floor slab. It was not clear if these cracks penetrate through to the concrete slab.

Photograph 3 Cracking to plaster finish on the underside of the suspended floor slab.

Due to the presence of cracking to the asbestos plaster ceiling lining in a number of the units throughout the complex, GHD Limited recommends that all the ceiling linings are inspected by asbestos specialists and dealt with according to their recommendations.

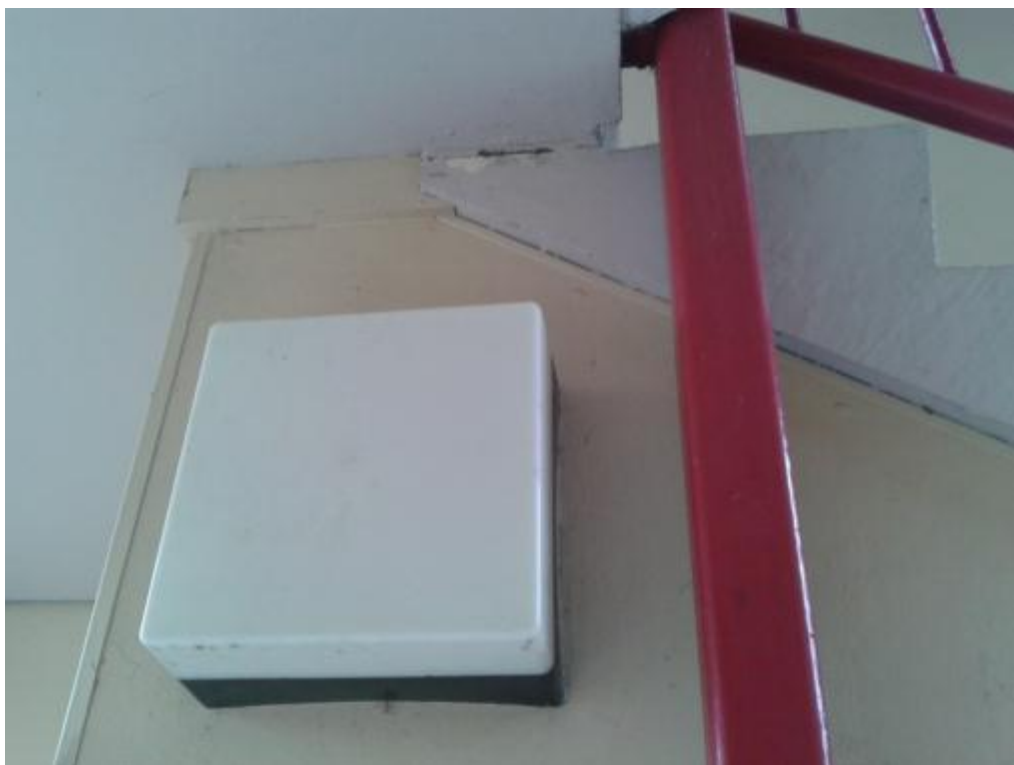
Photograph 4 Connection of stairs to first floor landing.

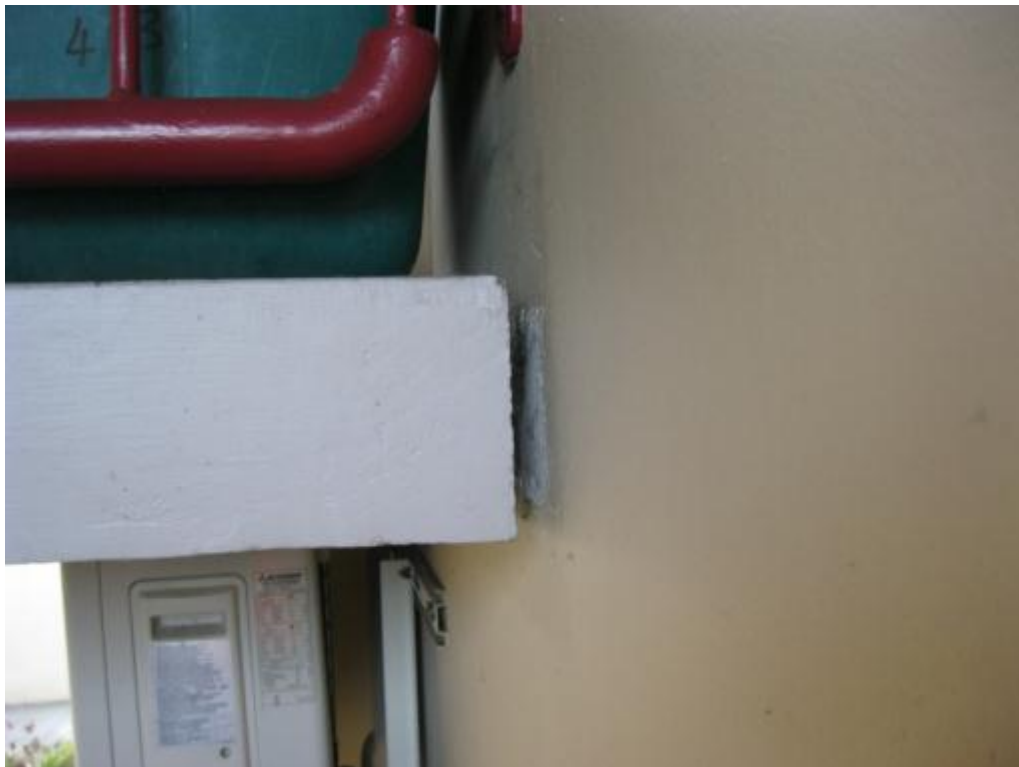
The dowel connection between the common landings and the building panel walls allows for differential movement of the staircase and wall panel in one direction only (out-of-plane of the wall panel). At the doors of apartments, the seismic gap between the landings and walls is filled but this seal does not appear to be flexible which would cause the transfer of loads between the two blocks of the building. Should differential seismic movement in the plane of the supporting panels occur, there is the potential for shear failure of the steel dowels which could cause failure of the staircase. This has the potential to cause serious injury to residents who might be using a stairs during, and may prevent egress following a large seismic event.

Photograph 7 Seismic gap between stairs landing and precast concrete wall panel.

As the connections between the staircase and the supporting precast panel walls do not allow adequate seismic lateral movement in the plane of the panel, it is recommended that secondary supports be provided to all landings in the form of equal angle supports fixed to the supporting panel walls. The stairs are the only means of egress from the upper floors and this issue should be addressed immediately.

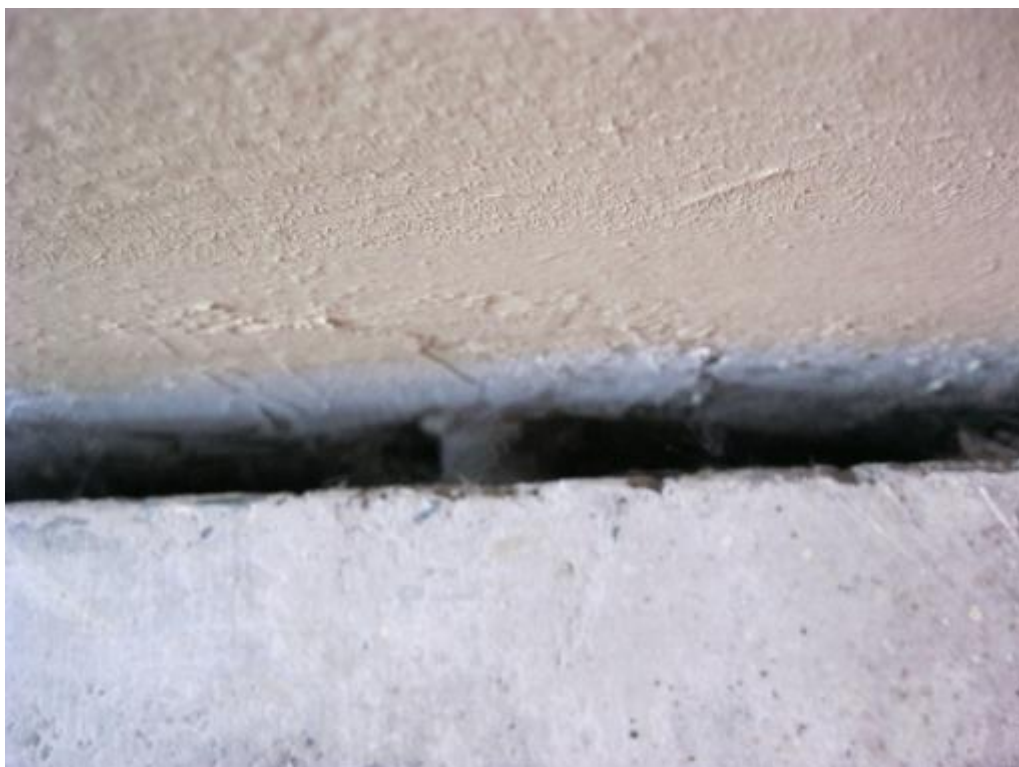
Photograph 8 Seismic gap between stairs landing and precast concrete wall panel showing steel dowel pin connection.

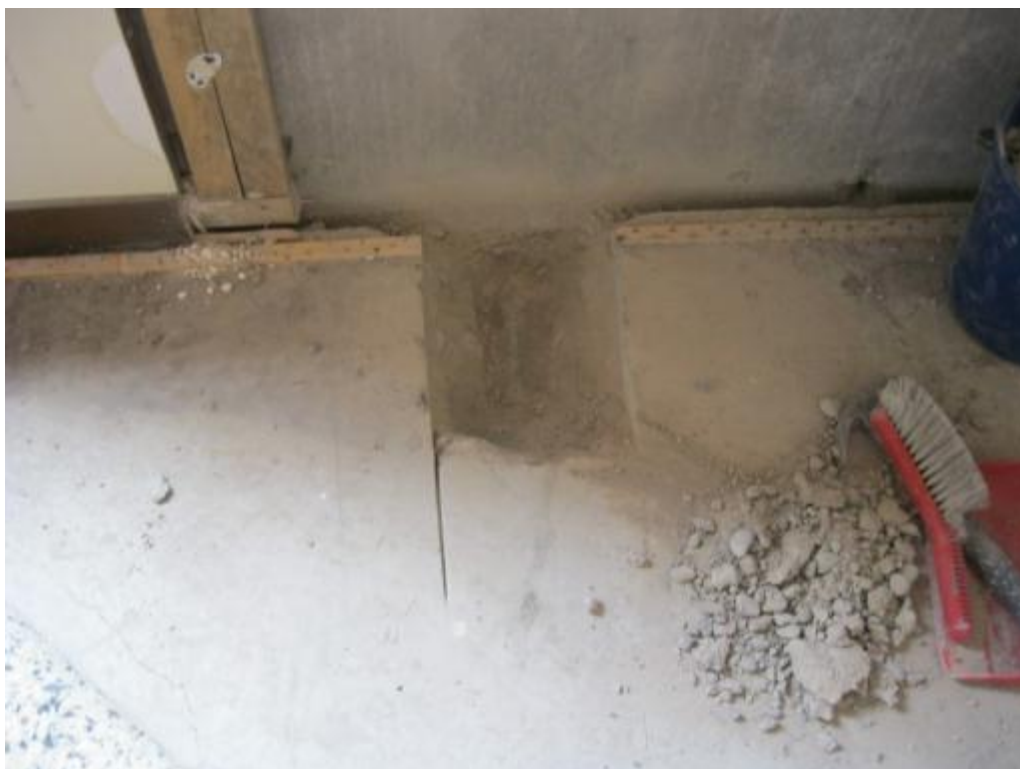
Photograph 20 Suspended slab steel reinforcement cage found not to be tied into precast wall from the top.

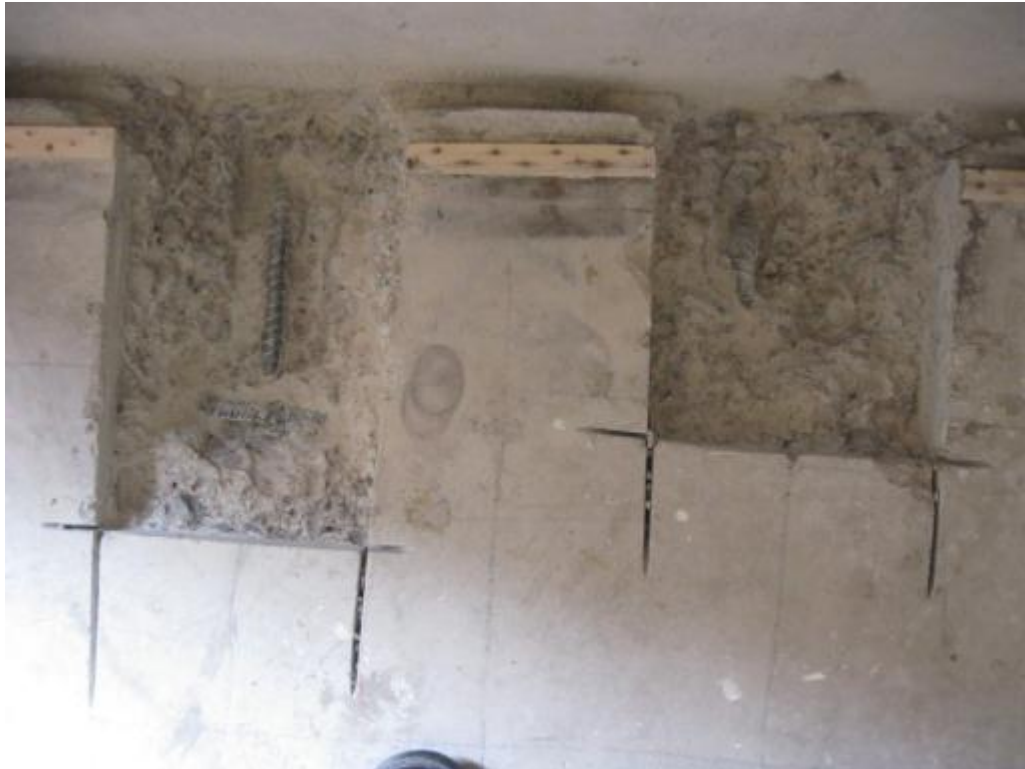
Photograph 21 Further opening up of the suspended slab showed the steel reinforcement cage not to be tied into precast wall from the top.

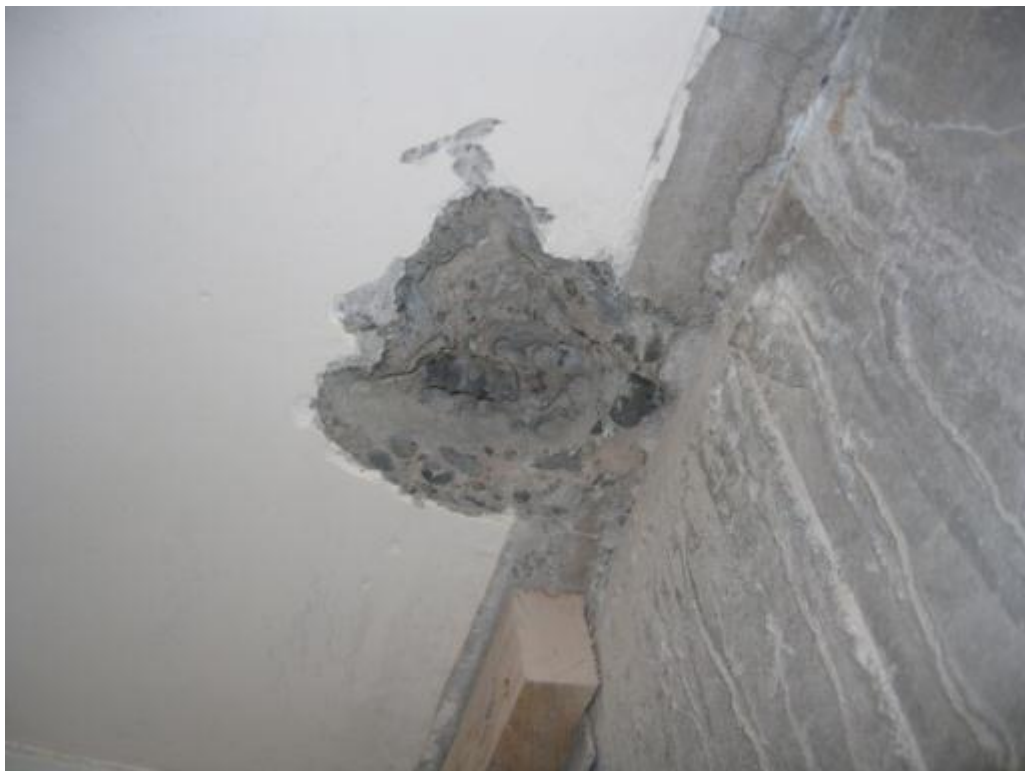
Photograph 22 Opening up to the underside of the second floor suspended slab showed the steel cage reinforcement not tied into the precast wall.

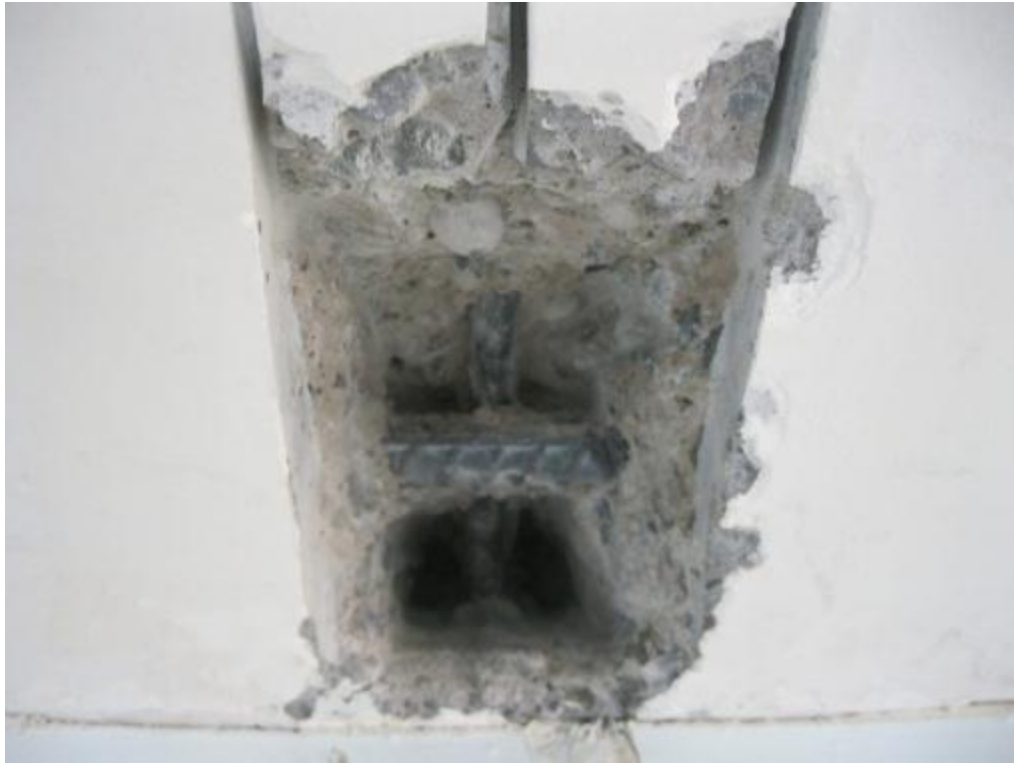
Photograph 23 Opening up in another location revealed a 10mm diameter steel bar tying the suspended slab back into the precast concrete wall panels.

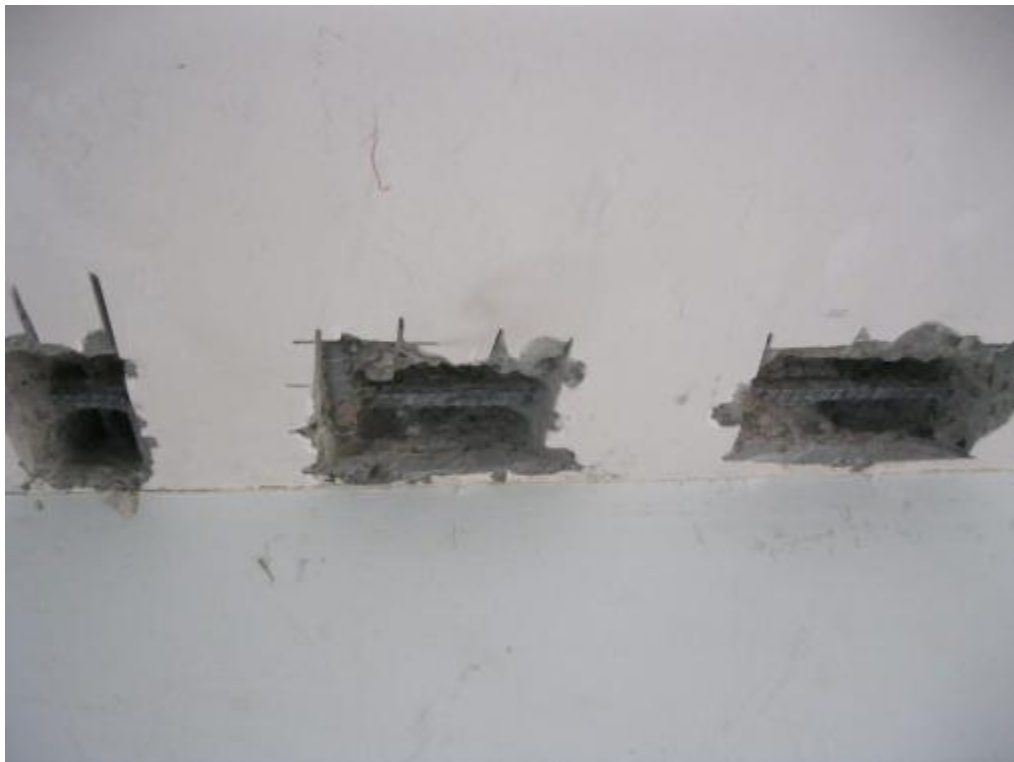
Photograph 24 Further opening up and reinforcement scanning revealed regular spacing of bars tying the slab into the precast panels at 250mm centres along all walls.
