Haast Courts Block E
BU 0792-005 EQ2
Detailed Engineering Evaluation
Quantitative Report
Version FINAL

151 Stanmore Road, Linwood

Christchurch City Council

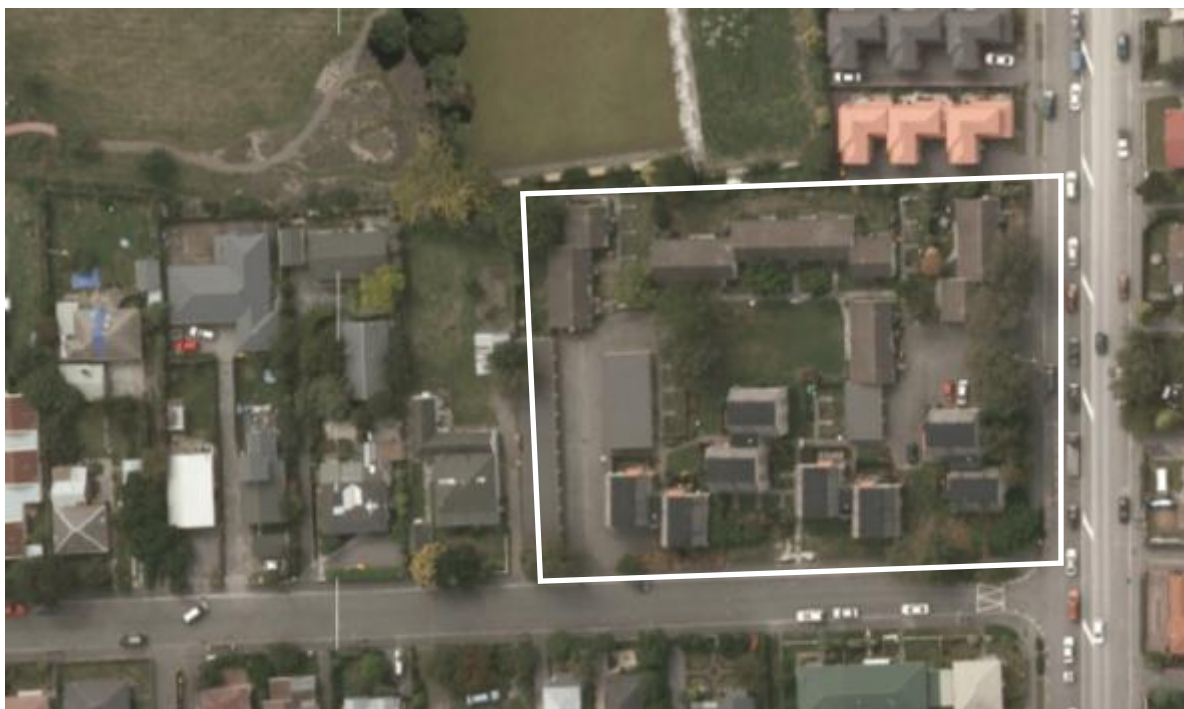
Figure 7.1 Post February 2011 Earthquake Aerial Photography³

Aerial photography taken following the 22 February 2011 earthquake shows no signs of liquefaction outside the building footprints or adjacent to the site, as shown in Figure 7.1.

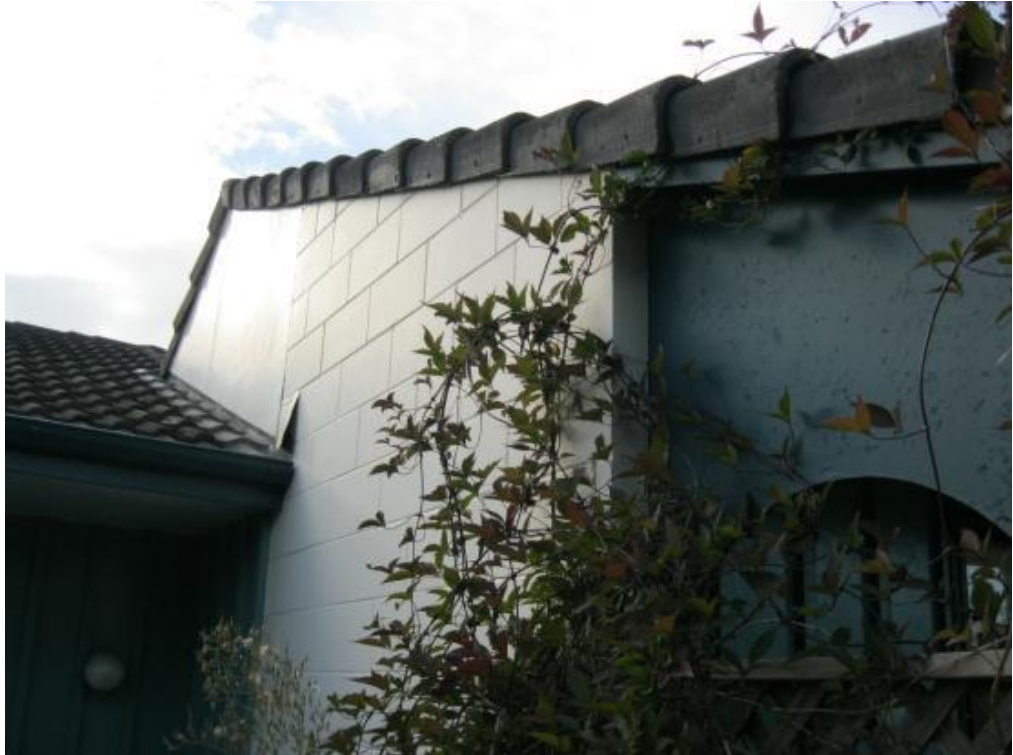
Photo 7 Apex tip of gable wall.

- ▶ The upper section of the gable walls are either removed or tied back to the building frame immediately as collapses of these sections are possible under earthquake load.
- ▶ The masonry walls are apparently unreinforced and the drawings do not indicate that there are tied back to the wall framing. Localised removal of the linings is recommended to identify if the veneer is tied back.
- ▶ If the veneer is found not to be tied back to the wall framing it is recommended that the veneer is either removed and replaced with light weight cladding or is tied back to the framing with masonry ties.
- ▶ The areas adjacent to the unreinforced gable walls should be cordoned off until the above recommendations have been completed.

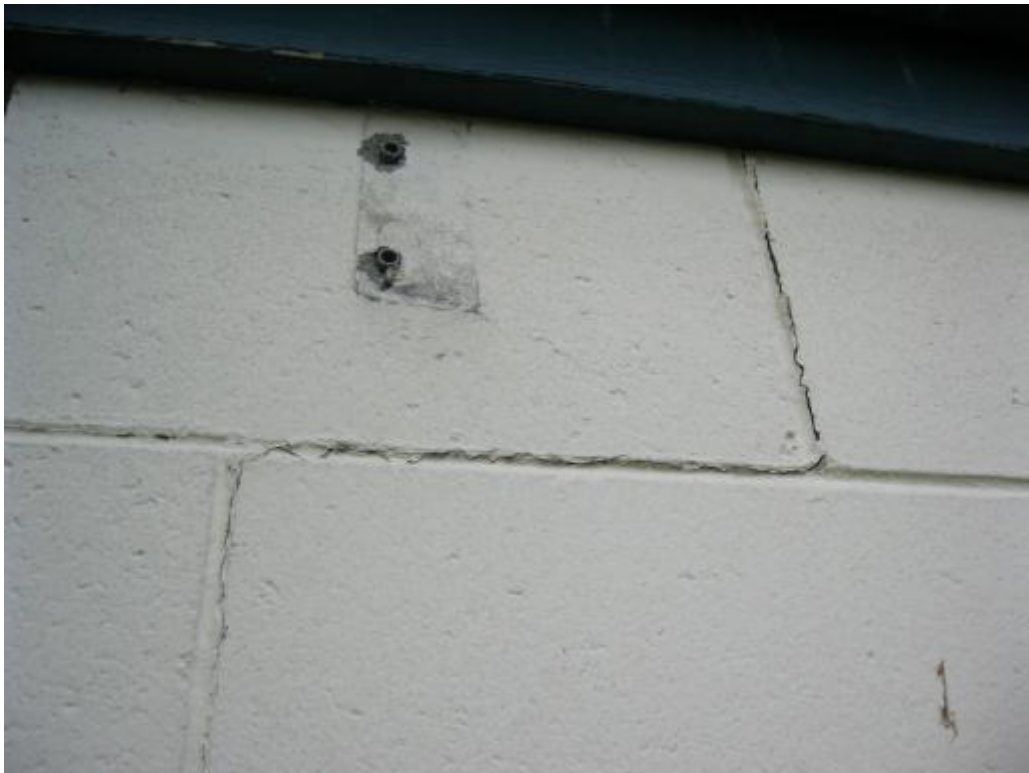
- Cracking at concrete block masonry wall

Photo 8 Zigzag cracks at concrete block masonry wall.

- ▶ The upper section of the gable walls are either removed or tied back to the building frame immediately as collapses of these sections are possible under earthquake load.
- ▶ The masonry walls are apparently unreinforced and the drawings do not indicate that there are tied back to the wall framing. Localised removal of the linings is recommended to identify if the veneer is tied back.
- ▶ If the veneer is found not to be tied back to the wall framing it is recommended that the veneer is either removed and replaced with light weight cladding or is tied back to the framing with masonry ties.
- ▶ The areas adjacent to the unreinforced gable walls should be cordoned off until the above recommendations have been completed.

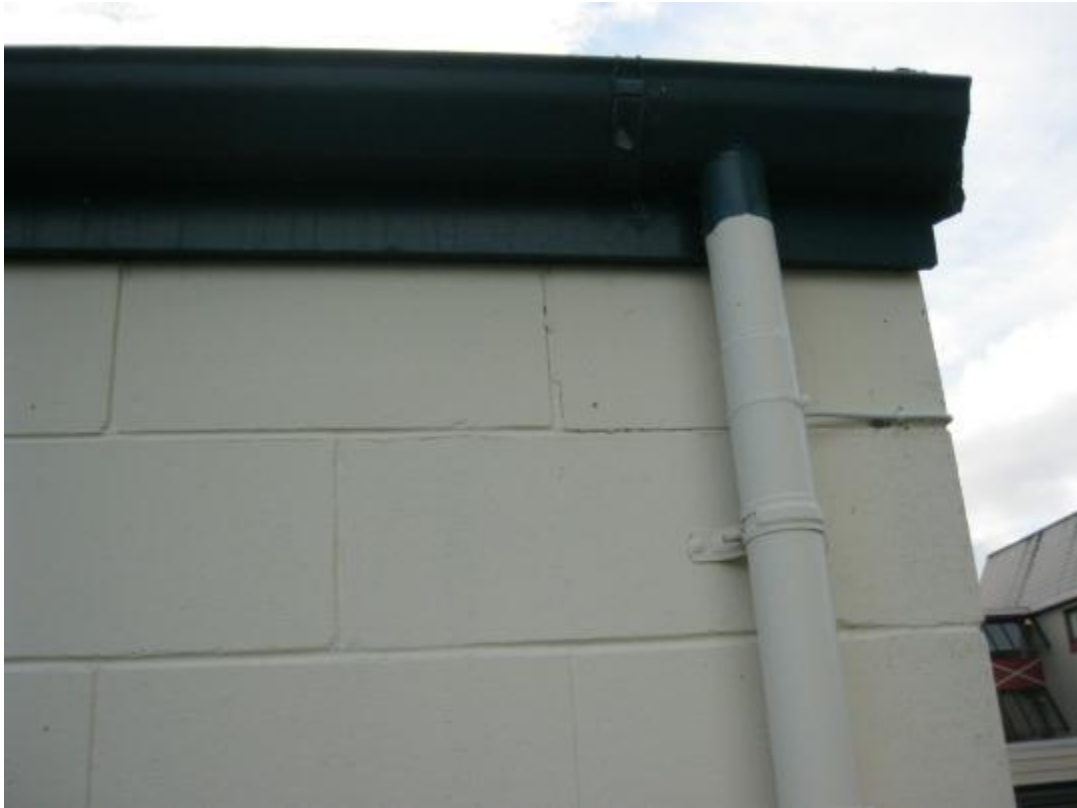
Photo 9 Zigzag cracks at concrete block masonry wall.

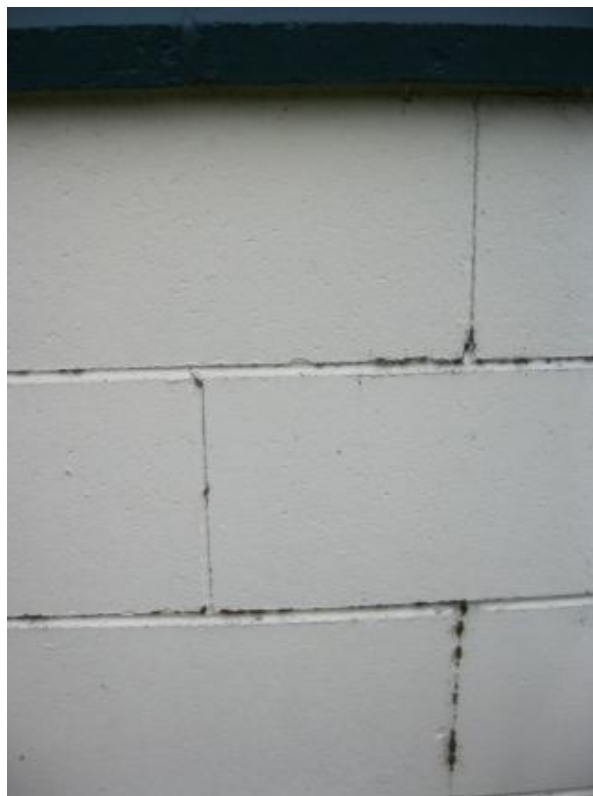
Photo 10 Zigzag cracks at concrete block masonry wall.

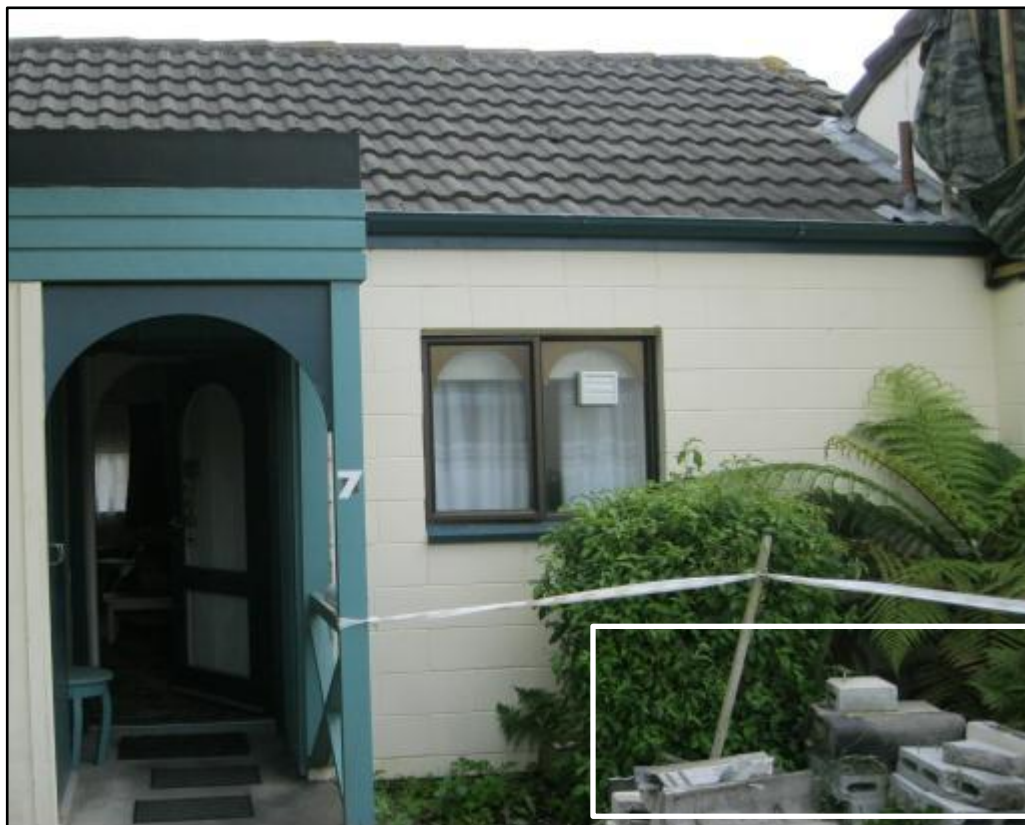
The masonry cladding appears to be unfilled or partially unfilled and unreinforced. This is visible in a collapsed gable end of block G, see (Photo 11). Where the gable has collapsed it is unfilled and unreinforced, this detail may also apply to the other masonry elements of the building. The archived construction drawings also appear to confirm the unreinforced nature of the masonry cladding. The individual residential units are separated by a 200mm wall of partially filled reinforced concrete bond beam style masonry construction, which continues above eave level to meet the roof.

Photo 11 Masonry blocks showing unreinforced gable of Block G, indicative of building style that may have been used in Block E.

- ▶ The gable sections of masonry veneer are immediately made safe by either removal or tying these to the structure framing
- ▶ The nature of the connection between the masonry veneer and the framing is identified
- ▶ If no positive connection between the masonry veneer is identified then the veneer walls are removed and replaced with lightweight materials or some form of positive connection between the veneer and the framing is added.
- ▶ The areas adjacent to the unreinforced gable walls should be cordoned off until the above recommendations have been completed.

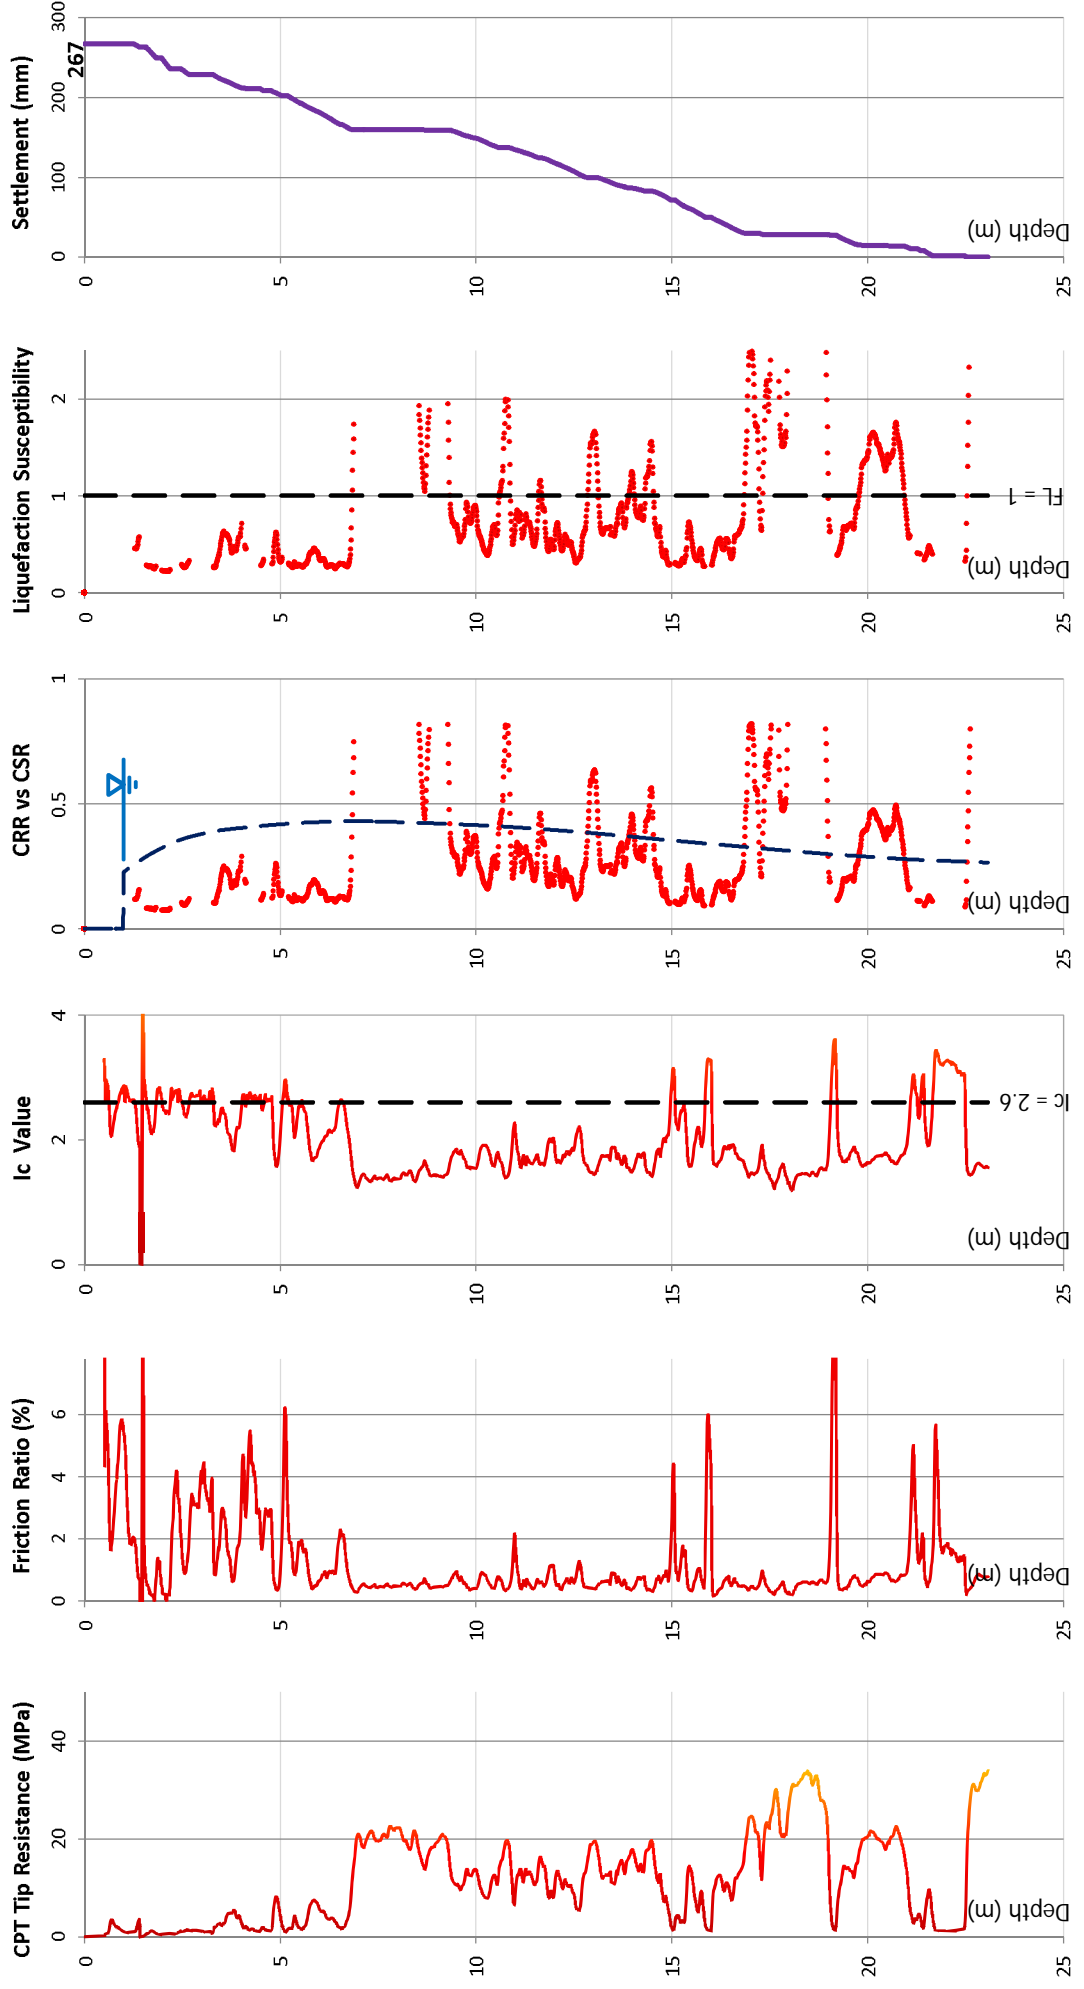
LOCATION : CPT 1
 PROJECT : Haast Courts - 149 Stanmore Road
 JOB NO : 51 30596 41
 TEST DATE : 28 Jun 2012
 SHEET : 1
 CALCULATED : HNN
 CHECKED BY :
 DATE : 4 Jul 2012

PGA (a_{max}): 0.35 g
 EQ Magnitude: 7.5
 Groundwater Level (m bgl): 1.0
 Atmospheric Pressure (kPa): 101
 Bore depth (m): 23.07
 Test data step (m): 0.01
 Total Estimated Settlement (mm): **267**

- The soil class of **D** (in accordance with NZS 1170.5:2004) recommended in Section 8 of the Qualitative DEE/IEP is still believed to be appropriate; and,
- Any remedial works to foundations (or proposed new structures) be undertaken in accordance with DBH's guidelines for **TC3** land, due to the high levels of estimated settlement.

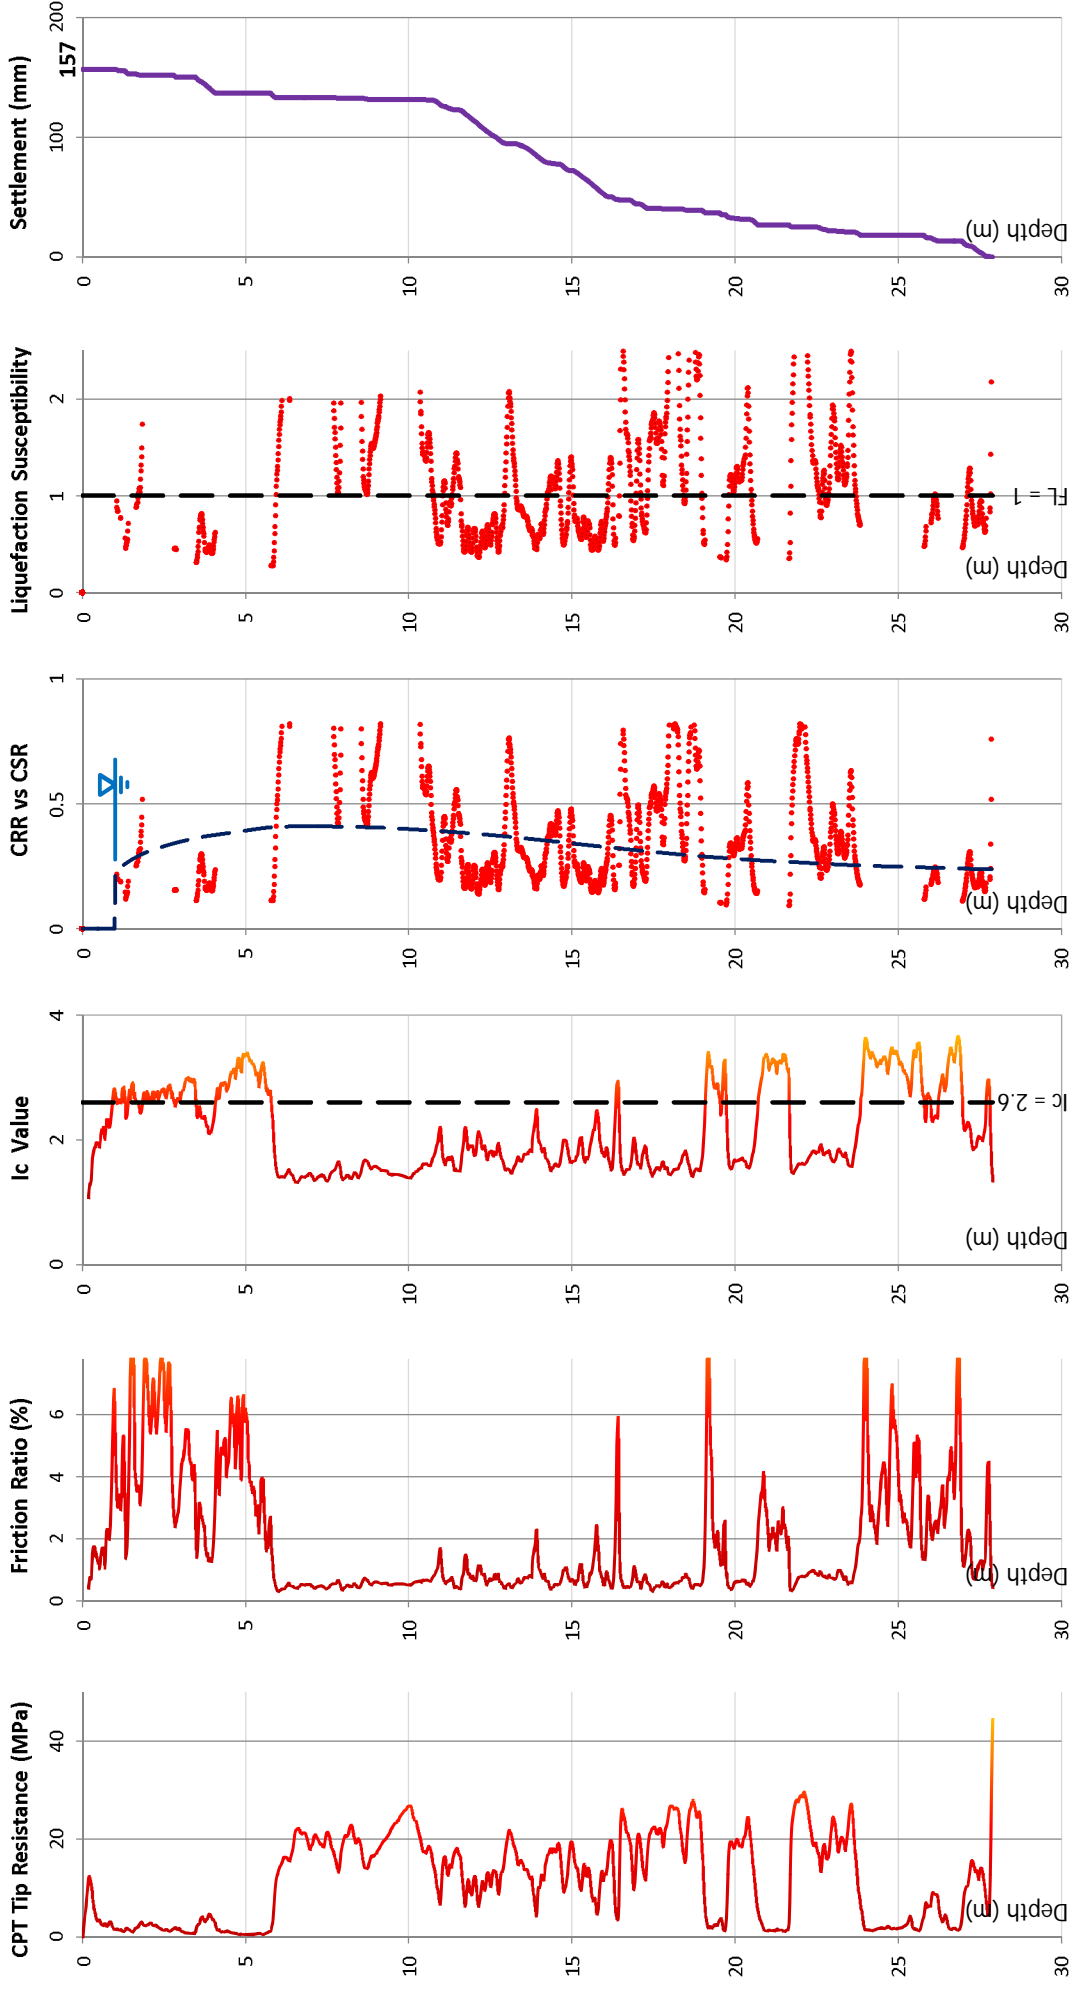
LOCATION : CPT 2
 PROJECT : Haast Courts - 149 Stanmore Road
 JOB NO : 51 30596 41
 TEST DATE : 28 Jun 2012
 SHEET : 2
 CALCULATED : HNN
 CHECKED BY :
 DATE : 4 Jul 2012

PGA (a_{max}): 0.35 g
 EQ Magnitude: 7.5
 Groundwater Level (m bgl): 1.0
 Atmospheric Pressure (kPa): 101
 Bore depth (m): 27.89
 Test data step (m): 0.01
 Total Estimated Settlement (mm): **157**
