Haast Courts Block G
BU 0792-007 EQ2
Detailed Engineering Evaluation
Quantitative Report
Version FINAL

151 Stanmore Road, Linwood

Christchurch City Council

Date
31/10/12

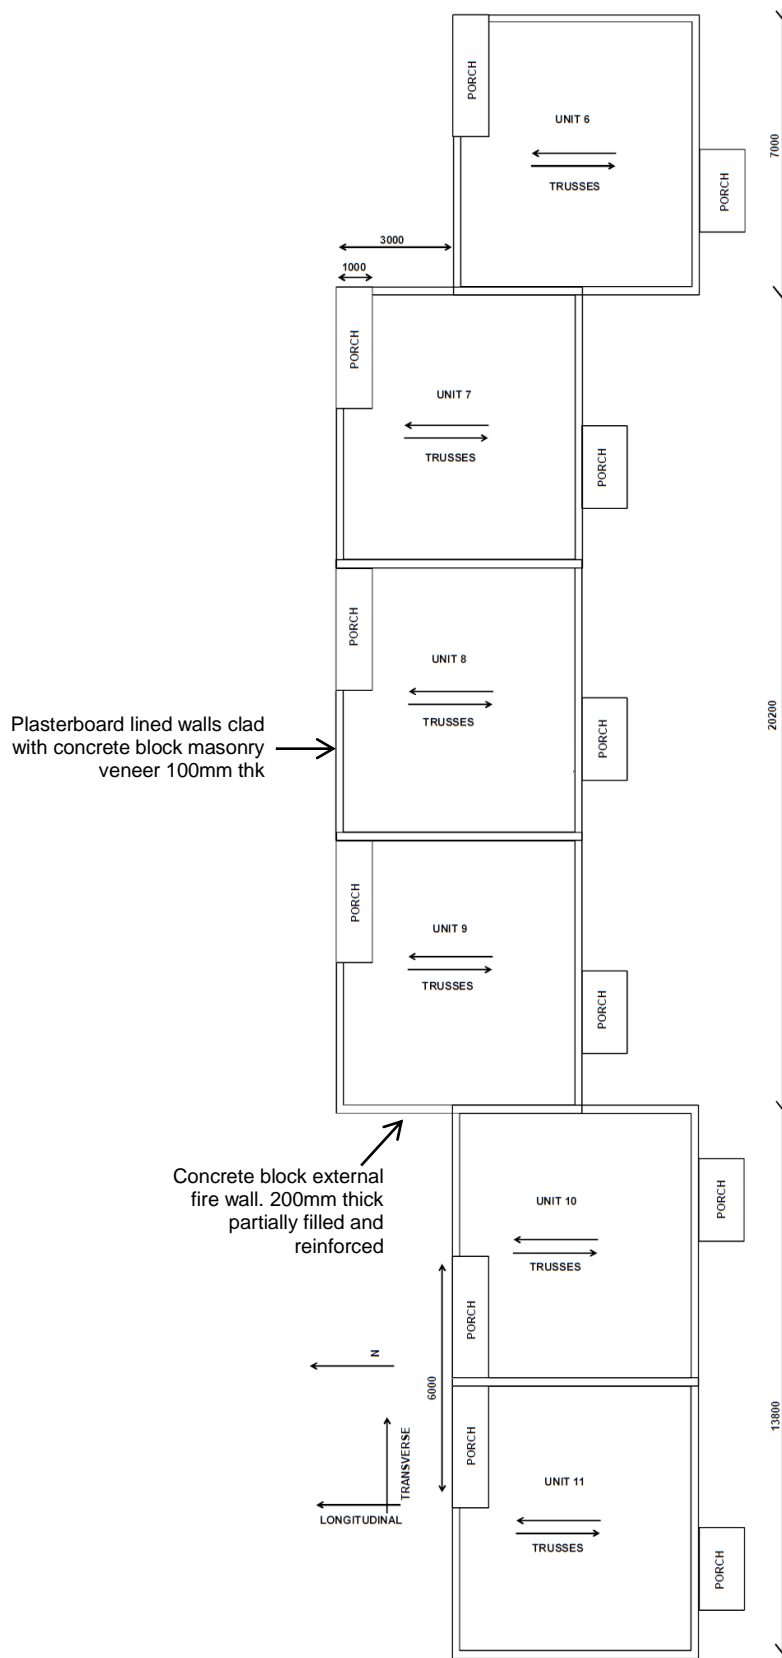
Figure 4.1 Plan sketch show key structural elements

The dimensions of the building are approximately 41.5m long, 9.8m wide and 4.7m in height. The overall footprint of the building is approximately 270m². Sketches of key details are shown in Figure 4.1.

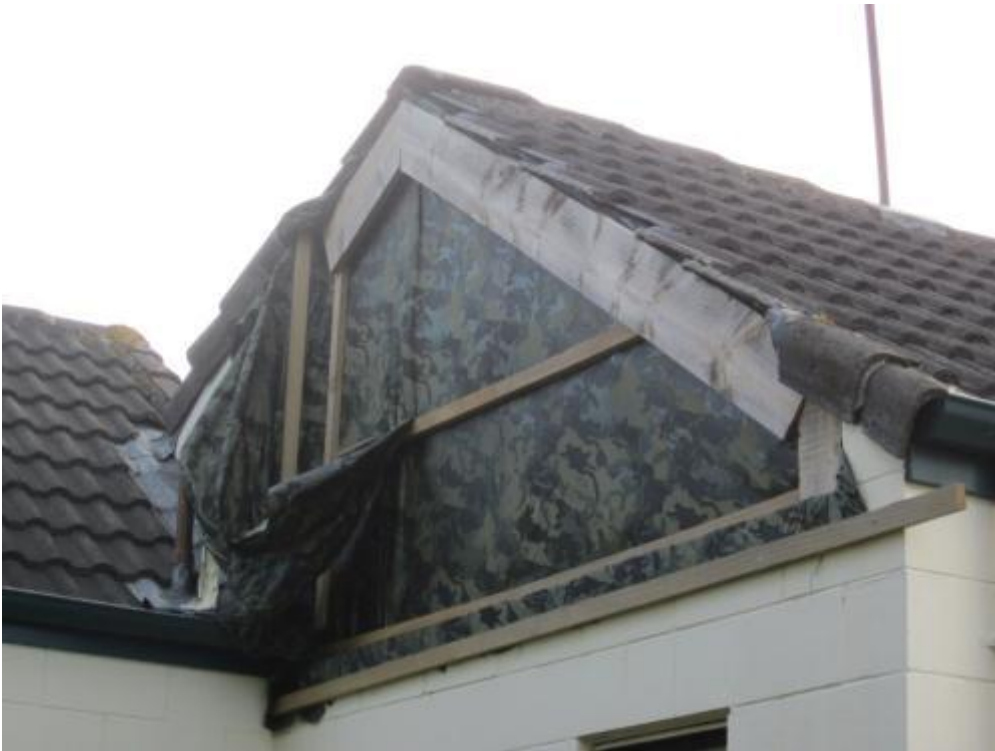
- Minor cracking was noted throughout the building
- No damage was noted to the roof structure
- No damage was noted to the floor slabs
- Collapse of the apex tip of west gable wall

Photo 11 Collapse of west gable wall.

- ▶ The upper section of the gable walls are either removed or tied back to the building frame immediately as collapses of these sections are possible under earthquake load.
- ▶ The masonry walls are apparently unreinforced and the drawings do not indicate that there are tied back to the wall framing. Localised removal of the linings is recommended to identify if the veneer is tied back.
- ▶ If the veneer is found not to be tied back to the wall framing it is recommended that the veneer is either removed and replaced with light weight cladding or is tied back to the framing with masonry ties.
- ▶ The areas adjacent to the unreinforced gable walls should be cordoned off until the above recommendations have been completed.

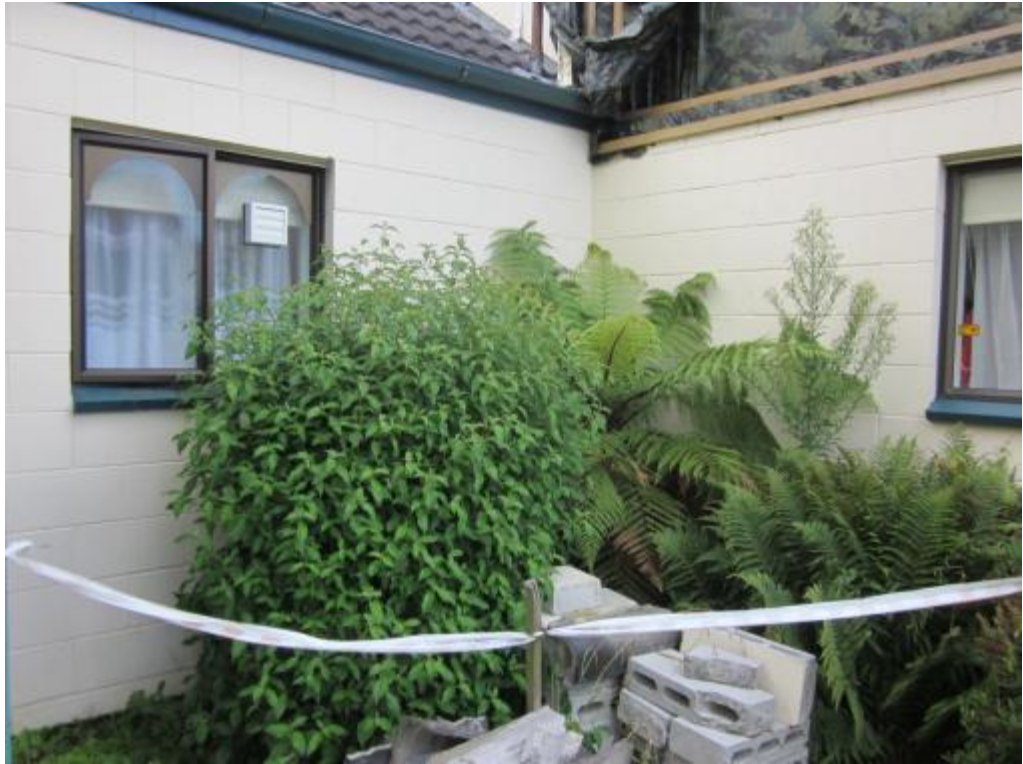
The masonry cladding appears to be unfilled or partially unfilled and unreinforced. This is visible in a collapsed gable end on this block, see (Photo 13). Where the gable has collapsed it is unfilled and unreinforced, this detail may also apply to the other masonry elements of the building. The archived construction drawings also appear to confirm the unreinforced nature of the masonry cladding. The individual residential units are separated by a 200mm wall of partially filled reinforced concrete bond beam style masonry construction, which continues above eave level to meet the roof.

Photo 13 Masonry blocks showing unreinforced gable of Block G. indicative of building style that may have been used.

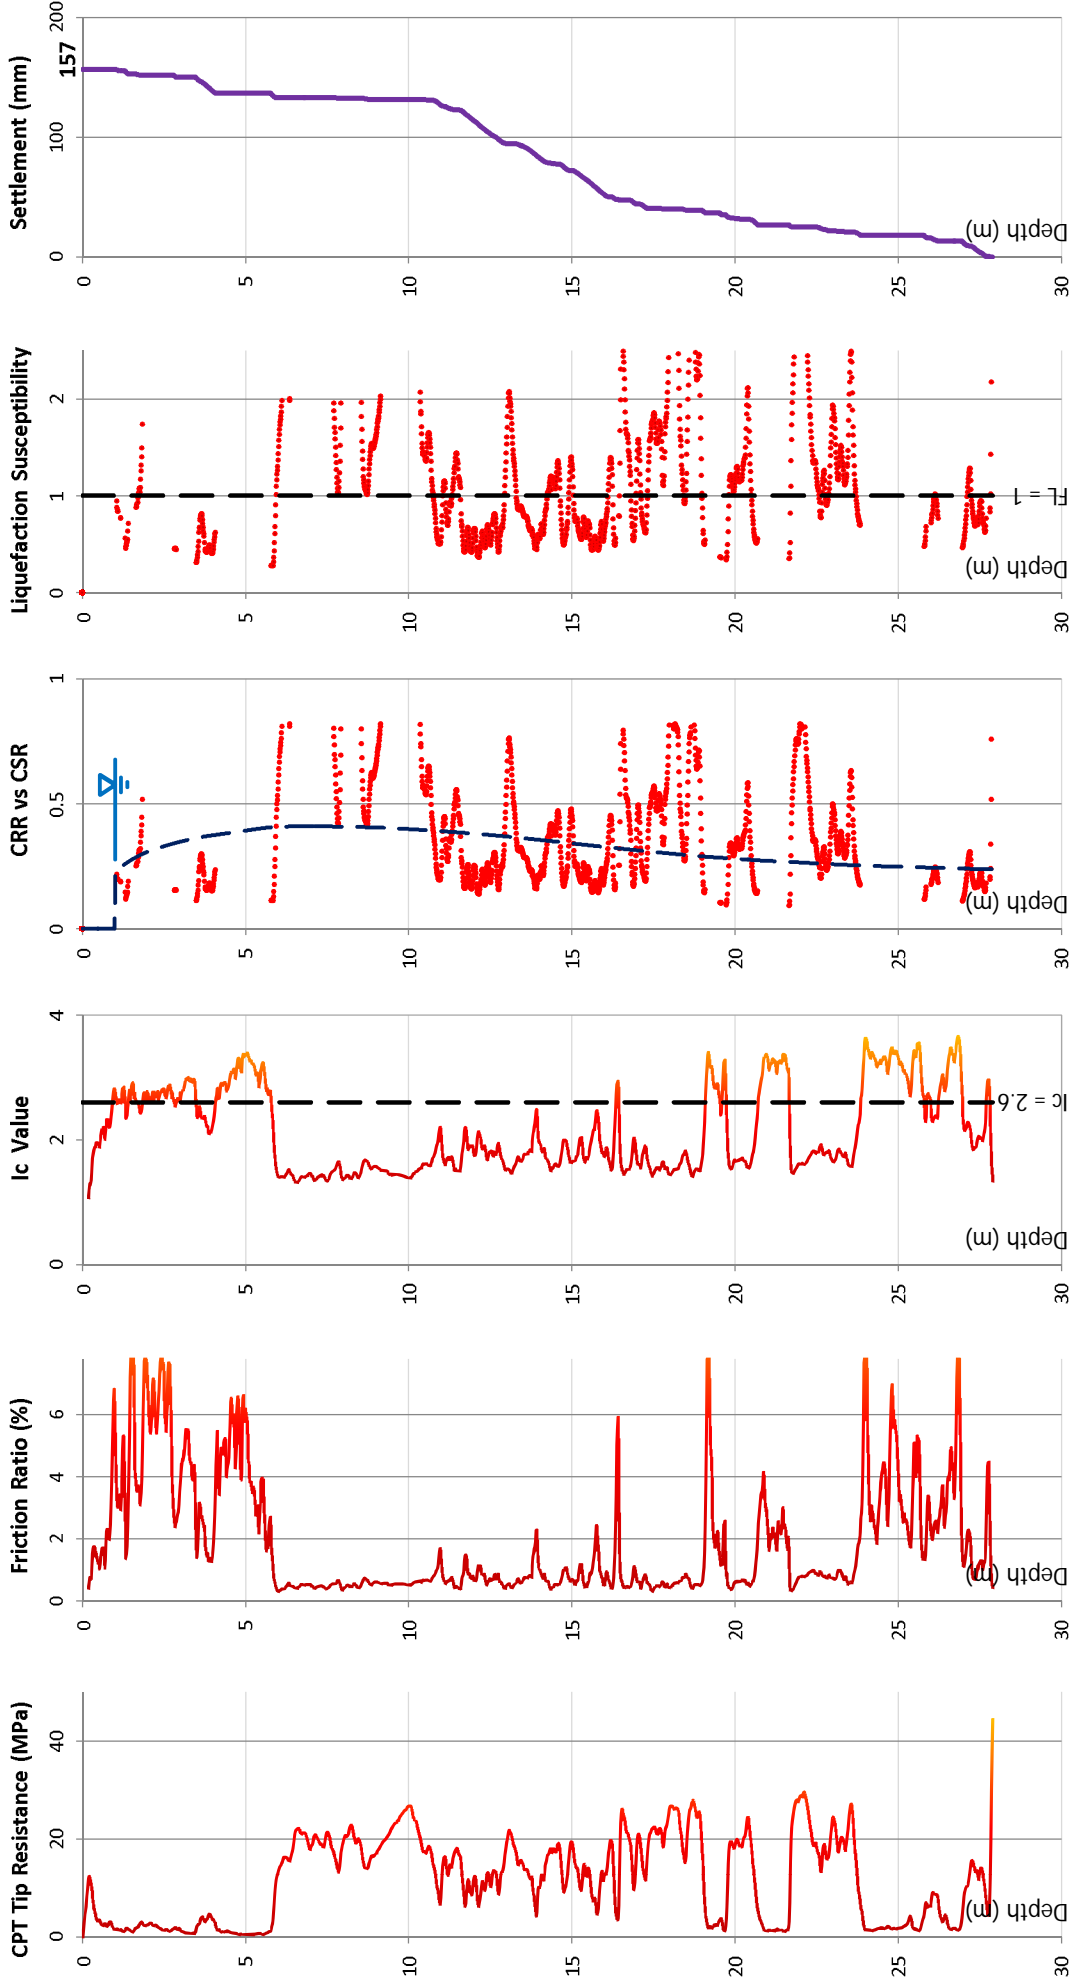
LOCATION : CPT 2
 PROJECT : Haast Courts - 149 Stanmore Road
 JOB NO : 51 30596 41
 TEST DATE : 28 Jun 2012
 SHEET : 2
 CALCULATED : HNN
 CHECKED BY :
 DATE : 4 Jul 2012

Settlement estimates for the CPT points are between 150mm and 270mm for ULS conditions.

PGA (a_{max}): 0.35 g
 EQ Magnitude: 7.5
 Groundwater Level (m bgl): 1.0
 Atmospheric Pressure (kPa): 101
 Bore depth (m): 27.89
 Test data step (m): 0.01
 Total Estimated Settlement (mm): **157**

- The soil class of **D** (in accordance with NZS 1170.5:2004) recommended in Section 8 of the Qualitative DEE/IEP is still believed to be appropriate; and,
- Any remedial works to foundations (or proposed new structures) be undertaken in accordance with DBH's guidelines for **TC3** land, due to the high levels of estimated settlement.
