**Hadfield Courts
Retirement Village
BE 1126 EQ2**

**Detailed Engineering Evaluation
Quantitative Assessment Report**

Somerfield, Christchurch

Date: 8 February 2013
Reference: 6-QUCC1.99
Status: Final

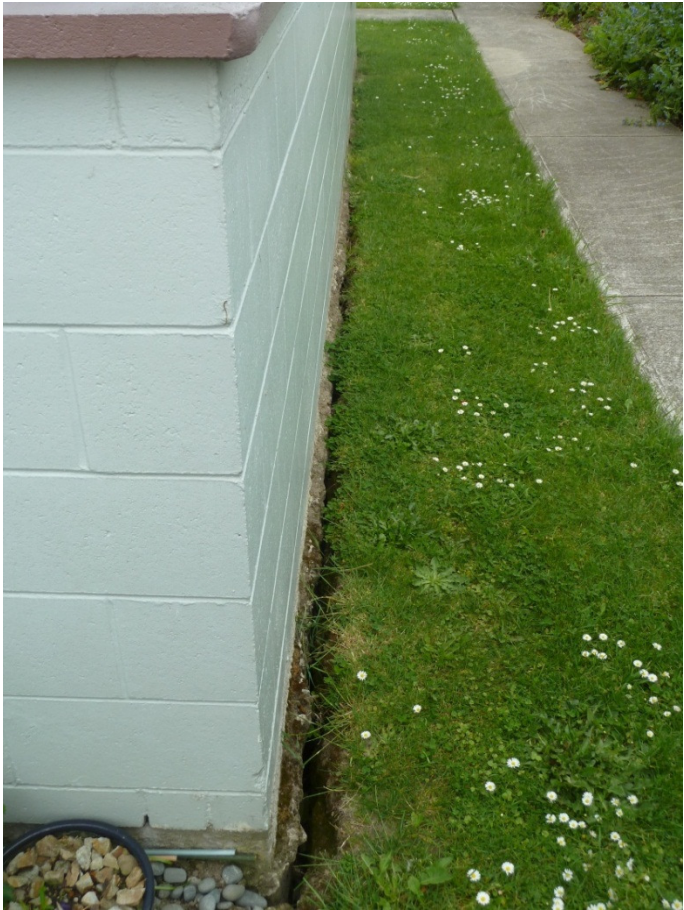
| 4 | Movement at Unit 21 | |

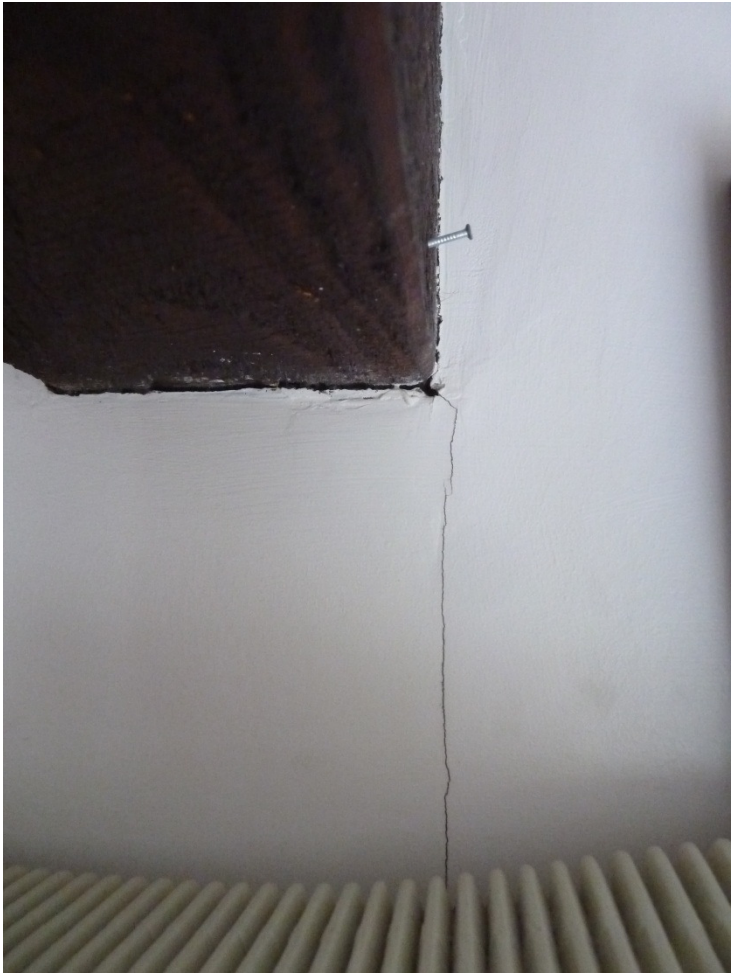
| 2 | Cracking in Unit 20 | A photograph showing a vertical crack in a white wall. The crack runs from the top edge of a radiator down to the bottom edge of a dark, textured ceiling. A small metal fastener is visible on the ceiling edge. The radiator below is white with a ribbed surface. |

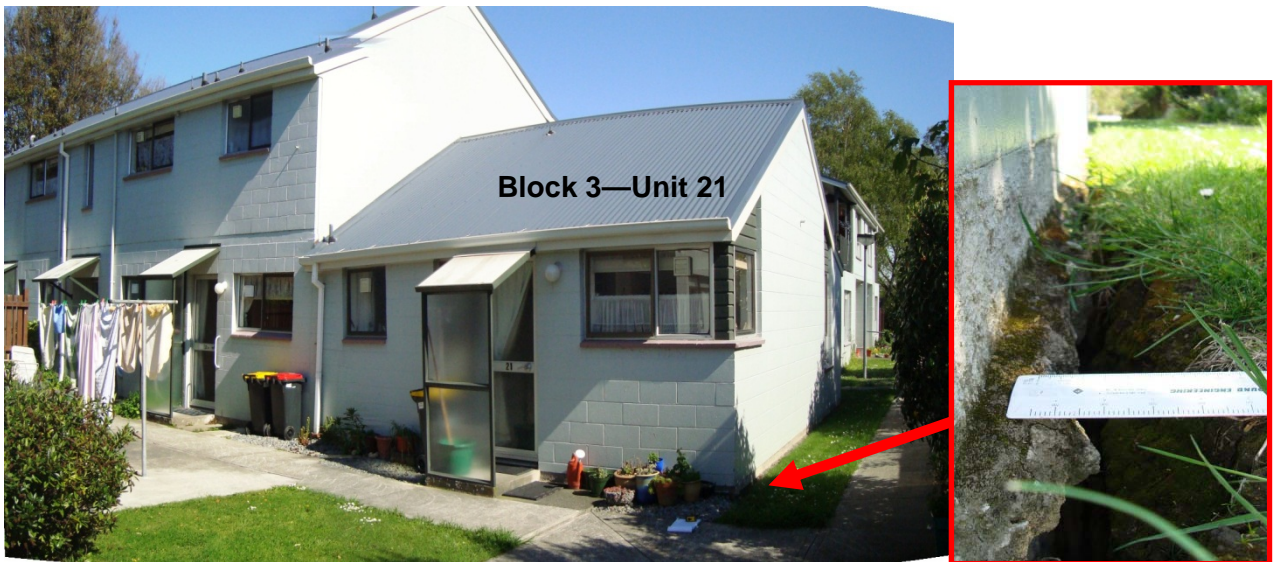
Due to the ground motion during the seismic events, the lateral movement that block 3 has undergone may have caused the soils to consolidate, resulting in the gaps observed between the perimeter foundation of Unit 21 and the ground. Alternatively, the void may have been caused as a result of liquefaction ejecta. The gap is about 70mm wide and 500mm deep. It was difficult to tell whether some differential settlement of the foundation has occurred from the exterior of unit 21. There was no evidence of cracking in the perimeter footing, where the gap was noted.

- Up to 70mm gap between the ground and perimeter foundation at the end elevation of Unit 21 (Photograph 6)
- Up to 10mm wide cracks on the asphalted footpath across the street from Hadfield Courts and up to 20mm of ground heave. (Photographs 9)

Due to the ground motion during the seismic events, the lateral movement that Block 3 has undergone may have caused the soils to consolidate resulting in the gaps observed between the perimeter foundation of Block 3 -Unit 21 and the ground on the eastern boundary of the site. Alternatively, the void may have been caused as a result of liquefaction ejecta. The gap was about 70mm wide and 500mm deep. It was difficult to tell

whether some differential settlement of the foundation has occurred from the exterior of Unit 21. There was no evidence of cracks in the perimeter footing where the gap was noted.

Photograph 6: Rear Elevation of Block 3 – Units 13 to 16, 21 (left photo). Up to 70mm gap between the ground and perimeter foundation at the end elevation of Unit 21 (right photo).

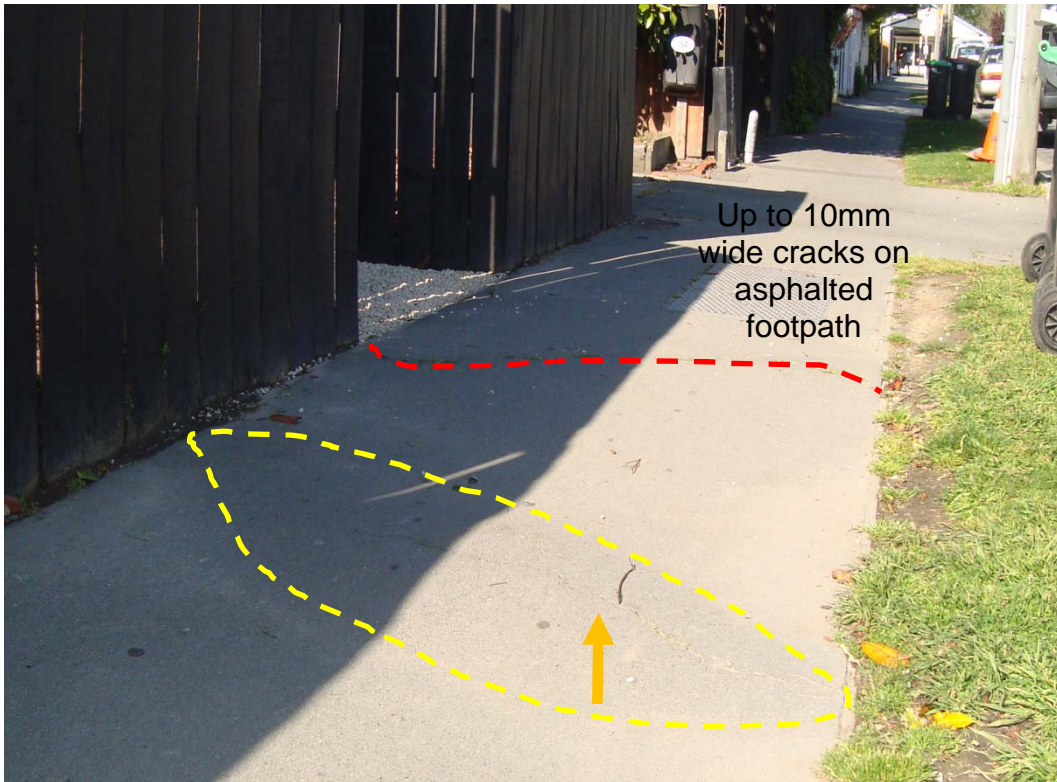
Photograph 9: Up to 10mm wide cracks on the asphalted footpath across the street from Hadfield Courts and up to 20mm of ground heave

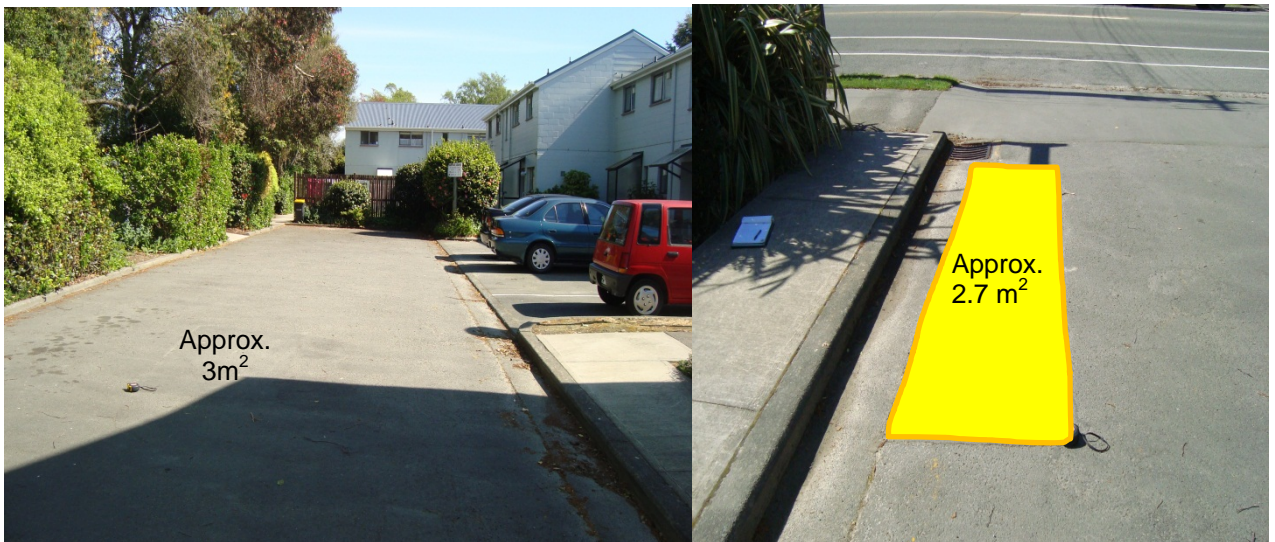
Photograph 10: Repaired liquefaction damaged asphalted ground by the driveway to Hadfield Courts

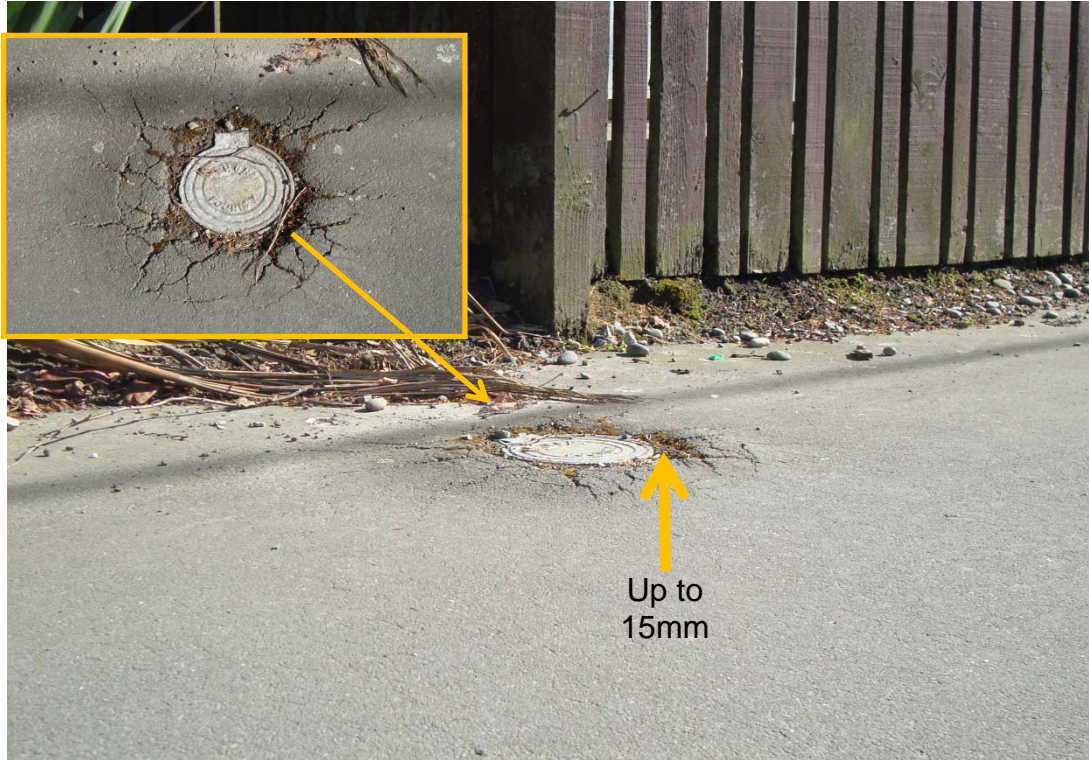
Photograph 11: Up to 15mm lift on the ground around buried services along Somerfield Street by the southern boundary of Hadfield Courts

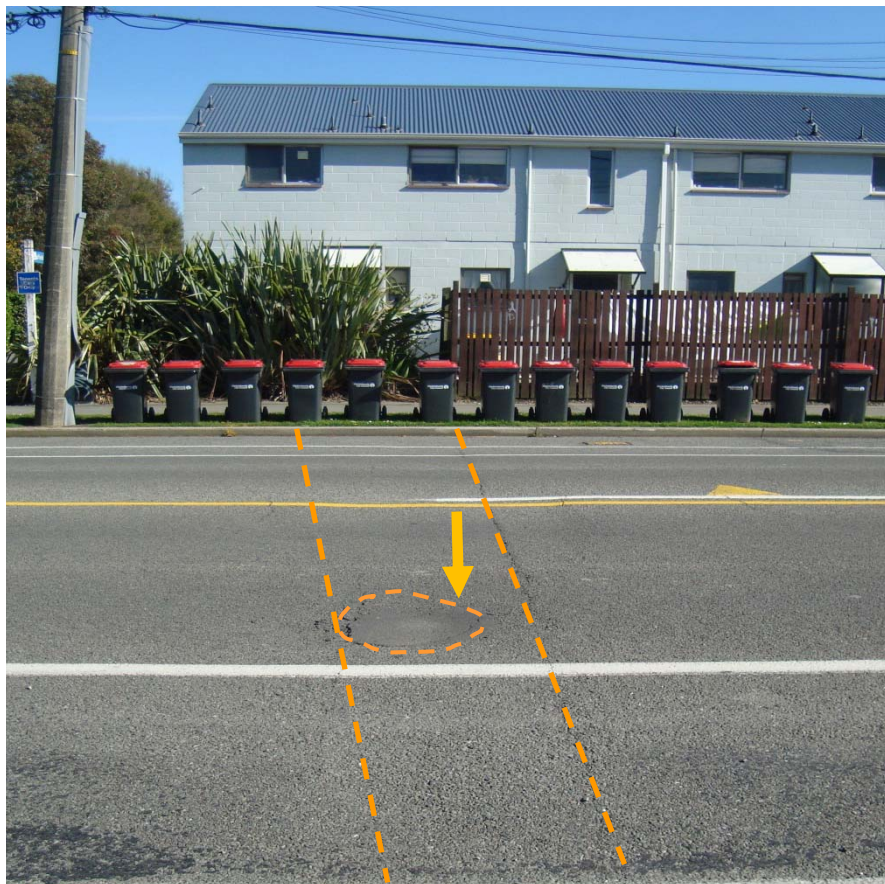
The apparent settlement of the ground above the trench excavation traversing Somerfield Street and the localised depression on the car park area west of Block 2, appears to be due to liquefaction subsidence of the underlying soils. Information from residents that liquefaction ejecta was observed within the car park area and along the eastern boundary of the site. The magnitude of ground heave on the areas mentioned above is unknown as the areas affected has been repaired (e.g. car park) and the ground at the eastern boundary now levelled. However, up to 20mm of ground heave has been noted around the site, which is inferred to result from ejected soils accumulating under an impermeable surface, such as asphalt.

Photograph 12: Up to 15mm localised depression and slight depression on the trench excavation where the buried services are.

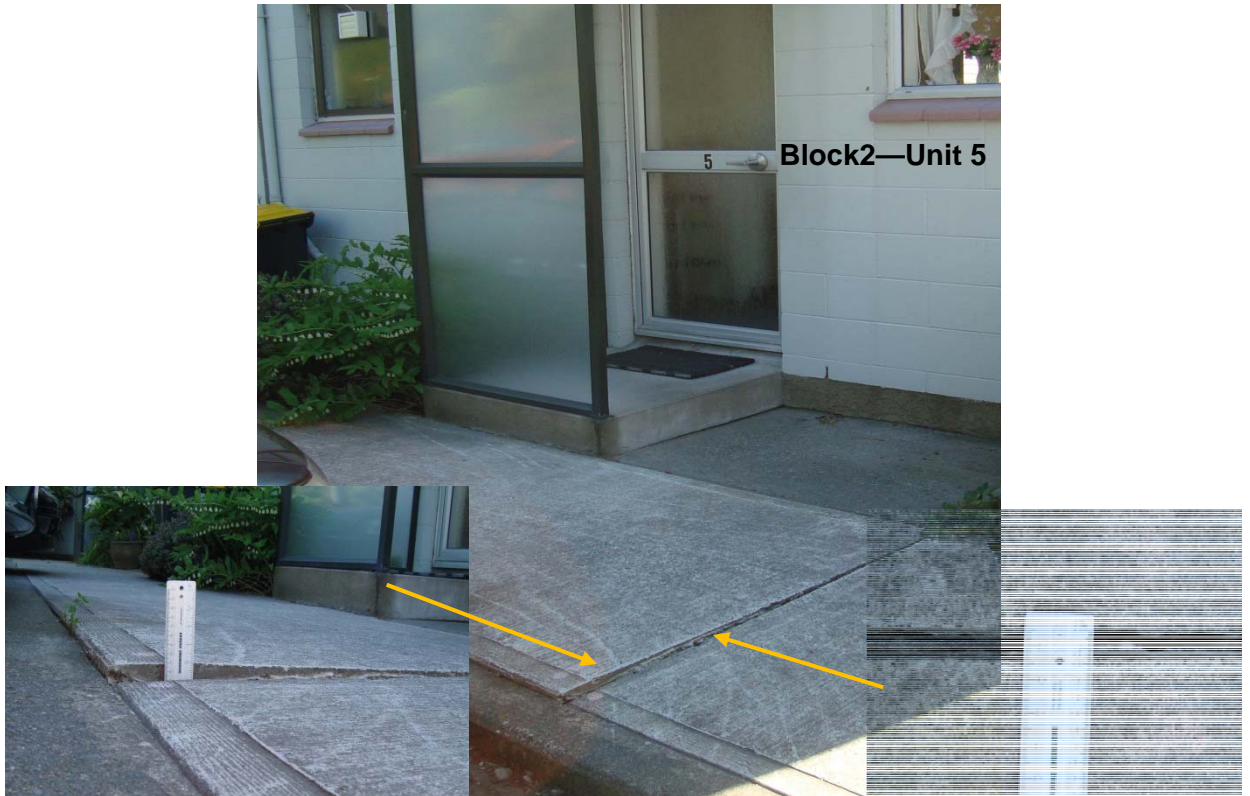
Photograph 13: 20mm lift on the concrete footpath with a 15mm wide gap west of the kitchen door of Block 2- Unit 5

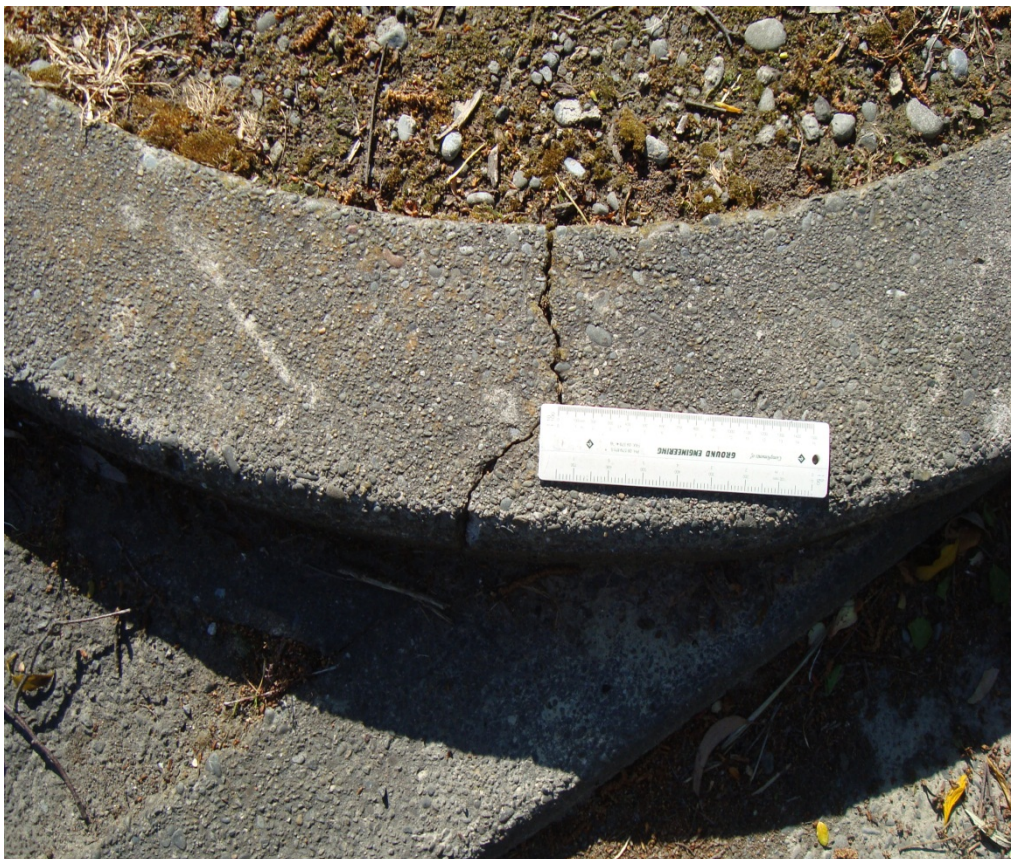
Photograph 14: Up to 4mm wide crack on the concrete kerb in various places within the car park area.

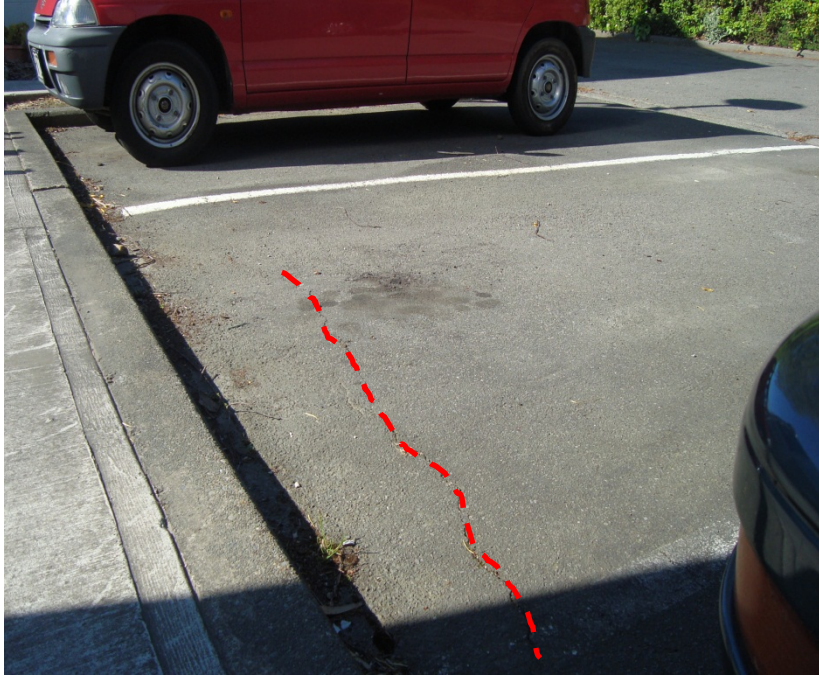
Photograph 15: Minor cracking (<5mm wide) in various places within the car park

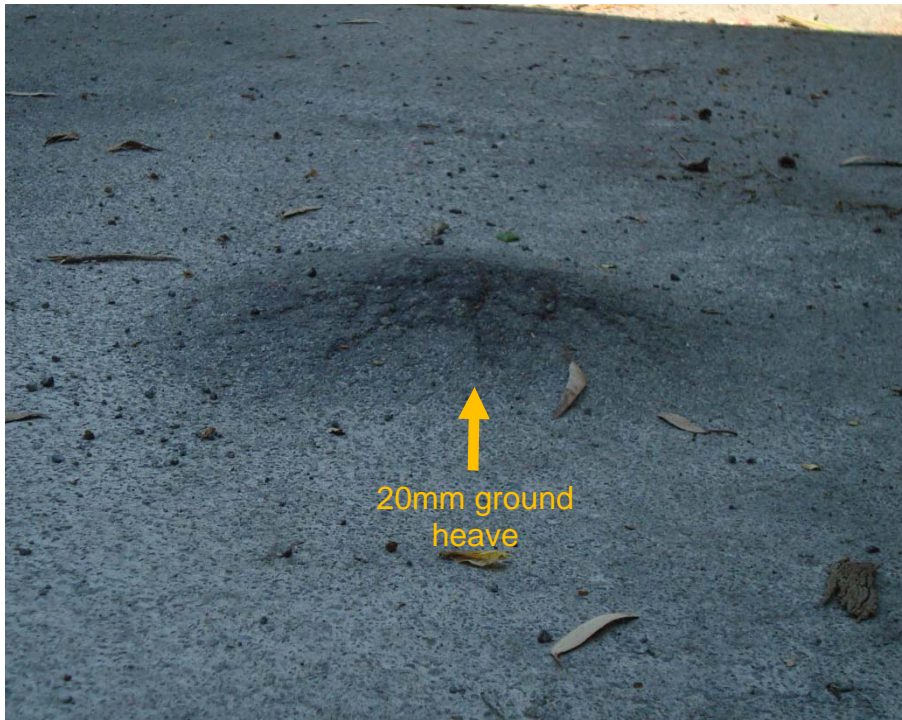
Photograph 16. 20mm ground heave on the asphalted car park in front of Unit 7

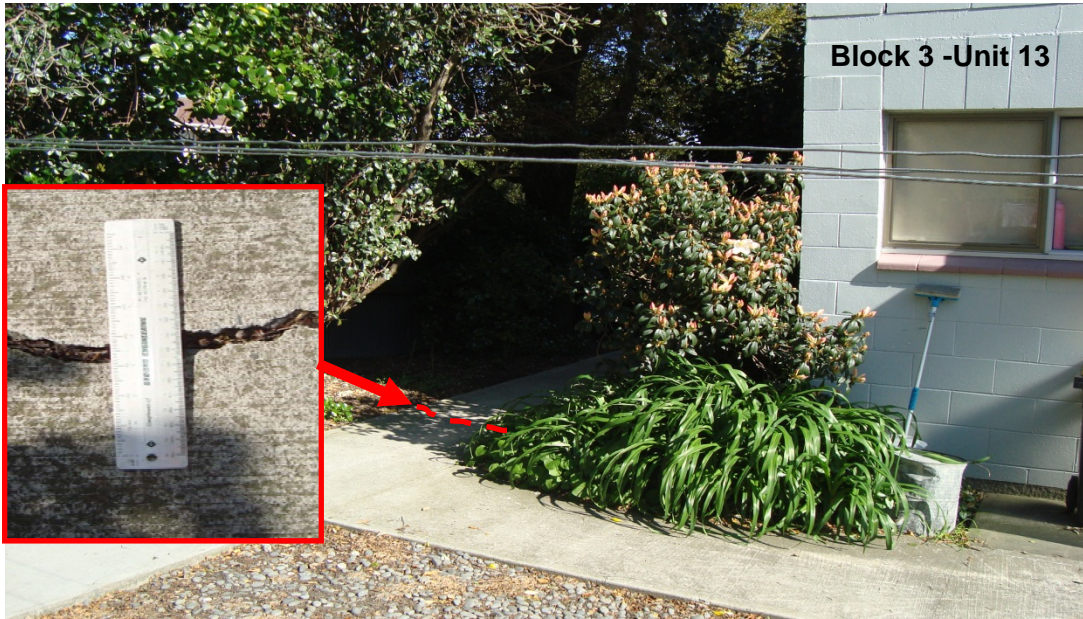
Photograph 17. Up to 15mm wide cracks on the concrete footpath east of Block 3-Unit 13

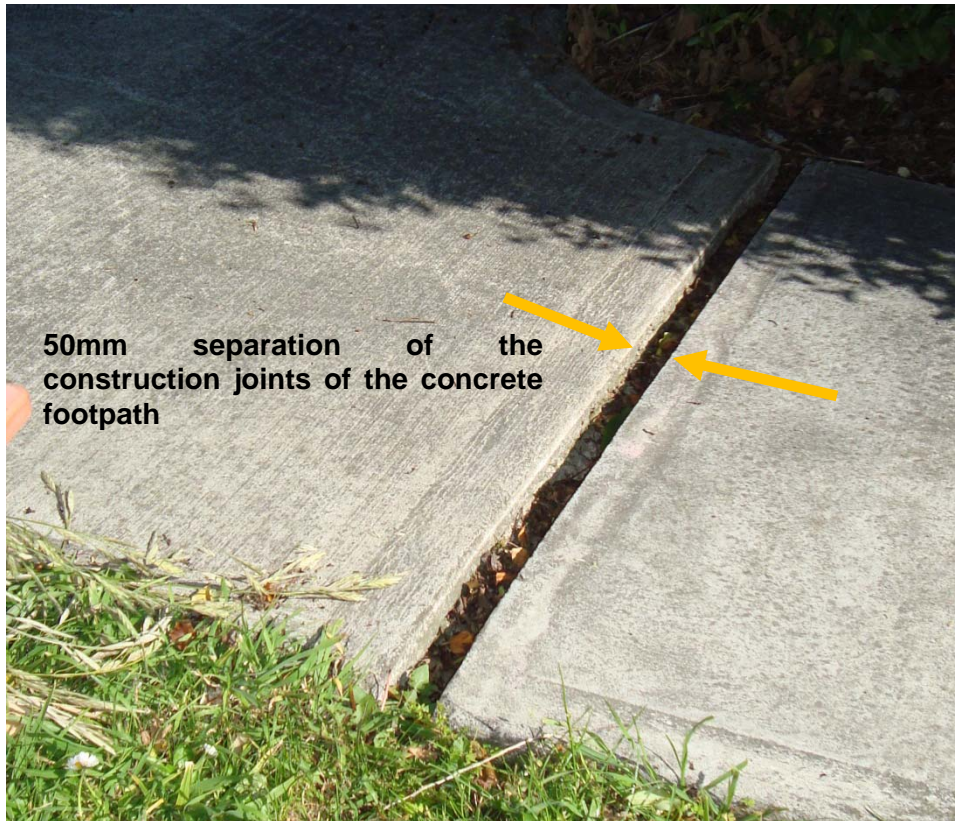
Photograph 18. 50mm wide separation of the construction joints on the concrete footpath at the front elevation of Block 3-Unit 13

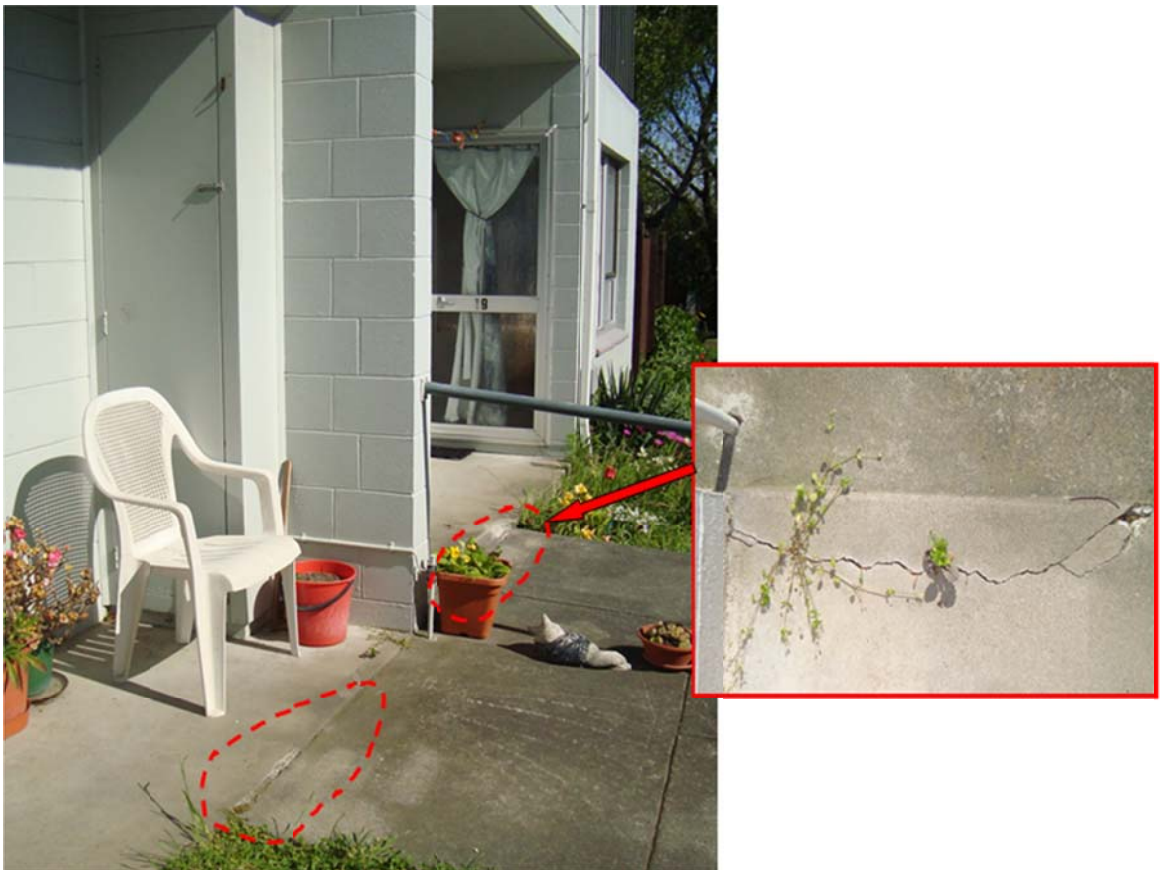
The cracks on the concrete patio of the most of the ground floor units of up to 7mm wide and settlement of up to 10mm is evident of liquefaction induced settlement of the underlying soils.

Photograph 20. Up to 10mm wide cracks and differential settlement of less than 10mm on the concrete patio by the lounge door entrance of Block 3 - Units 19 and 17

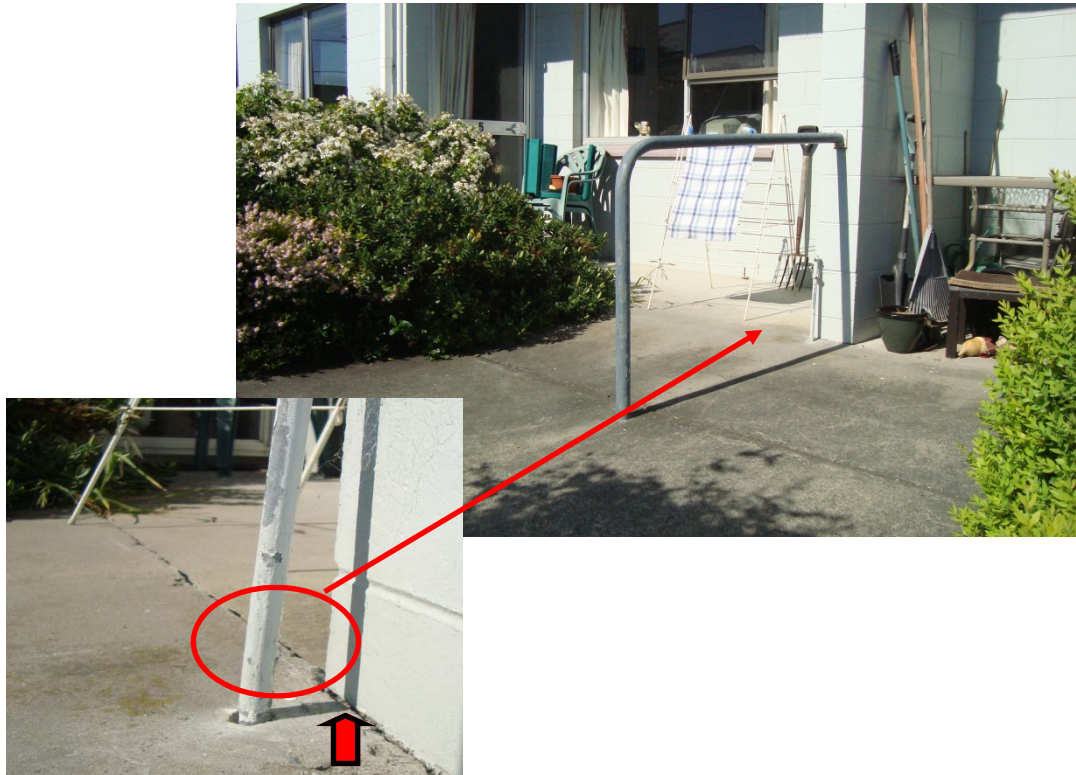
Photograph 21. Concrete slab by the lounge doors of Unit 5 and 7 lifted up to 9mm

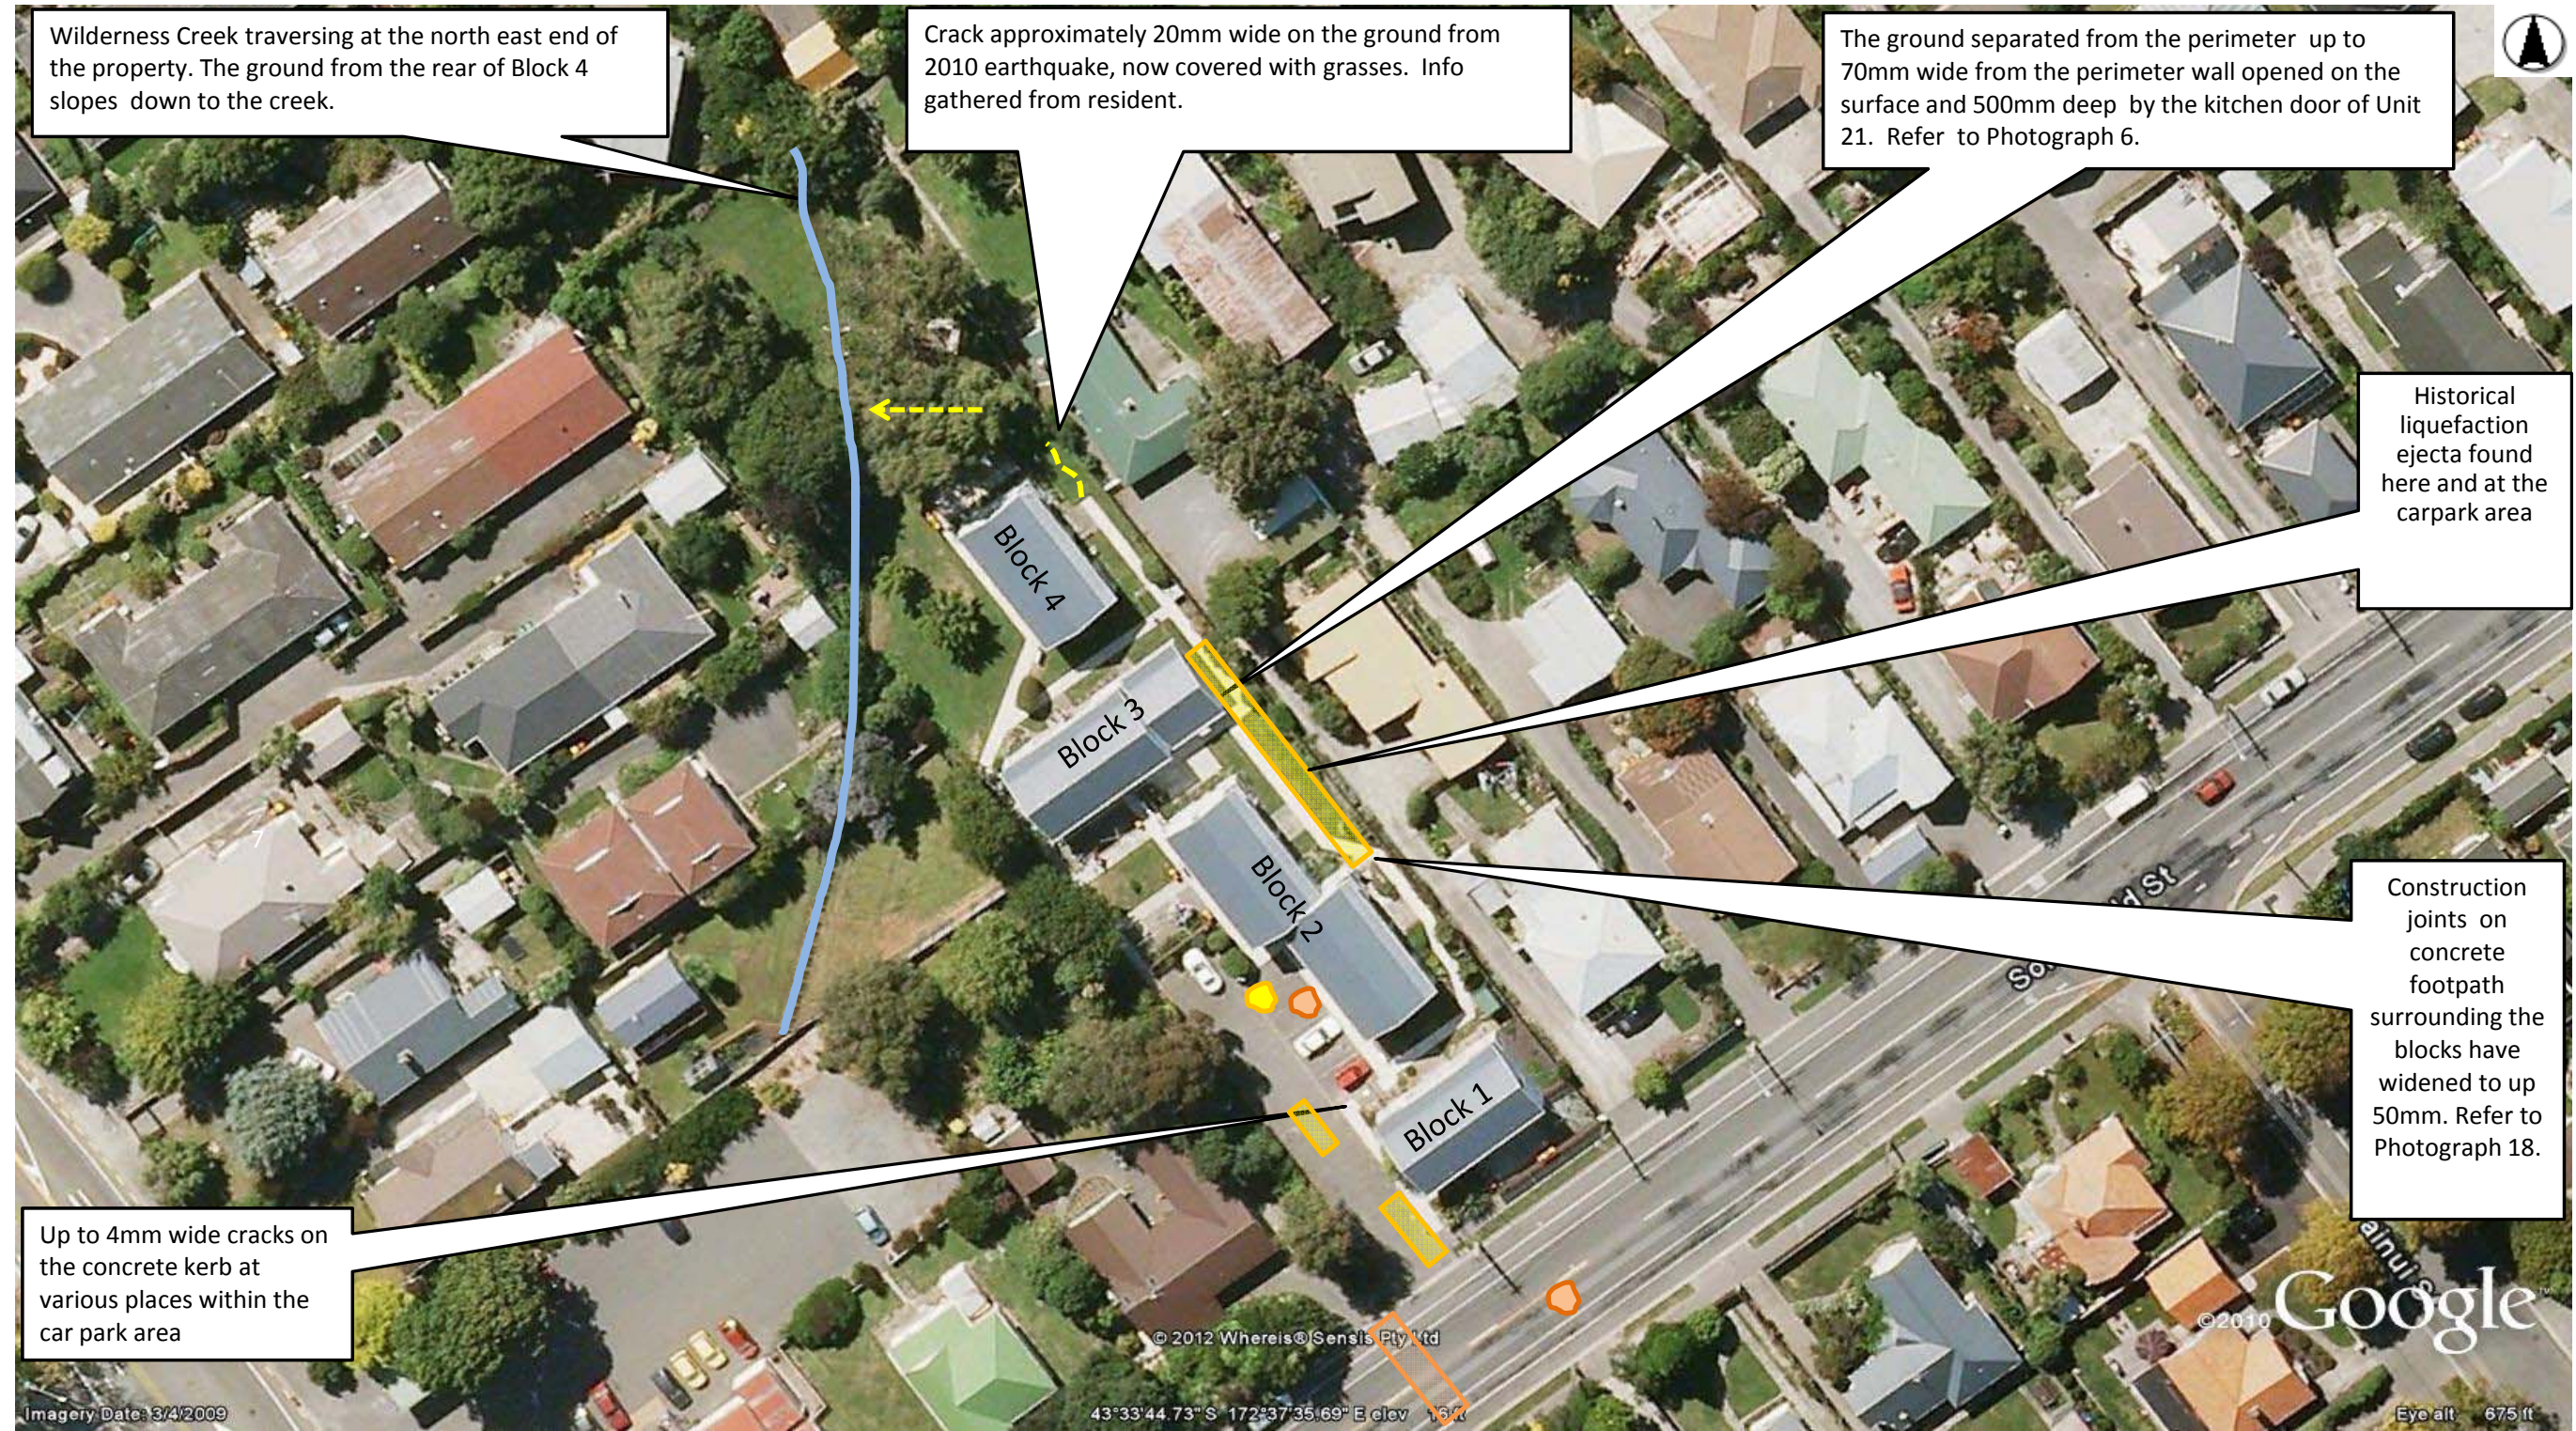
Wilderness Creek traversing at the north east end of the property. The ground from the rear of Block 4 slopes down to the creek.

Crack approximately 20mm wide on the ground from 2010 earthquake, now covered with grasses. Info gathered from resident.
