North Hagley Park – Pavilion
Qualitative Engineering Evaluation

Reference: 229615
Prepared for:
Christchurch City Council

Functional Location ID: PRK_1190_BLDG_016

Date: 14 October 2013

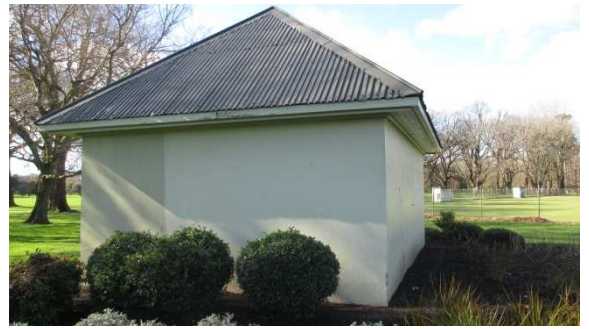
The North Hagley Park – Pavilion is currently in use and was occupied at the time the damage assessment was carried out. The North Hagley Park – Pavilion has performed well but has suffered damage to the floor and wall covering. There are minor cracks running through the concrete floor slab and wall. The cracks may have been pre-existing in the slab as it is unreinforced and likely over 70 years old.

<p>5. Crack in the concrete floor slab.</p>

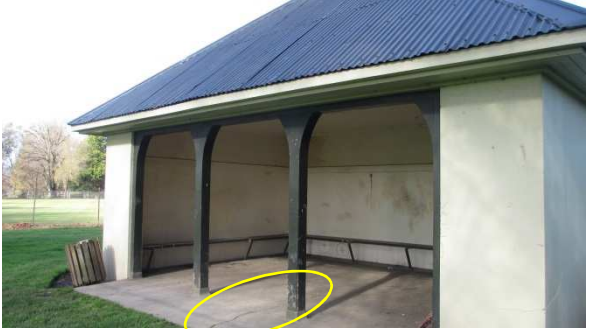
<p>6. Cracking to concrete covering.</p>

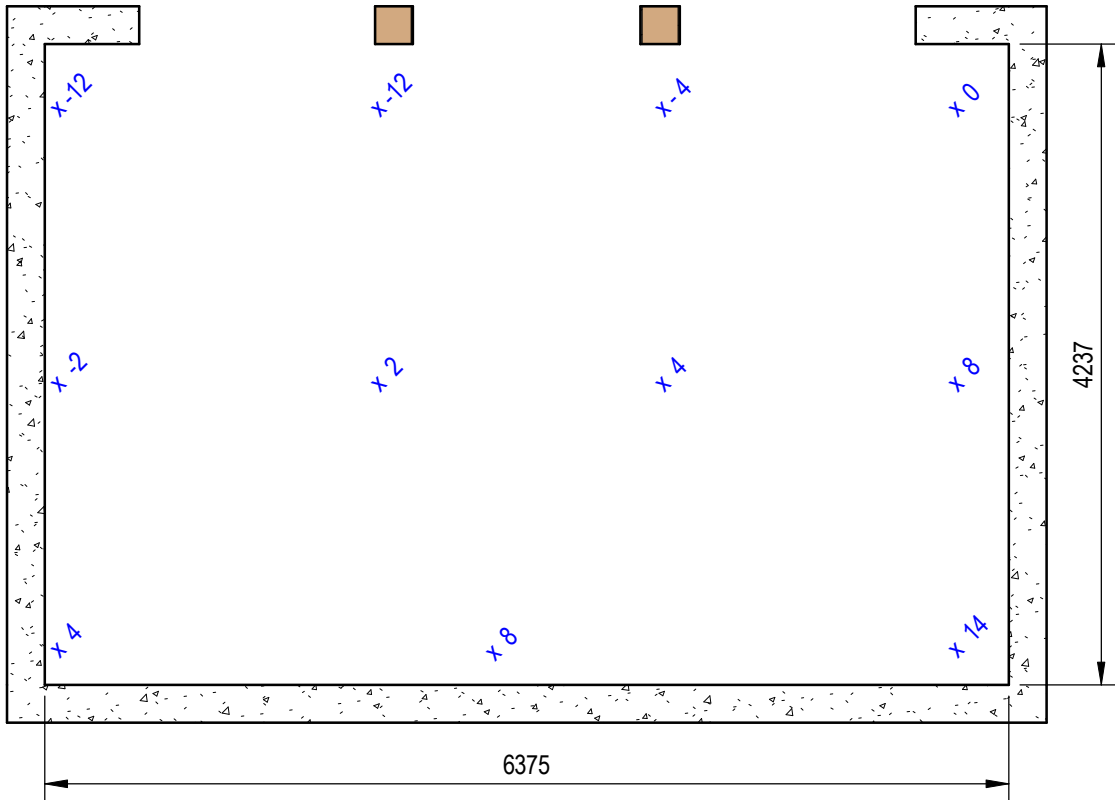
PLAN - LEVELS

The floor levels for the North Hagley Park – Pavilion were found to be within the recommended tolerances, although the slopes approach 0.5% in several locations.
