North Hagley RSA Bowling Club

PRK 1190 BLDG 008 EQ2

Detailed Engineering Evaluation

Qualitative Assessment Report

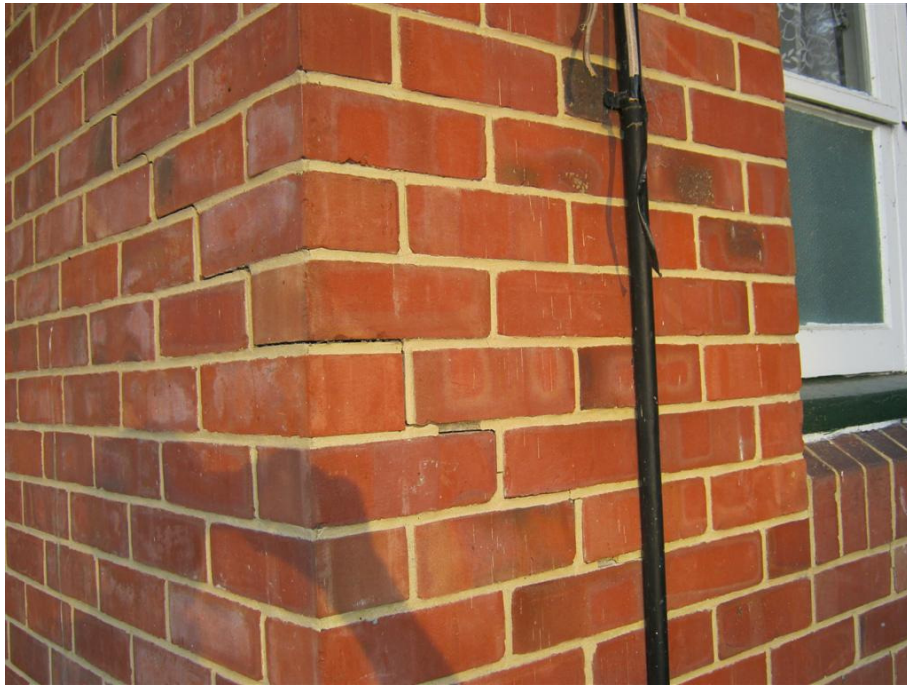
At ground level, there are a number of diagonal cracks in both skins of brick. On the north-west, south-west and south-east corners, there are cracks which extend the full height of the wall from foundation to first floor level. These are mirrored in the interior where the plaster has cracked and fallen away in some areas. There are a number of wide (up to 5mm) cracks in the foundations along the western side of the building. The interior brick wall to the building is not exhibiting any signs of damage through the 10mm plaster coating on both sides of the wall.

Step cracking on north west corner

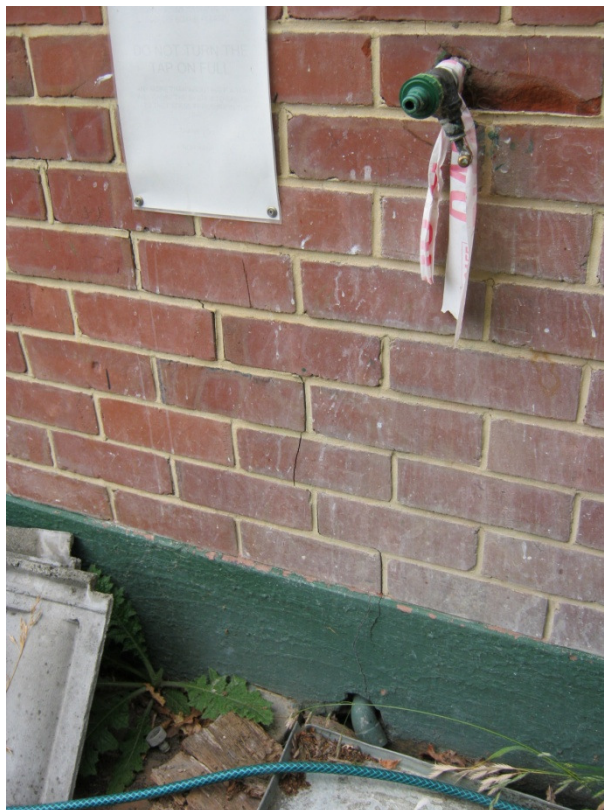
Minimal ground settlement was observed on this site (<10mm) and no damage has been observed that could be attributed to ground settlement. There are cracks in the foundations on the eastern and western sides of the building however no intrusive investigation has been undertaken at this stage. The attached geotechnical report notes that pavement to the north of the building has settled but anecdotal evidence suggests this pre-dates September 2010.

Foundation Damage

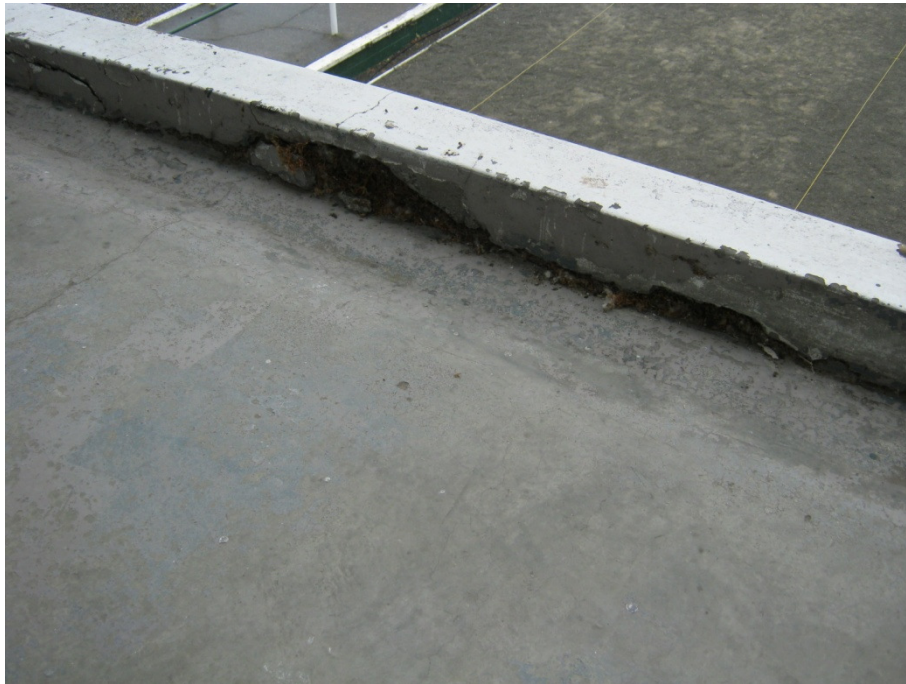
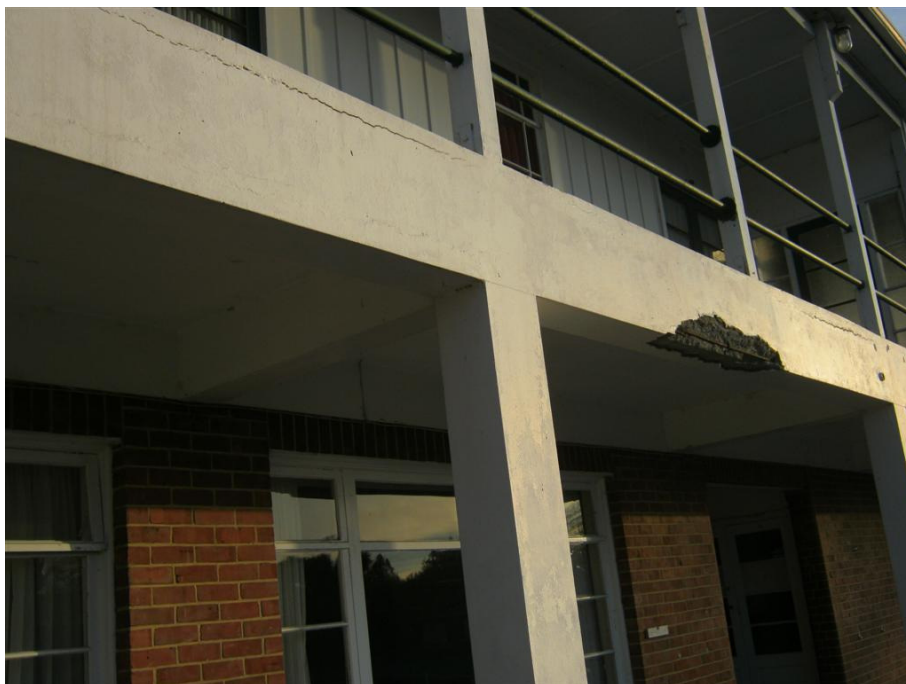
A small section spalled concrete on the northern edge of the first floor balcony is not earthquake related damage.

Spalled concrete on First Floor balcony

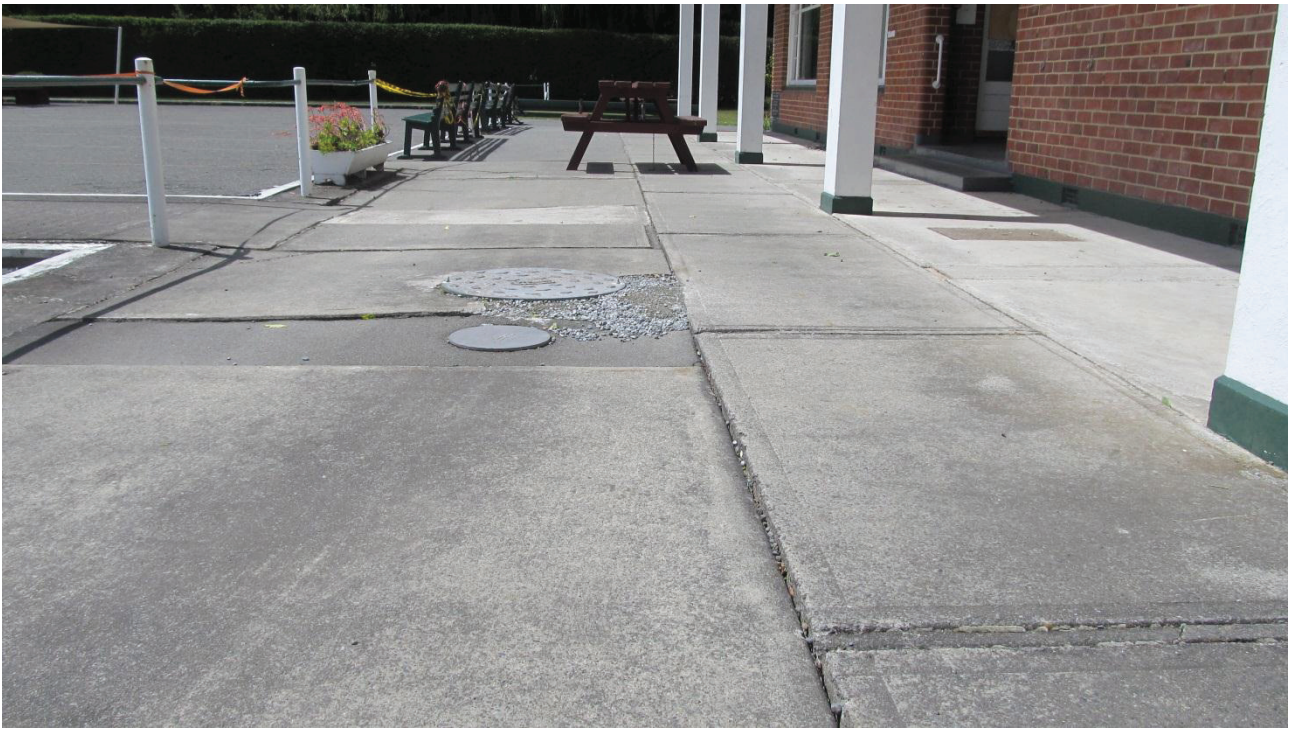
- The manhole at the north of the building appears to have risen by 10mm to 20mm causing the corner of concrete path to crack. Refer to Photo 3.
- Concrete paving on the northern side of the building has 10mm horizontal and vertical displacements. Refer to Photo's 3 and 4. Appears to have settled by 10mm to 50mm as indicated on site walkover drawing in Appendix B. Refer to Photo 3.

Liquefaction appears to have been relatively minor at the site and the close vicinity. Settlement (varying from 10mm to 50mm) in the concrete paving to the north and minor uplift of the manhole is consistent with liquefaction induced local damage.

Photo 3: Localised settlement of footpath (10mm-50mm) and manhole uplift (10mm to 20mm).

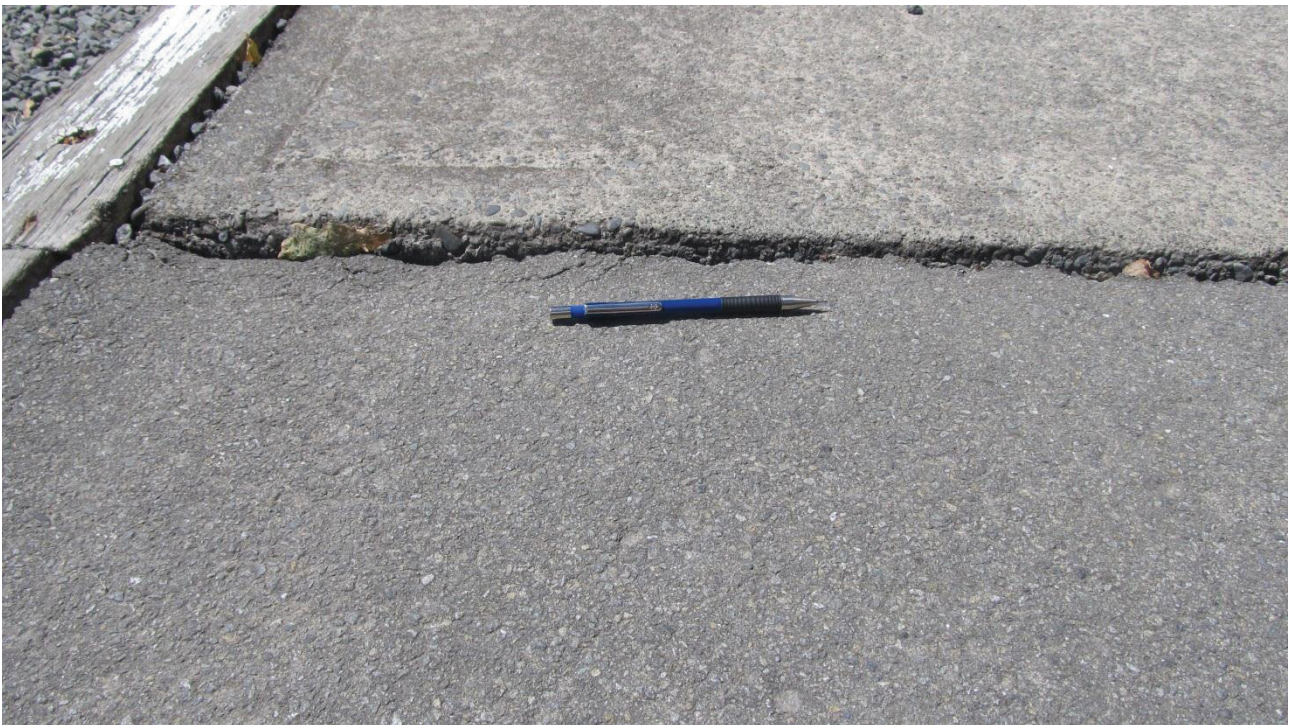
Photo 4: Upto 10mm of vertical and horizontal displacements of concrete paving.

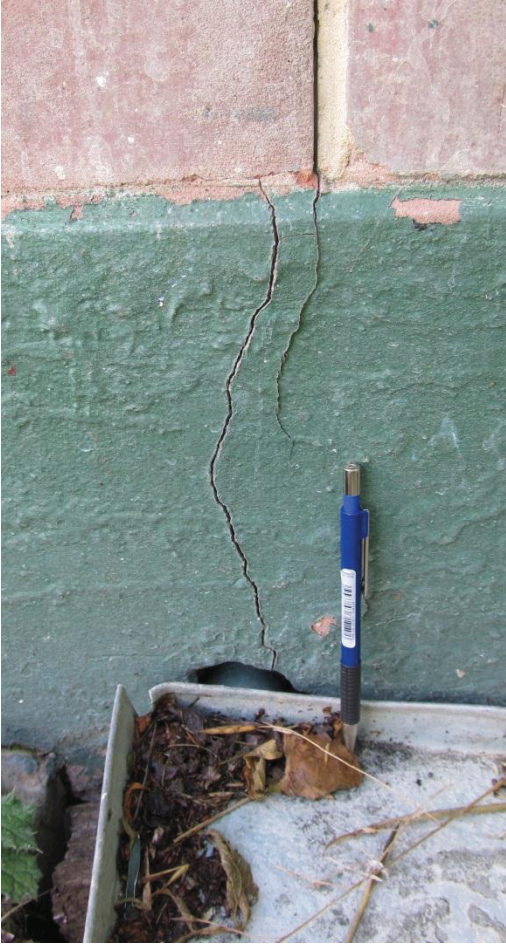
- Minor crack in concrete foundations steps up the masonry wall on the west elevation of the building. Refer to Photo 5.
- A 10mm wide crack across the footpath at the bottom of the stairs on the east elevation of the building. Refer to Photo 6.

The crack stepping up the western exterior wall may also indicate differential settlement of the building has occurred.

Photo 5: Minor cracking in the west elevation foundation. Start of “step cracking” up wall.

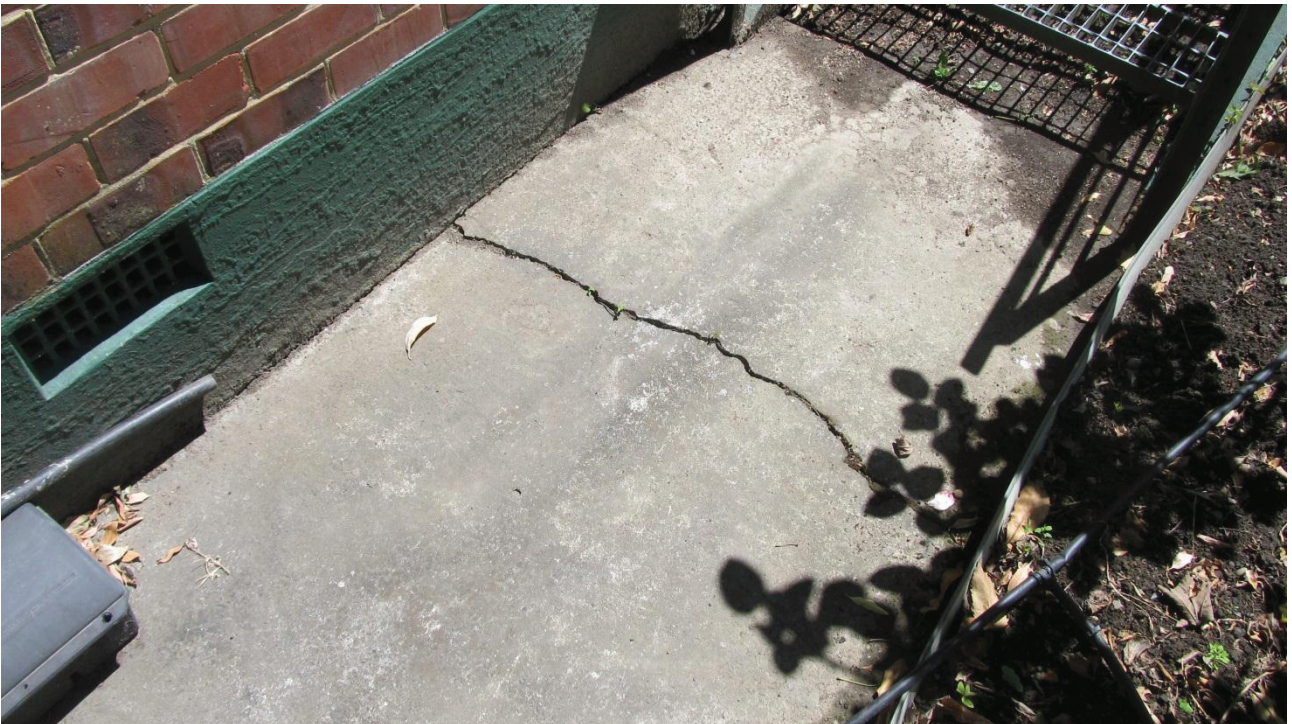
There appears to have been minor movement (0 to 10mm) of the ground illustrated by the lateral cracks that have formed on the east footpath and west foundation.

Photo 6: 10mm crack across footpath at east elevation.

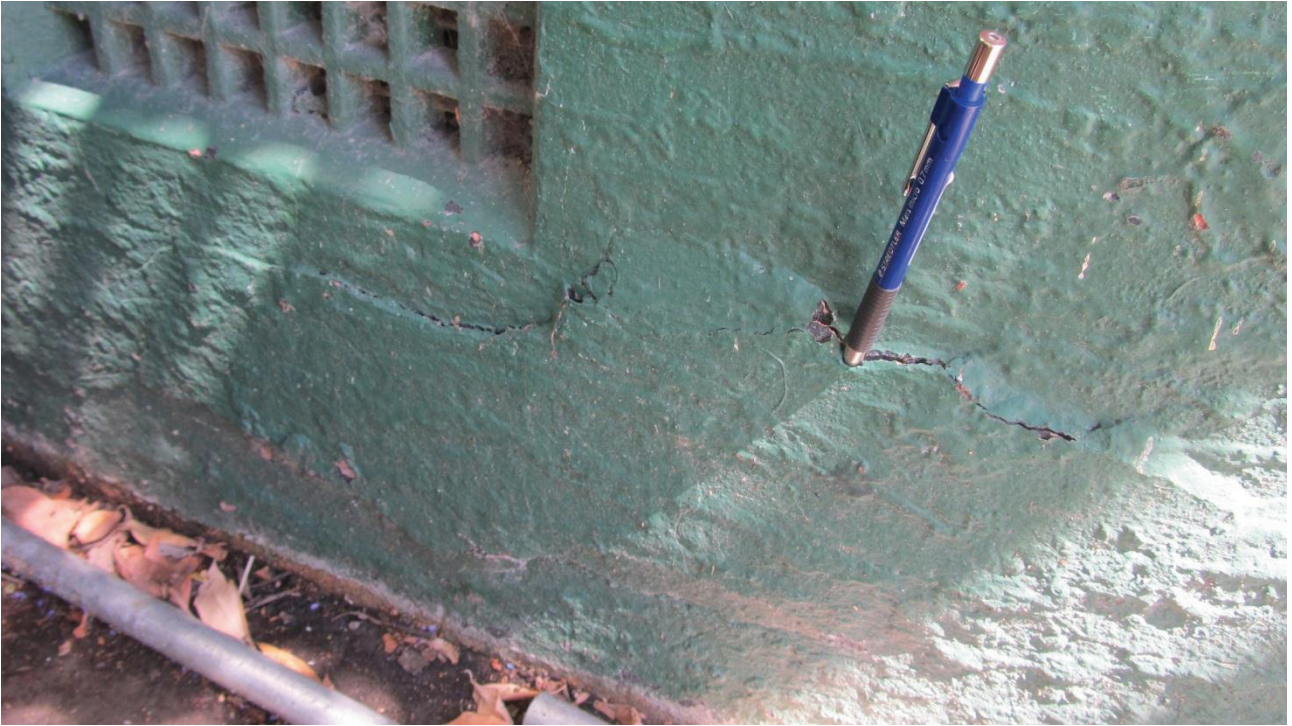
- Lateral crack in foundation on east elevation. Refer to Photo 7.
- The pavement north east of the building looks as though it has settled, but anecdotal evidence from a Club Member suggests the settlement pre dates the Canterbury Earthquake sequence.

Longitudinal cracking on the east foundation looks to be superficial, and is likely to be decorative plaster breaking off.

Photo 7: Possible superficial damage to east foundation.

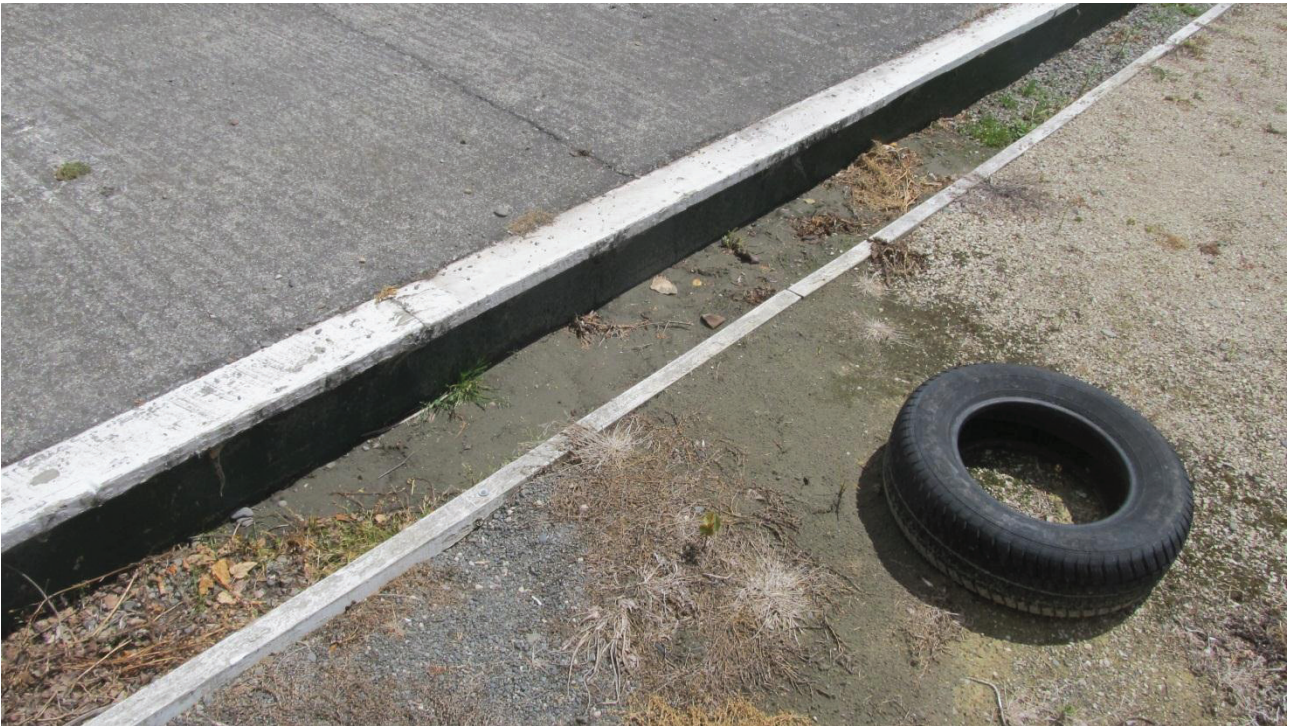
- Observations of the building indicate that there has been no differential settlement or rotation.
- An area of approximately 1m² located 20m north of the building was affected by surface rupture liquefaction. Refer to Photo 8 and site walkover plan for location.

Photo 8: Approximately 1m² of liquefaction.

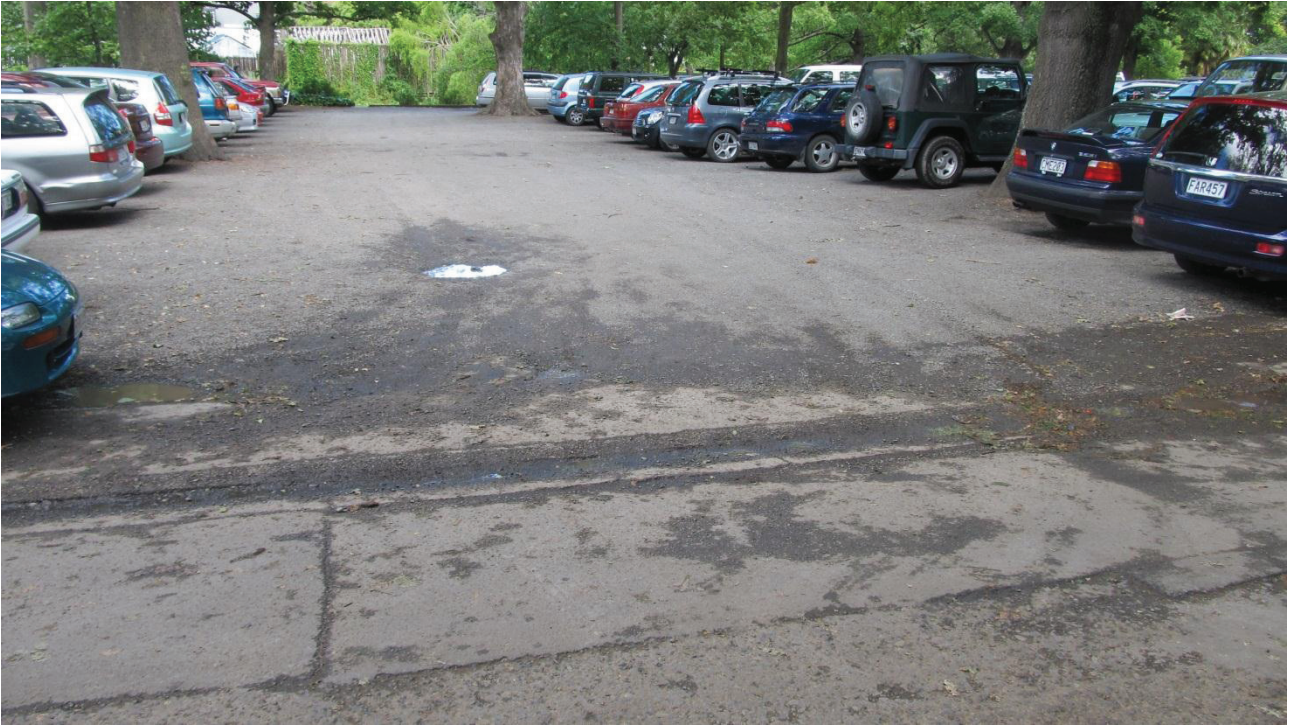
Photo 9: No evidence of cracking and heaving due to the earthquakes.

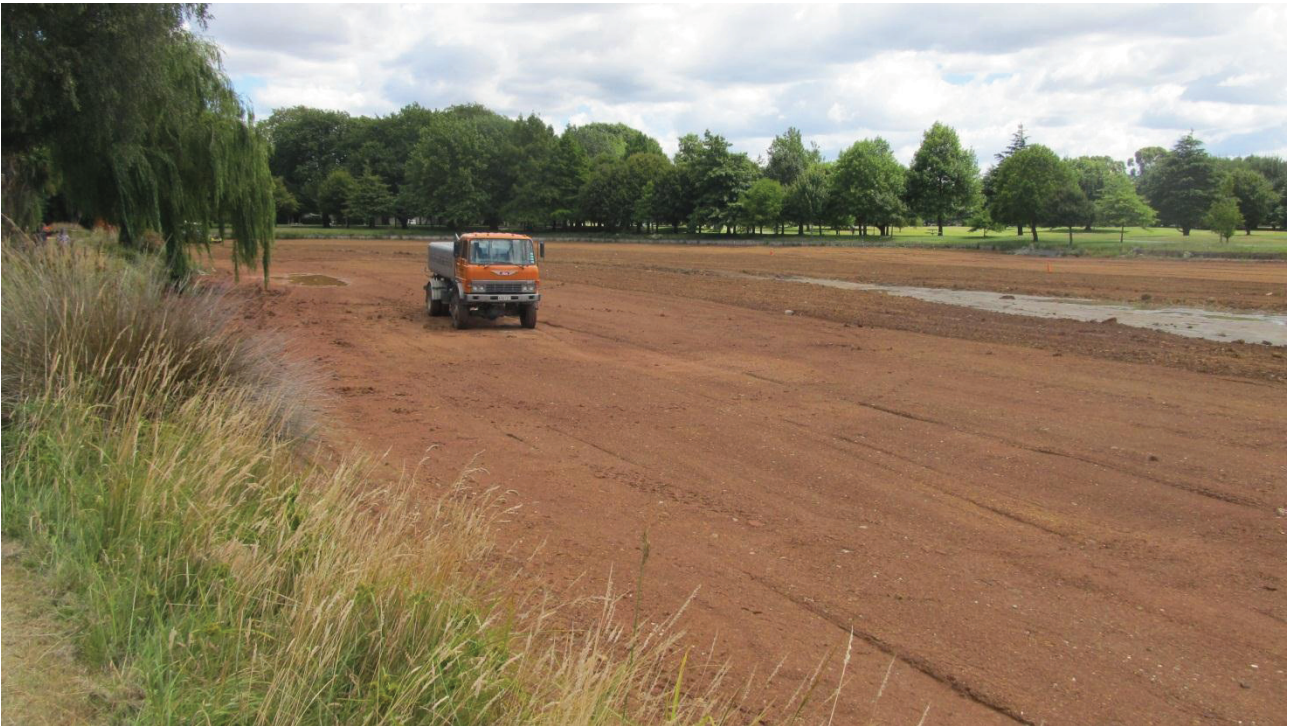
- Victoria Lake has been emptied and a new clay liner is currently being installed. It would suggest that the lakes previous liner had ruptured as a result of the Earthquakes. Refer to Photo 10.

Photo 10: New liner in Victoria Lake.

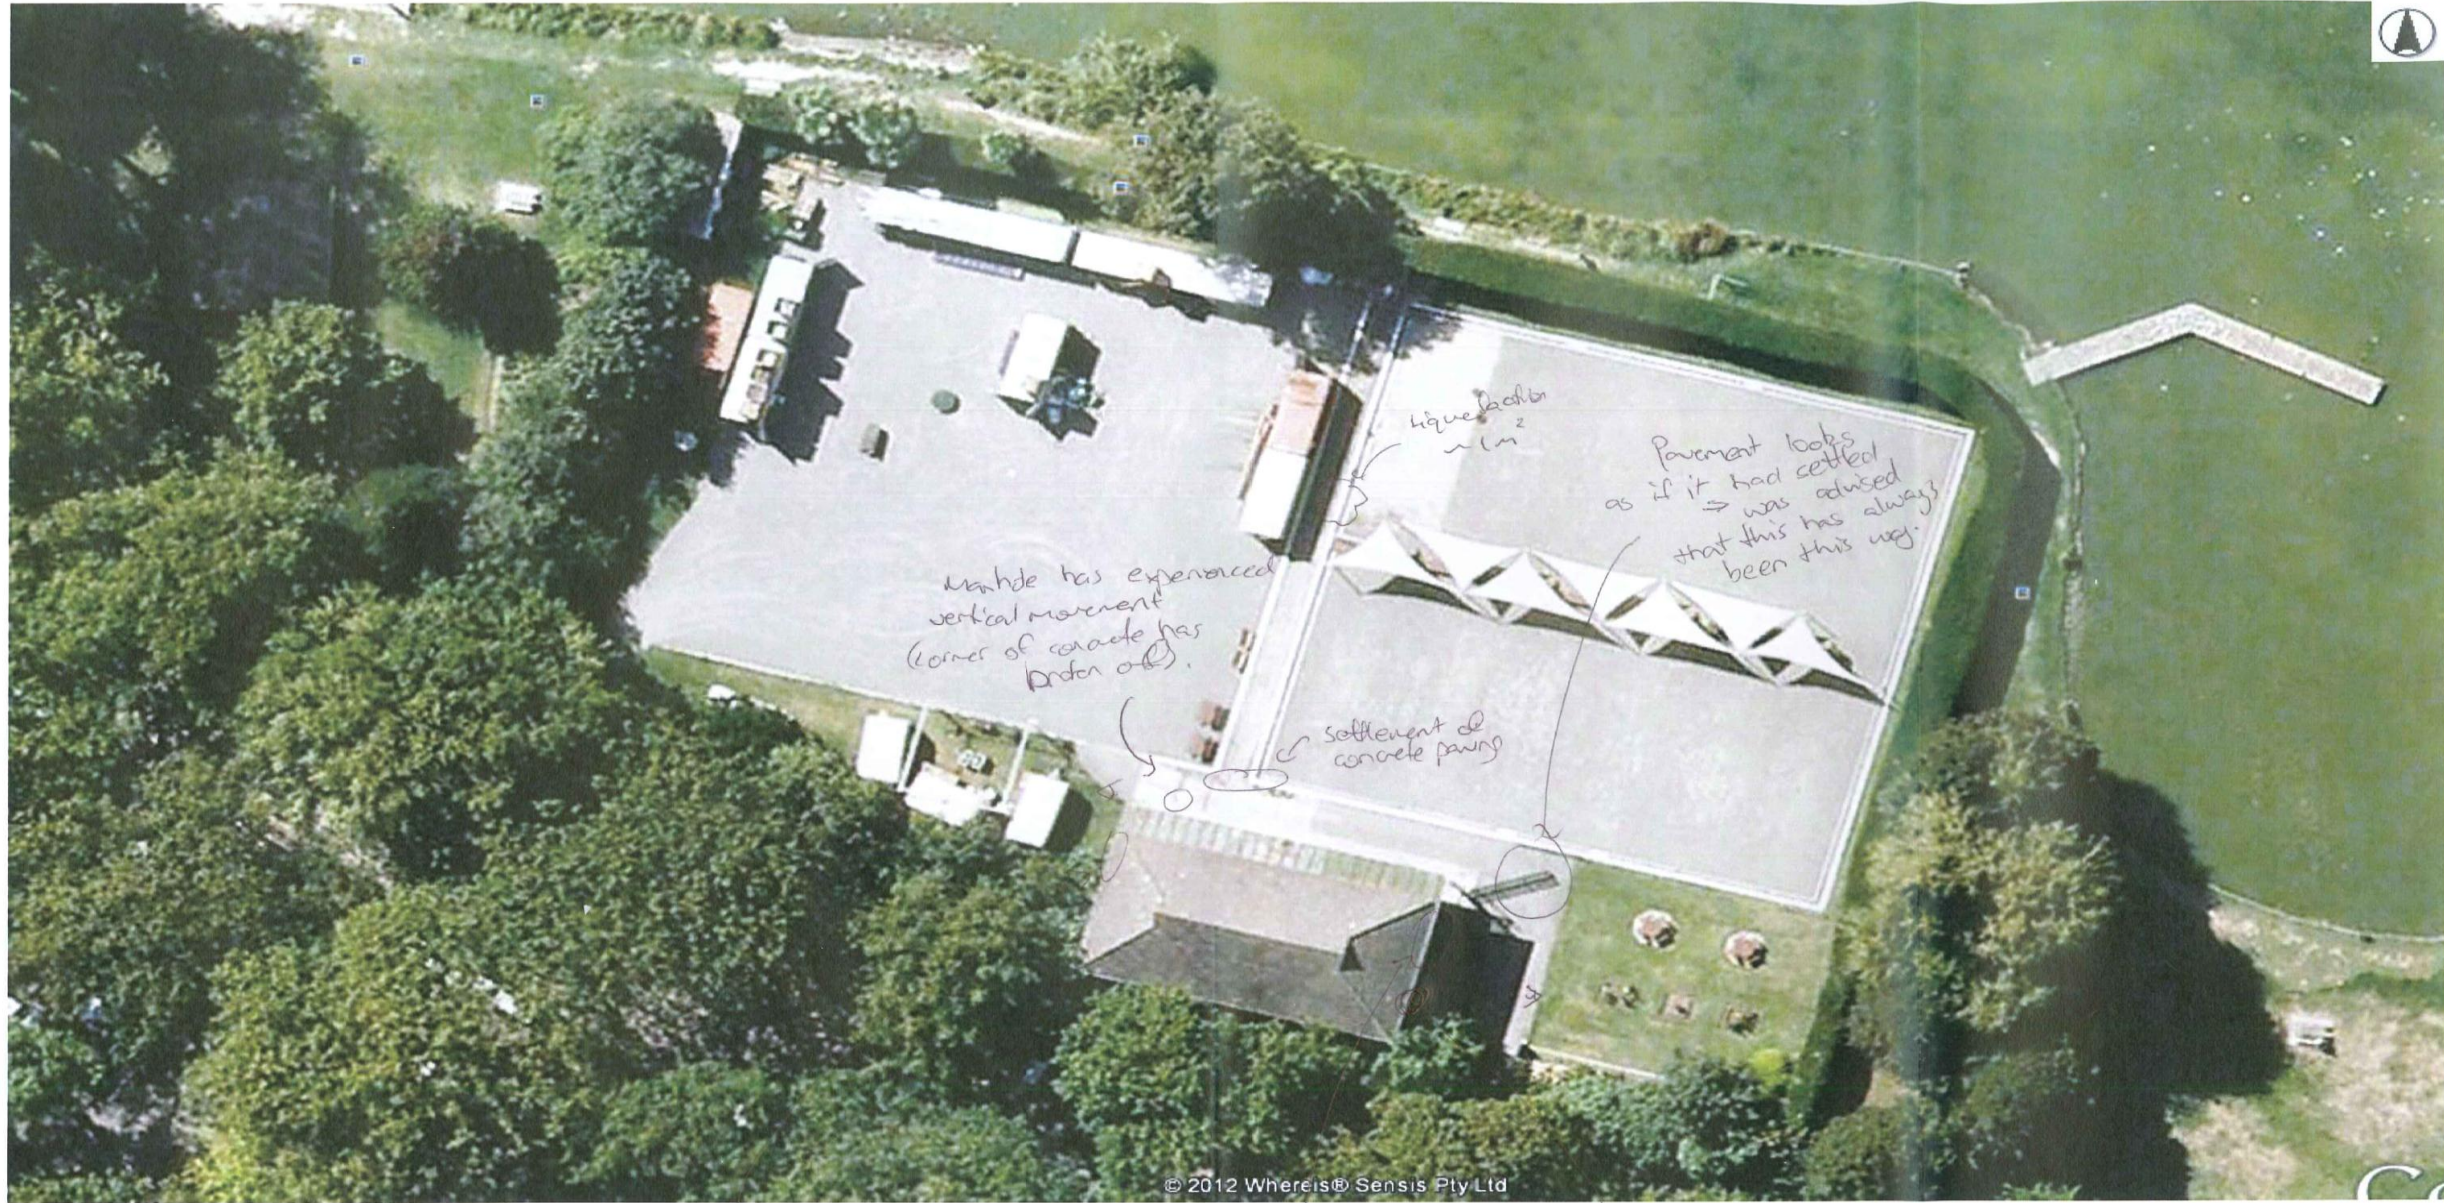
1mm vertical crack in foundation that proceeds up the wall at 45°

transverse crack in footpath - possible uplift.
