Hagley Park North Rugby Club Toilet Shelter

PRK 1190 BLDG 002

Detailed Engineering Evaluation

Quantitative Assessment Report

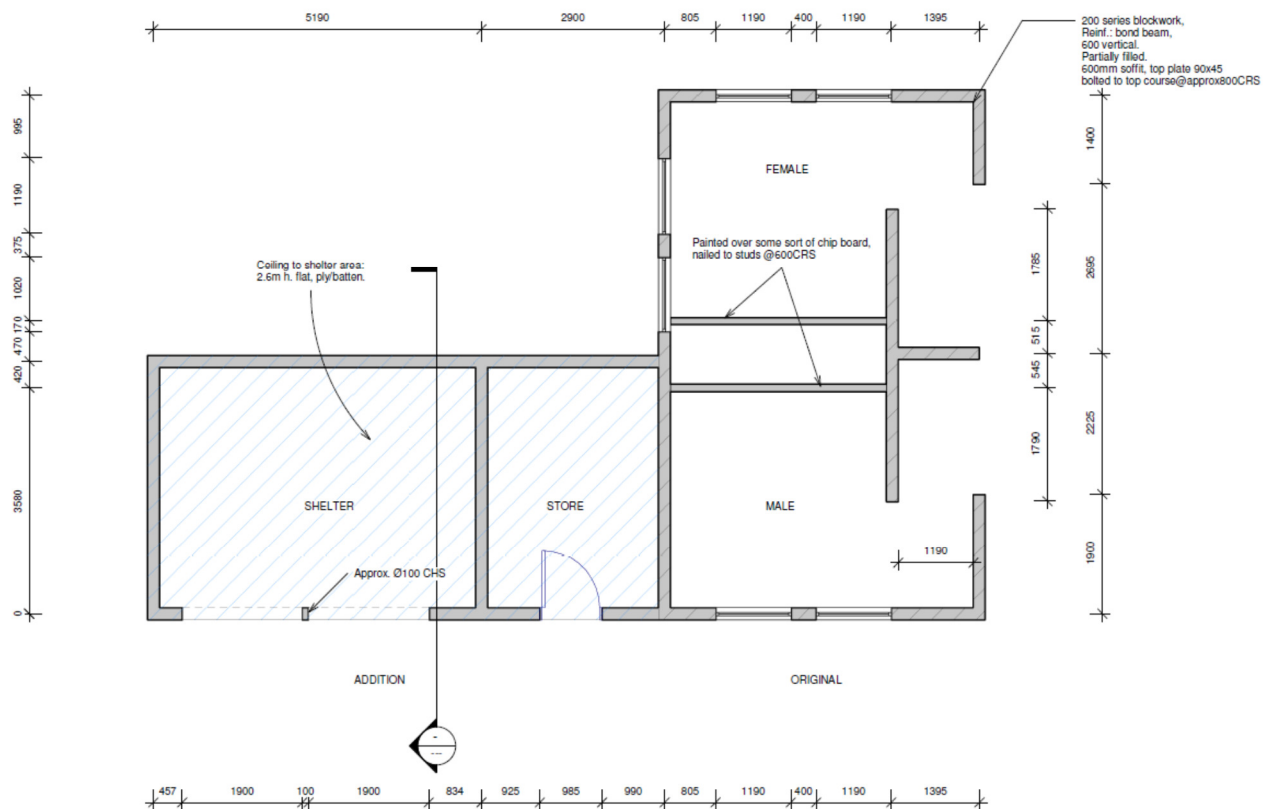
Figure 2: Wall plan of the toilets.

The building is approximately 13m long in the east-west direction and 8.2m wide in the north-south direction. The apex of the roof is approximately 3.6m from the ground with a wall height of approximately 2.6m. The building consists of a male bathroom at the south east corner, a female bathroom at the north east corner, and store and shelter rooms at the western end of the building.

Lateral restraint of the building is provided by the shear capacity of the reinforced concrete masonry walls.

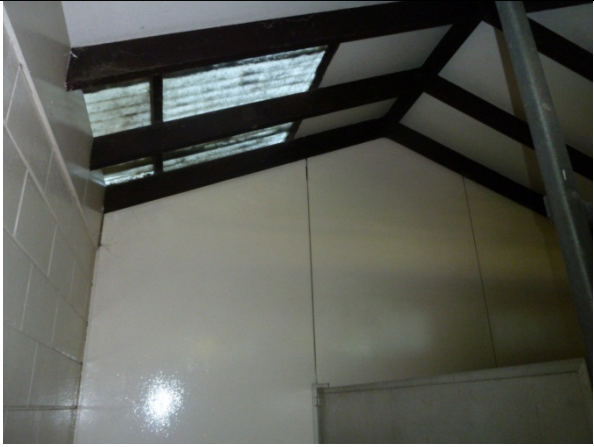
4.	View of a timber framed divider wall between the male and female toilets

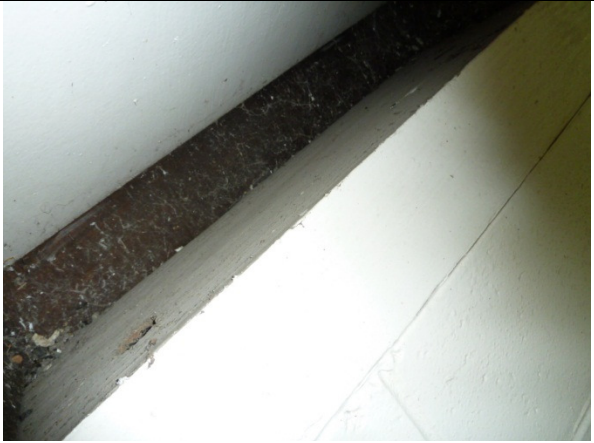
5.	View of the bolted connection between wall top plate and roof

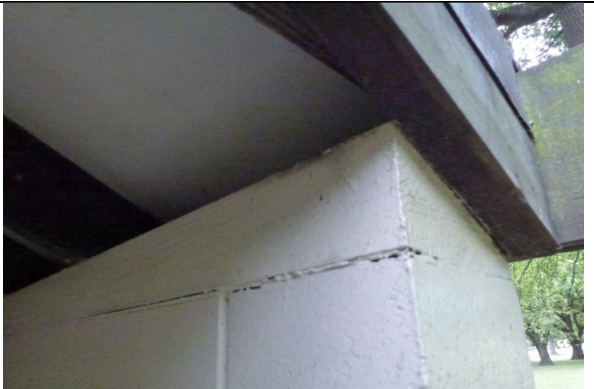
Overall the building has performed well under seismic conditions. The building has sustained only minor seismic damage such as step cracking along mortar joints, gaps opening up between the masonry wall and timber ceiling elements and cracking in timber doorframe of storage area.

6.	Gap between masonry wall and timber block directly under ceiling
