North Hagley Park Toilets
PRK 1190 BLDG 007 EQ2
Detailed Engineering Evaluation
Quantitative Report
Christchurch City Council

Detailed Engineering Evaluation Quantitative Report

Date: October 2012 Reference: 6-QUCC1.31

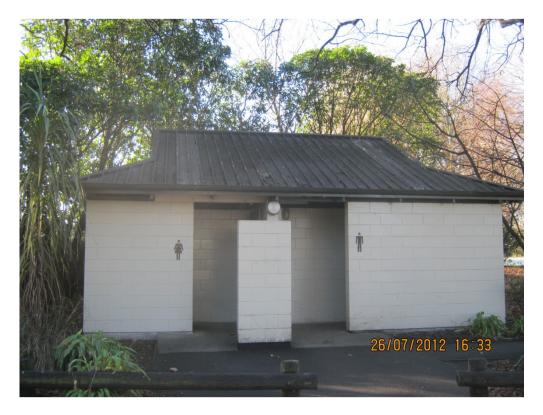
Photo 1: The north wall of the building

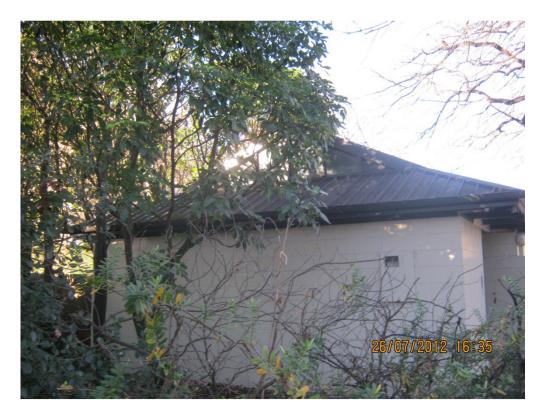
Photo 2: The east wall of the building

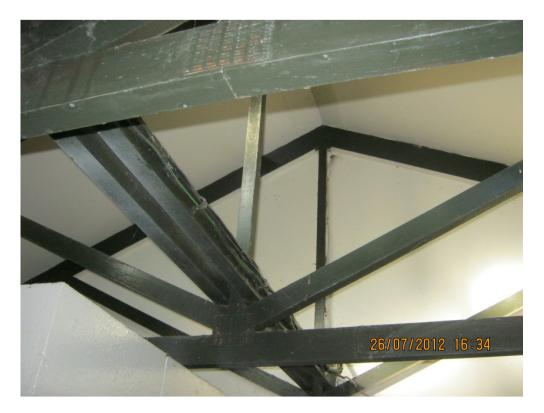
Photo 3: View of the roof truss

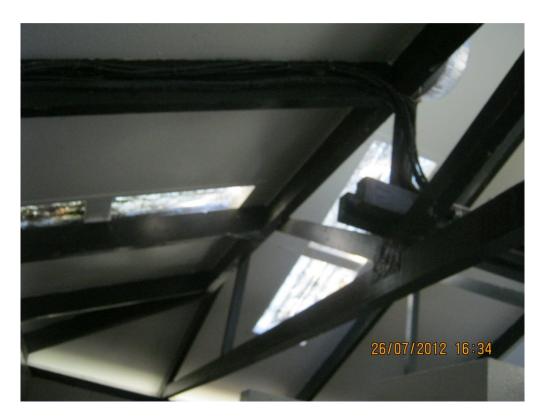
Photo 4: View of the roof of the east/west side joining to the main trusses
