Hagley Park South Implement Shed
PRK 1507 BLDG 020 EQ2
Detailed Engineering Evaluation
Quantitative Report
Christchurch City Council

Detailed Engineering Evaluation Quantitative Report

Date: September 2012

Reference: 6-QUCC1.05

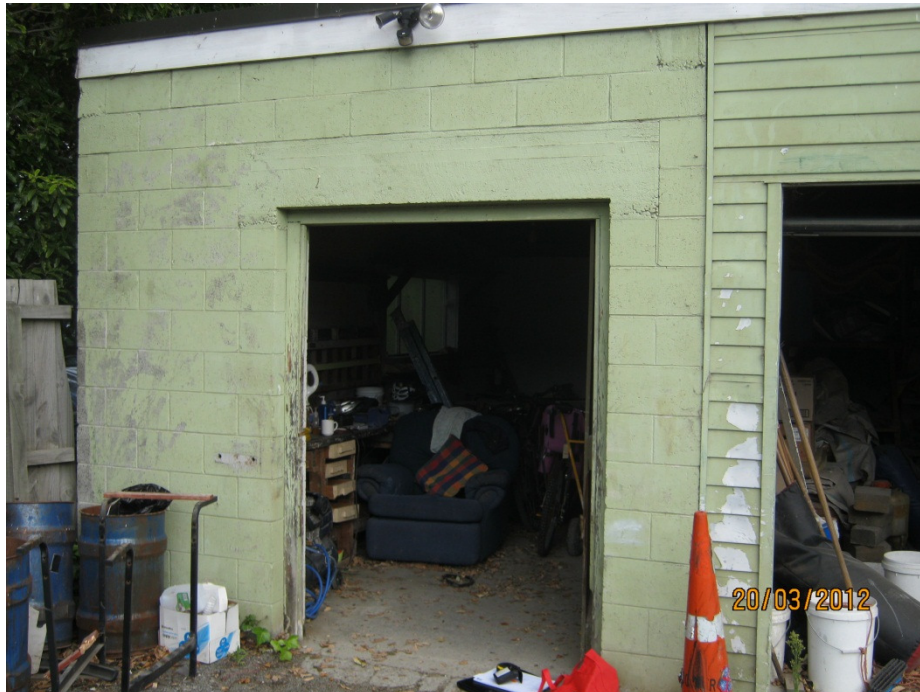
Seismic loads in both principal directions are resisted by the unreinforced masonry walls. The front wall with a capacity of only 14% NBS is a critical structural weakness. Failure of this front wall would cause collapse of the roof and walls along the front of the building. There is no alternative load path for seismic lateral forces due to the lack of a roof level diaphragm or roof bracing.

Photo 1: North elevation of the Implement Shed

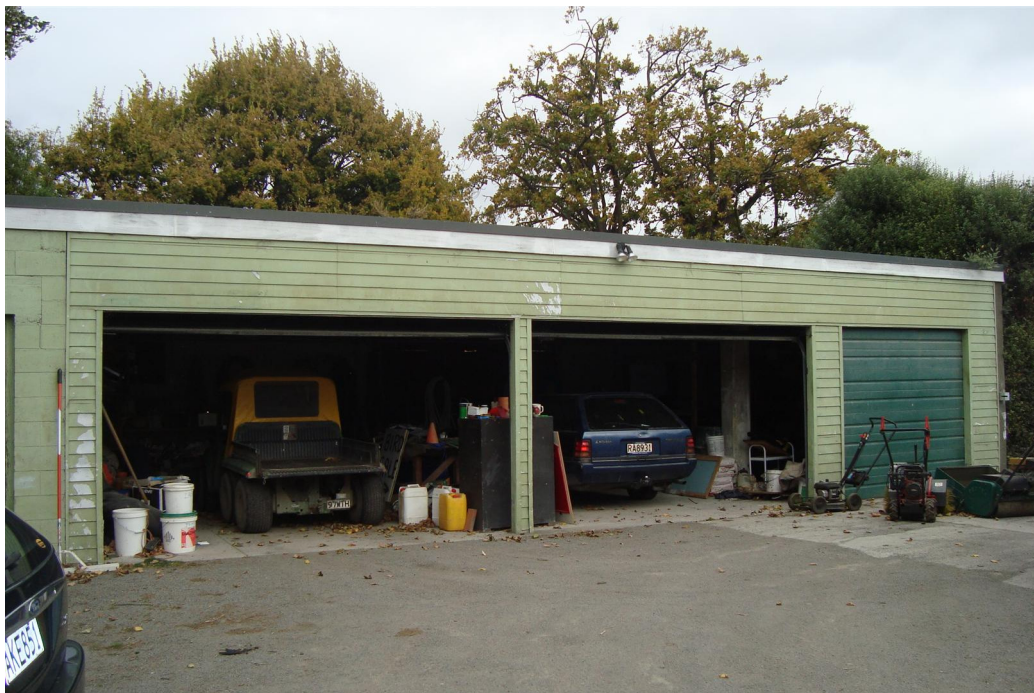
Photo 2: North elevation of the Implement Shed

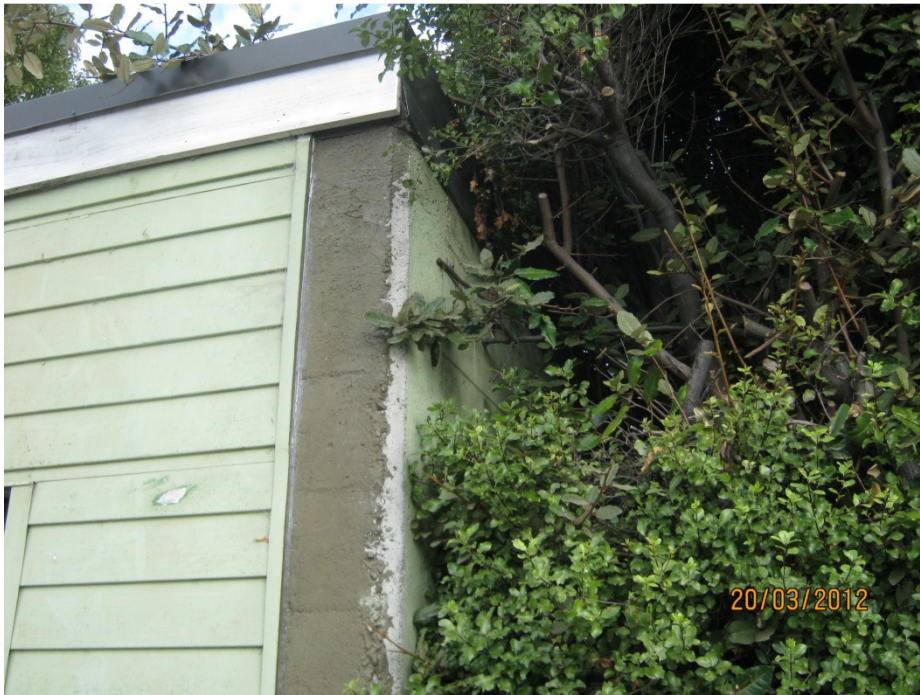
Photo 3: North-west corner of the Implement Shed

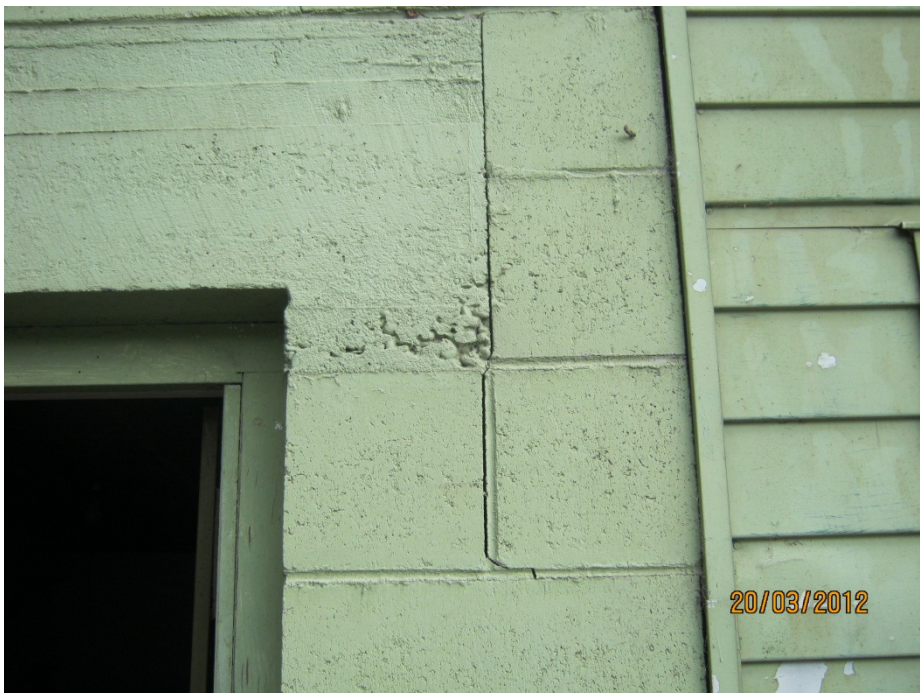
The Implement Shed front wall has a crack, approximately 5mm thick, at the end of the concrete lintel which is likely a result of the recent earthquake events. All other damage is minor and appears to be age related.

Photo 4: Crack at edge of concrete lintel

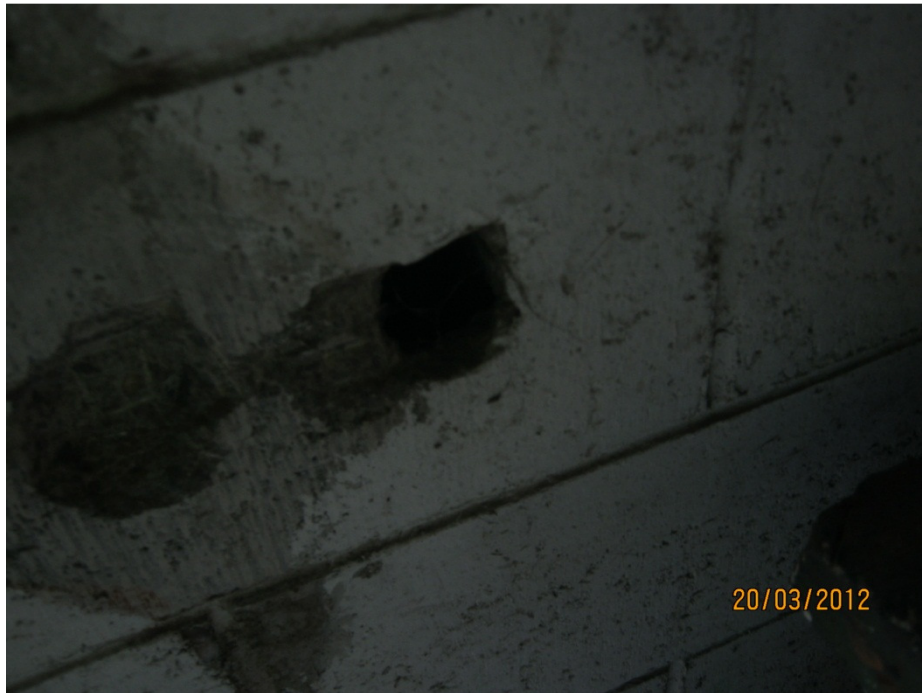
The cover-meter survey found that there was no reinforcement in the masonry, and it appears to be ungrouted.

Photo 5: Existing hole in block wall – ungrouted

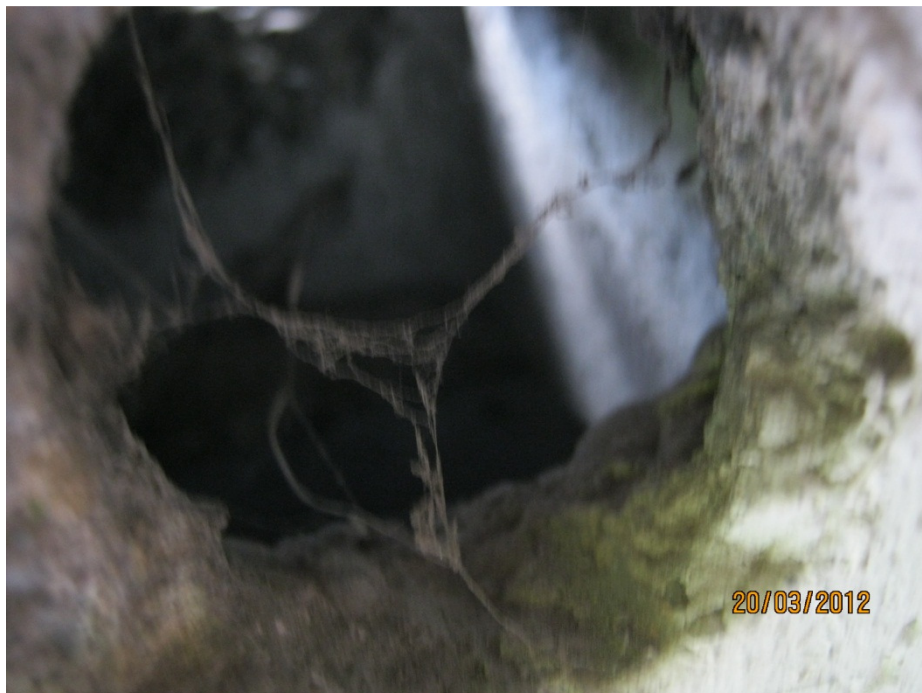
Photo 6: Existing hole in block wall – ungrouted (close-up)

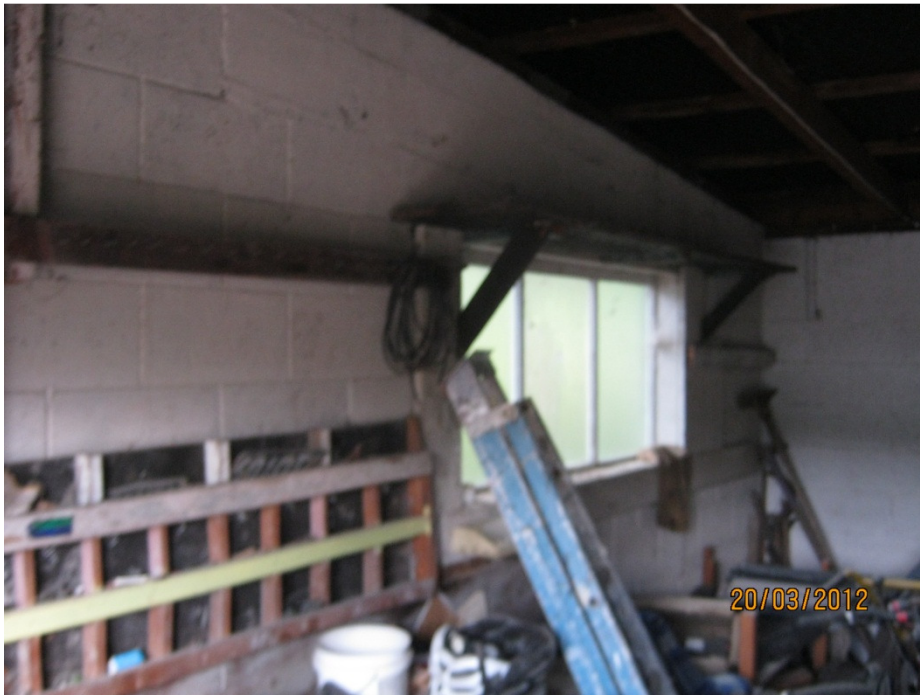
Photo 7: Interior of Implement Shed

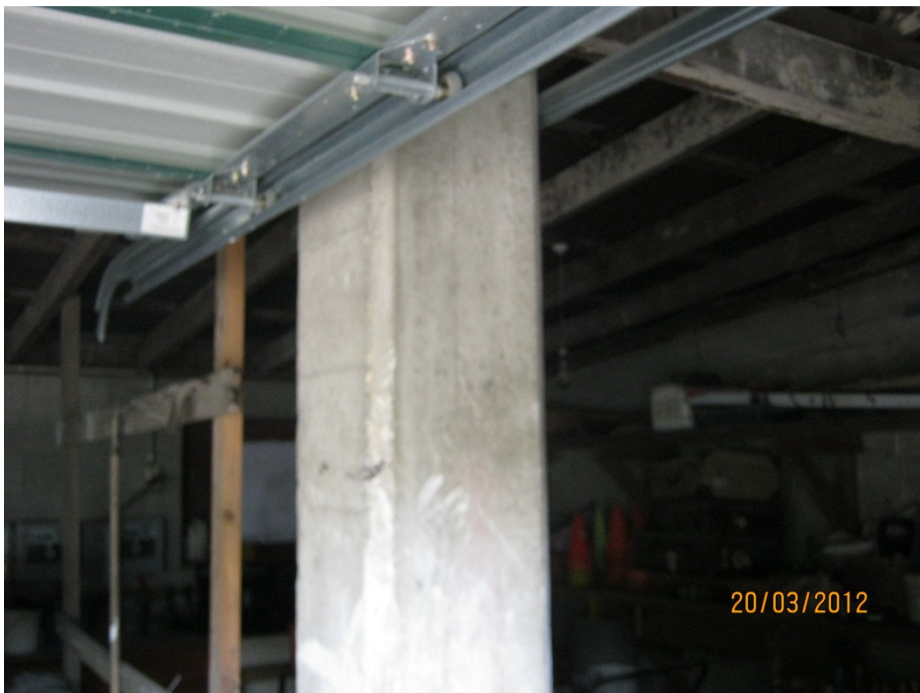
Photo 8: Interior concrete column beside roller doors

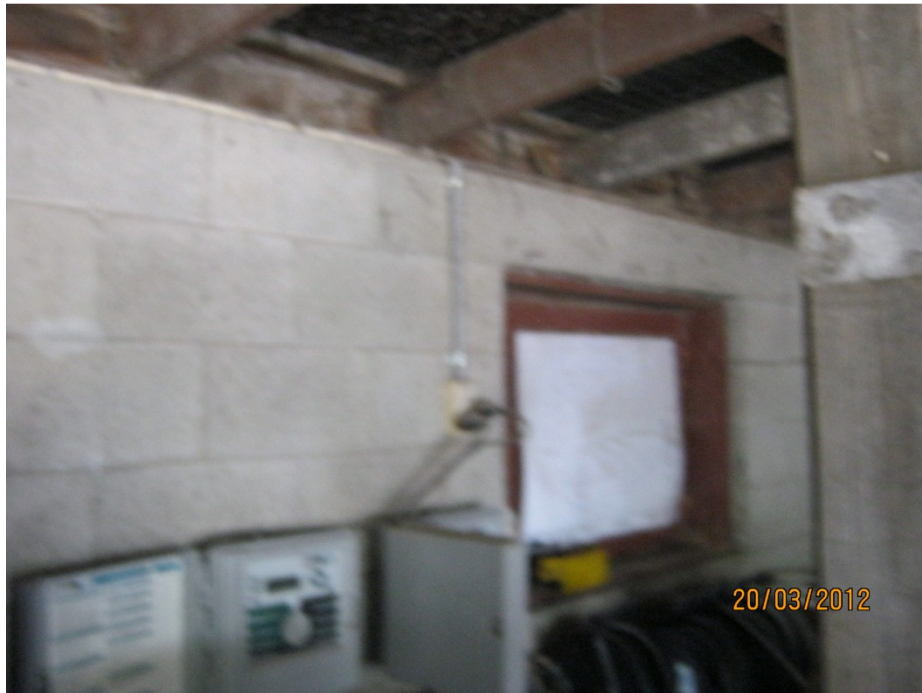
Photo 9: Roof supports of Implement Shed

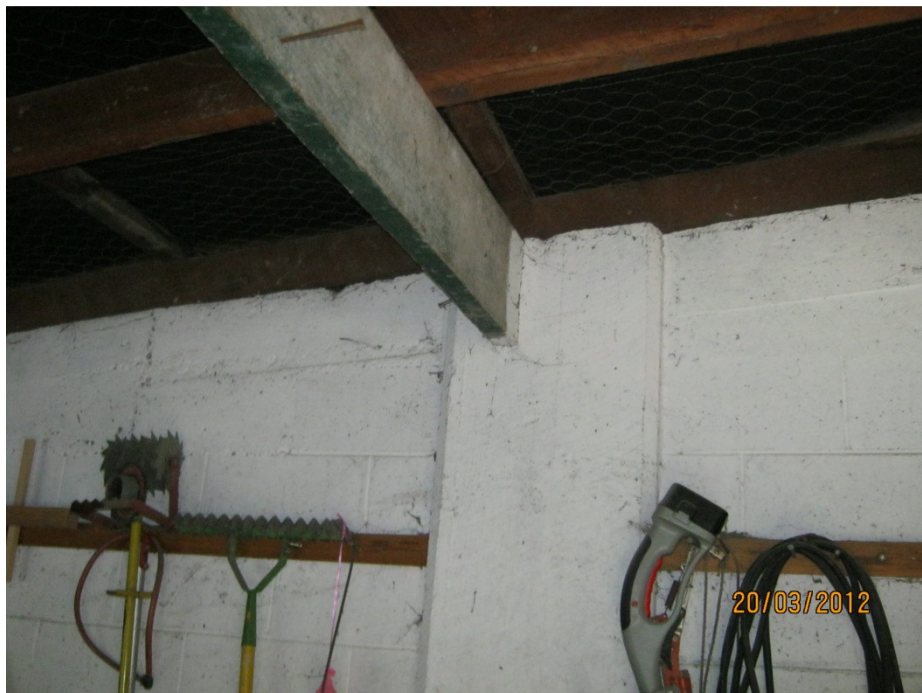
Photo 10: Roof framing of Implement Shed
