PRK_1507_BLDG_013 EQ2

South Hagley – Netball Toilets

Hagley Park, Christchurch Central

QUALITATIVE ASSESSMENT REPORT

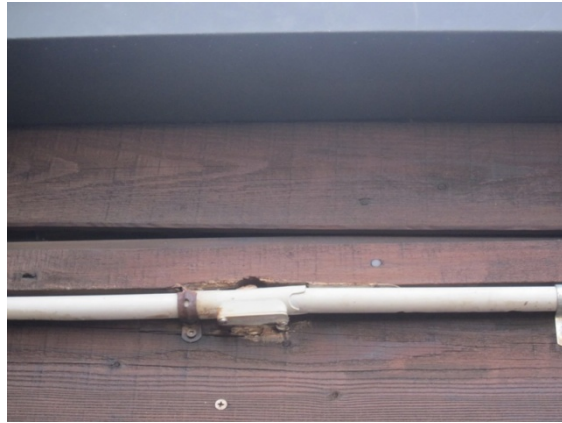
Photo 5: Existing damage to timber at cable level on north wall.

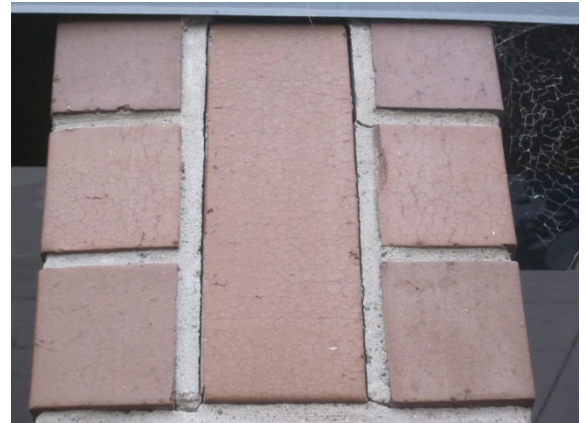
- 1) Gaps opening up between bricks and mortar at the top of the column in the centre of the north wall.
- 2) Cracking in a glass panel in the dome in the centre of the roof.
- 3) Cracking in the timber beam at roof level on the southwest corner.
- 4) Cracking in a wall tile in the entrance to the female toilets was noted, but due to the localised damage, it is not believed to be earthquake-related, but due to impact load on the door connection anchored to the concrete wall directly behind the tile.

Photo 6: Gaps opening up between masonry and bricks at the top of the column on the north wall.

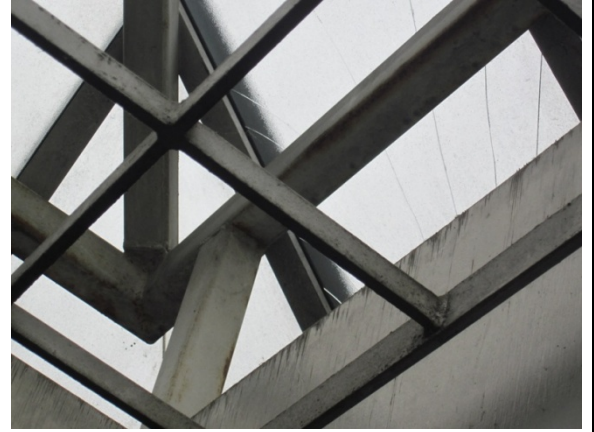
Photo 14: Cracked glass panel on west side of dome.

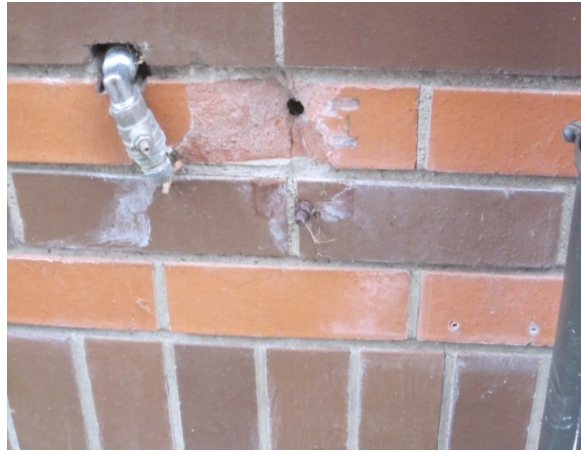
Photo 17: Existing damage to brickwork on west wall.

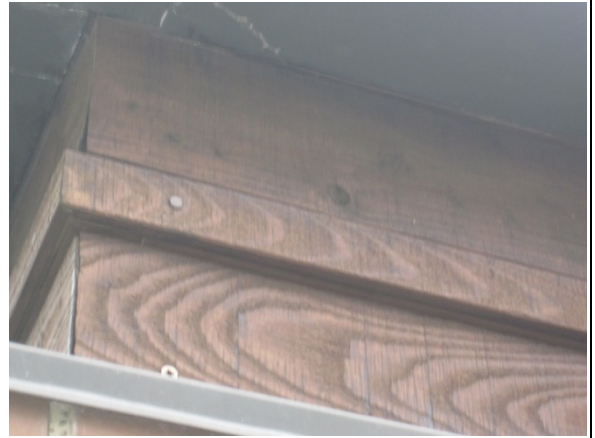
Photo 18: Crack in timber beam at roof level on southwest corner.

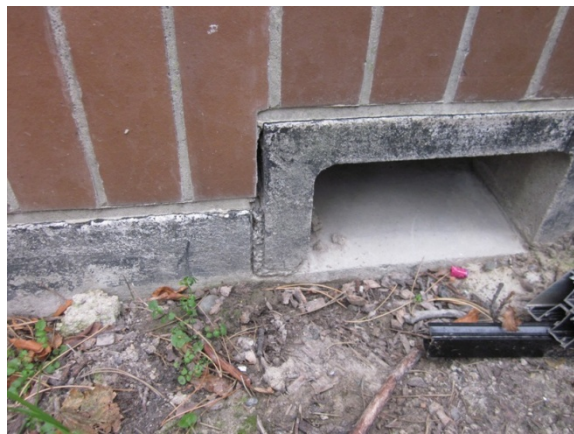
Photo 19: Existing mortar removal on south wall.

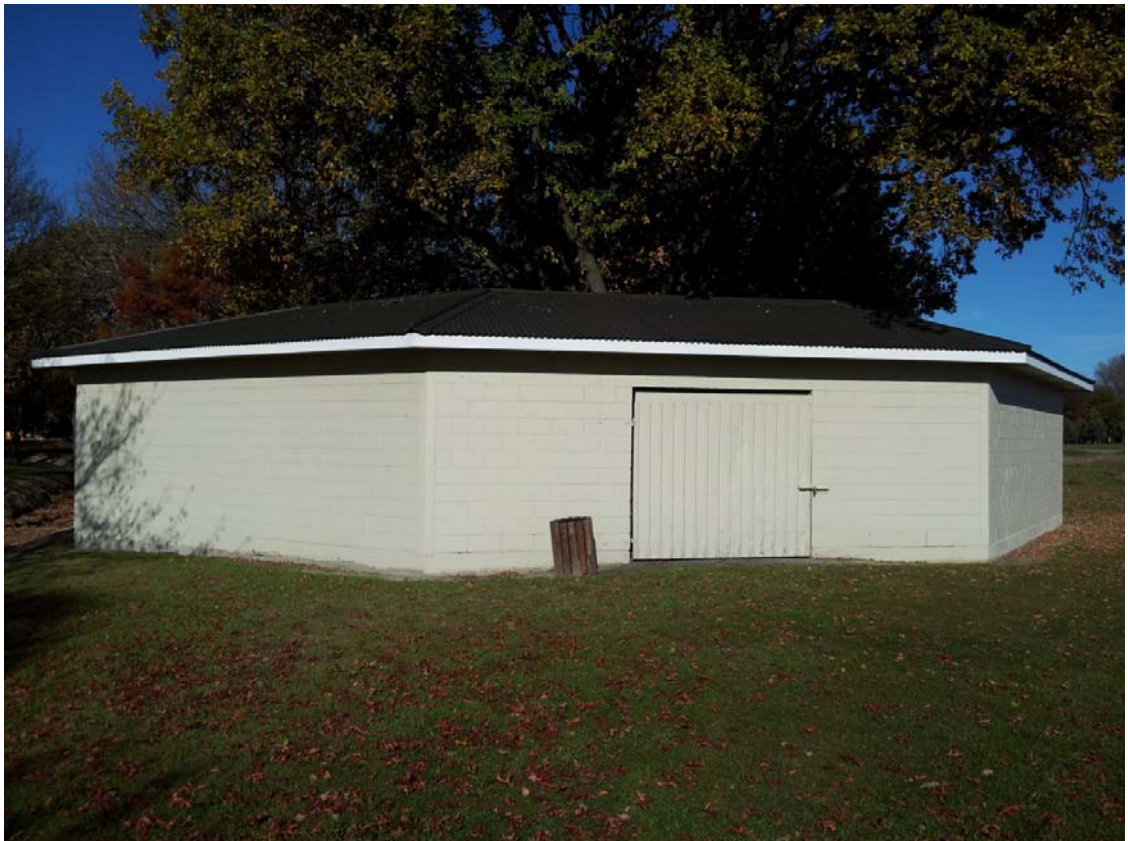
■ **Figure 7 Overview of structures – Pavilion**

The Pavilion was noted to be a masonry block building with sheet metal roof, slab on grade foundations. From the external inspection, cracking and spalling in concrete footing under masonry walls was observed on the west side of the building. Minor cracking in external concrete ground slab was also noted.

Some patches in grass were observed to the west of the building which may be evidence of liquefied material being ejected to the surface. No apparent land damage was observed on the site.

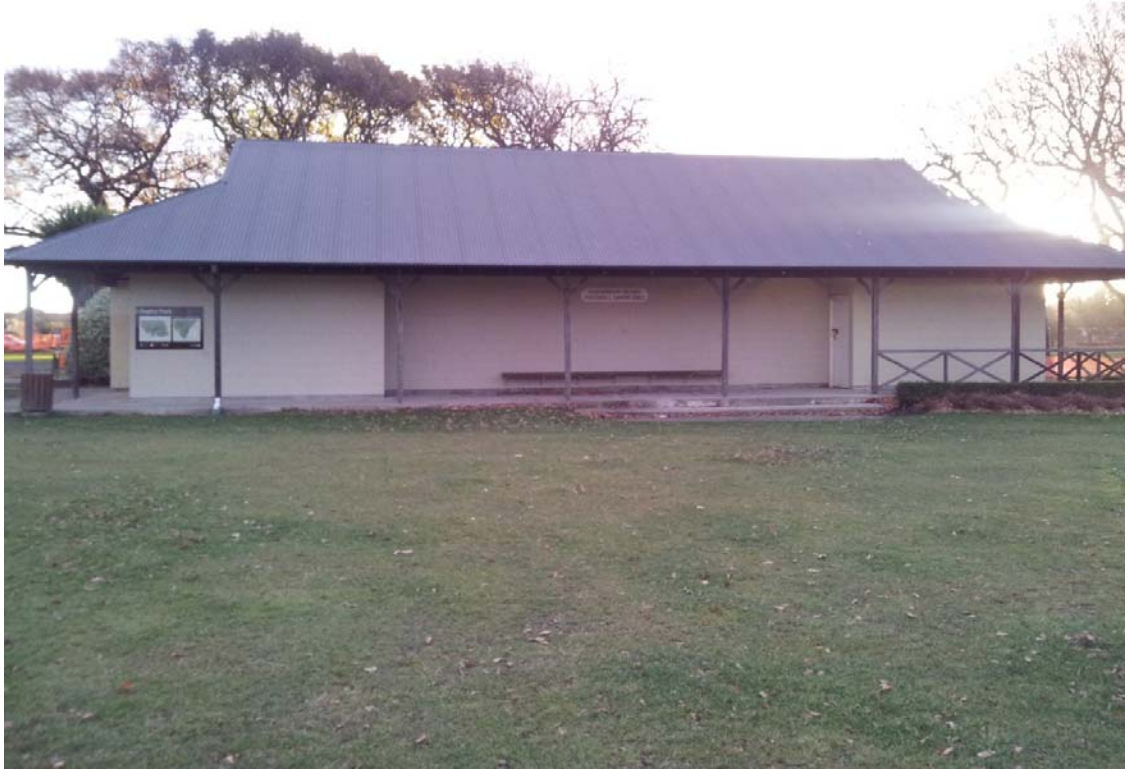
■ **Figure 10 Overview of structures – Rugby toilets**

The building was observed to be a masonry block building with sheet metal roof, slab on grade foundations. Some minor cracks in the masonry wall and external concrete slab were observed during the external inspection of the site. There was no evidence of surface expression of liquefaction or any land damage around the site.
