CHRISTCHURCH CITY COUNCIL
PRK_1507_BLDG_001 EQ2
South Hagley - Pavilion/Shelter (Polo)
Hagley Park, Christchurch Central

QUALITATIVE ASSESSMENT REPORT
FINAL

- Rev C
- 27 February 2013

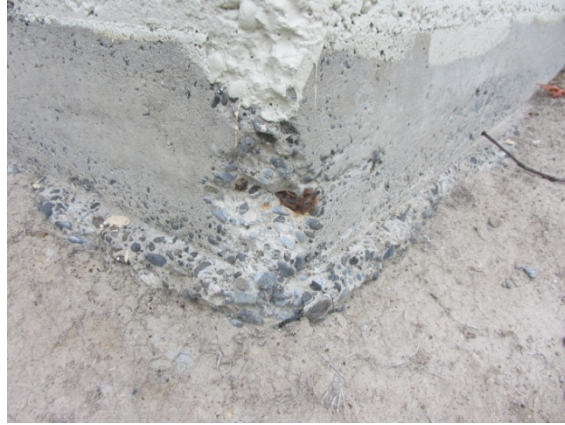
Photo 5: Existing impact damage to concrete footing on northwest corner, with rusted footing reinforcing exposed.

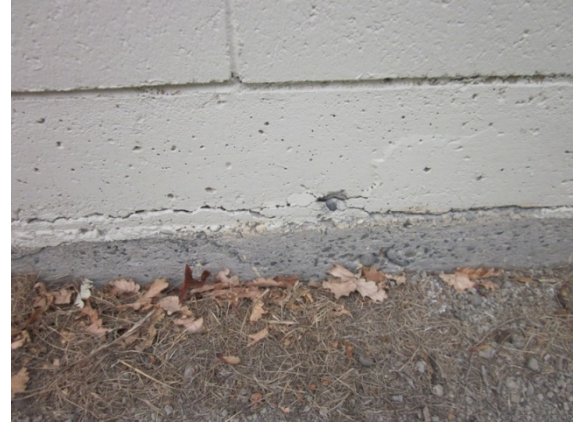
Photo 6: Hairline crack in concrete footing under west wall (typical).

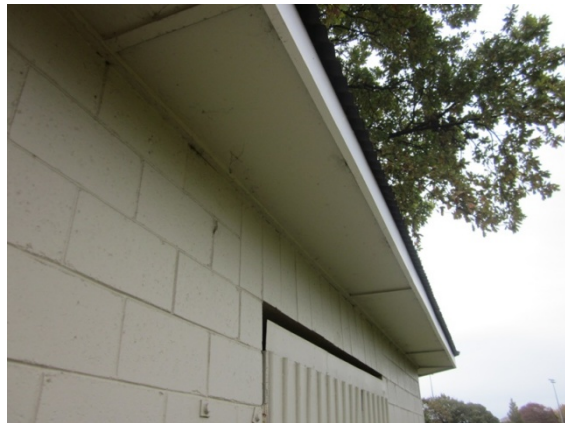
Photo 7: Soffit on west side.

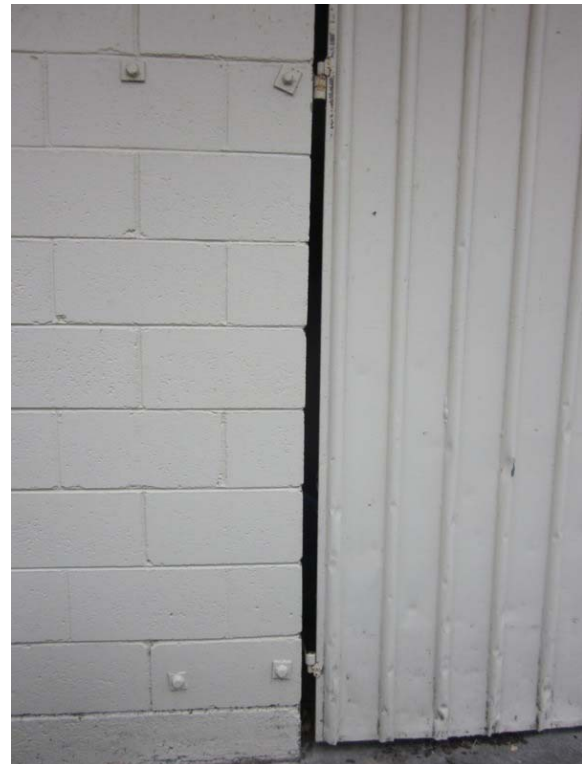
Photo 8: Door connection on west wall. Bolts through masonry wall visible.

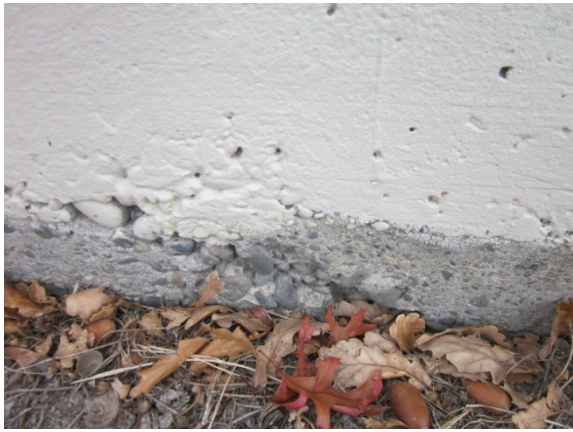
<p>Photo 9: Crack in external concrete ground slab on west side.</p>	<p>Photo 10: Hairline crack in concrete footing under masonry wall.</p>

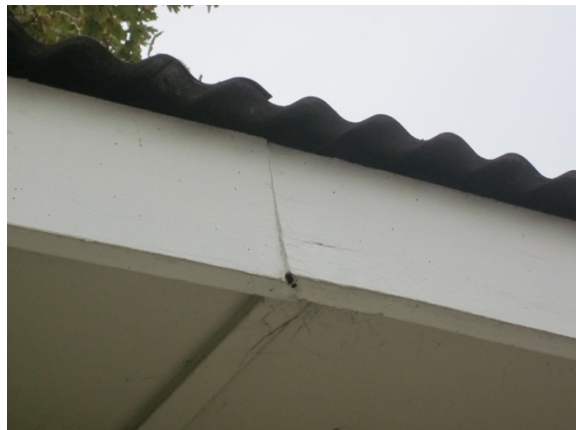
Photo 14: External roof cladding.

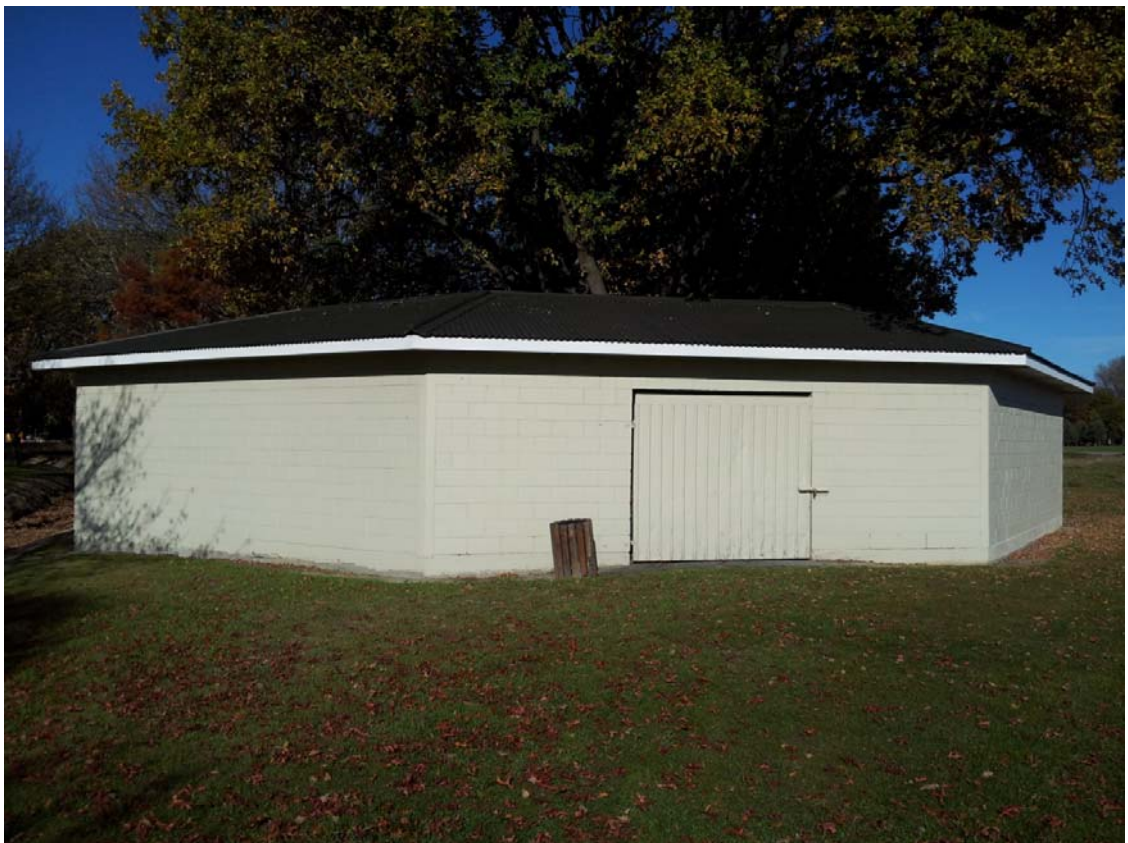
■ **Figure 7 Overview of structures – Pavilion**

The Pavilion was noted to be a masonry block building with sheet metal roof, slab on grade foundations. From the external inspection, cracking and spalling in concrete footing under masonry walls was observed on the west side of the building. Minor cracking in external concrete ground slab was also noted.

Some patches in grass were observed to the west of the building which may be evidence of liquefied material being ejected to the surface. No apparent land damage was observed on the site.

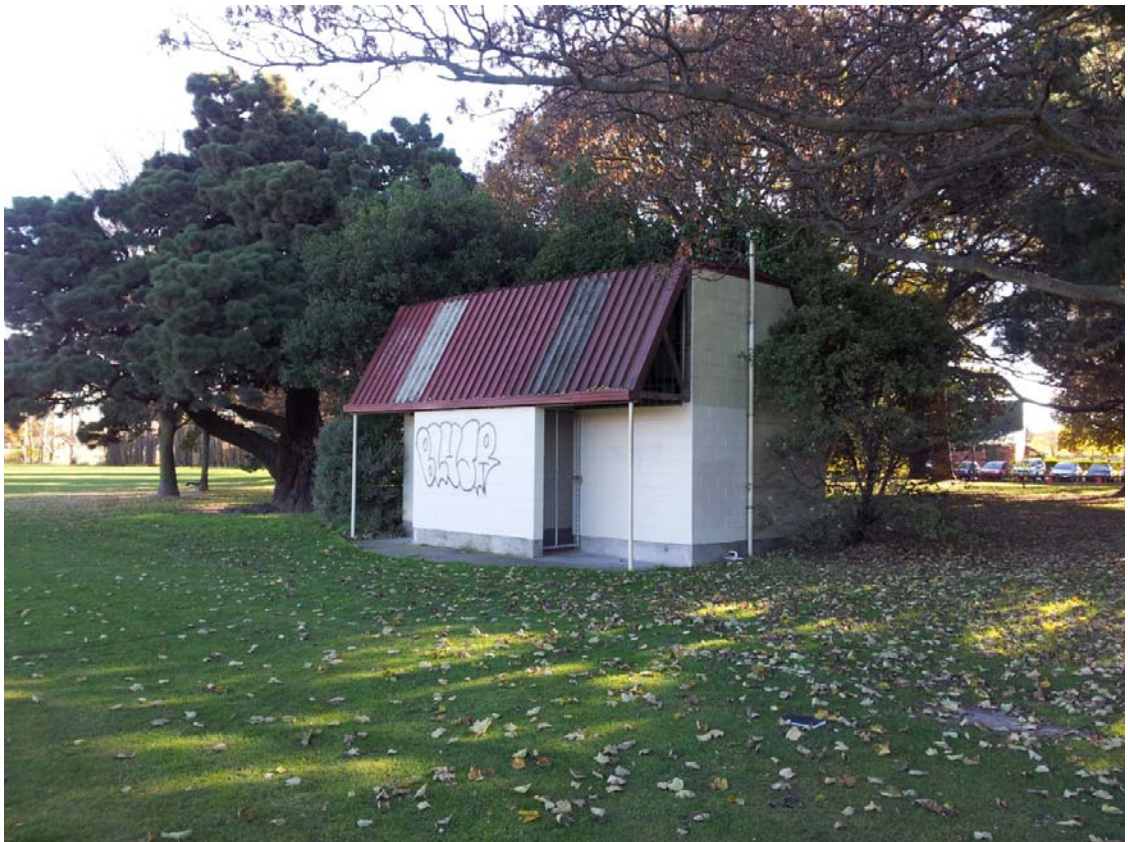
■ Figure 8 Overview of structures – Hospital toilet

The building was a masonry block construction with sheet metal roof and timber frames. The ground floor appeared to be supported on slab on grade foundation. Cracking and spalling of concrete footing was noted on the south east corner and some cracks were observed in external concrete ground slab.

No evidence of land damage was visible during the external inspection; however, the patchy grass present to the south of the building suggests that some liquefied material was ejected at surface due to the 22 February earthquake.

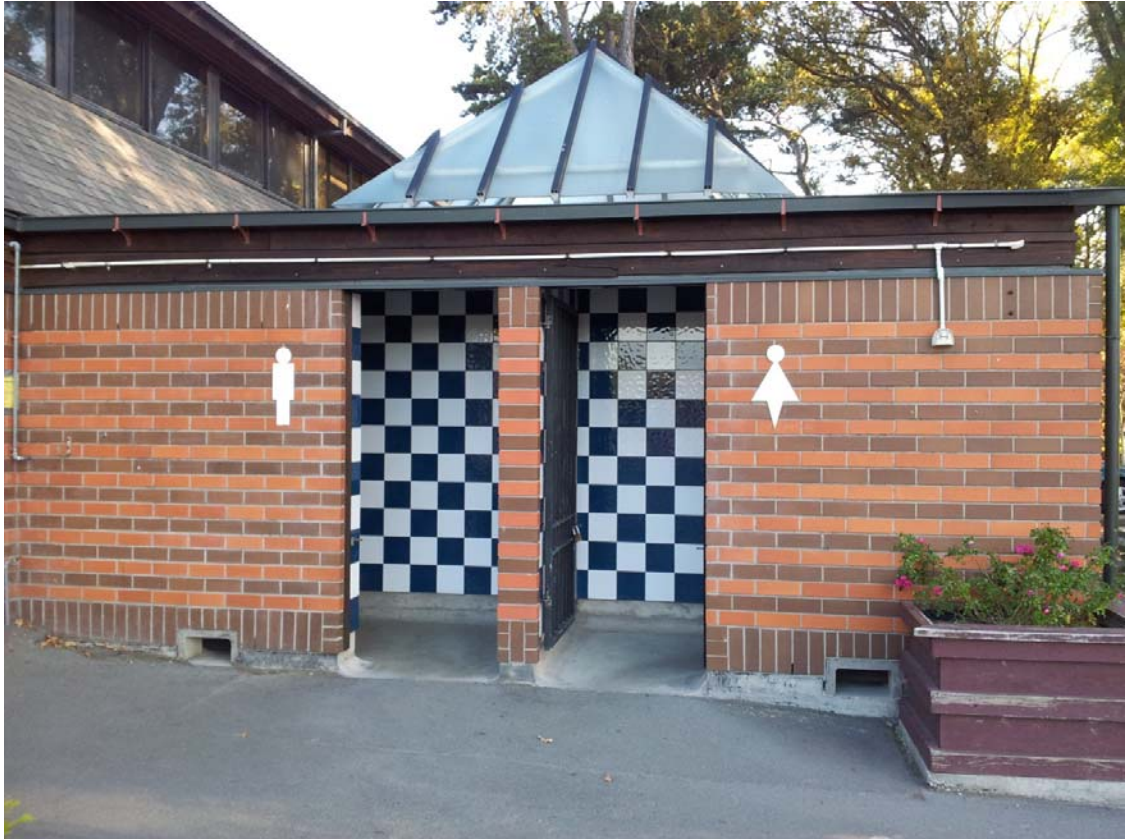
■ **Figure 9 Overview of structures – Netball toilets**

The toilet block was observed to comprise concrete walls with brick cladding and a timber-framed ceiling. The foundation was noted to be a slab on grade foundation and the roof appeared to be lightweight construction with a glazed skylight in the centre. The toilet block appeared to be attached to the Christchurch Netball Centre building. There were some gaps in the mortar between bricks at the footing and at the top of the wall.

Resealed patches were observed on the nearby netball courts, likely as a result of services being broken underneath. Surface cracks were also noted which had been sealed with resin. No evidence of liquefaction or land damage was visible during the external site inspection.

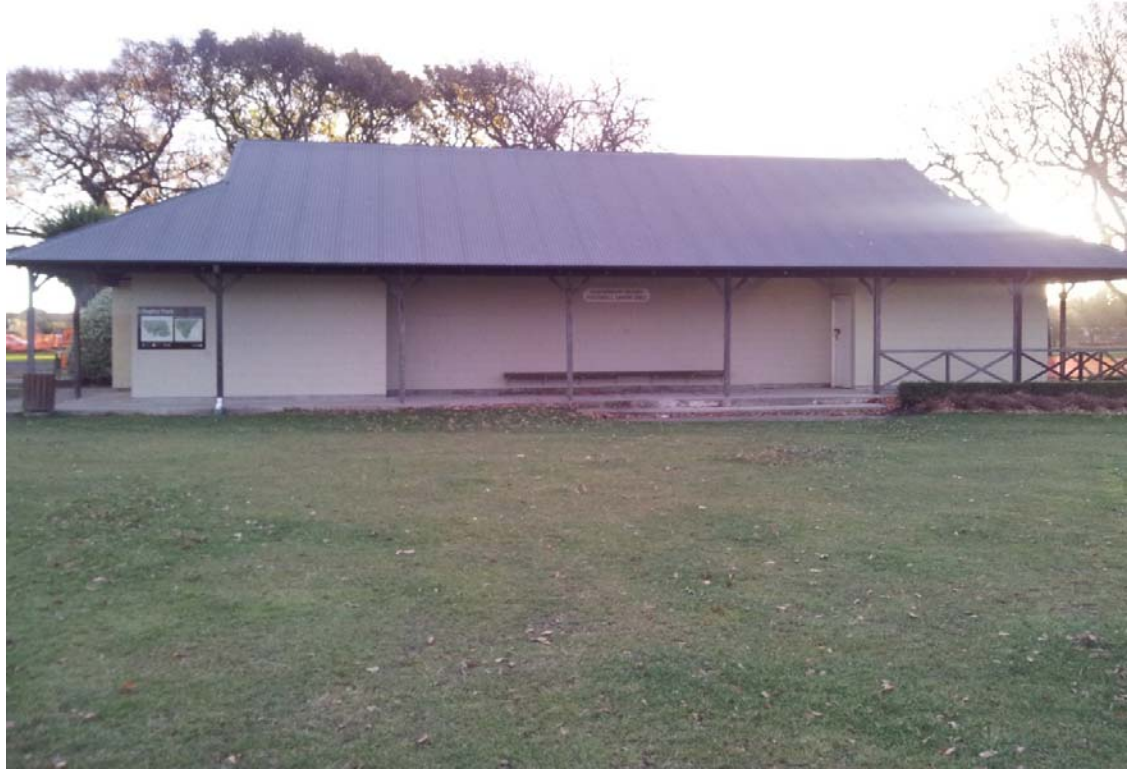
■ **Figure 10 Overview of structures – Rugby toilets**

The building was observed to be a masonry block building with sheet metal roof, slab on grade foundations. Some minor cracks in the masonry wall and external concrete slab were observed during the external inspection of the site. There was no evidence of surface expression of liquefaction or any land damage around the site.
