# **Hagley Park South – Storage Shed**

**PRK 1507 BLDG 021 EQ2**

**Detailed Engineering Evaluation**

**Quantitative Assessment Report**

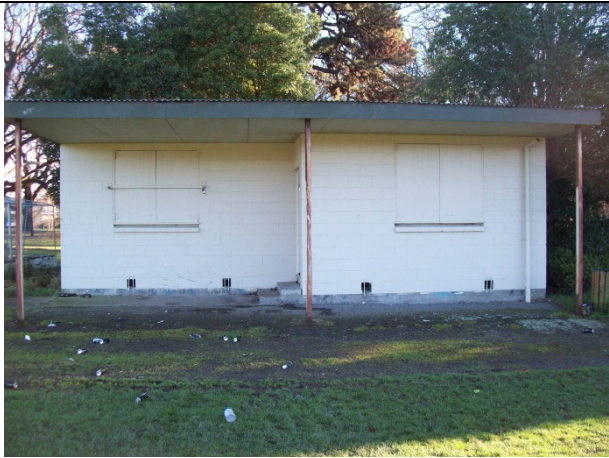
Hagley Park South Storage Shed		
No.	Item description	Photo
1.	South-east view of building

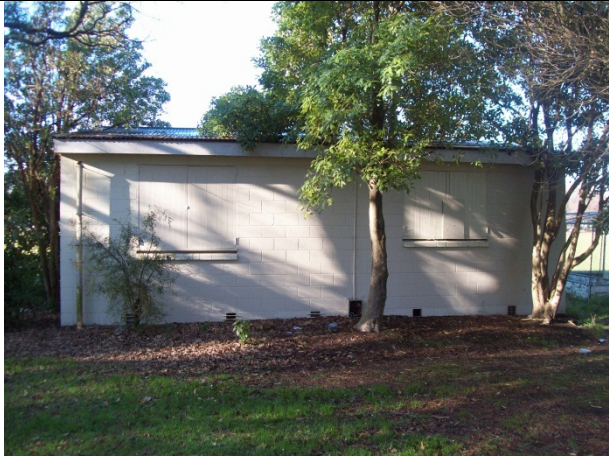
A photograph showing the south-east view of a white storage shed. The building has a flat roof and two large white doors. It is situated on a grassy area with trees in the background.
2.	North-west view of building

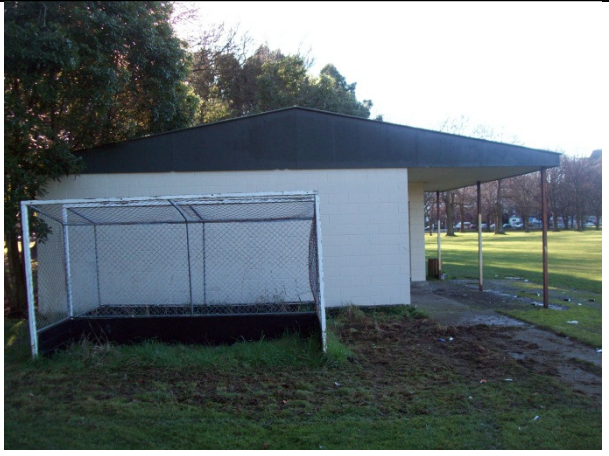
A photograph showing the north-west view of the storage shed. The building is white with a flat roof and is surrounded by trees and grass. The lighting suggests it is daytime.
3.	South-west view of building

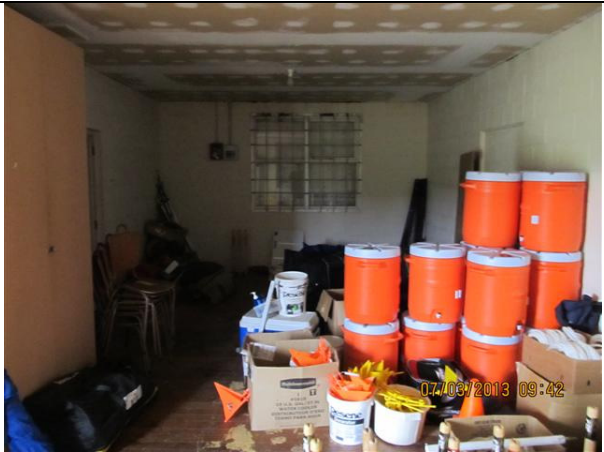
At the time of our inspection a new ceiling had recently been installed and not yet painted (refer to Appendix 1, photo 4). Our cover meter survey also determined that one wall was fully grouted and reinforced while the other walls in the building were not. We would expect that this is a result of renovation works to the building, however as no original drawings of the building were available, we have been unable to determine the extent of works undertaken.

4.	Inside room of building. Note new ceiling installed.

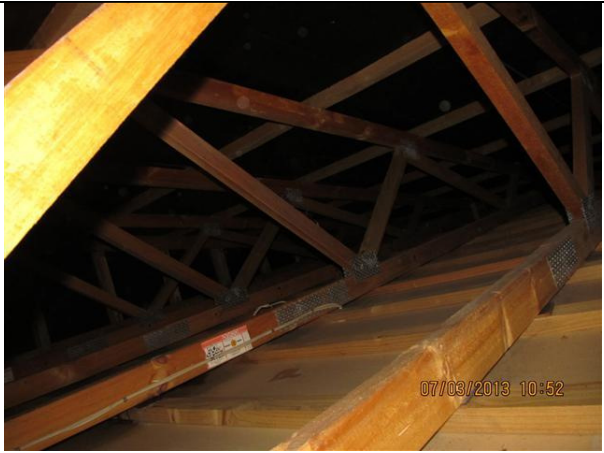
A photograph showing the interior of a storage room. The ceiling is newly installed with a pattern of circular recessed lights. The room contains several large orange plastic drums, boxes, and other miscellaneous items. A timestamp in the bottom right corner reads "07/09/2013 09:42".
5.	Timber roof trusses and ceiling battens.

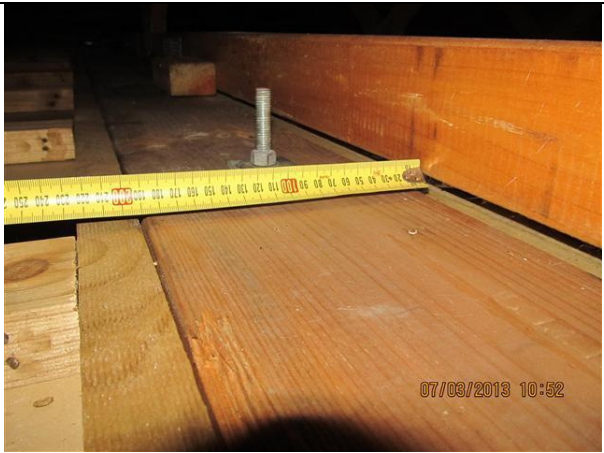
A close-up photograph of the timber roof structure. It shows a network of wooden trusses and ceiling battens. A timestamp in the bottom right corner reads "07/09/2013 10:52".
6.	Top plate fixed to top of block wall under.

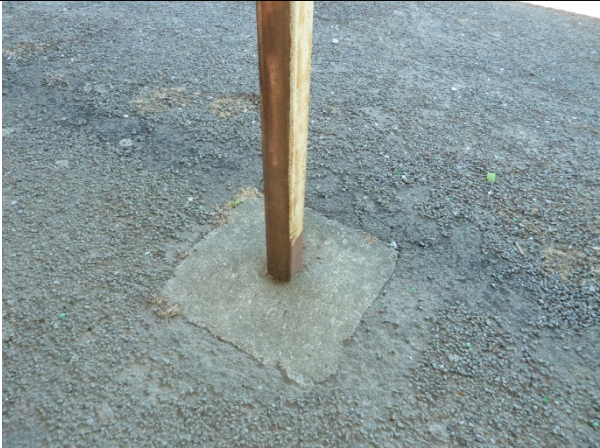
7.	Base of patio posts

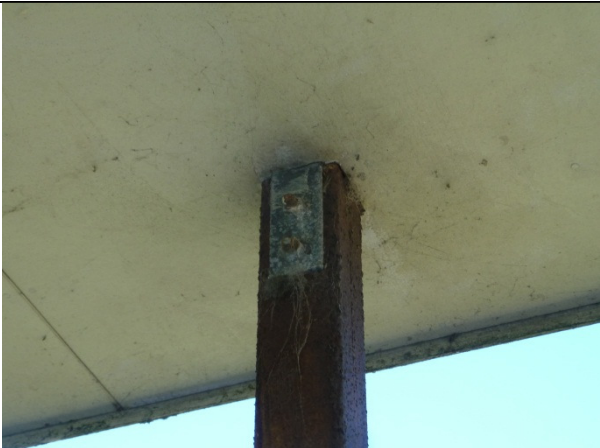
Due to the non-intrusive nature of our investigation the extent of rust observed in the porch posts is unknown, and as such the impact on their capacity could not be determined.

8.	Top fixing of patio posts. Posts significantly rusted.

- a) If strengthening is required to increase the seismic capacity of the building to at least 67%NBS, options should be investigated for strengthening the unreinforced sections of masonry wall for out-of-plane bending.
- b) The extent of corrosion of the porch posts should be investigated to determine if remedial or maintenance measures are required.

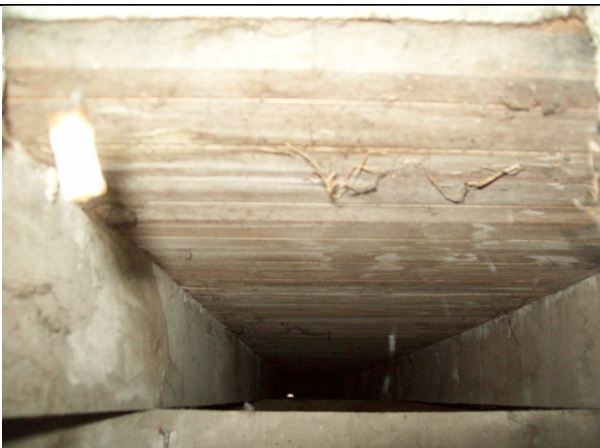
9.	Timber framed floor. No access.
