Christchurch City Council
Hagley Park South Toilets
Damage and Strengthening Report
Version FINAL

PRK_1507_BLDG_010

Date
11 March 2013

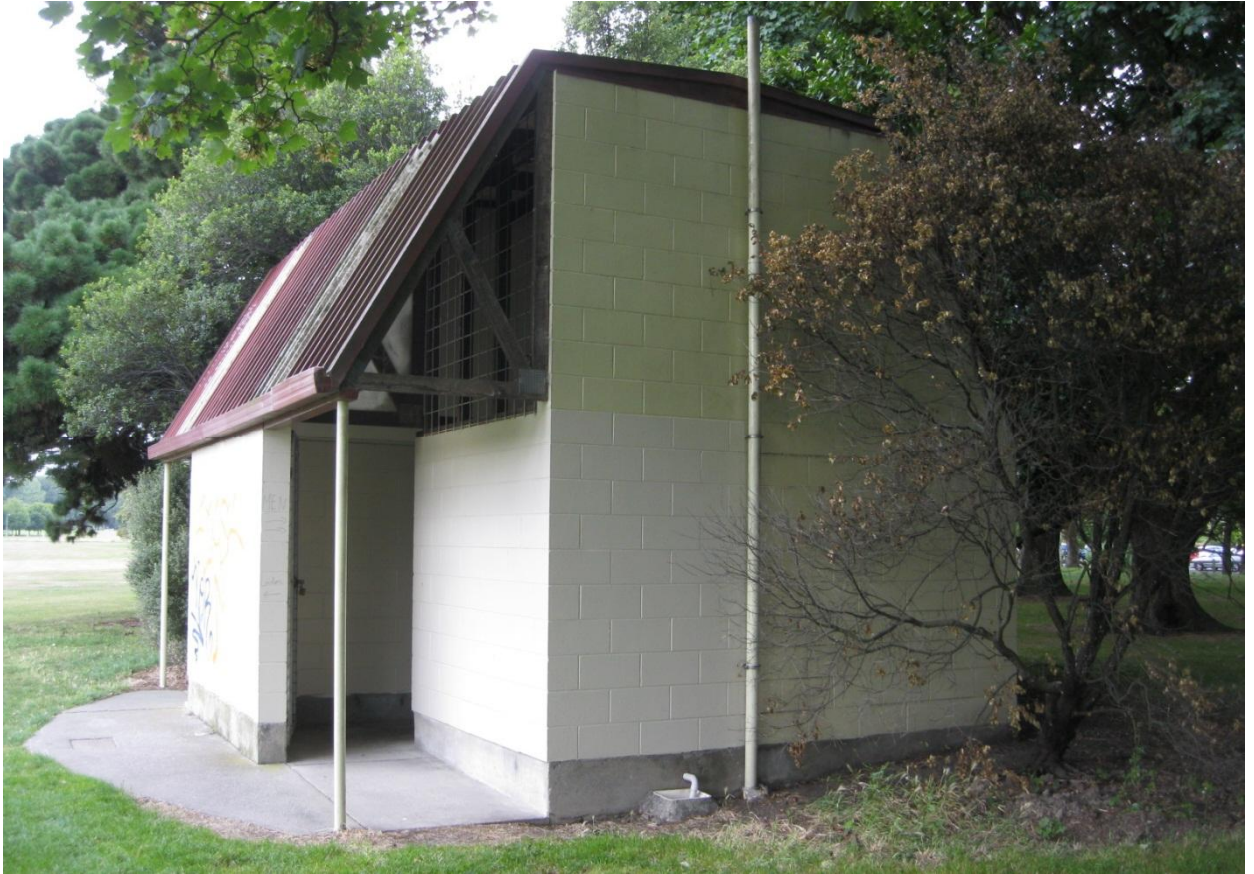
The lowest scoring structural elements to the building are the 4m high concrete masonry walls on both ends of the building. There are various options available to provide strengthening to the structure, however, it is considered that the installation of bracing to these walls within the existing roof structure would cause only minimal disruption during construction and therefore be the most economical solution.

Photograph 5: East elevation with cantilevered concrete masonry wall

Strengthening is recommended to achieve 67% NBS in accordance with NZSEE Guidelines, and the recommended solution, which would cause minimal disruption during construction, involves the installation of steel bracing within the existing roof structure to the 4m high walls.

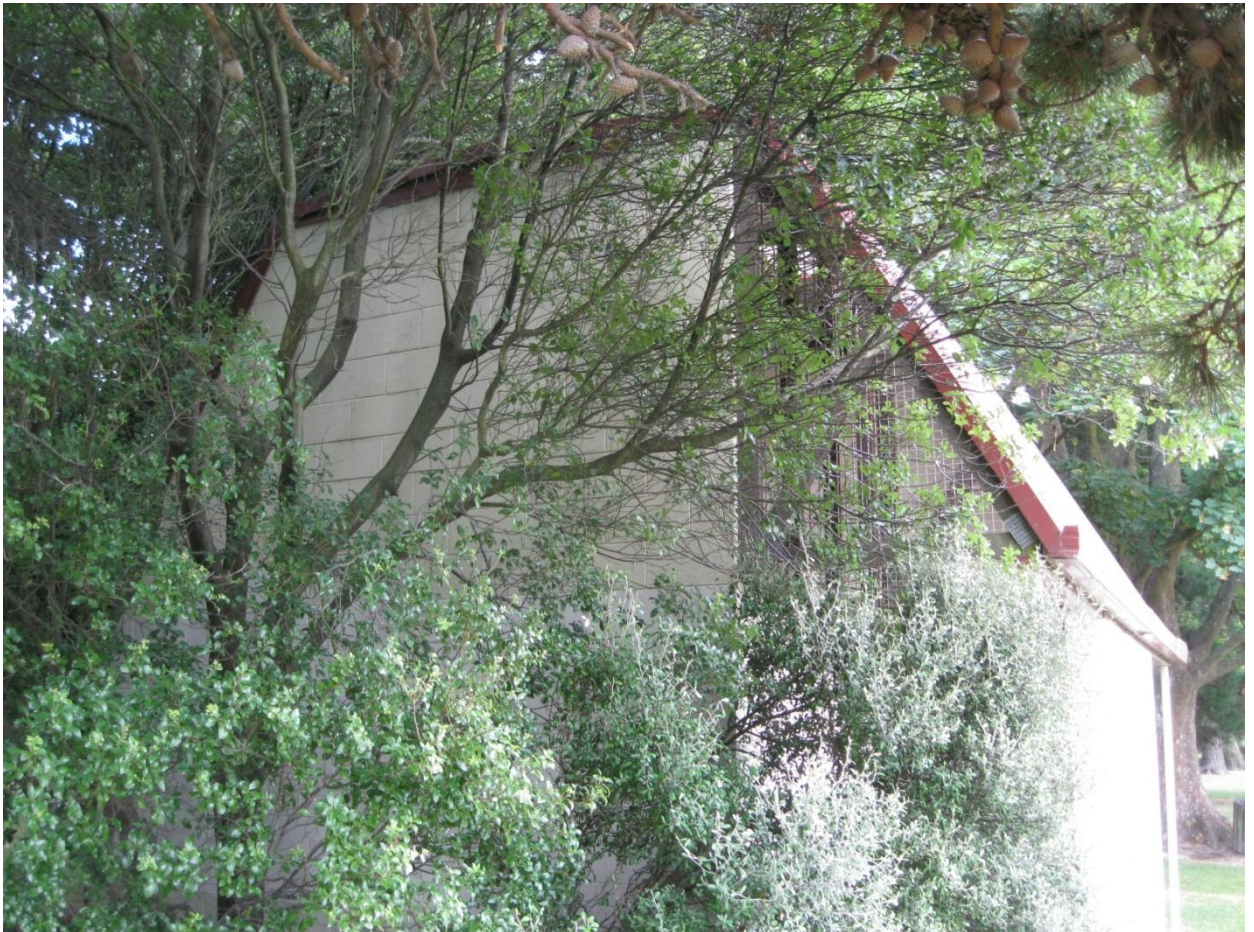
Photograph 6: West elevation with cantilevered concrete masonry wall

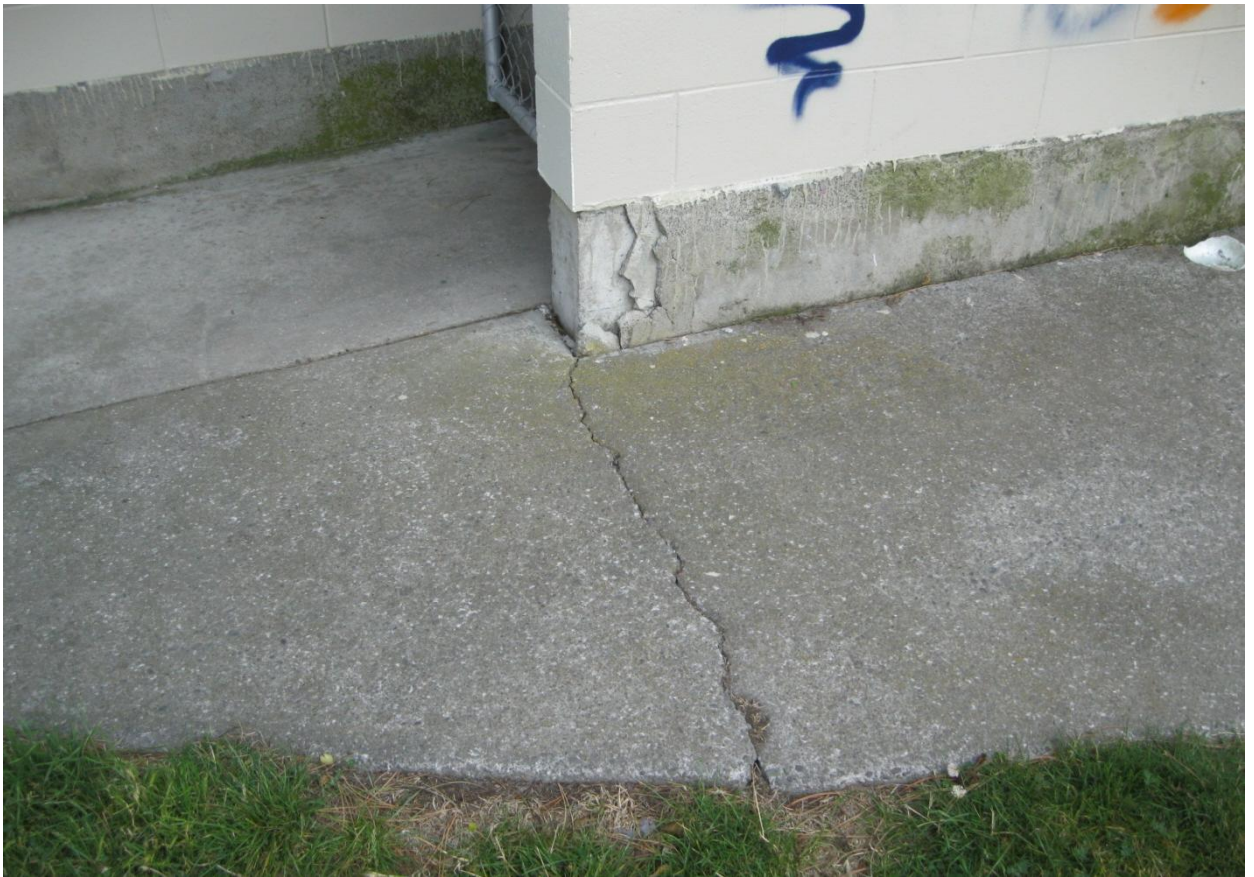
Photograph 13: Cracking in external slab and spalling of render on concrete footing to wall

Cracks are to be filled using a suitable plaster system to match the existing. Where the render has spalled off, any adjacent loose render should be removed and the edges squared off. A new plaster render should be installed according to manufacturer's instructions.

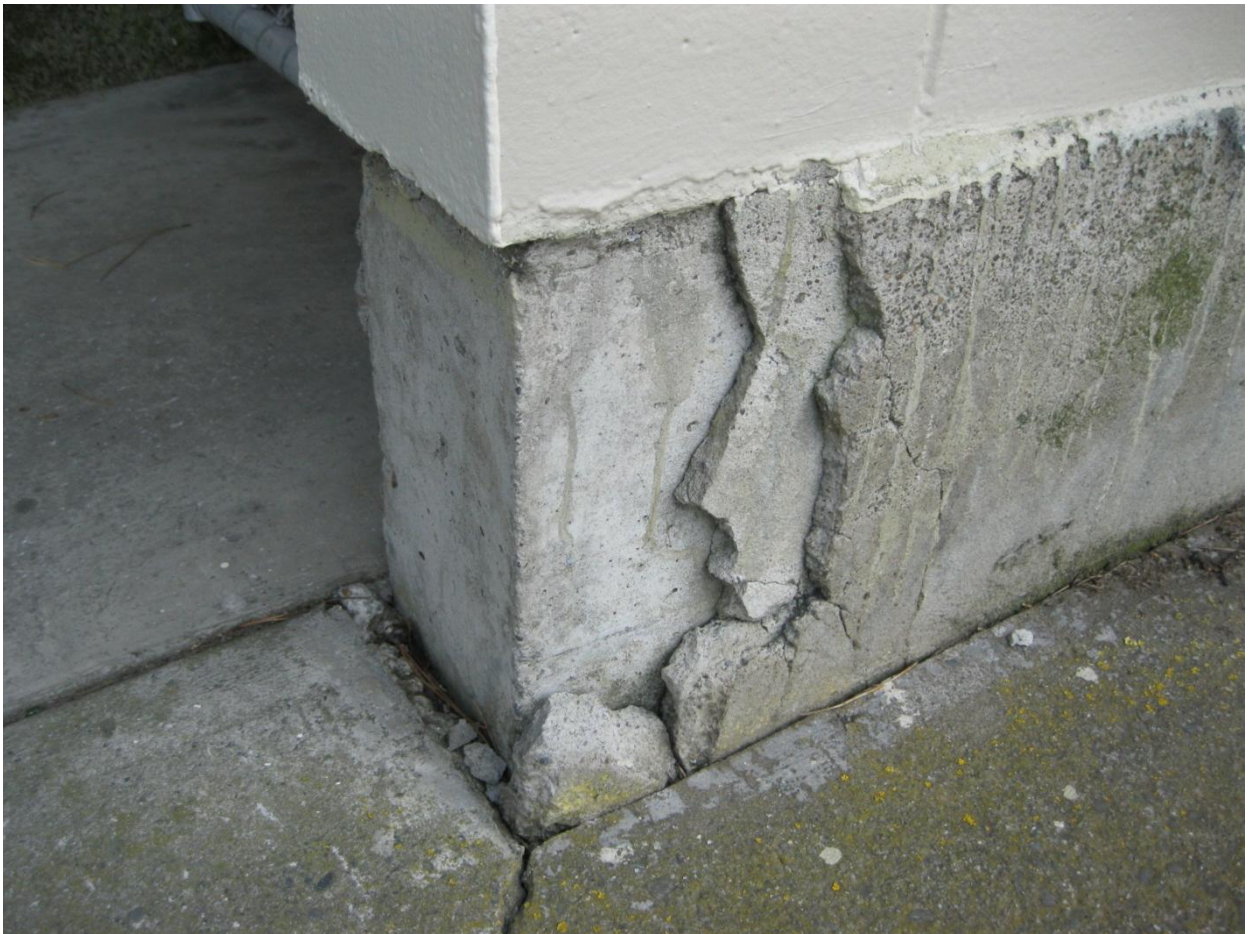
Photograph 14: Close-up view of spalling of render on concrete footing to wall

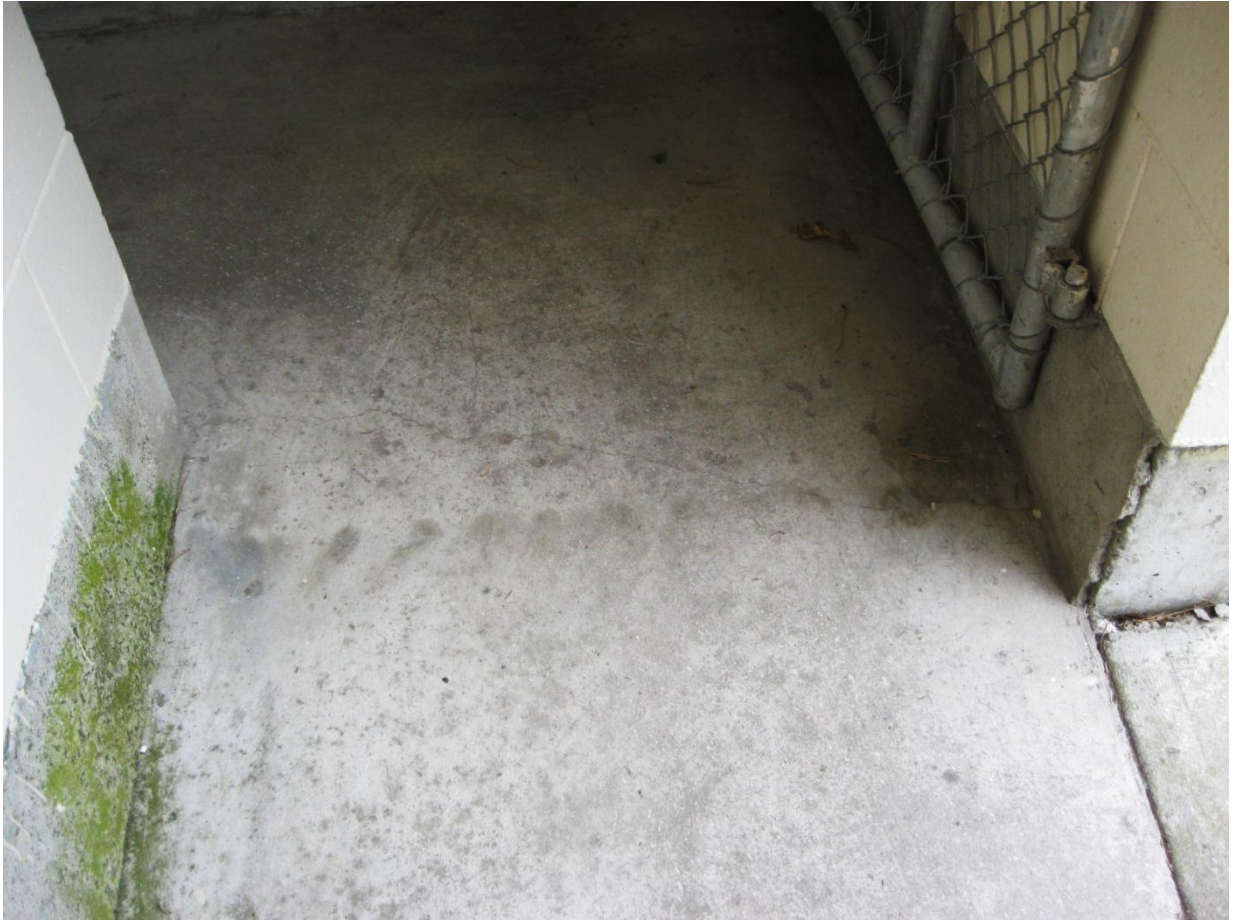
Photograph 15: View of crack in internal concrete floor slab

Where the crack widths are less than 2mm, we recommend that an epoxy crack injection system (e.g. Sika Sikadur or similar approved) be used for their repair, it should be noted that epoxy injection cannot be carried out where crack widths are less than 0.2mm in width, however these cracks are not considered to be significant or requiring repair. Repairs should be carried out in accordance with manufacturer's instructions.

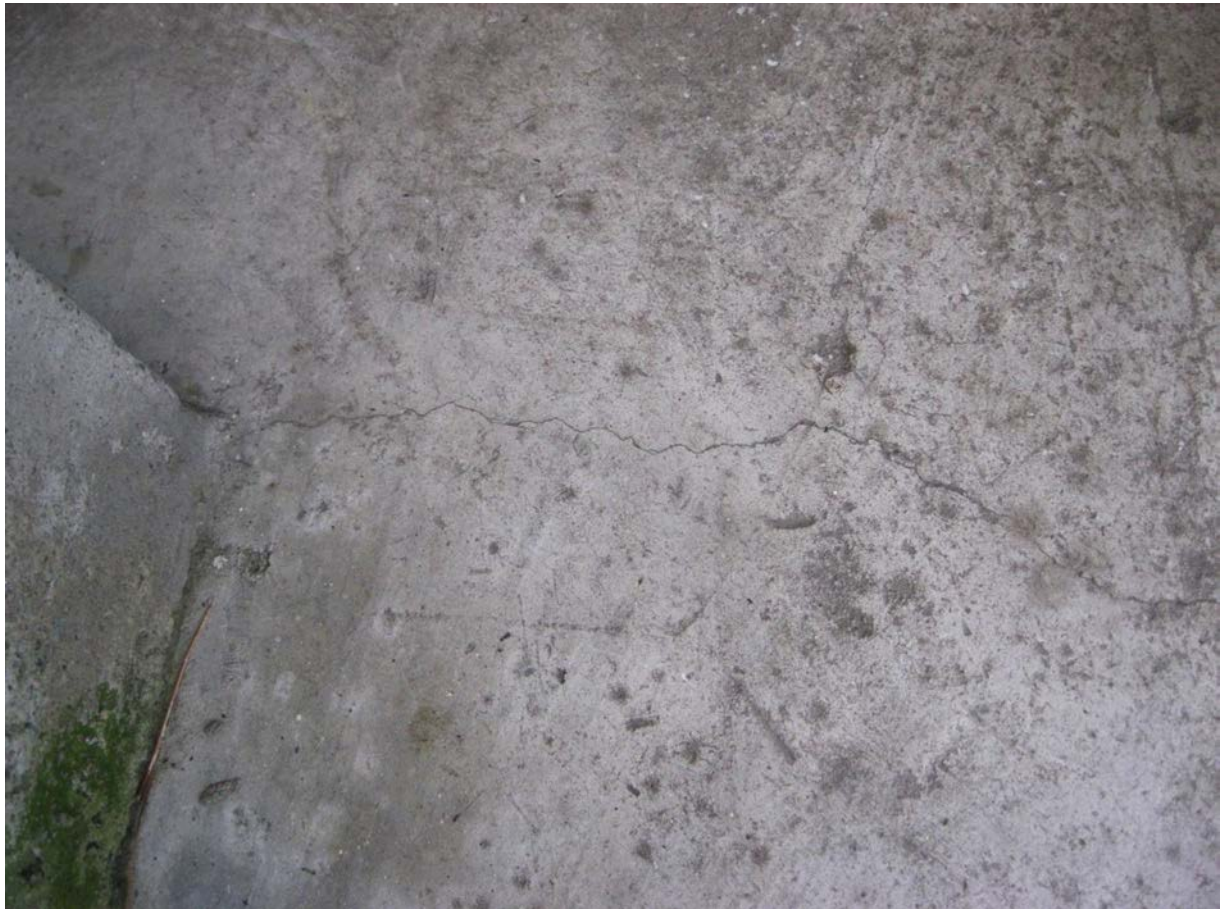
Photograph 16: Close-up view of crack in internal concrete floor slab

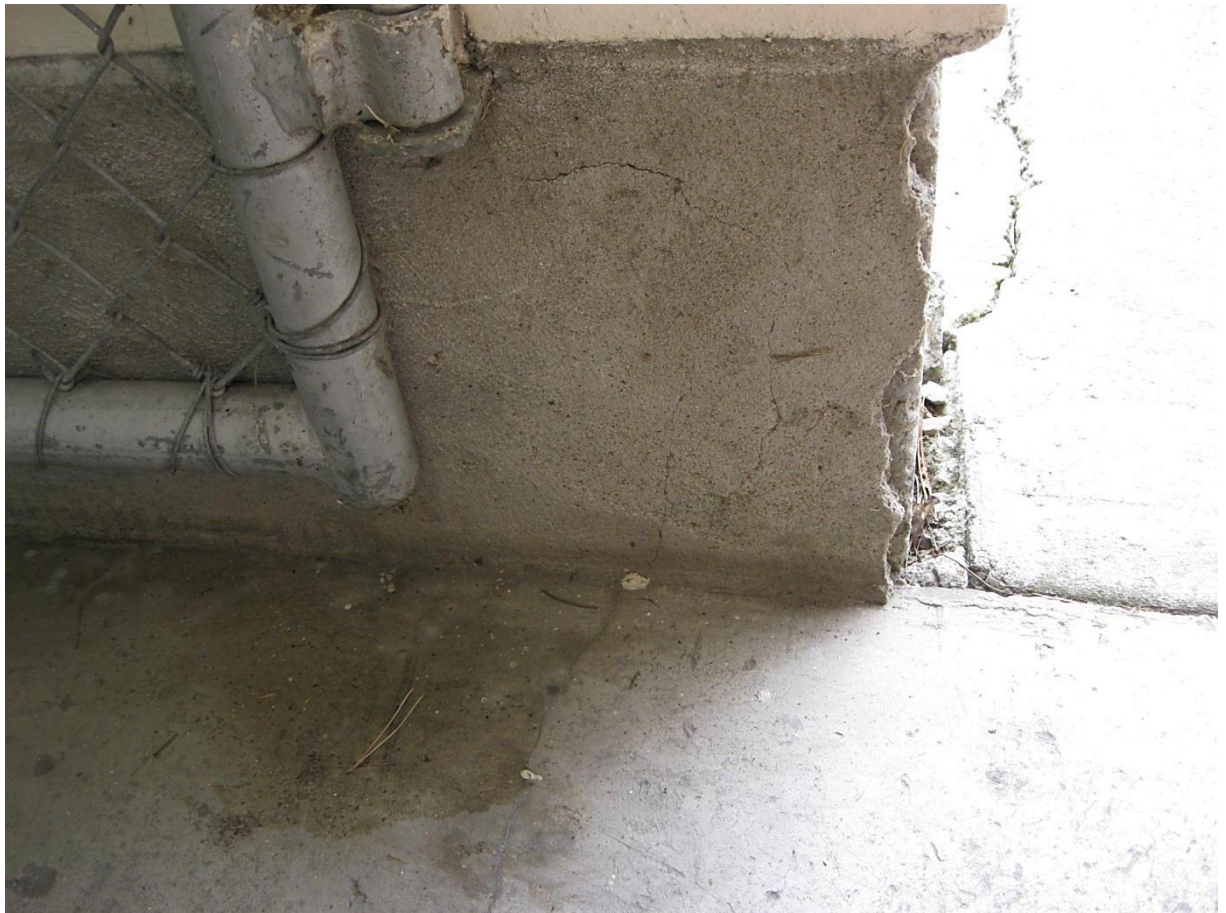
Photograph 17: Close-up view of crack in concrete floor slab and in render on footing to wall

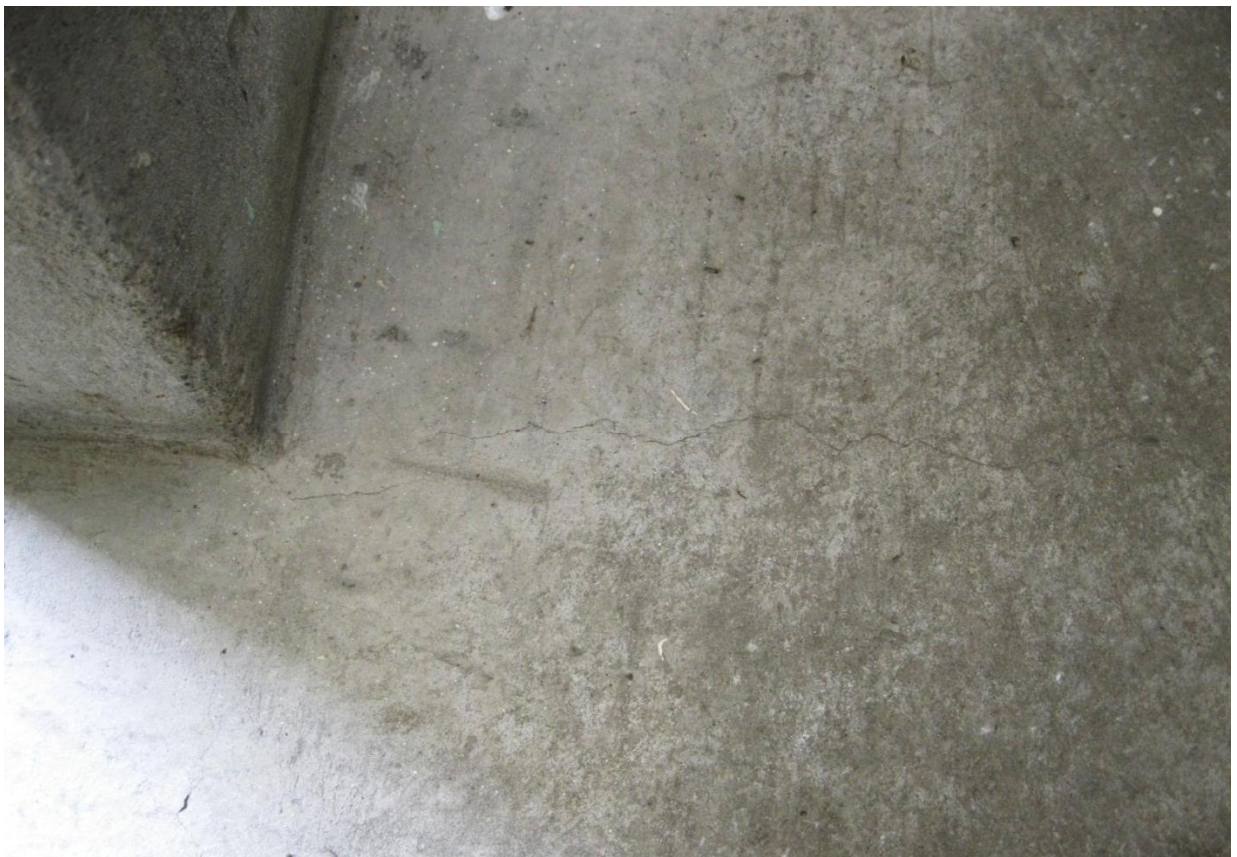
Photograph 18: View of crack in internal concrete floor slab

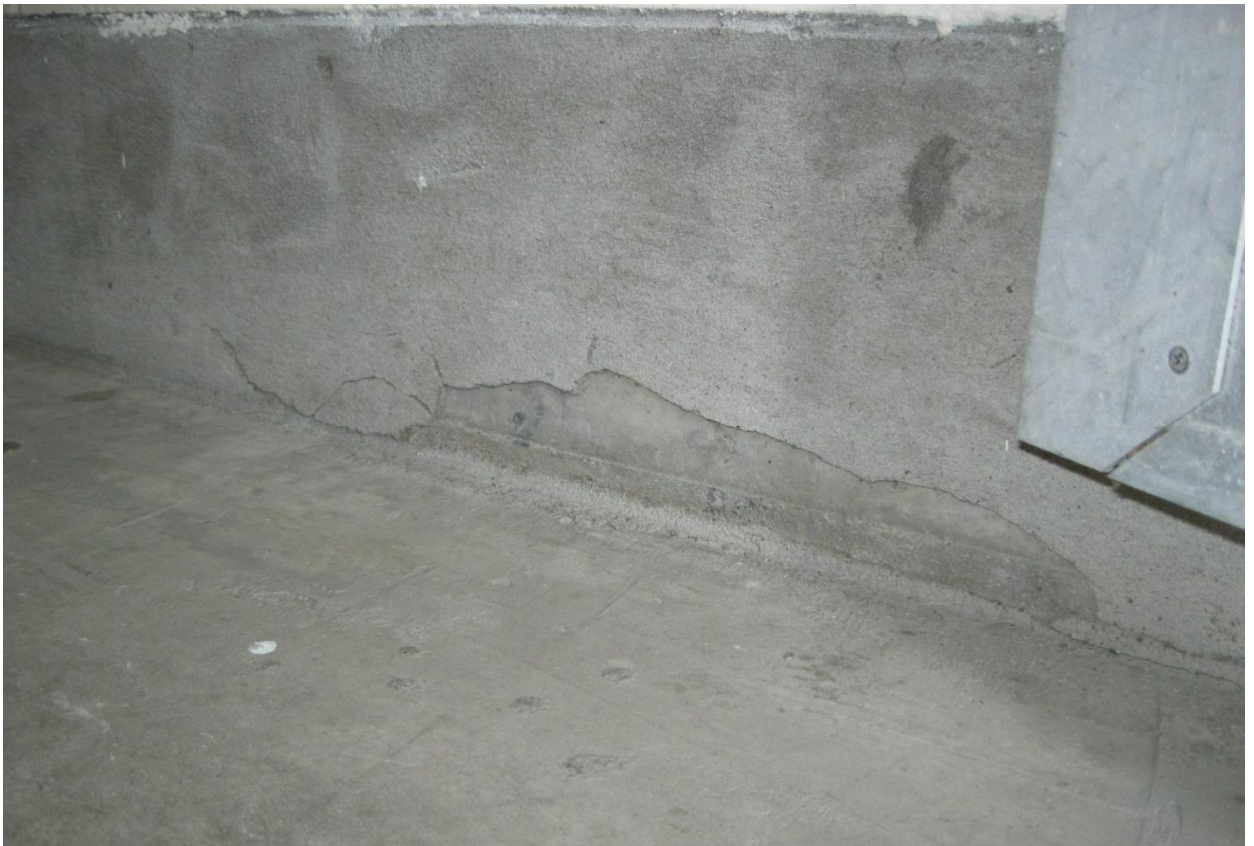
Photograph 19: Cracking and spalling of render on concrete footing to internal wall

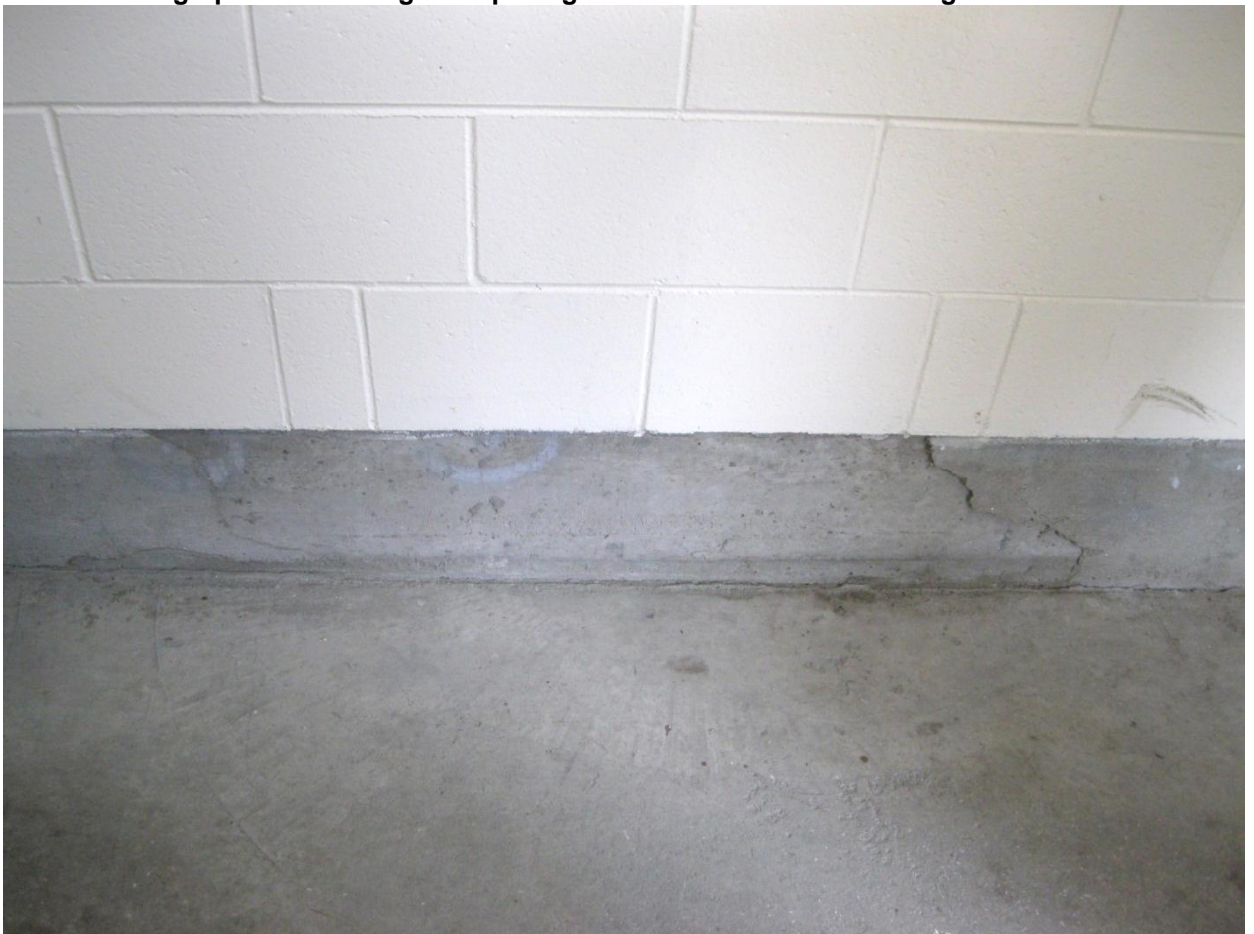
Photograph 20: Spalling of render on concrete footing to internal wall

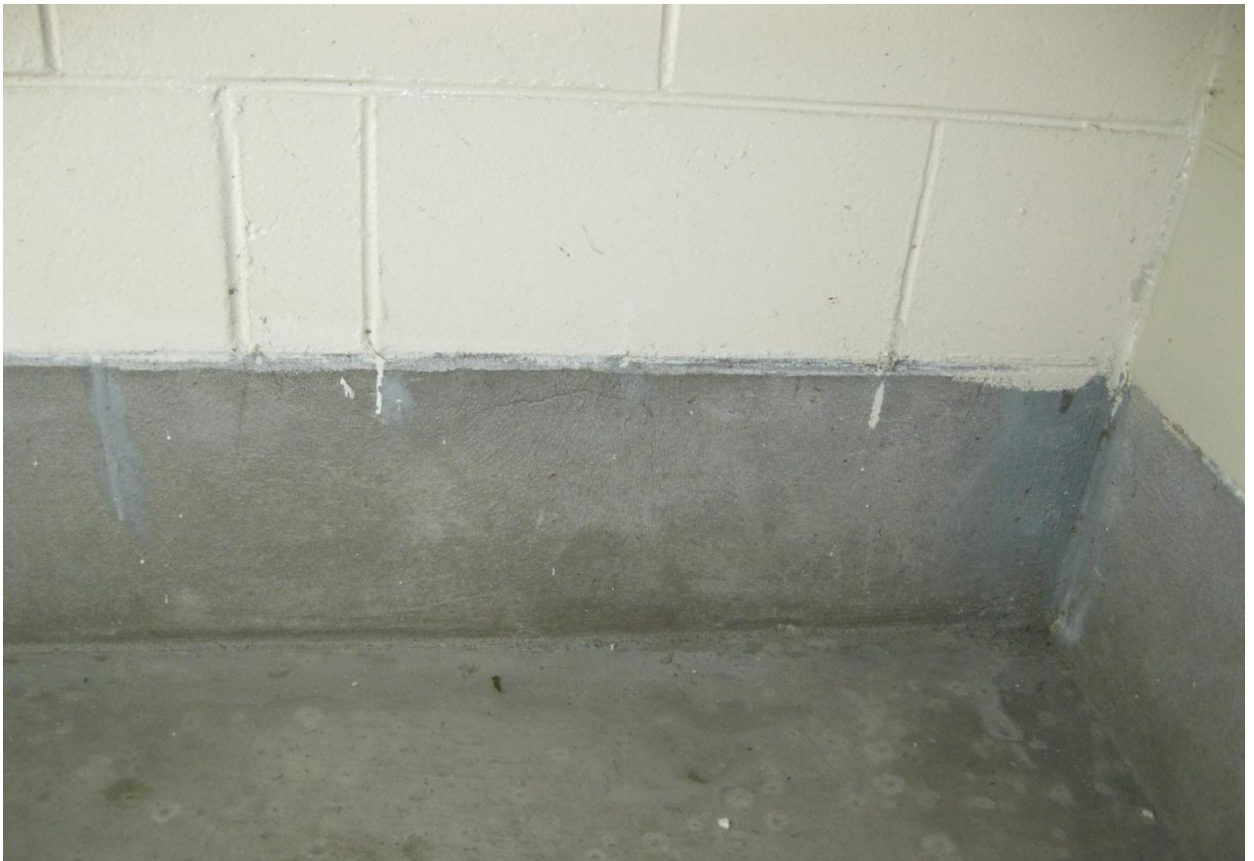
Photograph 21: Minor cracking in render on concrete footing to internal wall

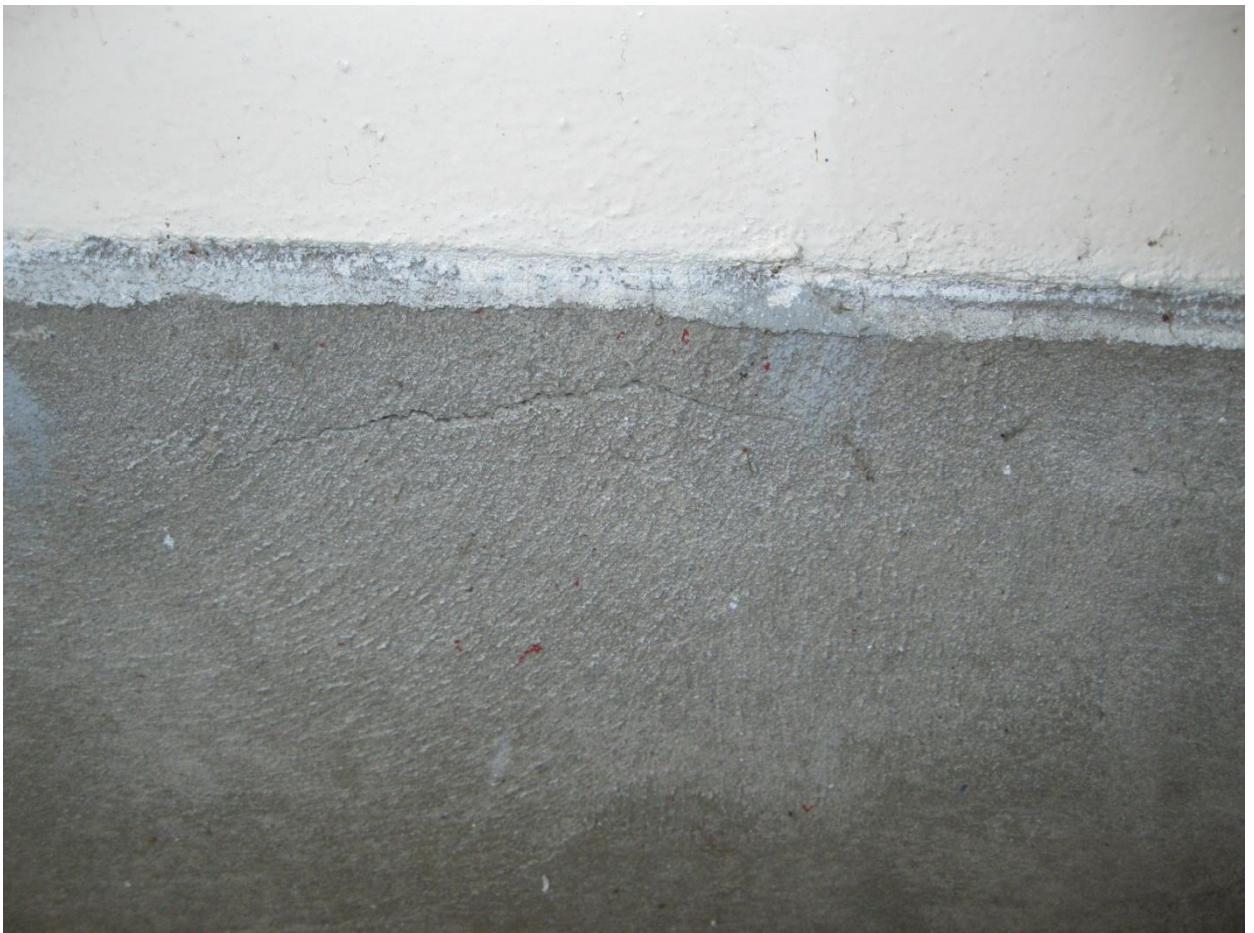
Photograph 22: Close-up view of minor cracking in render on concrete footing to internal wall

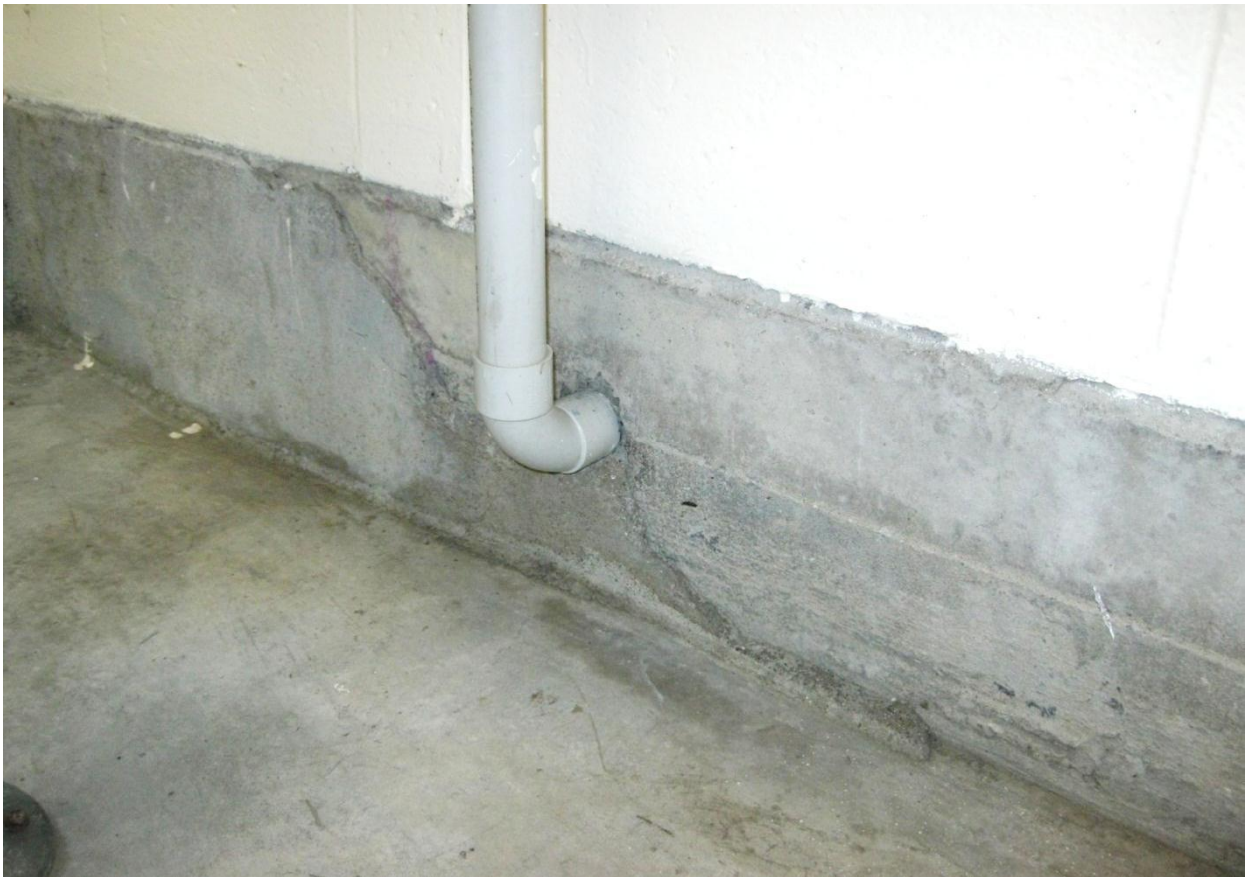
Photograph 23: Spalling of render on concrete footing to internal wall

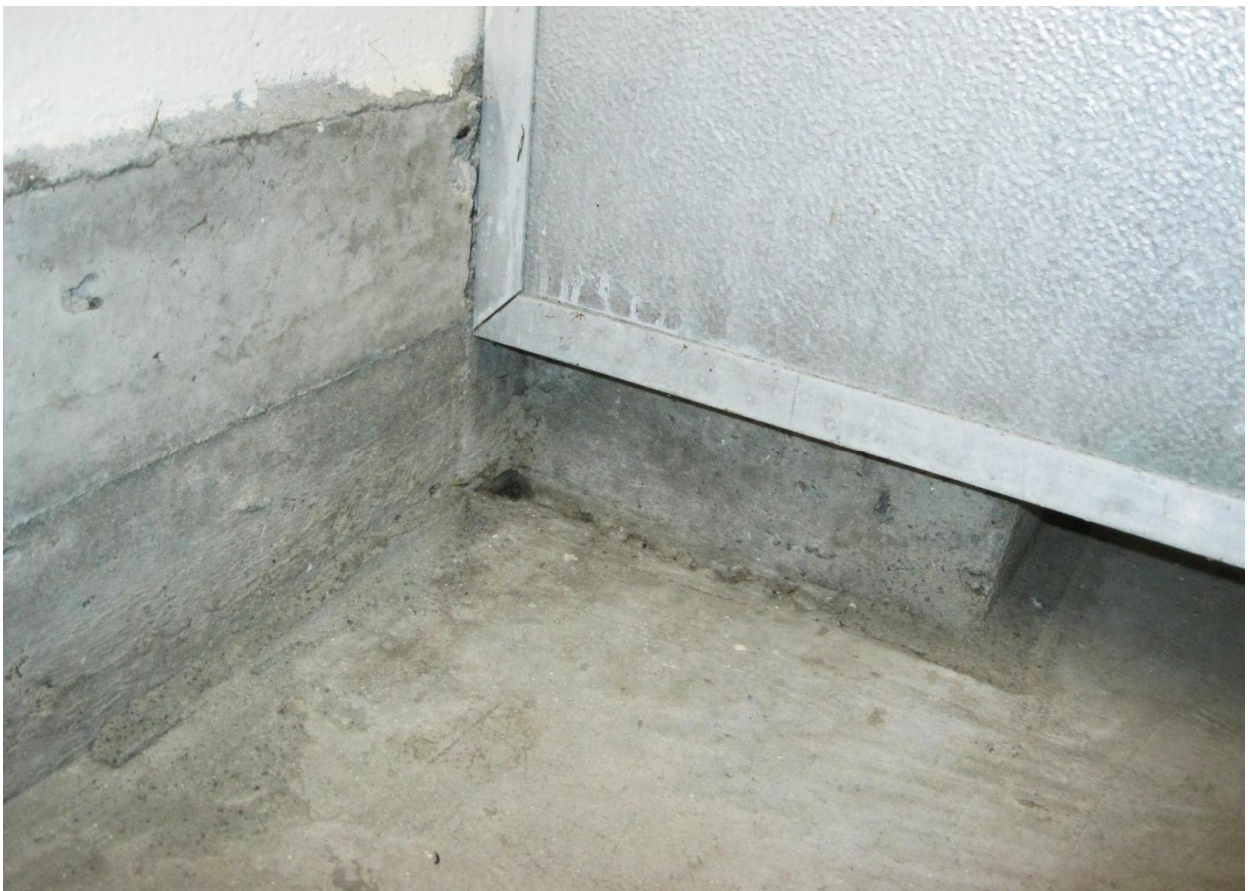
Photograph 24: Render spalled off concrete footing to internal wall

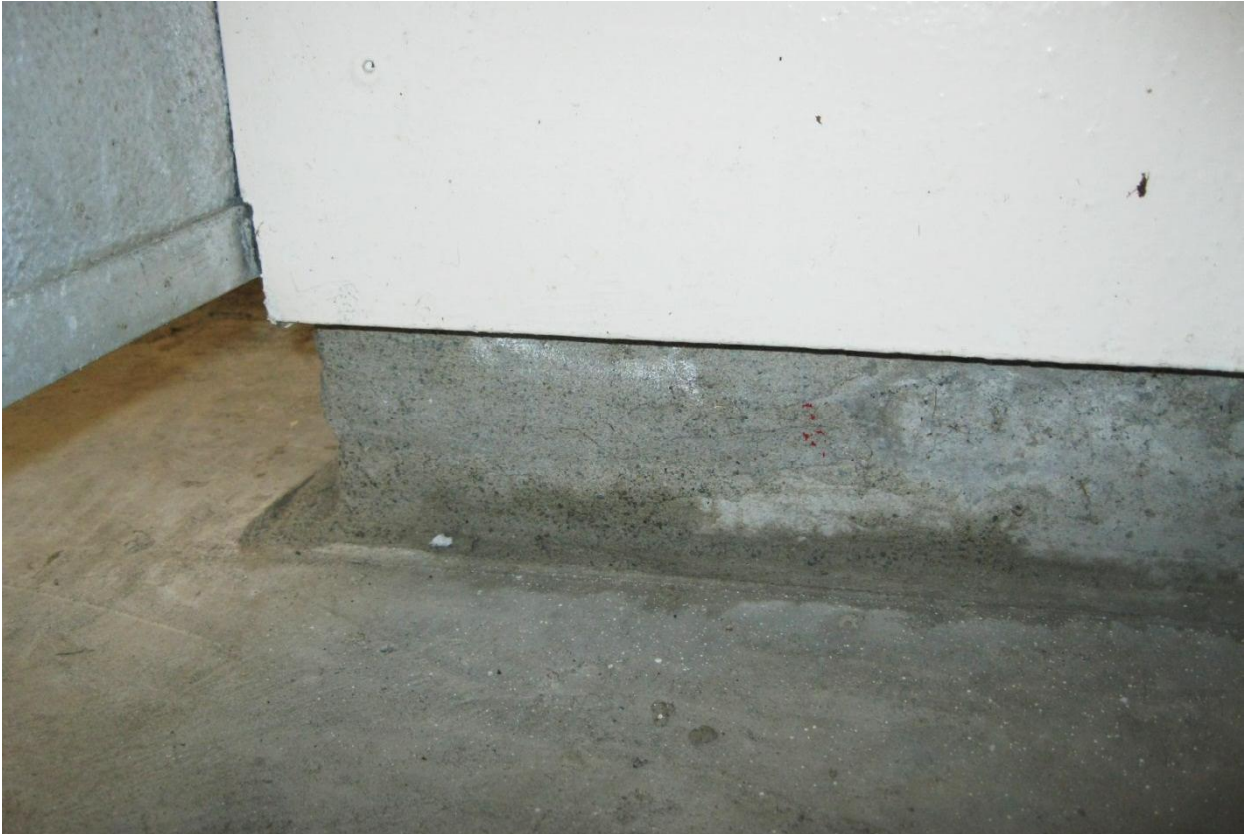
Photograph 25: Render spalled off concrete footing to internal wall

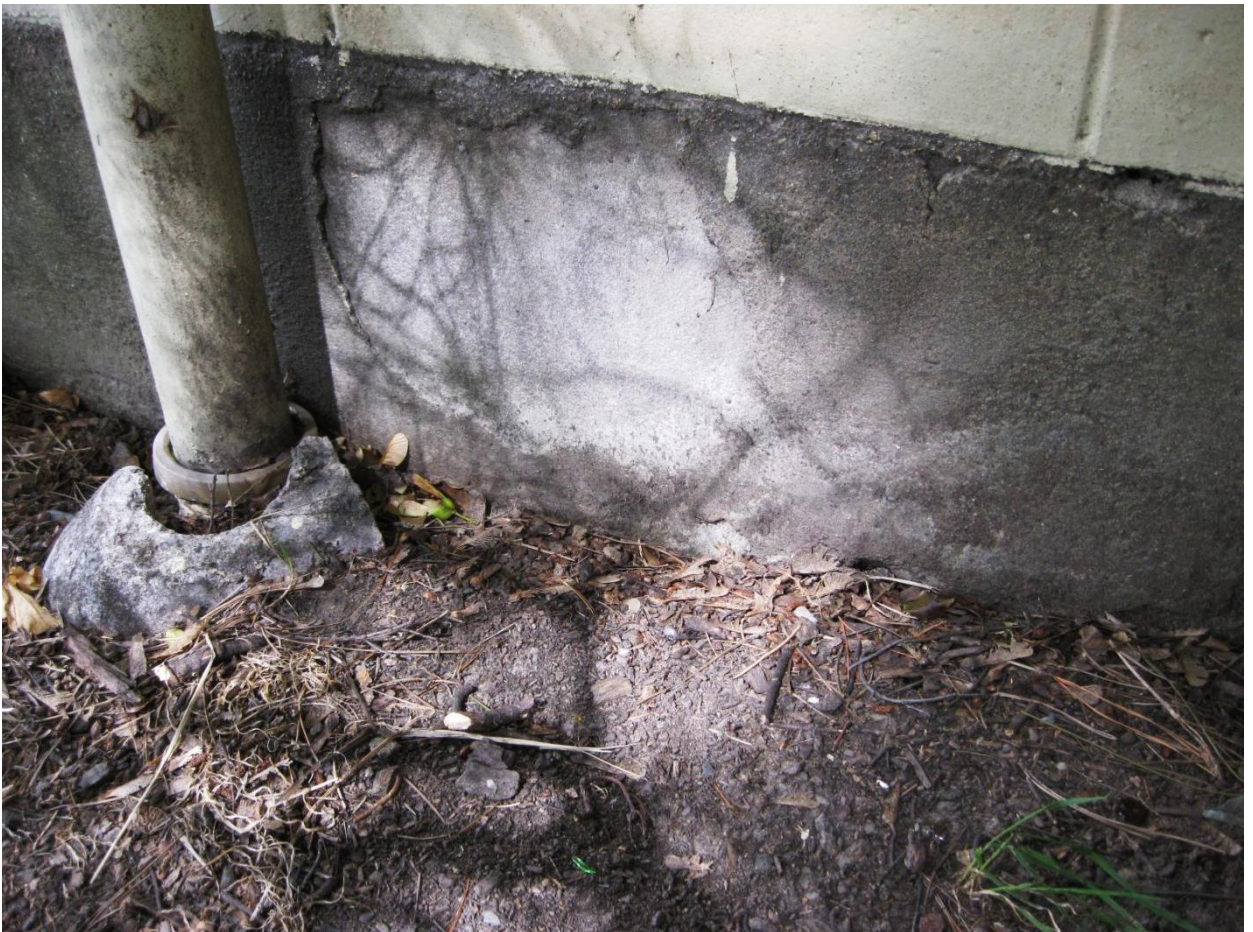
Evidence of movement of the building elements was noted by a gap opening up between the flashing of the roof cladding and the top of the concrete masonry wall on the western elevation. Also, by the residual gap between the concrete cover to the external drain and the drain pipe on the eastern elevation.

Photograph 26: Spalling of render on external concrete footing and movement of building shown by gap between concrete and drainpipe

The damaged concrete drainage cover should be replaced with new concrete to suit the existing detail.

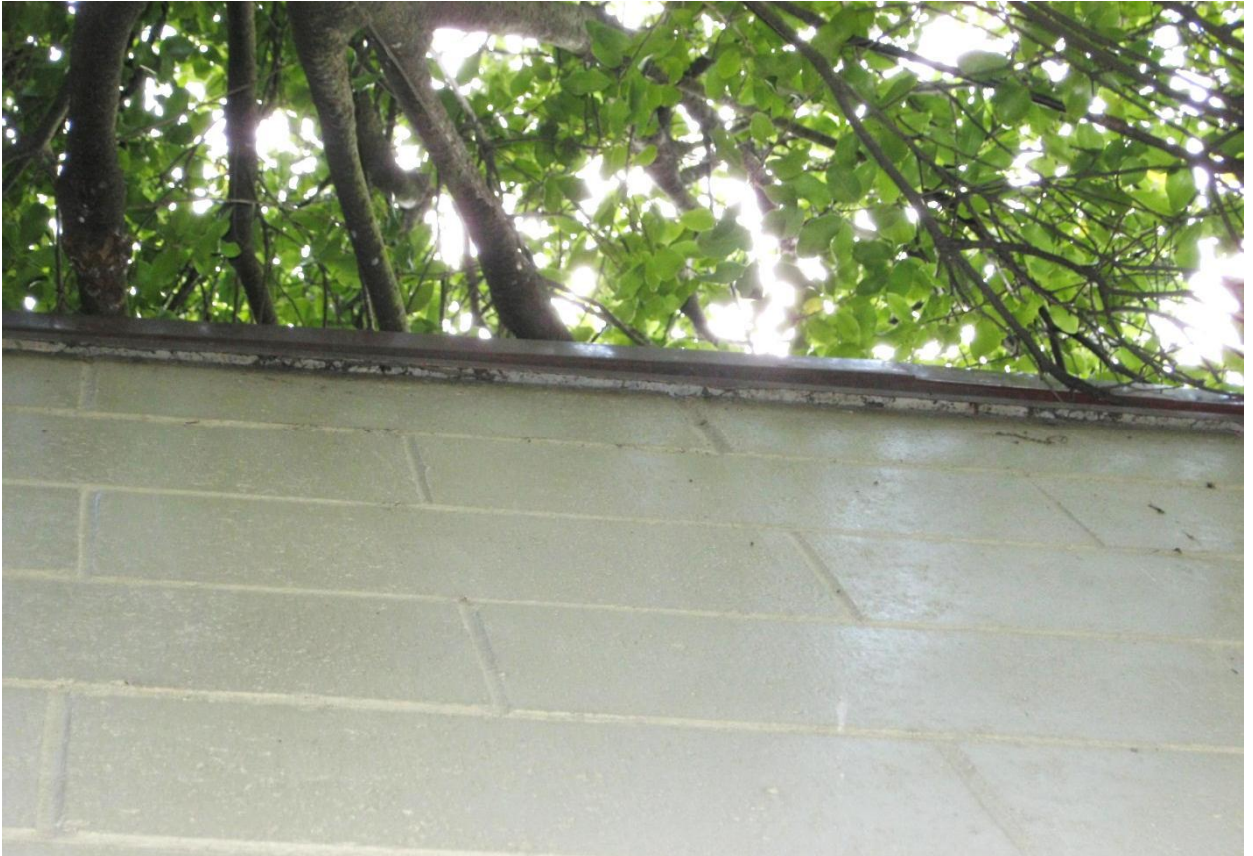
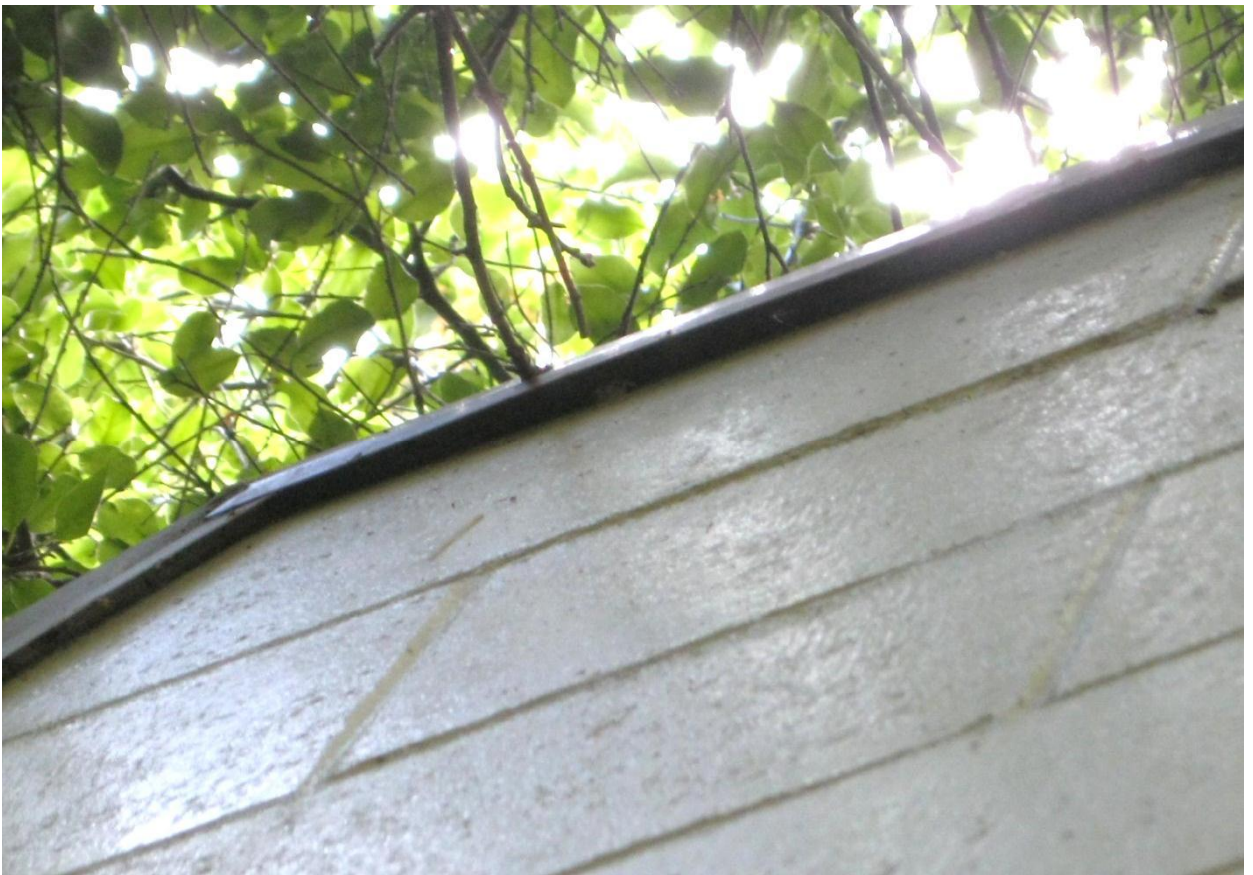
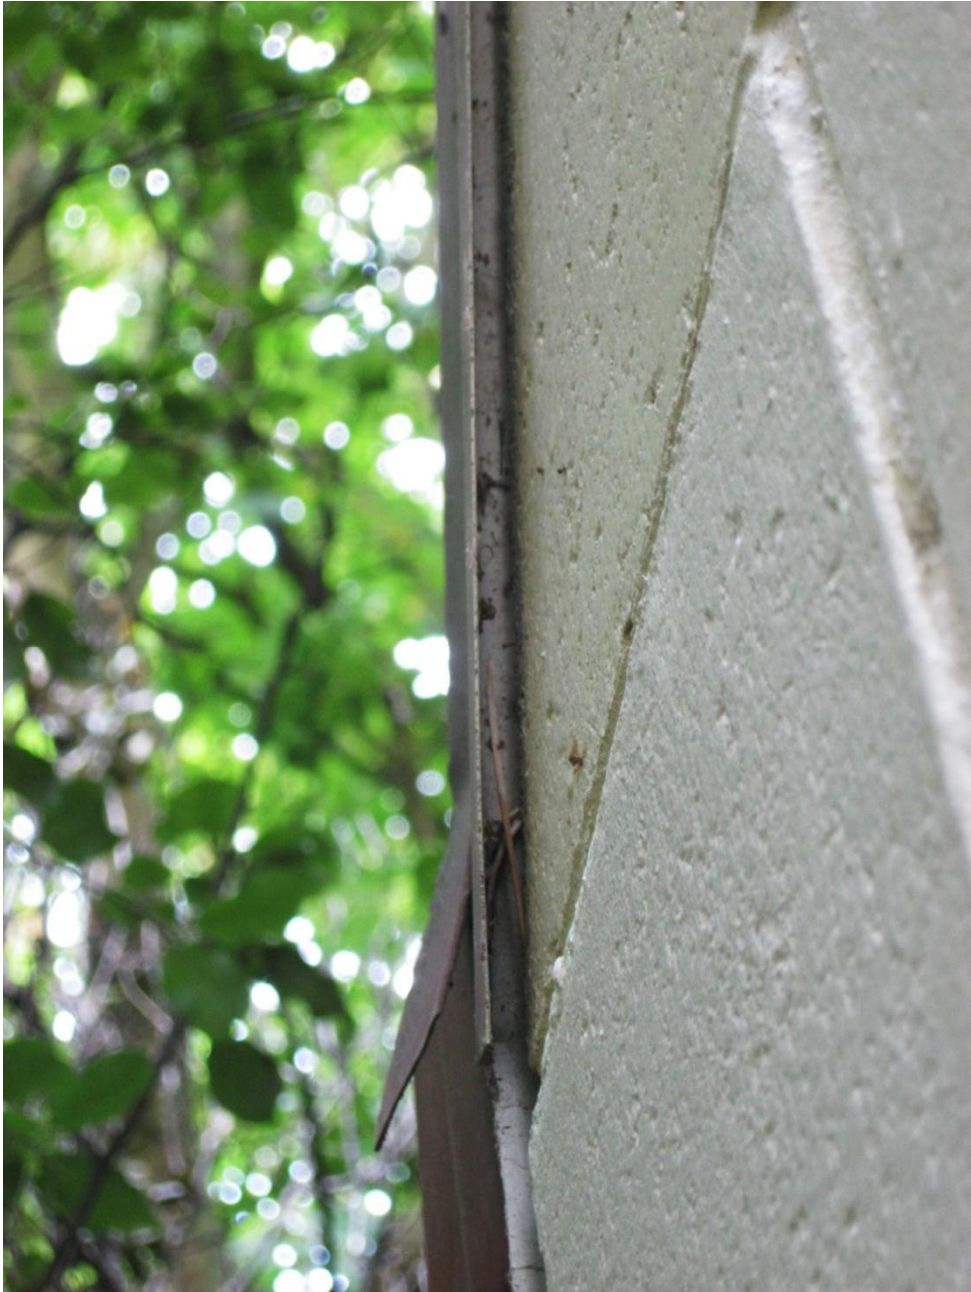
No structural damage has been observed to the roof, and there has been no reported damage or evidence of leaking. However, there is a gap opened up between the flashing and the top of the concrete masonry wall on the western elevation, due to earthquake induced movement. It is recommended that a further close-up inspection of the roof cladding and waterproof flashings is carried out by a competent tradesman to determine if this movement has caused any further damage to the cladding requiring repair. The flashing that has opened up should be fixed back to the top of the wall to ensure the waterproofing detail remains intact. Any further repairs required should be carried out in accordance with manufacturer's instructions.

Photograph 27: Close-up view of gap between roof flashing and top of concrete masonry wall on West elevation

Photograph 28: Close-up view of gap between roof flashing and top of concrete masonry wall on West elevation

Photograph 29: Close-up view of gap between roof flashing and top of concrete masonry wall on West elevation

- a. Inspect roof, check all flashings and waterproof joint details and repair where necessary.
- b. Reinststate the flashing fixings where the gap has opened up along the top of the western wall – refer to separate specification and advice from specialist Contractor.
- c. Pour new concrete drainage cover.
