Christchurch City Council
Hagley Park South Toilets
Damage and Strengthening Report
Version FINAL

PRK_1507_BLDG_010

Date
11 March 2013

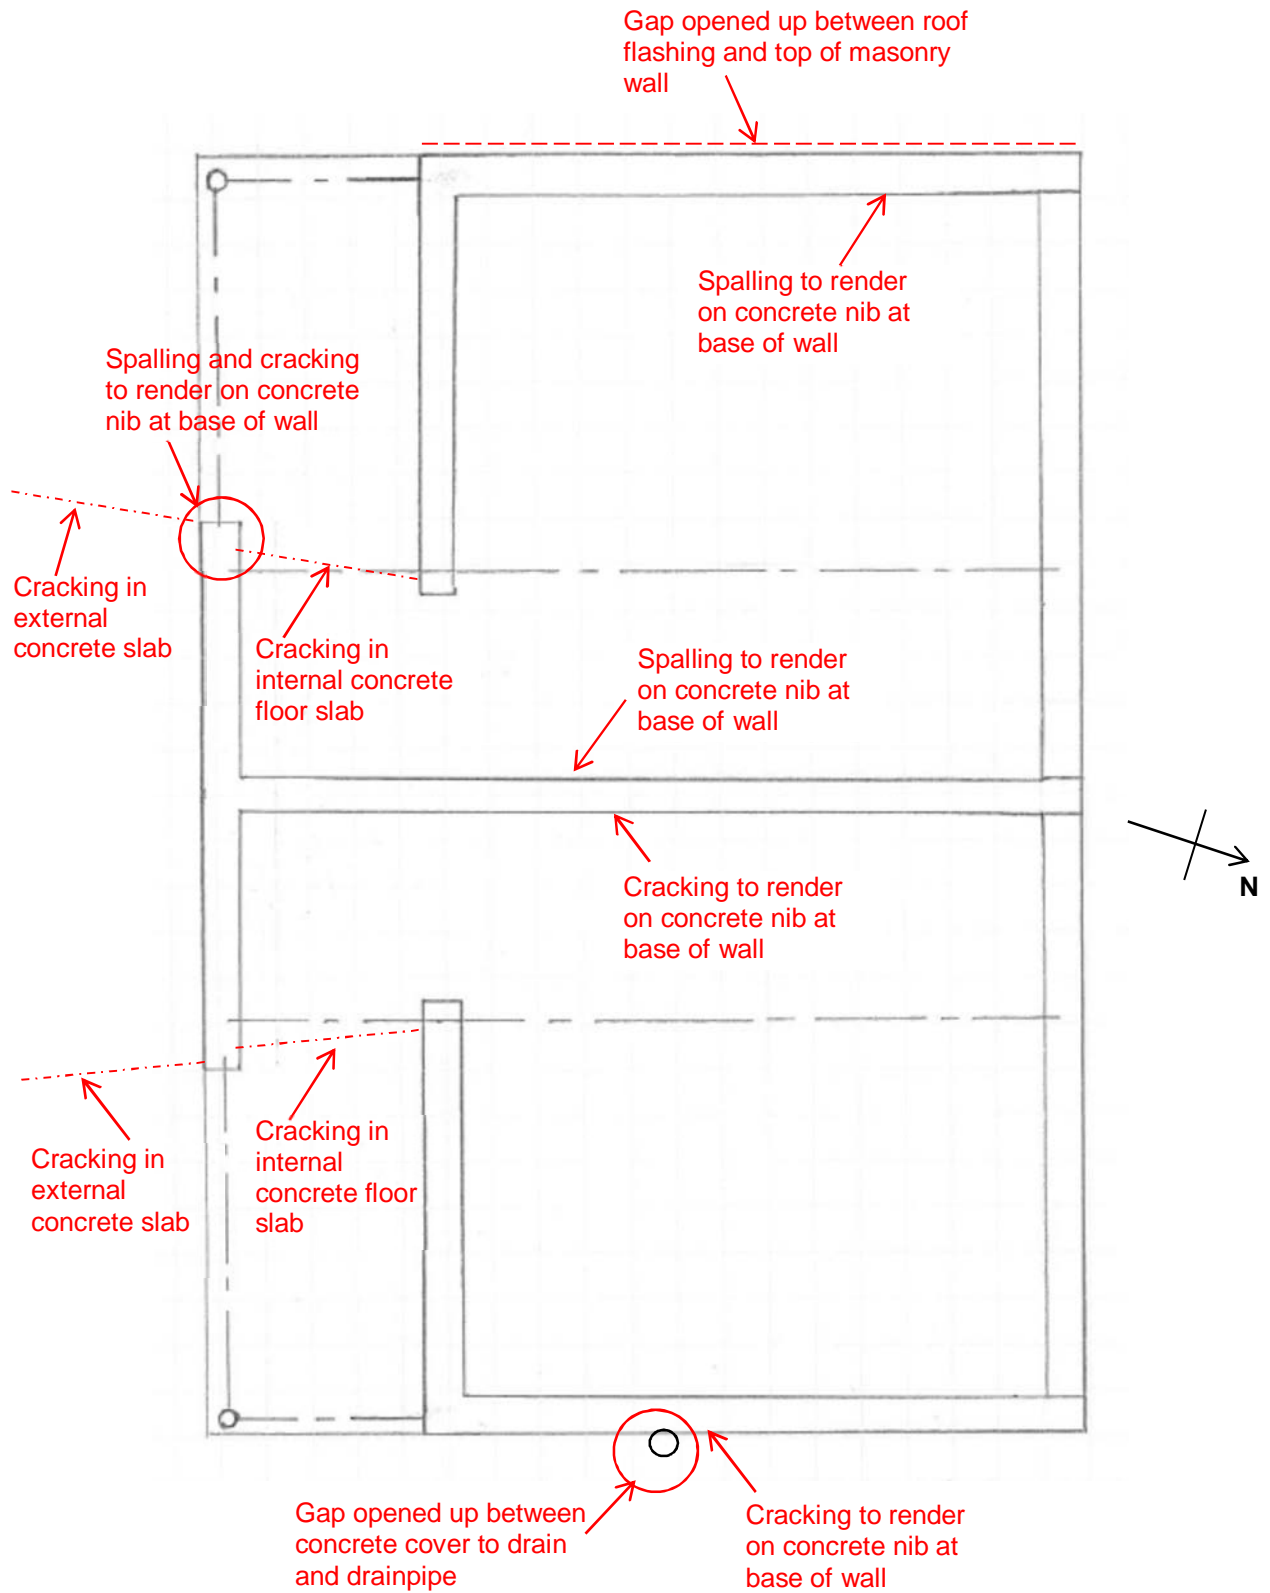
Figure 7 Damage Plan – Hagley Park South Toilet Block – 12 January 2013

The damage observed consists of minor cracking to the internal and external concrete floor slabs. Also, cracking and spalling of the plaster render on the concrete nibs at the base of the concrete masonry walls. However, no significant settlement or evidence of significant liquefaction were observed.

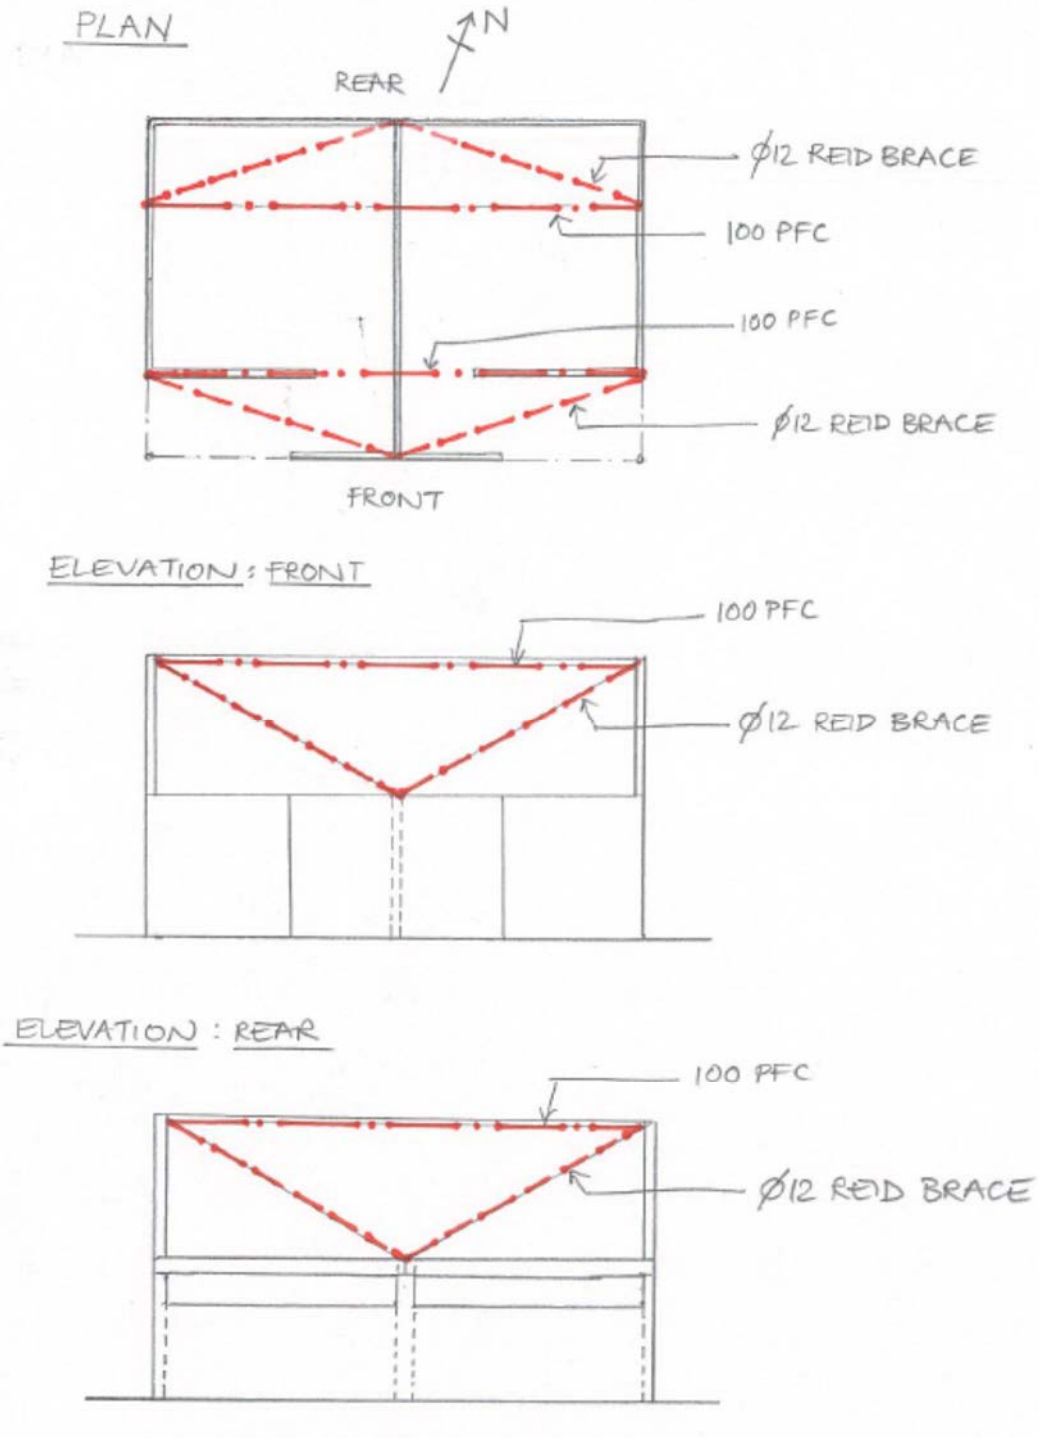
Figure 8 Conceptual Strengthening Plan to 67% NBS – Hagley Park South Toilet Block

Addition of bracing within roof structure

Strengthening is recommended to achieve 67% NBS in accordance with NZSEE Guidelines, and the recommended solution, which would cause minimal disruption during construction, involves the installation of steel bracing within the existing roof structure to the 4m high walls.
