# Halswell Aquatic Centre – BBQ Shelter

## Detailed Engineering Evaluation

### BU 1691-006 EQ2

## Qualitative Report

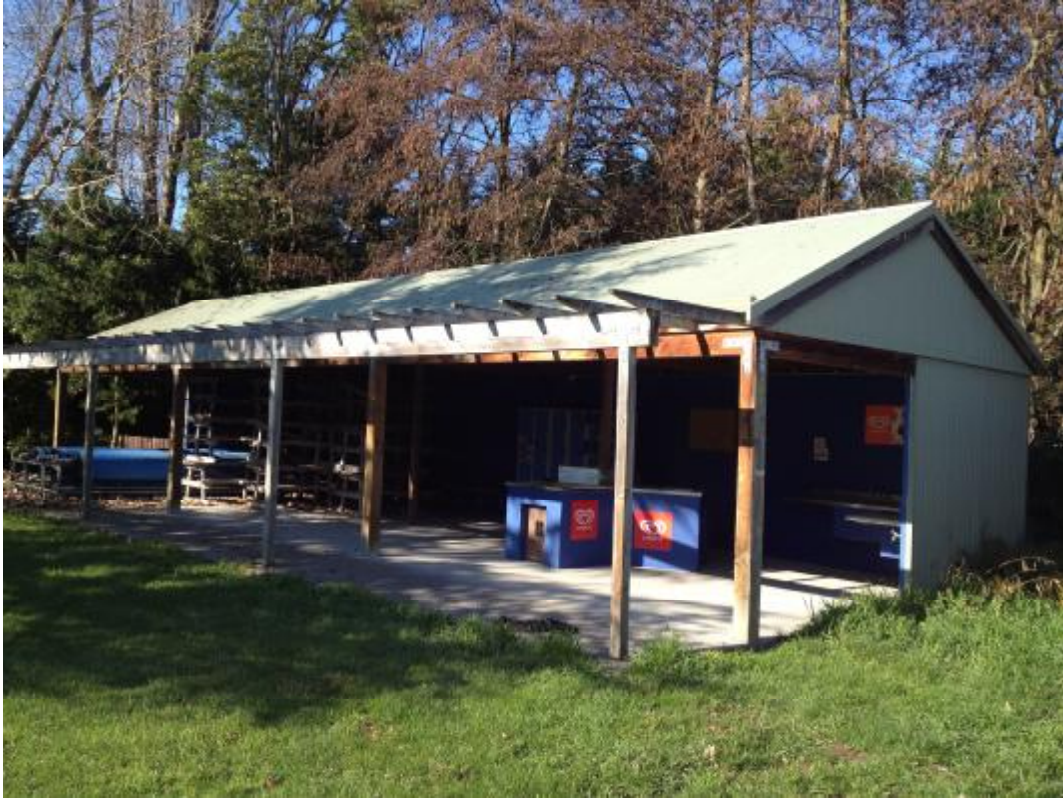
**Photo 1:** External view of the building with awning.

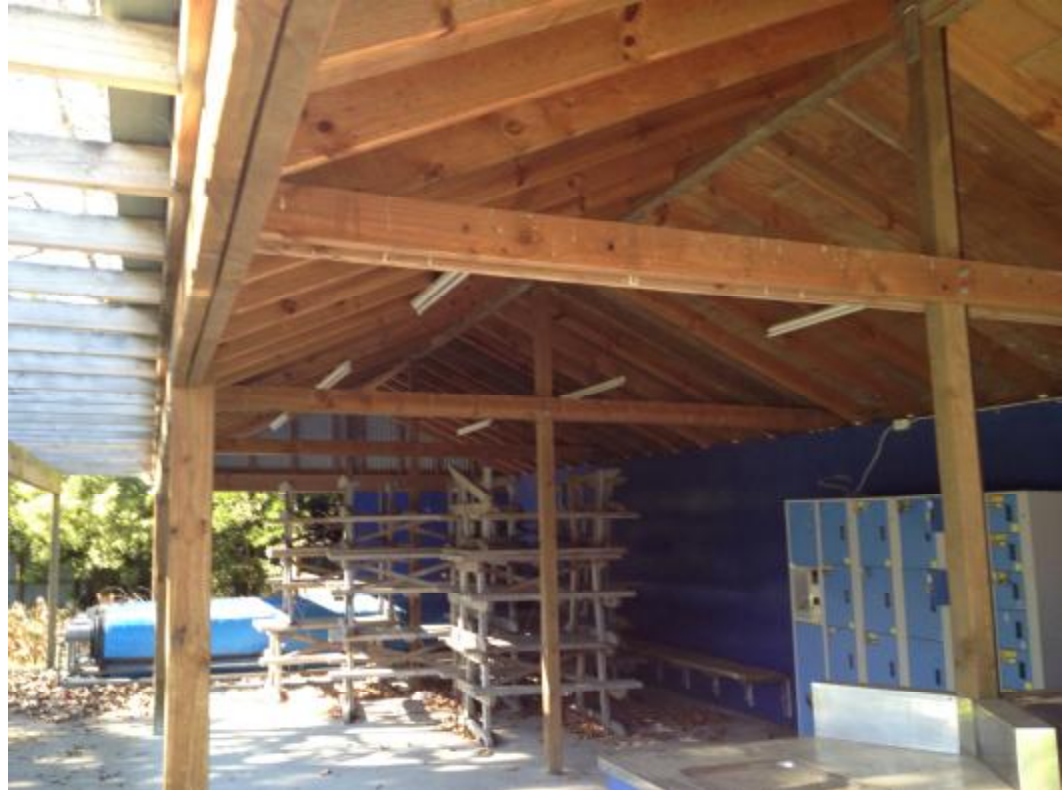
**Photo 2:** Internal view with the southern wall linings shown.

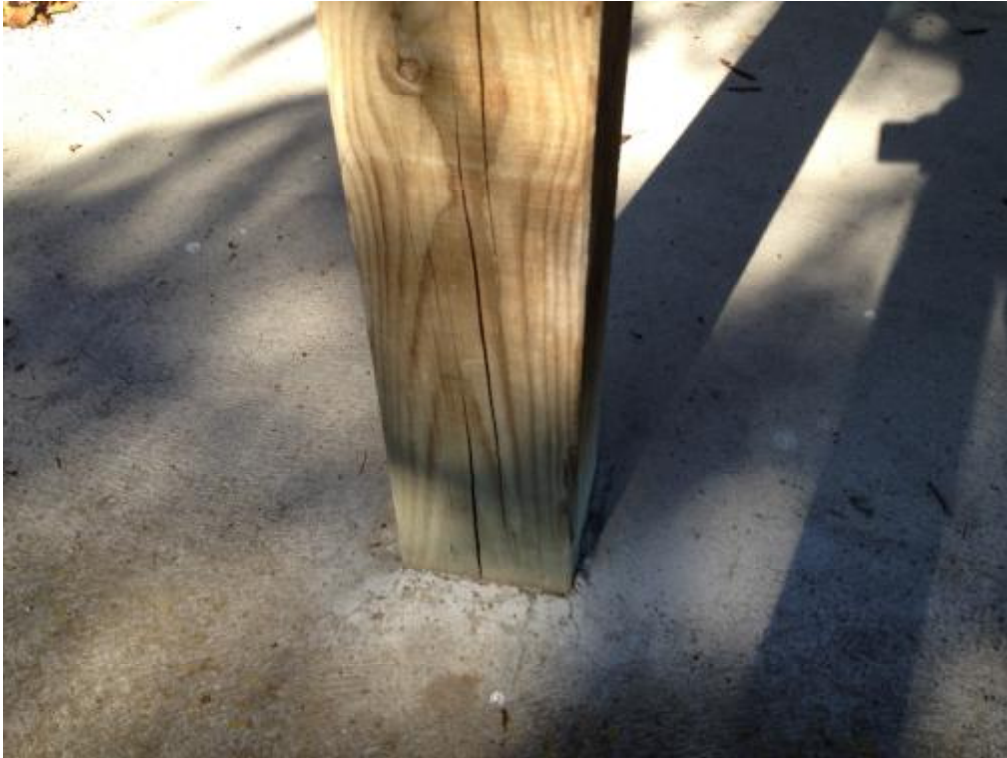
**Photo 3:** Timber column embedded into concrete slab.

**Damage Description:** Splitting/ Cracking of timber columns. Hairline cracks in concrete slab

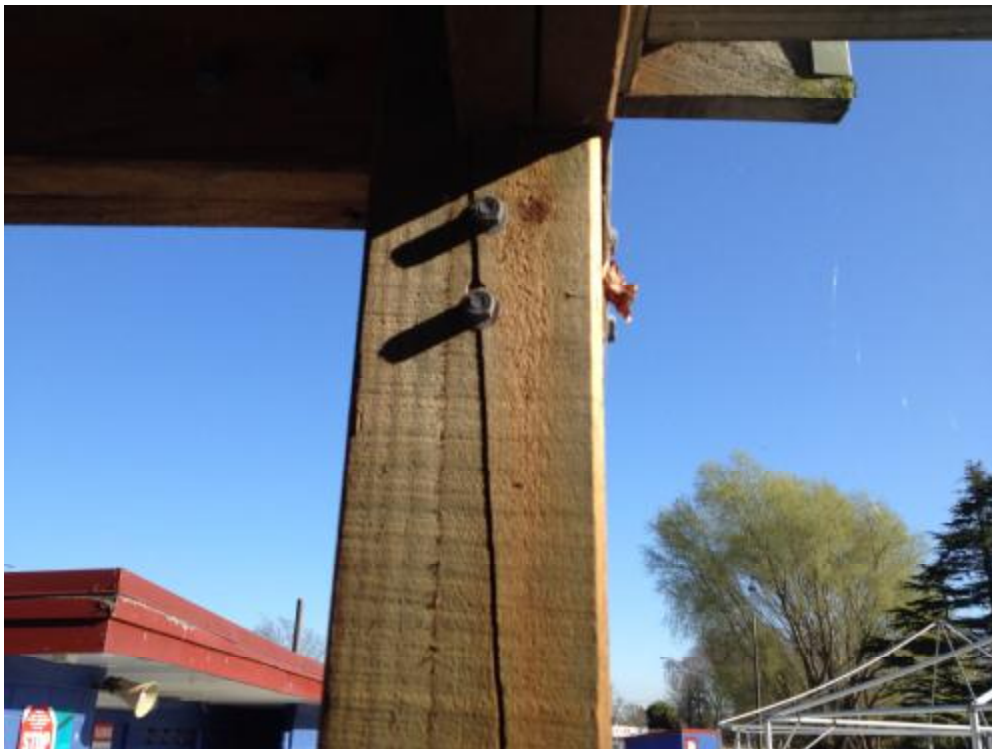
**Photo 4:** Typical column/beam connection

**Damage Description:** Splitting /Cracking of timber column near connection.

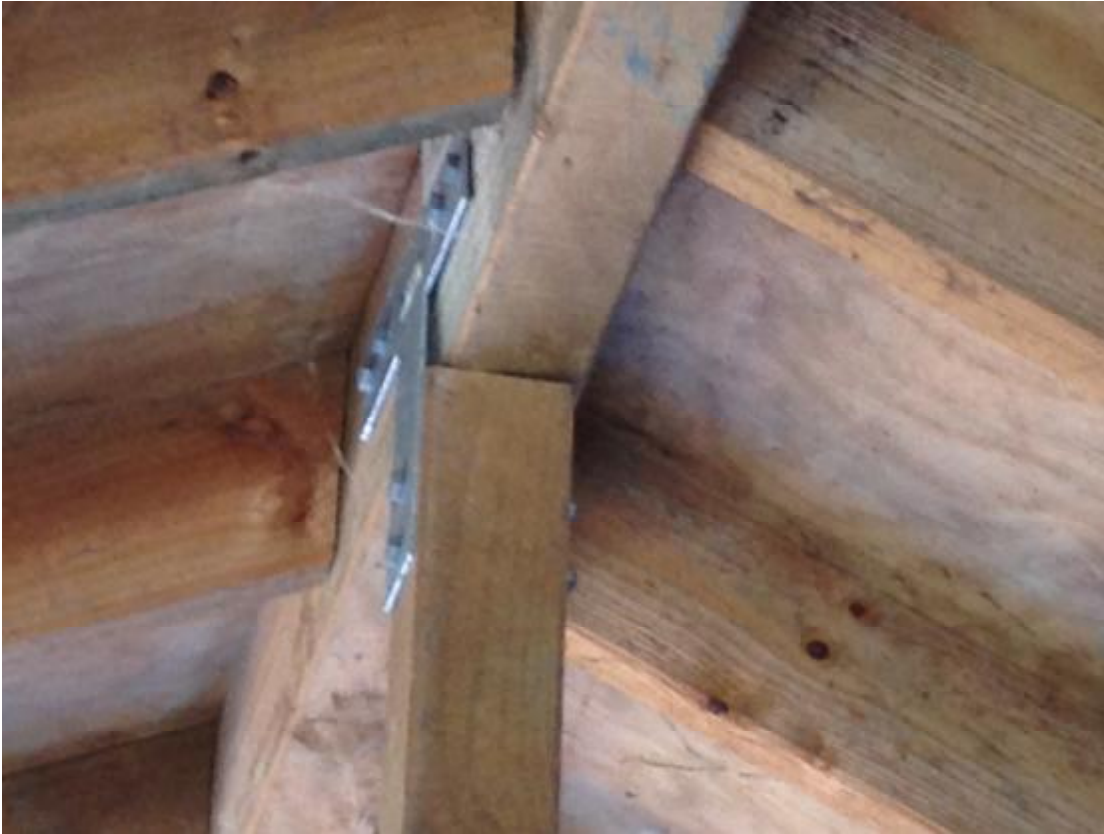
**Photo 5:** Ridge beam and rafter typical connection.

**Damage Description:** Ridge beam connection movement.
