Halswell Aquatic Centre, Waterslide Detailed Engineering Evaluation BU 1691-003 EQ2 Quantitative Report

Prepared for Christchurch City Council (Client)

By Beca Carter Hollings & Ferner Ltd (Beca)

4 October 2013

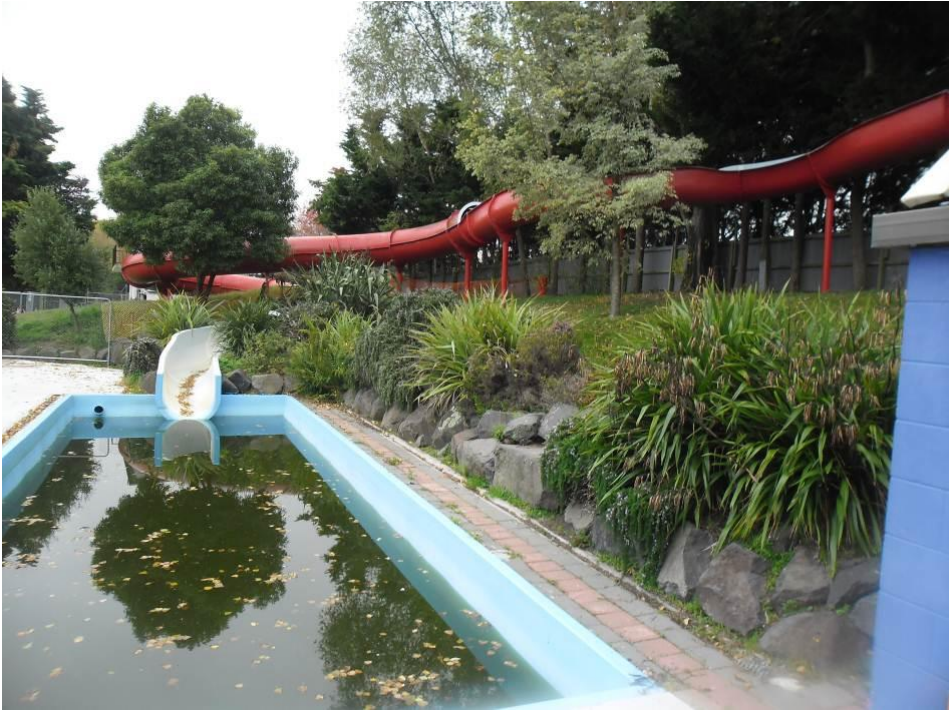
Photo 1: External view

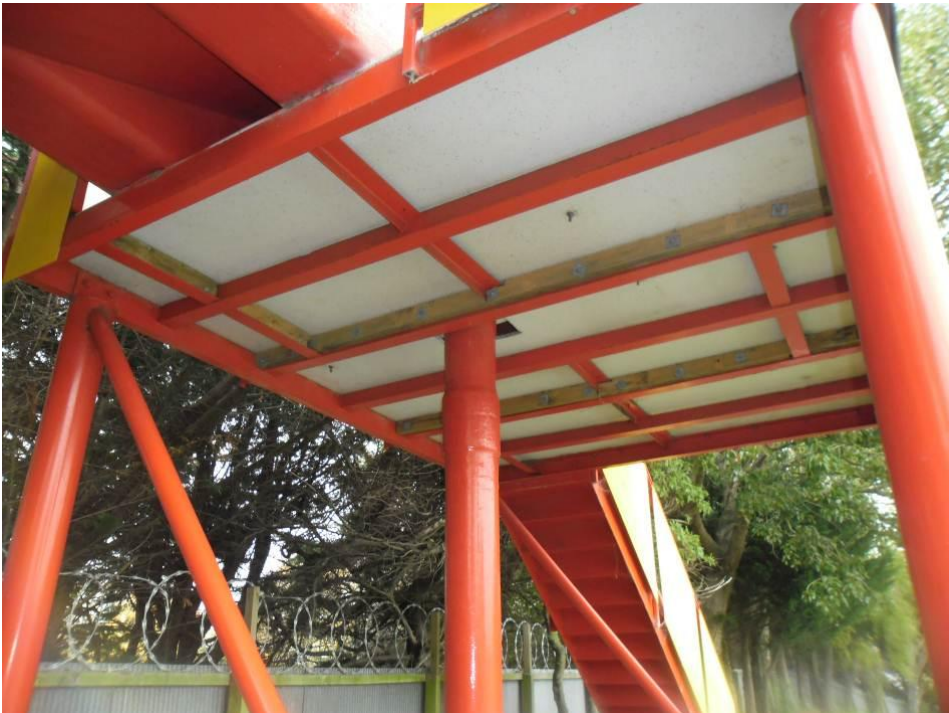
Photo 2: Underside of entrance platform

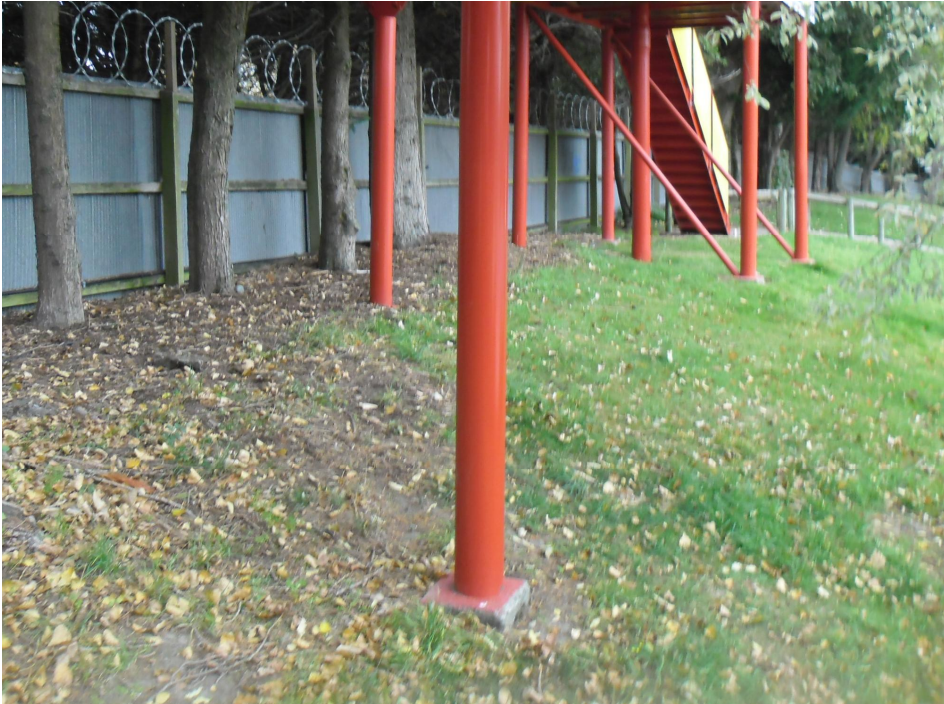
Intrusive investigations were carried out on the foundations on 4 February 2013 as part of the Level 5 quantitative assessment. This revealed that the foundations are 700mm in diameter and have a depth of 700mm minimum. Site measurements were undertaken on 9 November 2012 (refer Appendix B).

The intrusive investigation of the foundation was carried out to a depth of 700mm. Excavation was halted at this depth but the foundation may continue deeper.

Photo 3: Exposed part of foundation

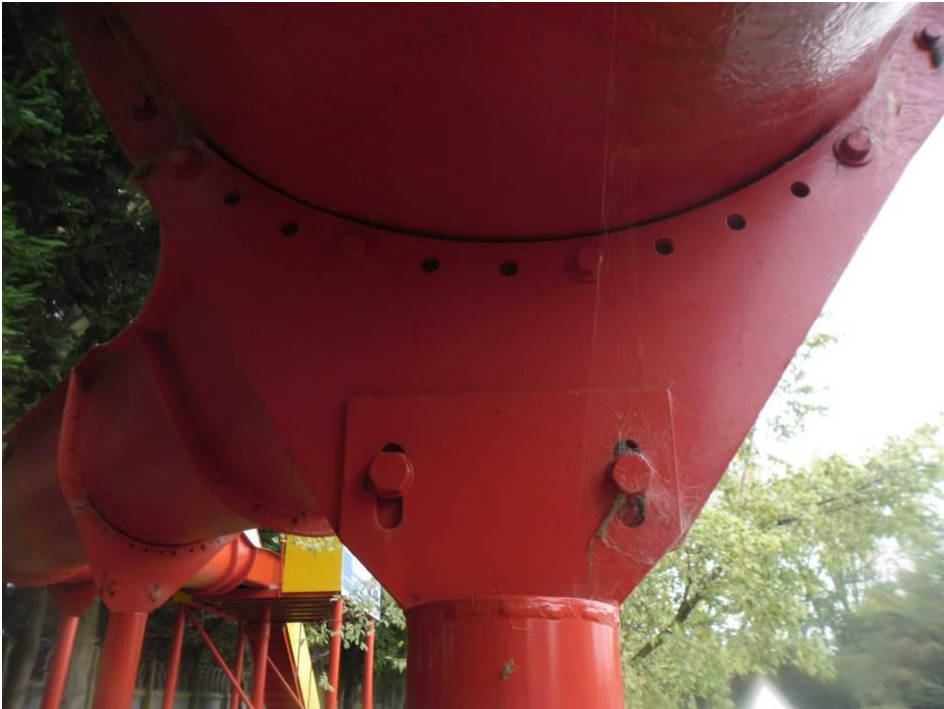
Photo 4: Connection between slide and cantilever support column
