**Halswell Courts
Housing Complex
PRO 1630**

**Detailed Engineering Evaluation
Quantitative Assessment Report**

Halswell, Christchurch

Date: November 2013
Reference: 6-QC355.00
Status: Final

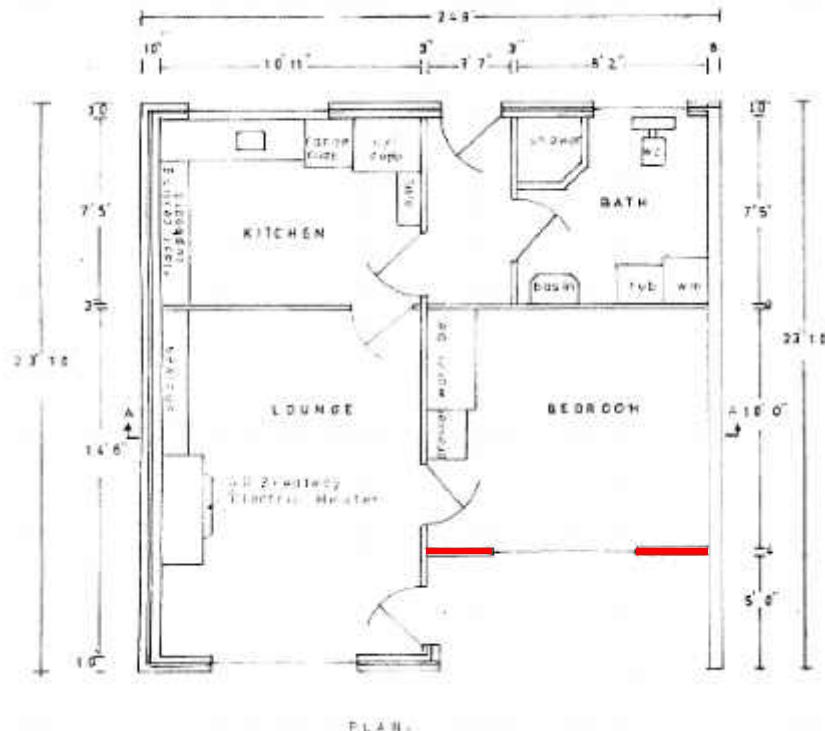
Figure 8: Location of critical walls (in red) governing the %NBS rating of the unit blocks.

Building	Loading Direction	Failure Mode, or description of limiting criteria based on displacement capacity of critical element.	% NBS based on calculated capacity.
Unit Blocks	Longitudinal	Bracing capacity of shear walls in the longitudinal direction.	58%
	Transverse	Bracing capacity of shear walls in the transverse direction.	>100%
	N/A	Out-of-plane failure of block masonry fire walls.	>100%
Garages	Longitudinal	Bracing capacity of shear walls in the longitudinal direction.	87%
	Transverse	Bracing capacity of shear walls in the transverse direction.	>100%

It is recommended that the residential unit blocks be strengthened to at least 67% NBS and the damaged walls, slabs and foundations are addressed.

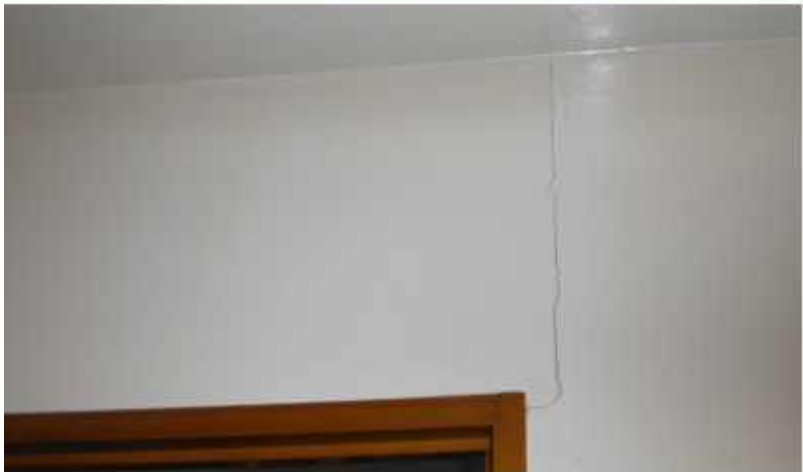
A photograph of a residential unit at Halswell Courts. The unit is a single-story house with a gabled roof and a light-colored exterior. A paved driveway leads to a dark-colored SUV parked on the right. A green lawn with a white fence runs along the front of the property. The sky is clear and blue.
<p>5</p>	<p>Typical cracking of wall linings from corners of doors.</p>

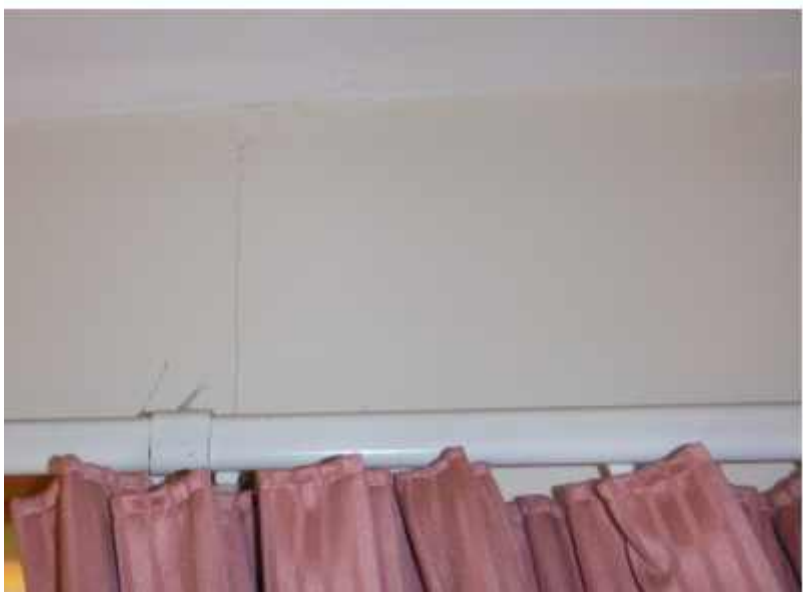
A close-up photograph of a white wall. A vertical crack is visible, starting from the top edge and extending downwards. The crack is located near the top corner of a wooden door frame, which is visible at the bottom of the image.
<p>6</p>	<p>Typical cracking of wall linings from corners of windows.</p>

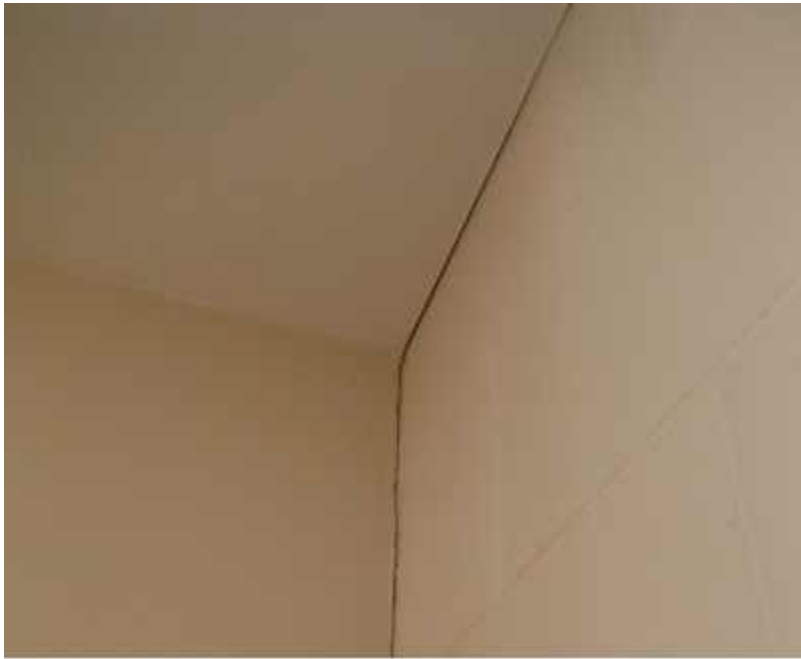
<p>7</p>	<p>Typical separation/cracking of timber walls and ceilings from block masonry firewalls.</p>

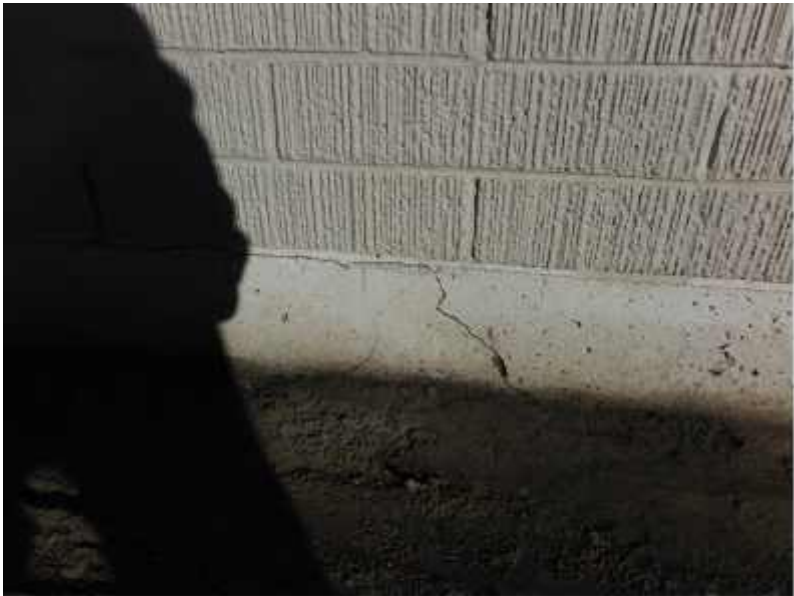
<p>9</p>	<p>Typical cracking to external surface of concrete foundations.</p>

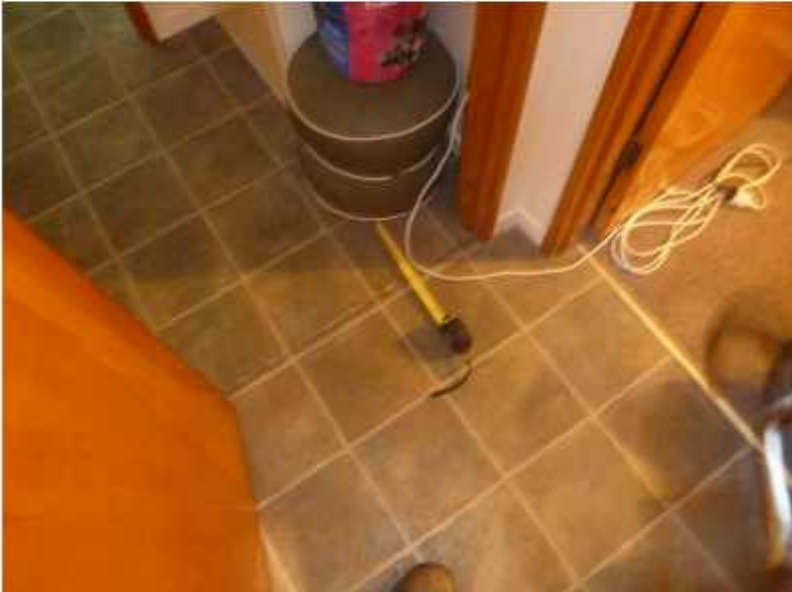
Damage to the foundations of the units included extensional cracking (up to 10mm wide) in the concrete slab of Unit 8 and minor external cracking to the ground slabs of Unit 3, Unit 6, Unit 7 and Unit 13.

A photograph showing the external surface of a concrete foundation. The concrete has a vertical ribbed texture. A vertical crack is visible, extending from the top of the foundation down to the ground level. A dark shadow is cast on the left side of the wall.
<p>10</p>	<p>Extension crack to slab of Unit 8.</p>

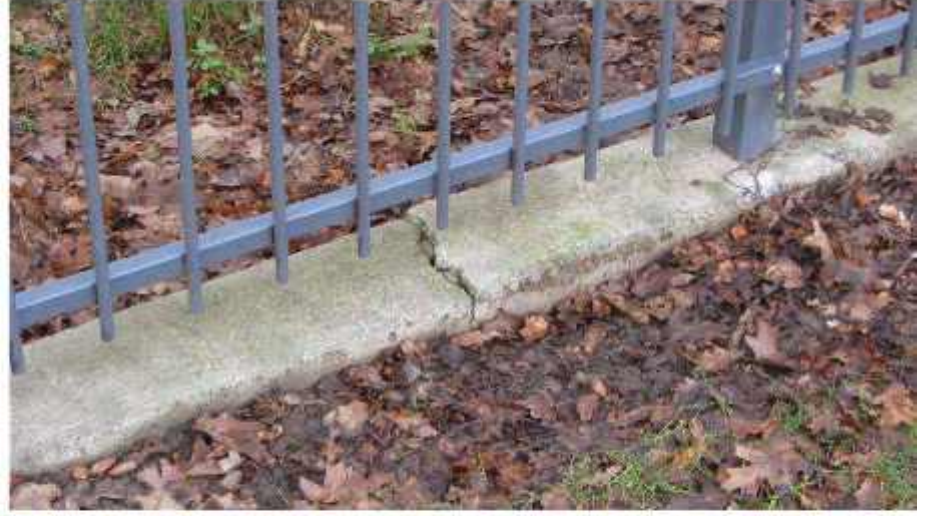
Photo 10: View Cracked Southern Fence Foundation, Looking Southwest

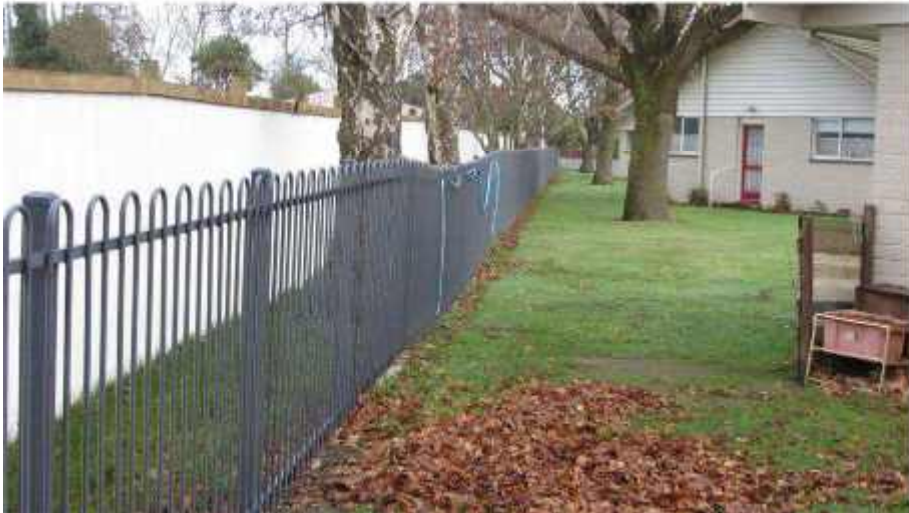
Photo 11: View of Southern Fence Distortion, Looking West

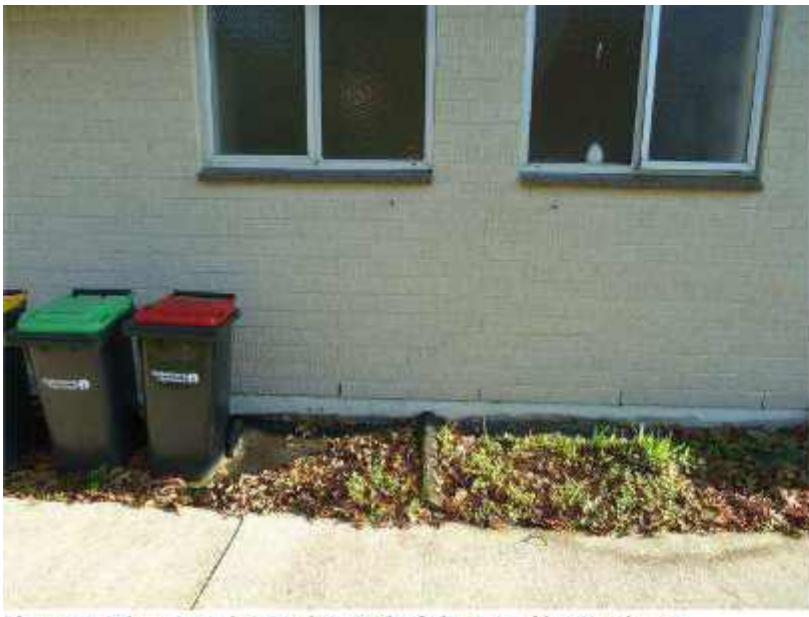
Photo 21: Minor Stepping Crack at Back of Flat 6, Looking Northwest

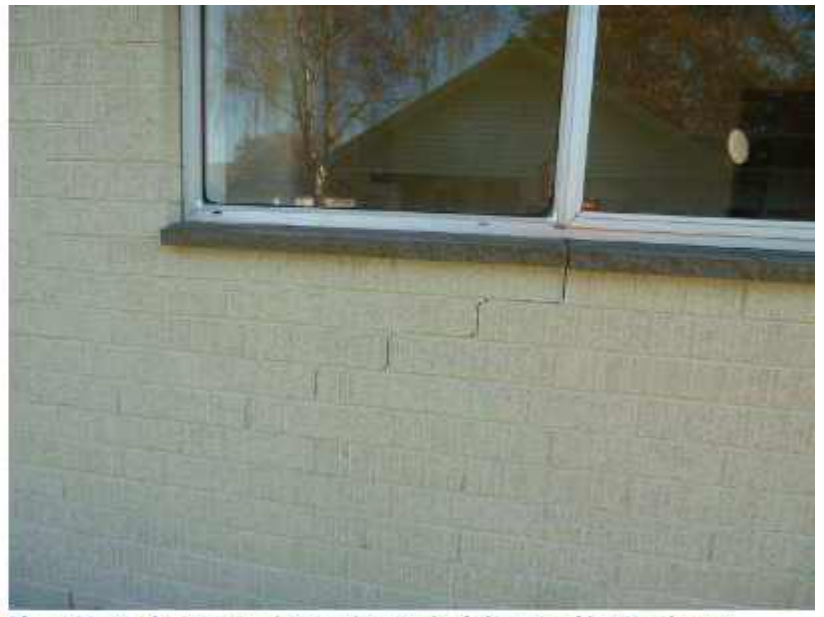
Photo 22: Moderate Stepping Crack at Back of Flat 7, Looking Northwest

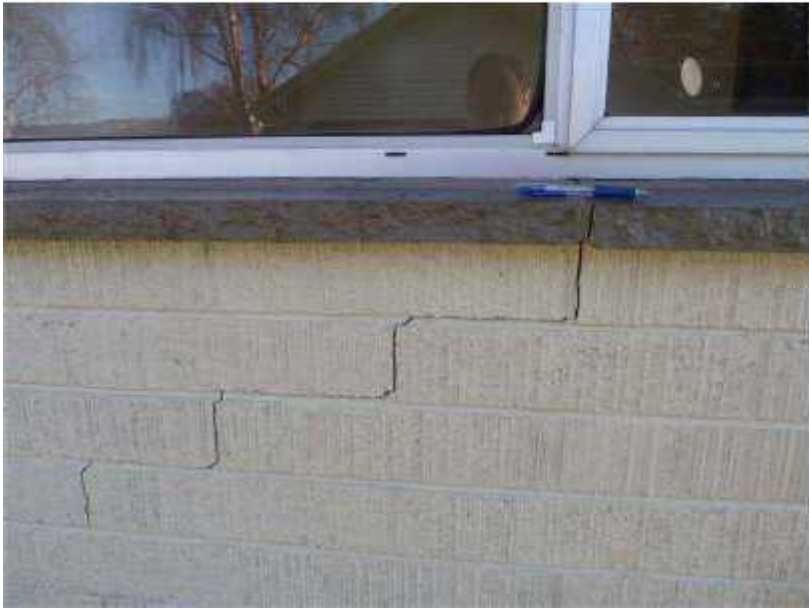
Photo 23: Moderate Stepping Crack at Back of Flat 7, Looking Northwest

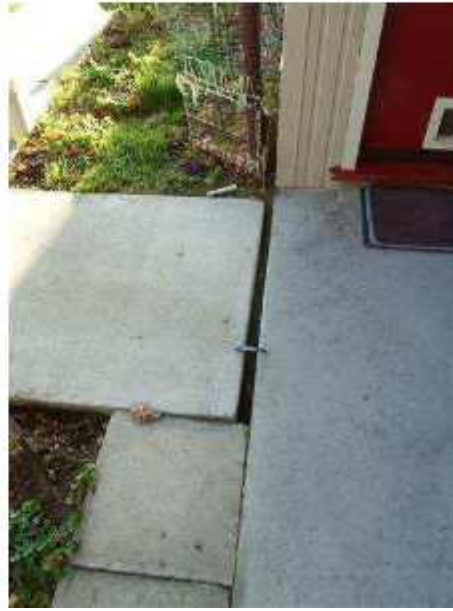
Photo 24: Displacement in Concrete Footpath at Front of Flat 15, Looking Northeast

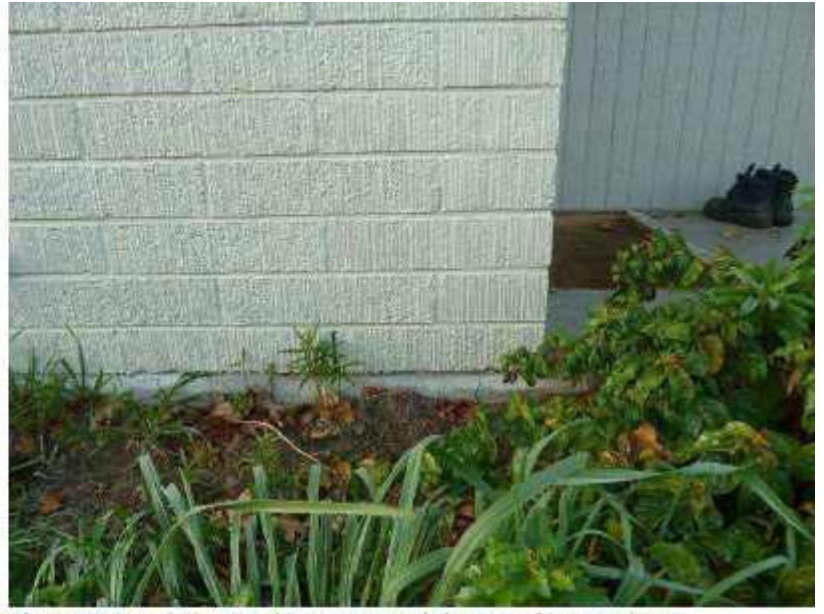
Photo 26: Foundation Cracking at Front of Flat 8, Looking Southeast

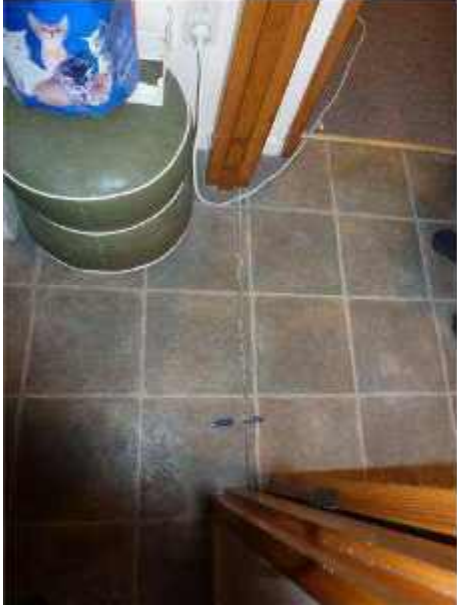
Photo 27: Cracking of Concrete Slab Floor in Flat 8

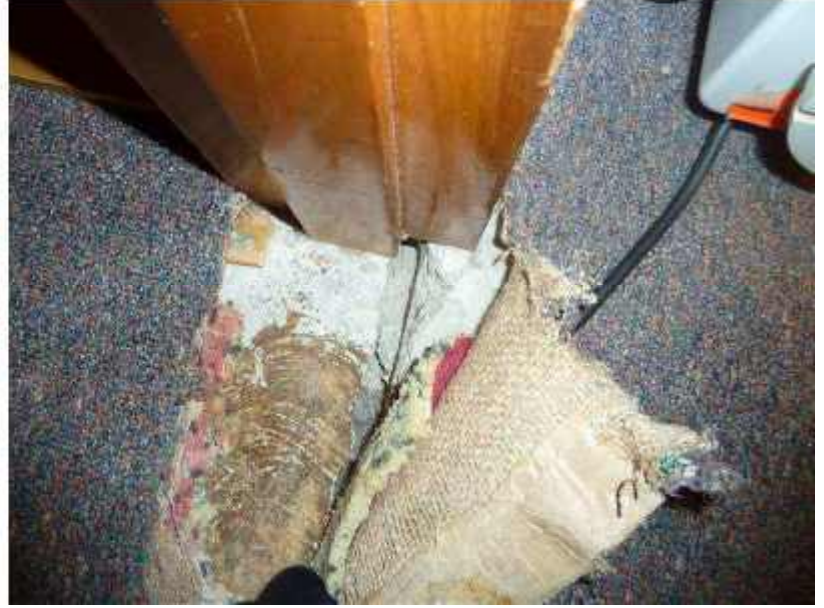
Photo 28: Cracking of Concrete Slab Floor in Flat 8

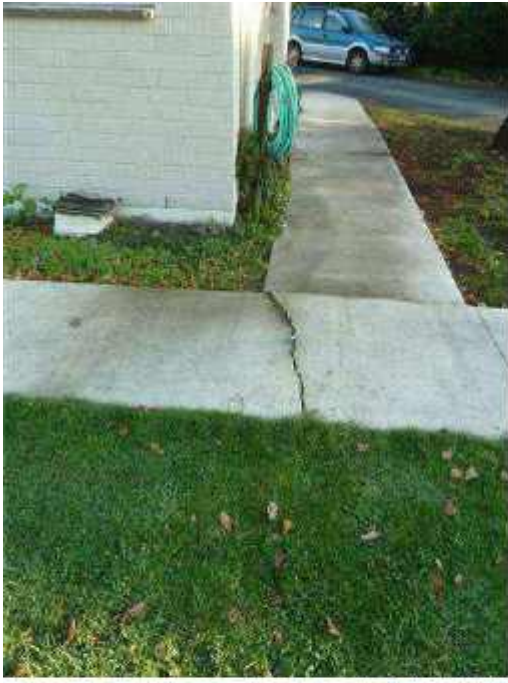
Photo 29: Cracking of Concrete Footpath Behind Flat 6, Looking Northwest

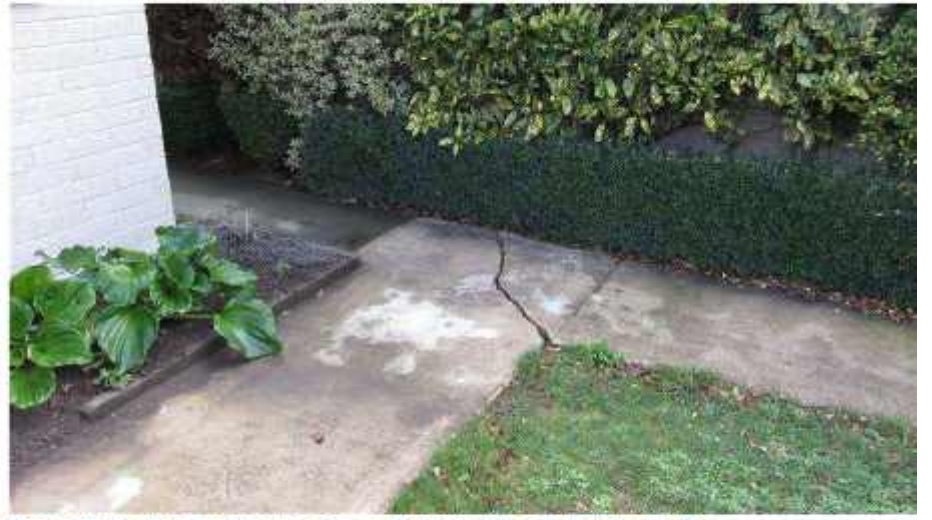
Photo 30: Cracking of Concrete Footpath behind Flat 1, Looking North

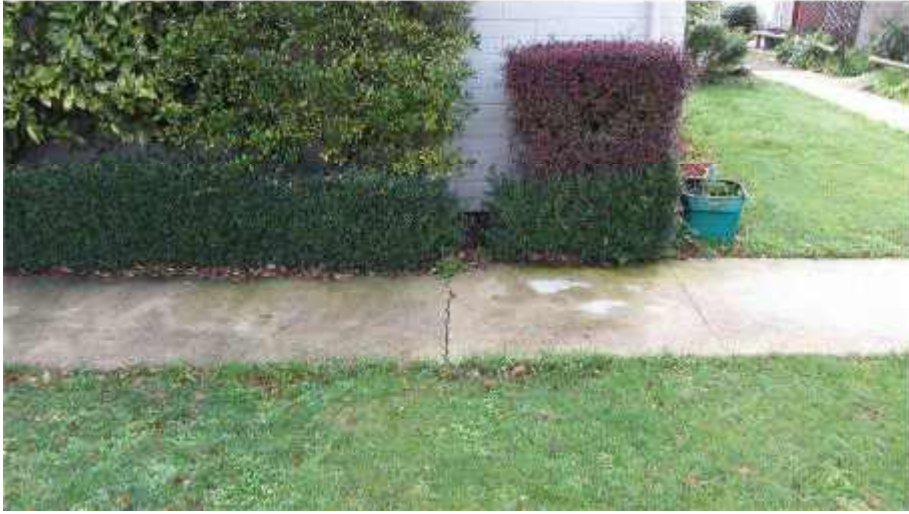
Photo 31: Cracking of Concrete Footpath behind Flat 1, Looking Northeast

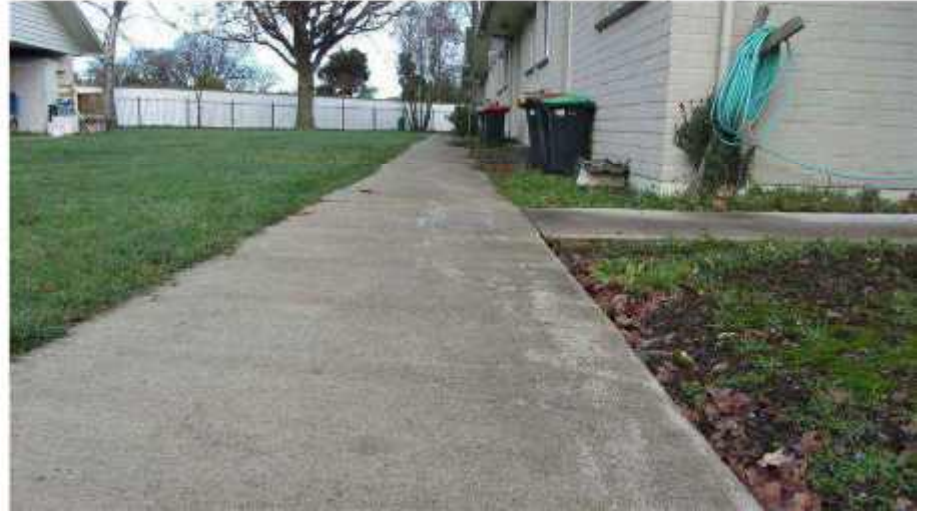
Photo 32: Subsidence Tilting of Concrete Footpath behind Flats 6-8, Looking Southwest
