**Harold Denton Place  
Housing Complex  
PRO 0618**

**Detailed Engineering Evaluation  
Quantitative Assessment Report**

**163 Springfield Road, St Albans,  
Christchurch 8014**

Date: September 2013  
Reference: 6-QC357.00  
Status: Final

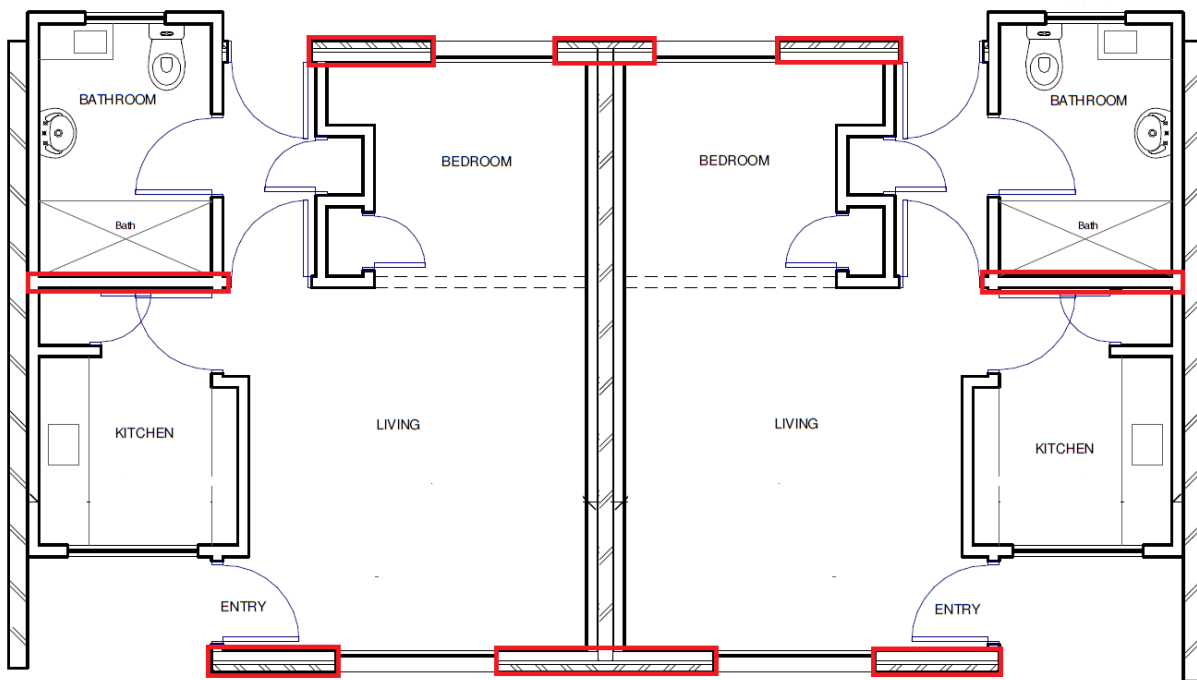
Figure 6: Walls used for bracing in the longitudinal direction.

The residential units have capacities of 58% NBS and are limited by the in-plane shear capacity lined timber-framed shear walls in the longitudinal direction.

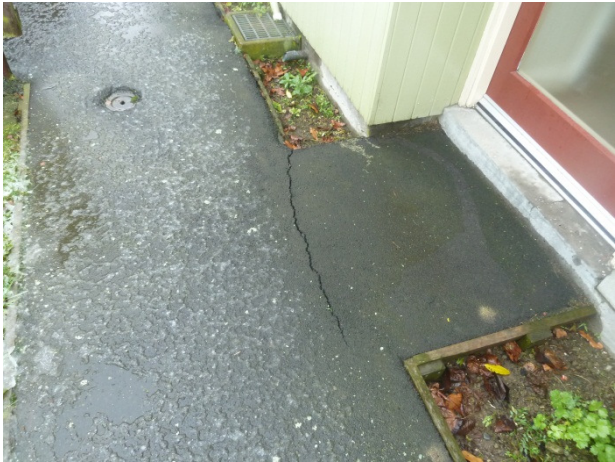
7	Cracking of exterior paving.

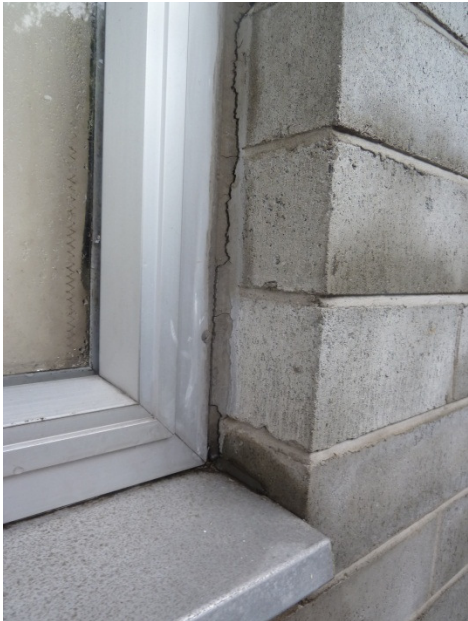
Cracking in the brick and block veneer exterior cladding mortar joints was observed on some units (Photos 8 & 9). This is not widespread throughout the units.

A photograph showing a close-up of a dark asphalt or concrete paving surface. A prominent vertical crack runs down the center of the frame. To the right, a portion of a light green wall and a red door frame are visible. A small circular drain is located on the left side of the paving.
8	Cracking of block veneer mortar joint.

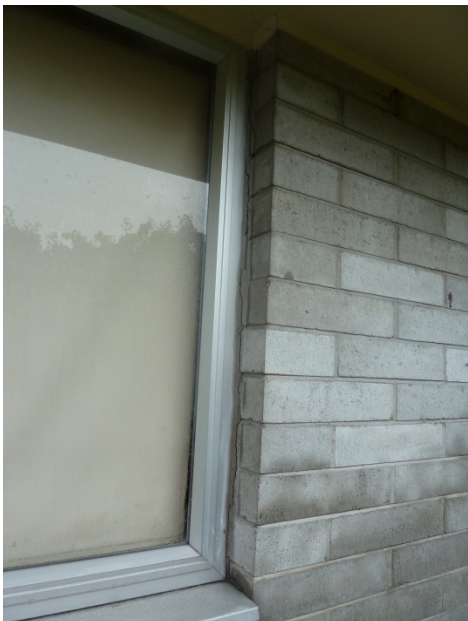
A photograph showing a close-up of a concrete block veneer wall. A vertical crack is visible in the mortar joint between two blocks. A white door frame and a concrete step are visible on the left side of the image.
9	Cracking of block veneer mortar joint.

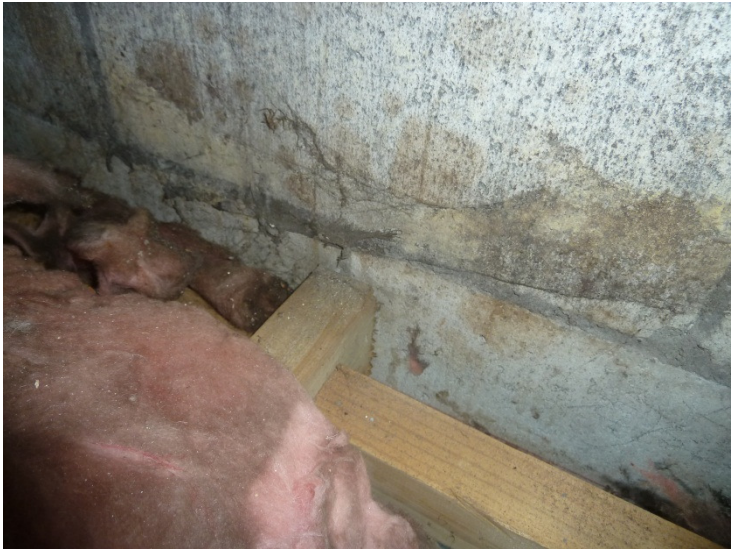
10	Typical roof cavity.

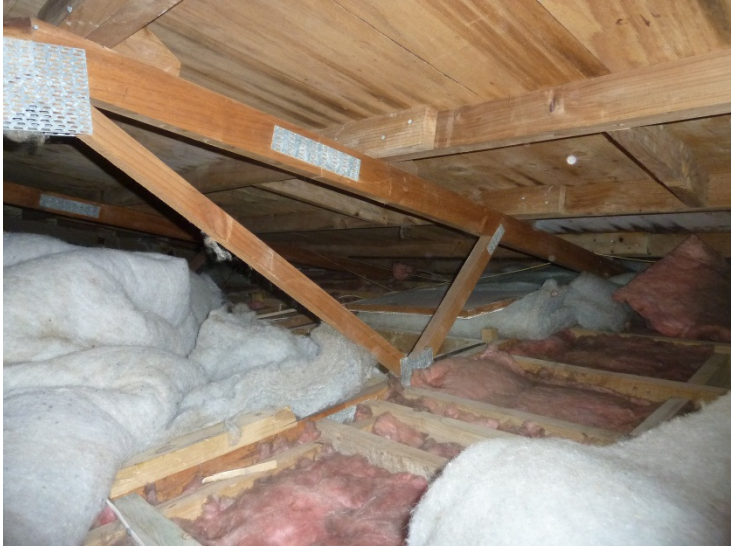
11	Typical roof cavity.

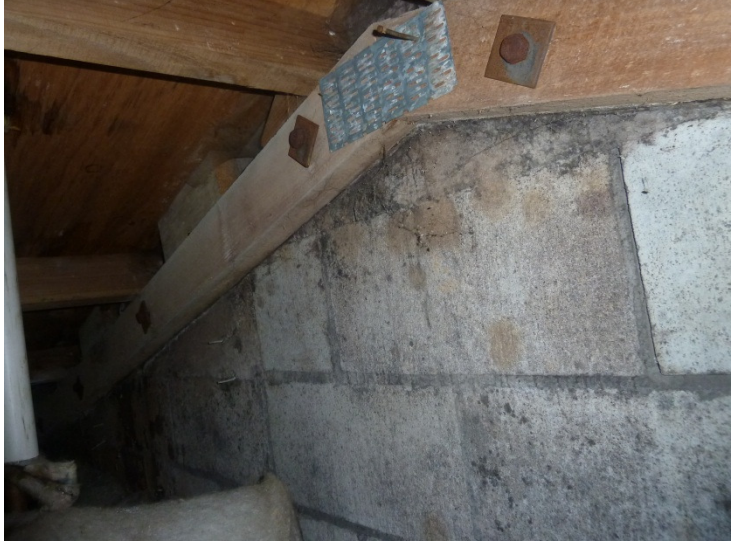
12	Connection of roof to fire wall.
