Hennessy Place Housing Complex PRO 1093

**Detailed Engineering Evaluation
Quantitative Assessment Report**

**2 Hennessy Place, Spreydon,
Christchurch 8024**

Date: August 2013
Reference: 6-QC358.00
Status: Final

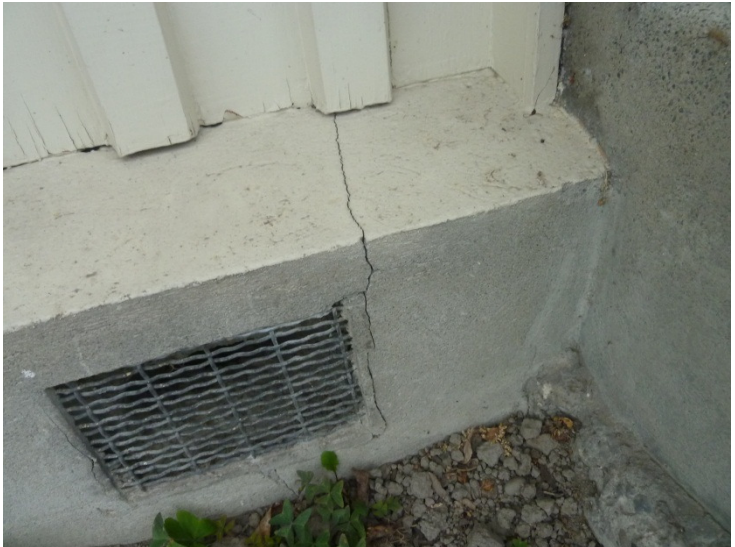
In all block units 0.1-1mm wide cracks can be observed in the concrete perimeter wall, these are commonly located around the sub floor ventilation gaps (photo 4). A small area of spalling is evident in the perimeter footing of Unit 2 which exposes reinforcing bars (photos 5 and 6). Access to view the timber subfloor framing was limited to a visual assessment through a floor access hatch in Unit 18.

4	Typical cracking of concrete perimeter foundation footing.

- Undertake remedial repair works to foundations, wall cracks and cosmetic damage.
- Repair exposed reinforcing bar in the perimeter footing of unit 2.

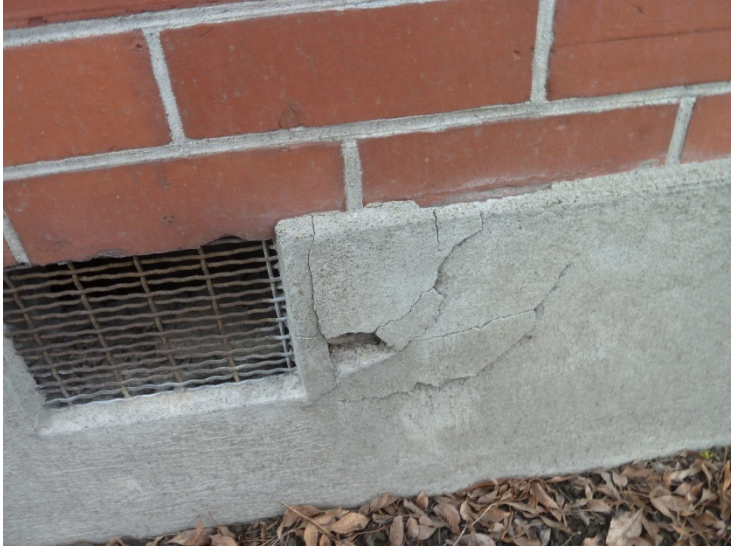
Structural damage to the residential units was generally minor and was limited to the cracking of the ceiling diaphragm and concrete foundation perimeter footing in some residential unit blocks. In one instance, spalling of the perimeter footing has exposed a portion of reinforcing bar.

5	Spalling of concrete perimeter foundation footing (unit 2).

Repair exposed reinforcing bar in the perimeter footing of unit 2.

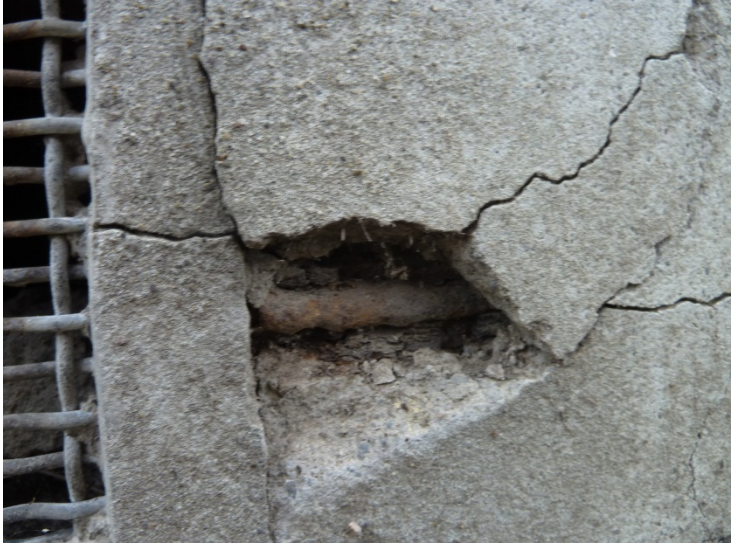
6	Reinforcing bars exposed from spalling of foundation footing (unit 2).

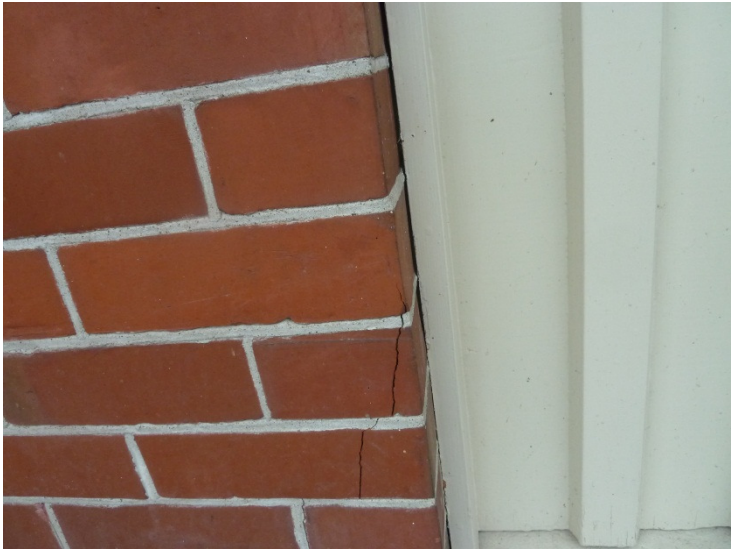
Cracking of the mortar and in the brick veneer exterior cladding itself was observed on some units (Photo 7) along with a displaced brick in unit 2 (photo 8). This form of damage is not widespread throughout the units.

7	Crack in brick veneer.

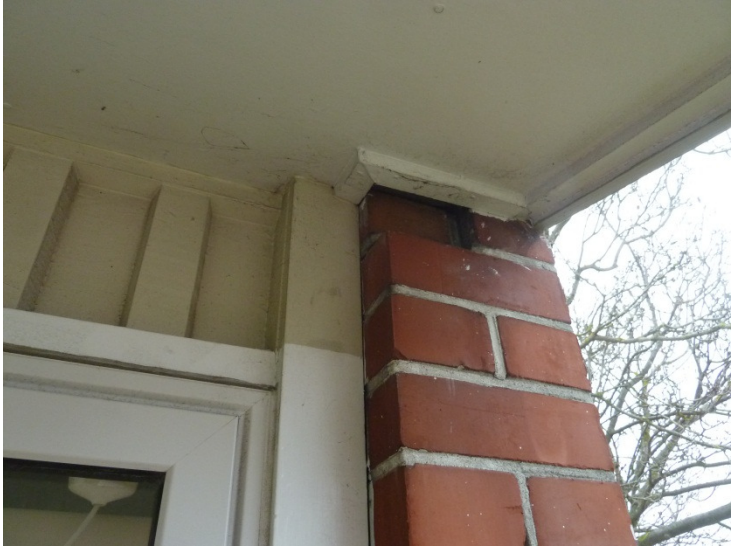
8	Displaced brick veneer block (unit 2).

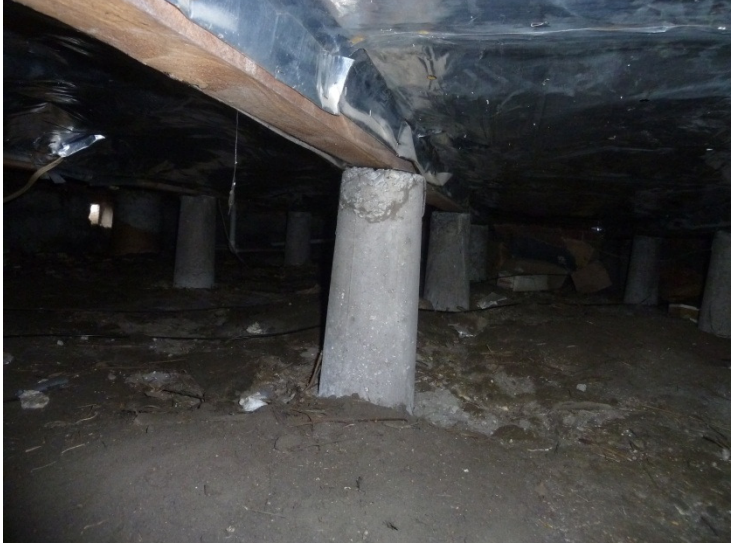
9	Typical timber framed subfloor with ordinary concrete piles.

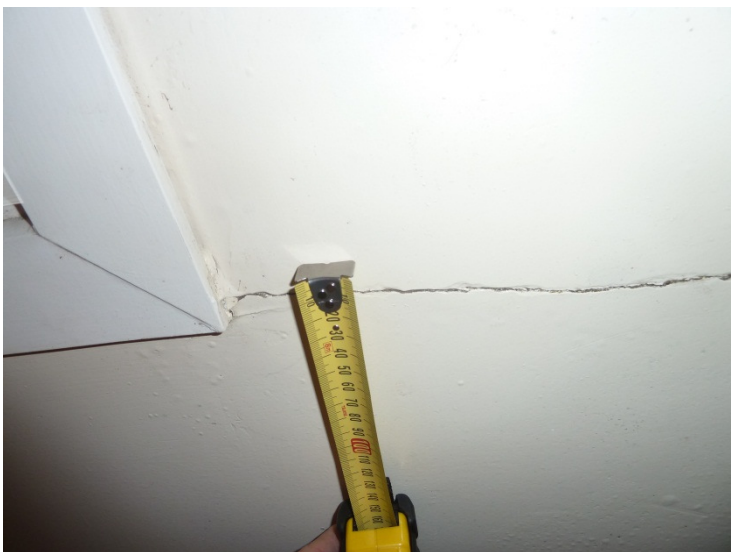
Some cracking of GIB ceiling diaphragms and wall linings was observed in many of the units, particularly surrounding window and door openings (photo 10). This was consistent throughout all the units visited.

10	Typical cracking of GIB wall linings, particularly around window openings.

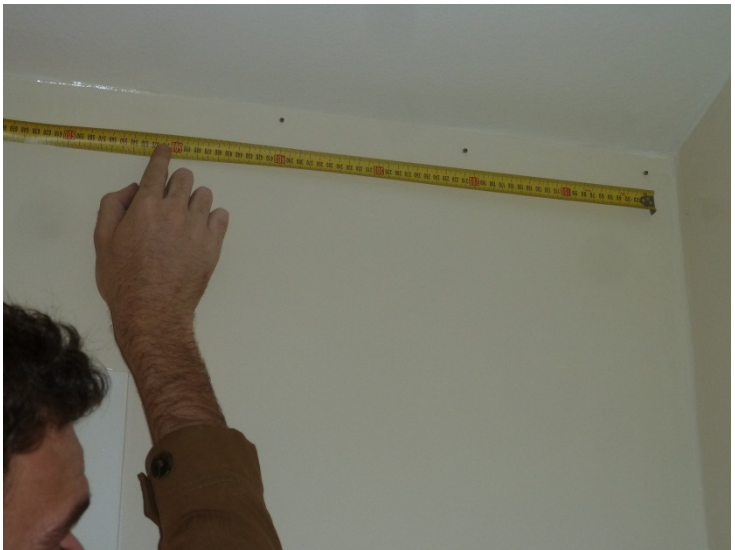
11	Typical 200mm spacing of GIB lining fixings.
