Hillsborough Park Pavilion
PRK_0962_BLDG_001
Detailed Engineering Evaluation
Qualitative Report
Version Final

Christchurch City Council

Date
23 May 2013

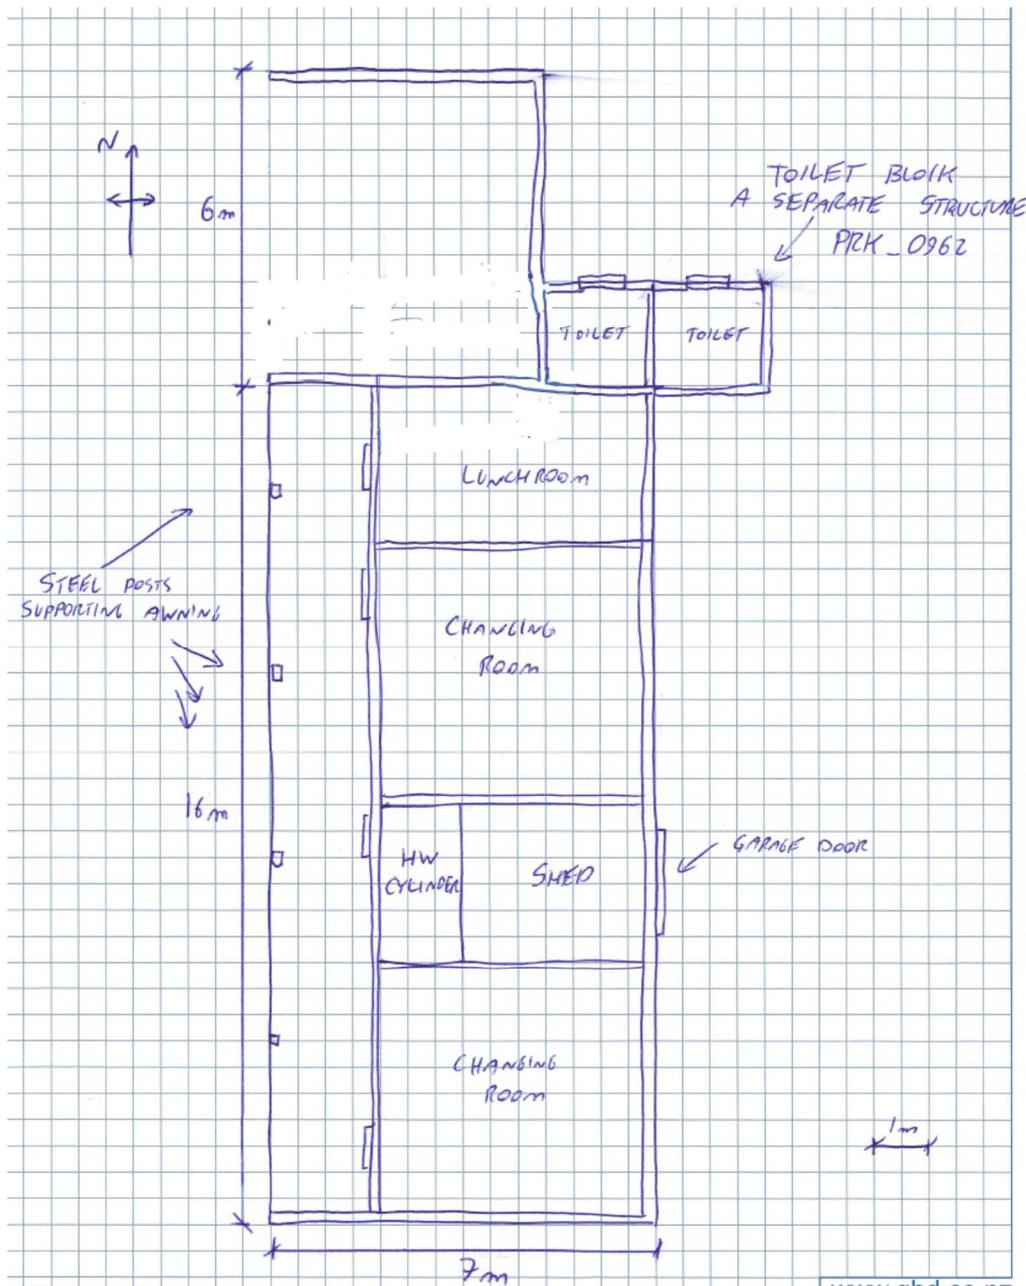
Figure 2 Plan Sketch Showing Key Structural Elements

The building is a single row of filled or partially filled concrete blockwork masonry. The single storey construction has a concrete slab on grade floor. The timber beam roof consists of lightweight metal cladding with a single plastic skylight panel supported by timber purlins and beams.

The dimensions of the pavilion building are 16m long by 7m wide and 3.6m high at the apex. This area includes a 2m wide veranda covered by a canopy on the western side of the building. The canopy is supported by end walls and 4 steel support posts.

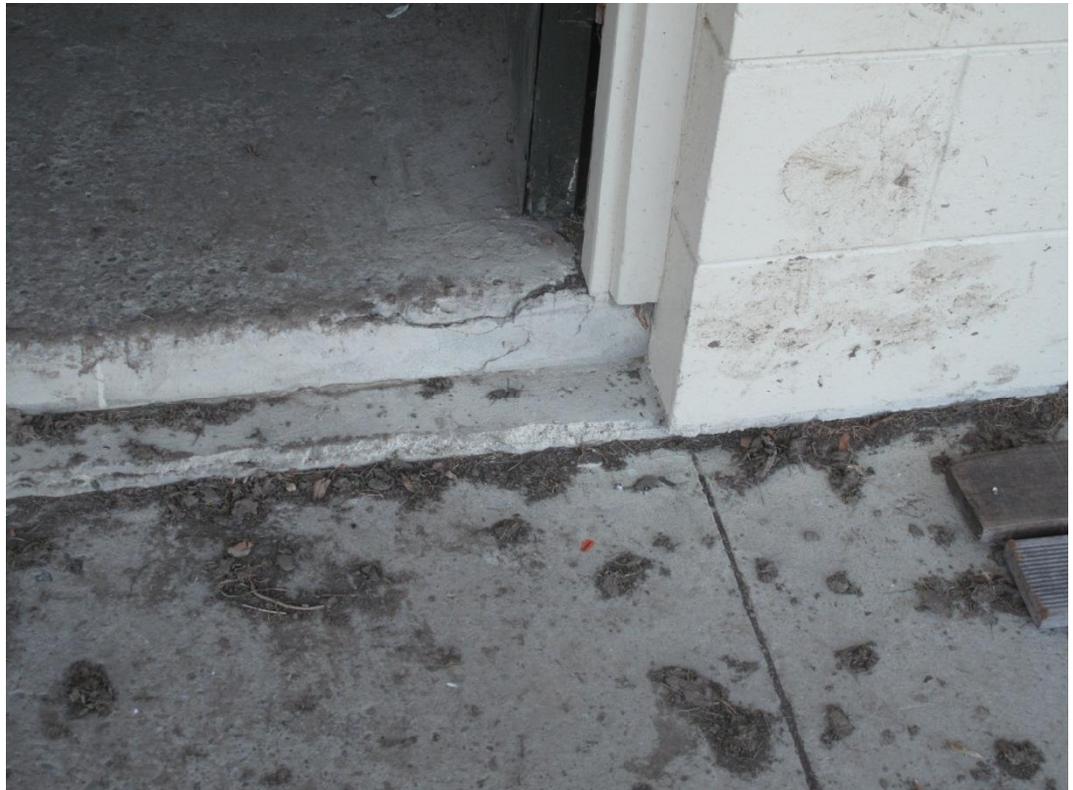
The only visible external damage was minor cracking at the edges of the concrete slab on grade around the door areas.

Photograph 4 Minor cracking at edges of slab on grade

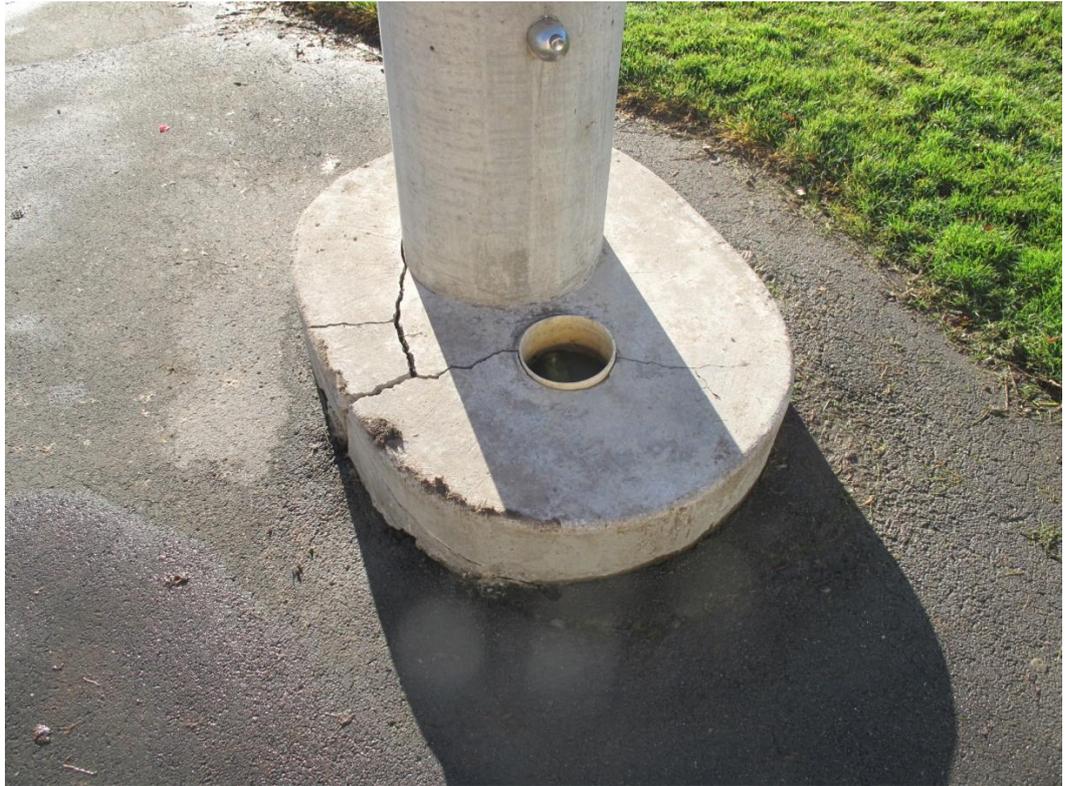
With regards to the adjacent drinking foundation concrete foundation significant damage was observed. Shear failure has occurred both along and across the foundations with the largest crack width 30 mm. The cracks are evident in Photographs 5 and 6 in Appendix A. In addition pieces of concrete have been displaced and are now missing.

Photograph 5 Cracking in base of adjacent drinking fountain.

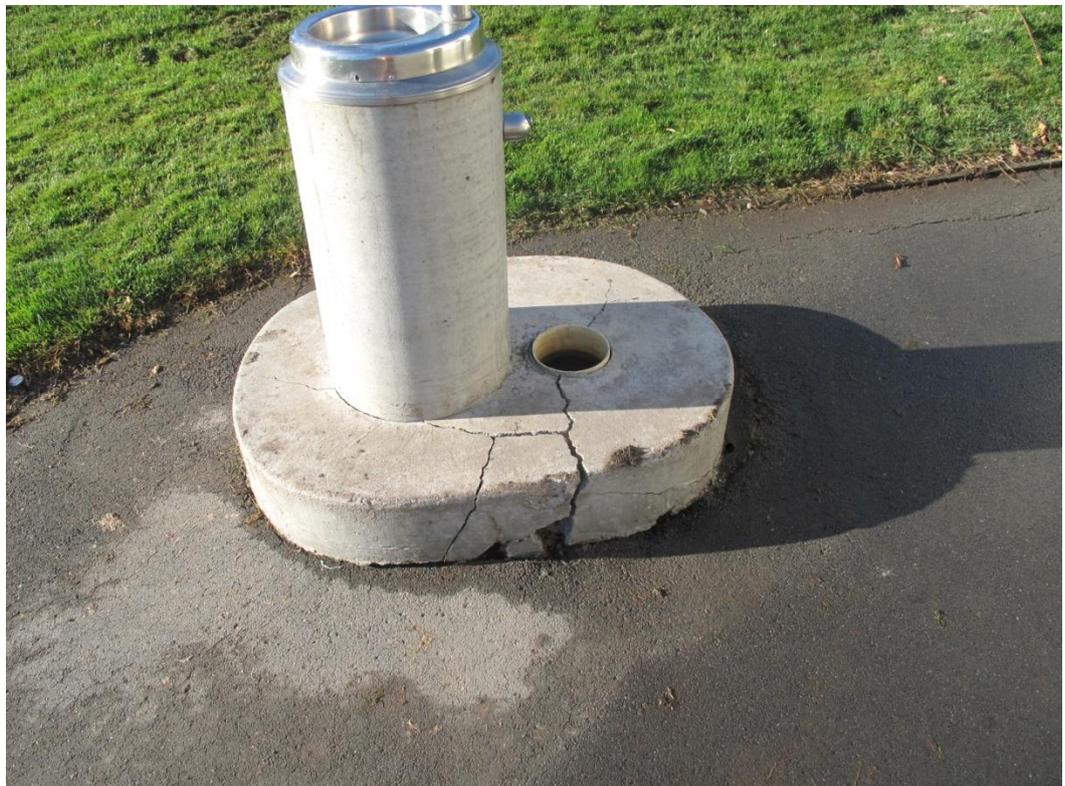
Photograph 6 Cracking and loss of concrete in base of drinking fountain.
