CHRISTCHURCH CITY COUNCIL

PRK_0722_BLDG_001_EQ2

Horseshoe Lake Reserve - Toilet

QUALITATIVE ASSESSMENT REPORT

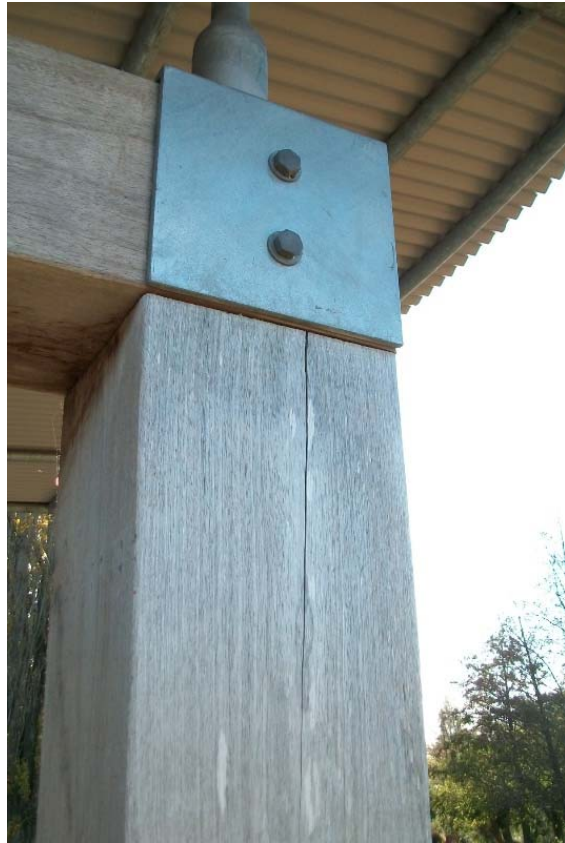
- 1) Cracking in timber beams and columns along the grain

Photo 5: Cracking along the grain of one of the South timber columns (typical).

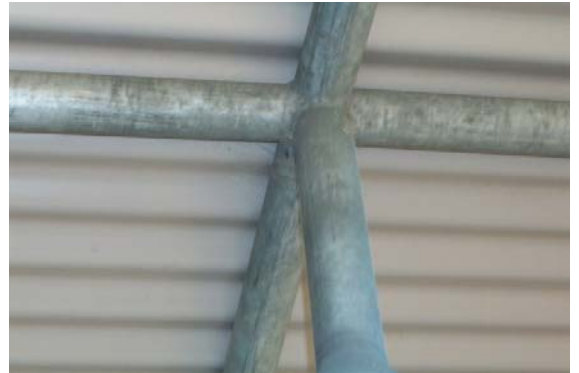
Photo 6: Connection detail of steel grid frame supporting the roofing.

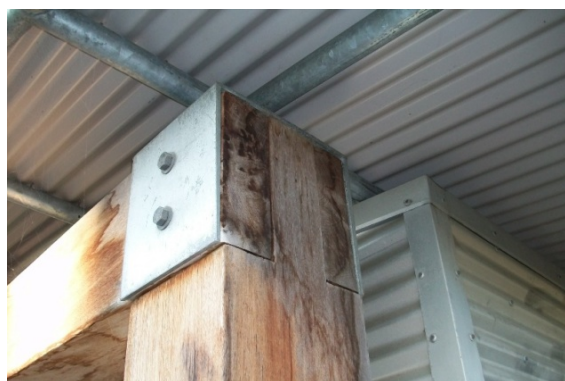
Photo 7: Beam-column connection detail of timber portal frame on West side of building (typical).

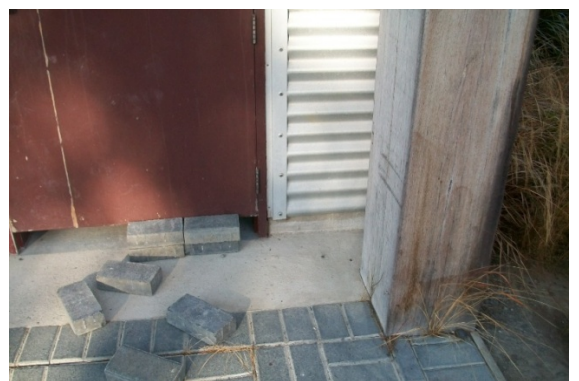
Photo 8: No damage to foundation slab (North side of building shown, typical).

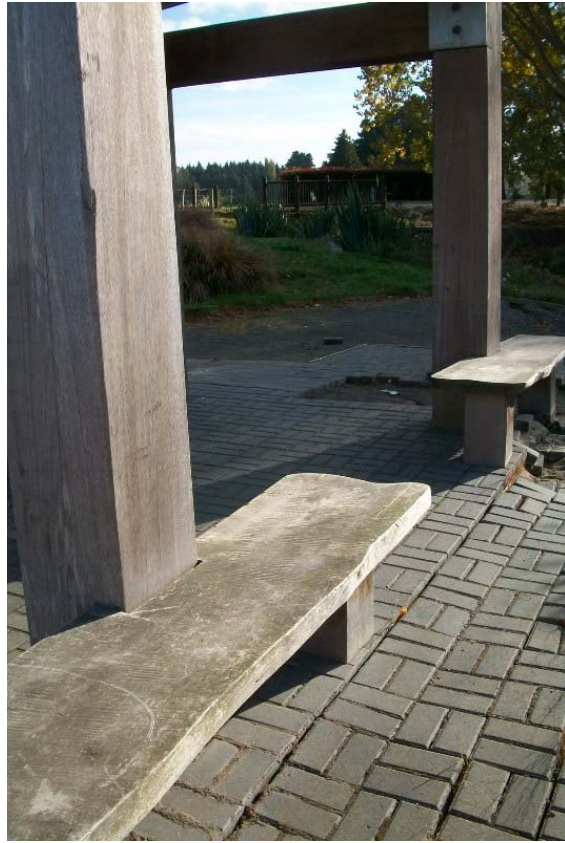
Photo 13: Ground movement in front of the East side of the building.

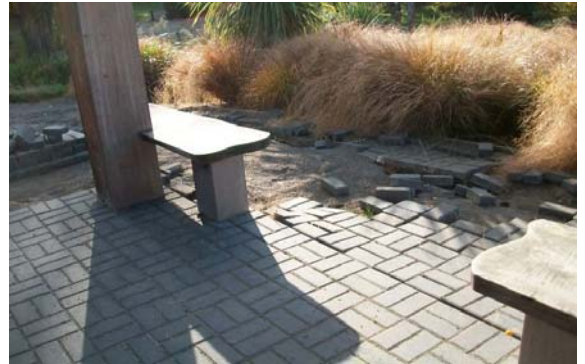
Photo 14: Ground movement in front of the East side of the building.

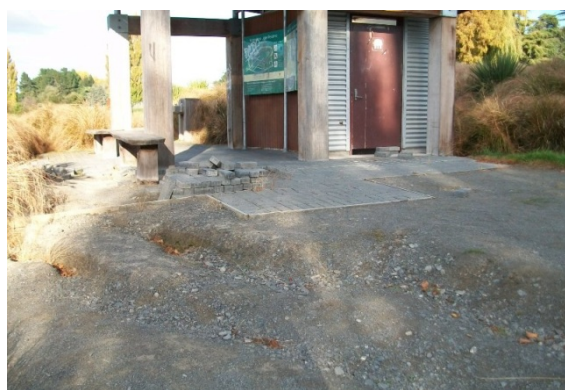
Photo 15: Ground movement around the building.

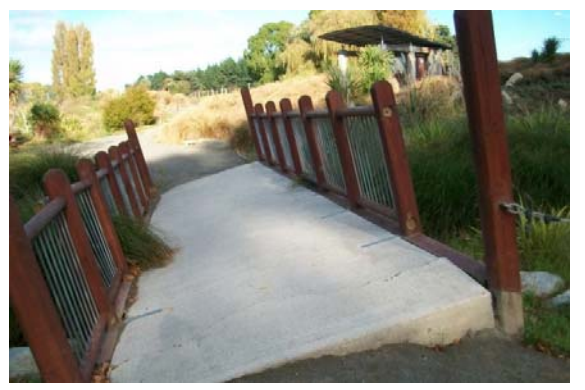
Photo 16: Ramp angled and cracked showing evidence of ground movement Northeast of the building.

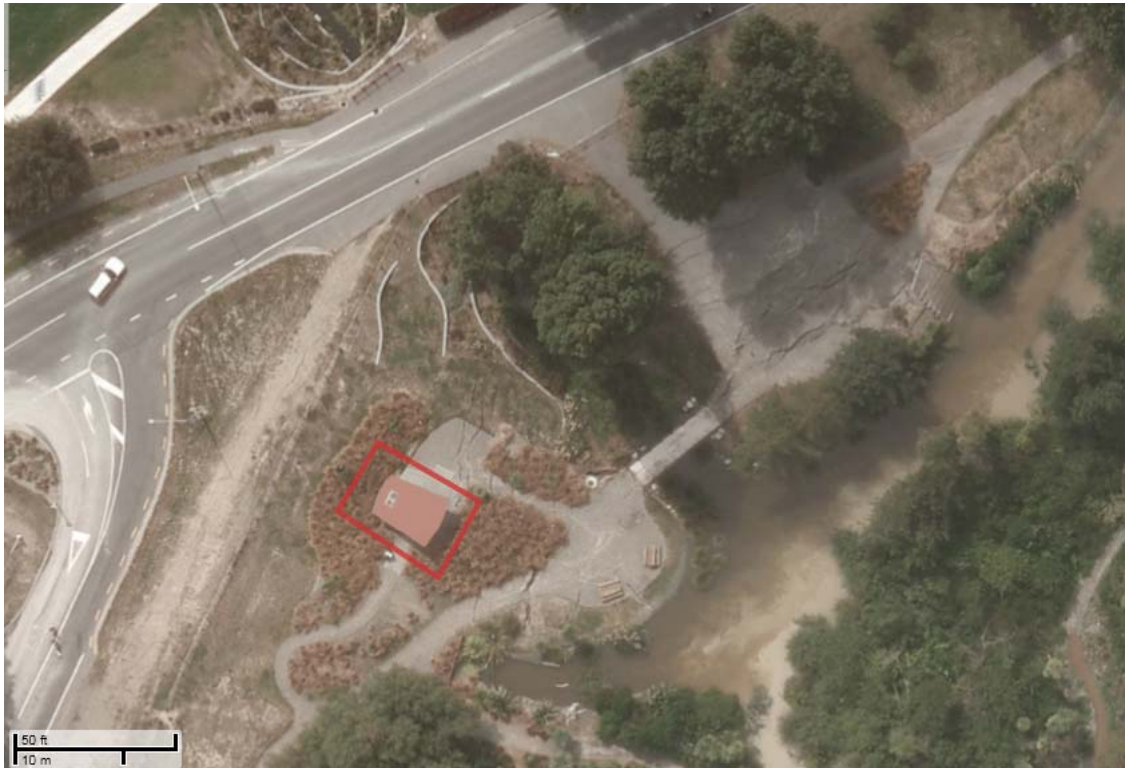
■ **Figure 5 – Aerial photography from 24 Feb 2011 (<http://viewers.geospatial.govt.nz/>)**

Aerial photography shows significant land damage after the 22 Feb 2011 event. There appears to be minor liquefaction along Horseshoe Lake Road. The majority of damage appears to be lateral spreading in towards the lake.

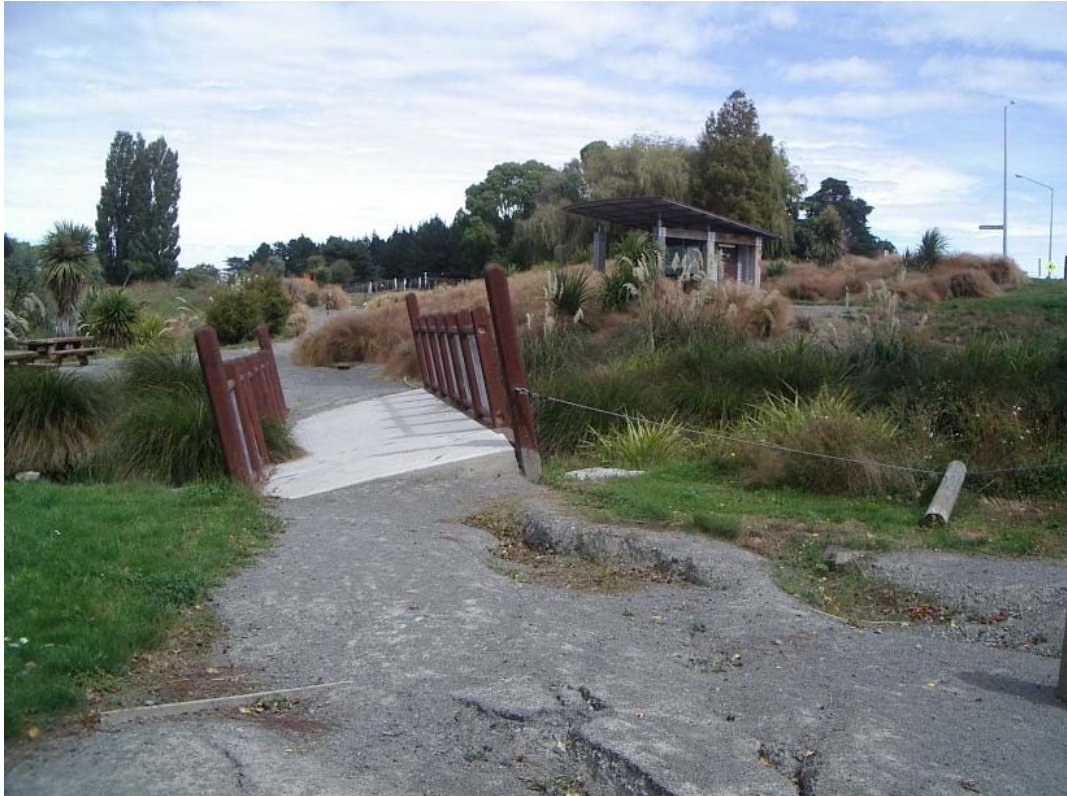
The bridge to the east of the toilets was severely damaged and was tilted to one side.

- **Figure 7 Overview of toilet block with damaged bridge in foreground**

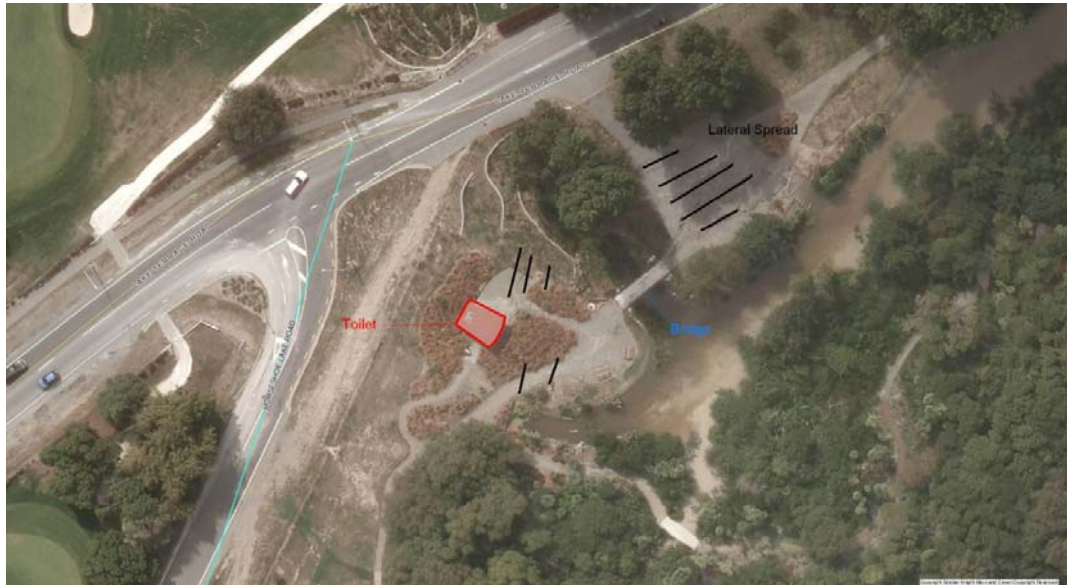
The paving next to the toilet had been removed. Large amounts of lateral spread was observed to the north east of the building on the asphalted car park area (next to the river) and directly around the toilet (to the north east and south west). Large tension cracks were seen in the ground around the site running parallel to the lake edge.

■ **Figure 8 Overview map showing alignment and distribution of tension cracks**

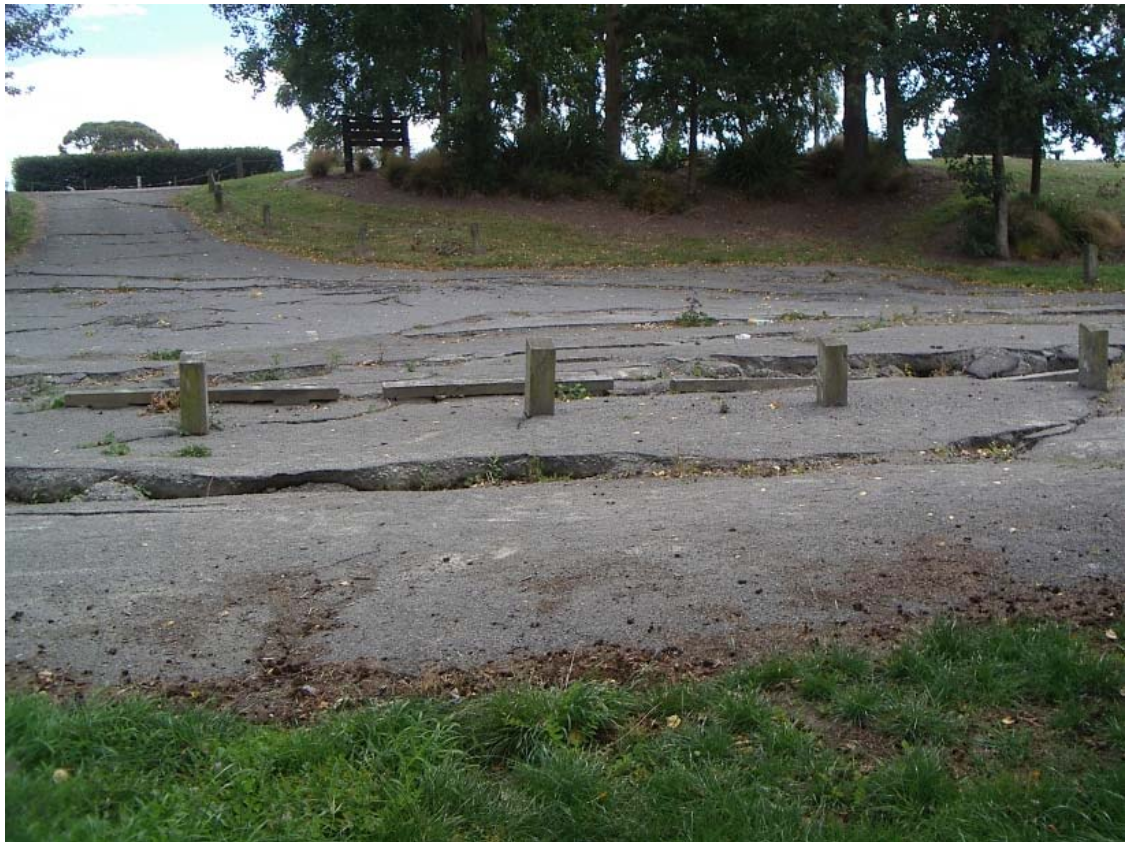
- **Figure 9 Lateral spreading in access way to north east of toilet block**
