Christchurch City Council
PRK_1497_BLDG_002 EQ2
Kainga Hall Public Toilets
161 Kainga Road

QUANTITATIVE ASSESSMENT REPORT

- Rev B
- 06 May 2013

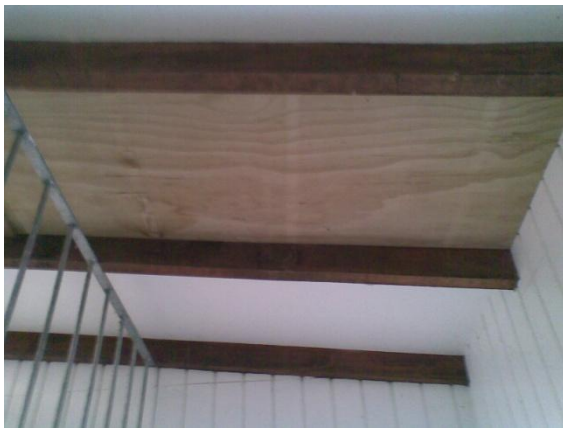
Photo 7: Replacement of roof panel or skylight with plywood

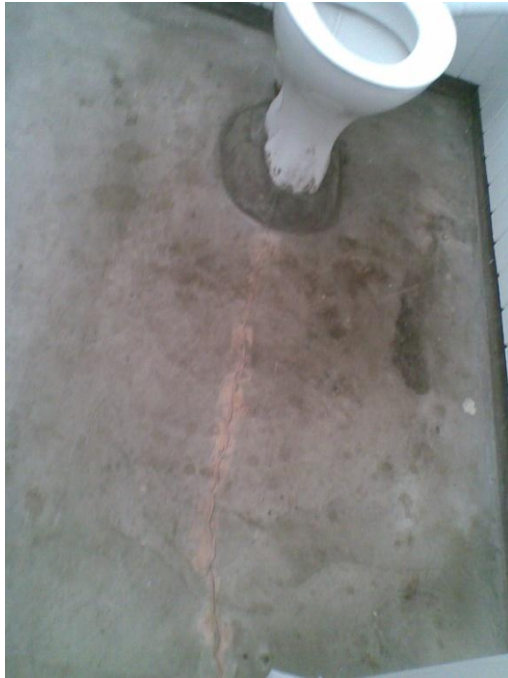
- 1) Cracking to the concrete slab on grade foundations extending from penetrations. These have reopened where they have previously been in filled. See photos 9-12.

Photo 9: Typical cracking to slab foundation extending from floor penetration

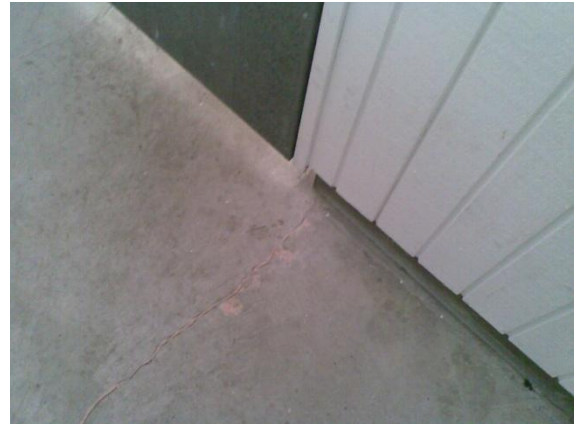
Photo 10: Crack extending to change in floor at wall support

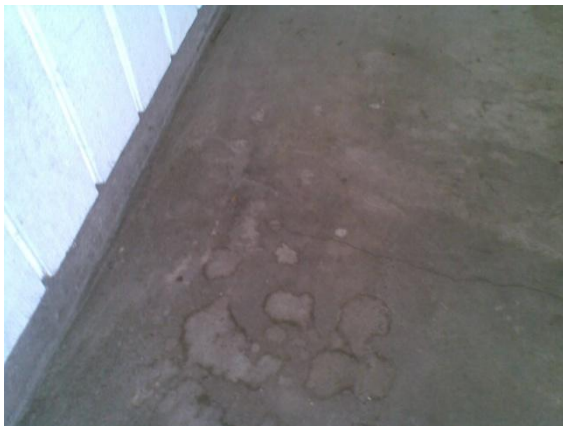
Photo 11: Floor slab cracking in the toilets

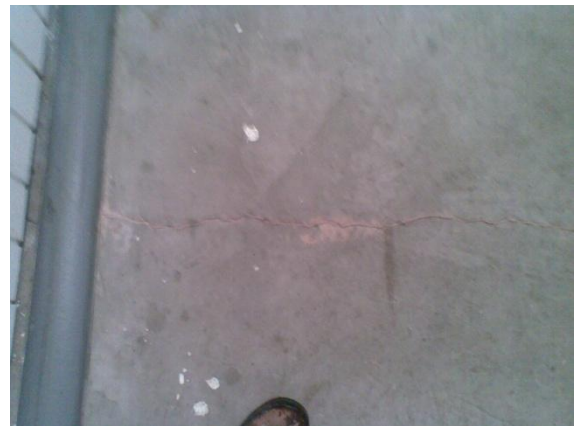
Photo 12: Cracks have been filled but have reopened

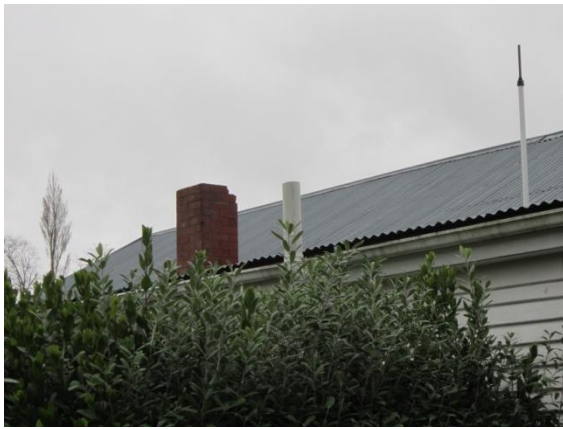
Photo 13: Chimney over the Kainga hall which lost an estimated 400mm of height

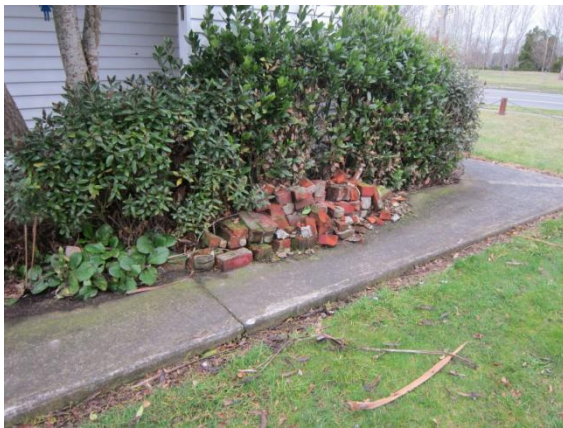
Photo 15: Bricks from Chimney piled by the Kainga toilets

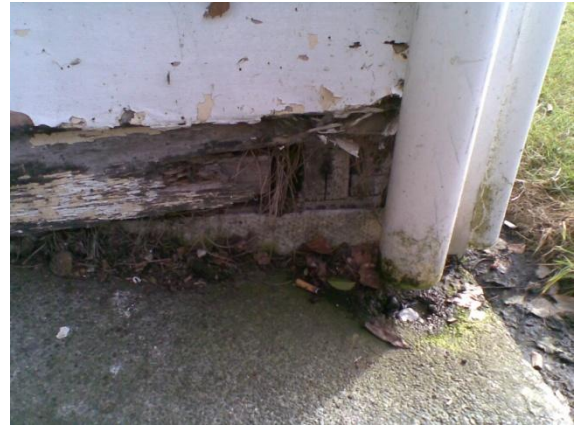
Photo 20: Rotten timber weatherboarding at the hall entry

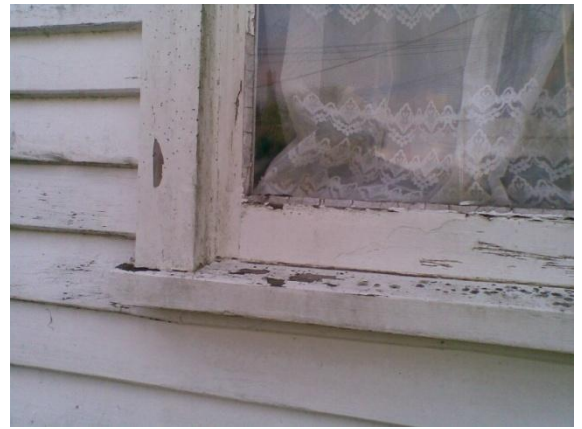
- 2) Hall internal timber columns are out of plumb. See Photo 28
- 3) Non earthquake related rot to the external weatherboard cladding. See photos 22, 25-27

Photo 26: Timber rot around the window framing

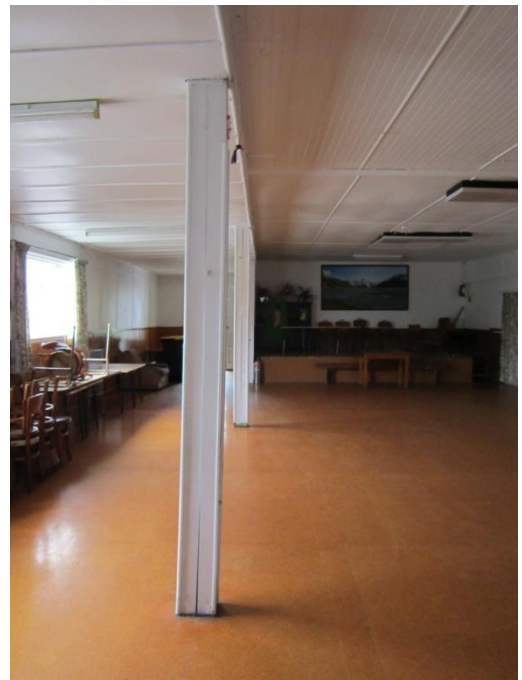
Photo 28: Internal timber columns noticeably out of plumb

- a) We consider that barriers around the building are not necessary.
- b) Options to bring the building to a target of 67% are investigated in addition to determining the length diameter and spacing of nailing to the hardboard linings.
- c) A level and verticality survey should be carried out to inform the repair.

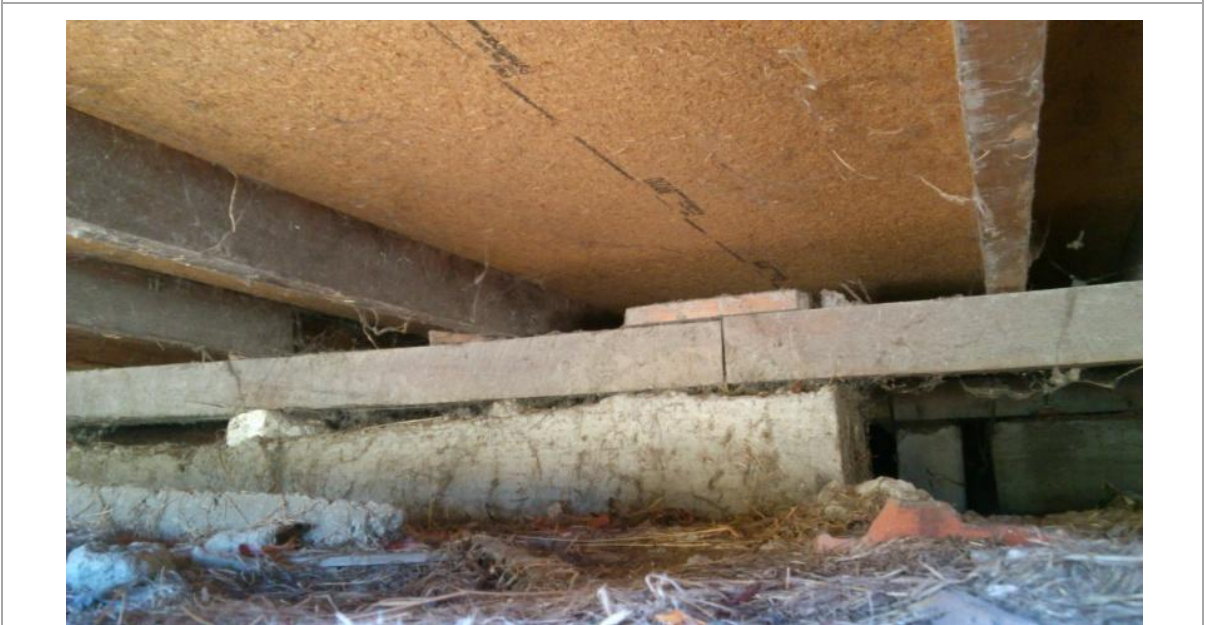
Photo 34: Particle board floor on timber joists and bearers supported by concrete pad foundations. Connection between bearer and pad could not be verified. Background - internal discrete pile supporting bearer and pad foundations
