Kaituna Hall  
Qualitative Engineering Evaluation

Functional Location ID: BU 3672 001 EQ2

Address: 2543 Christchurch Akaroa Road

**Date:** 14 December 2012

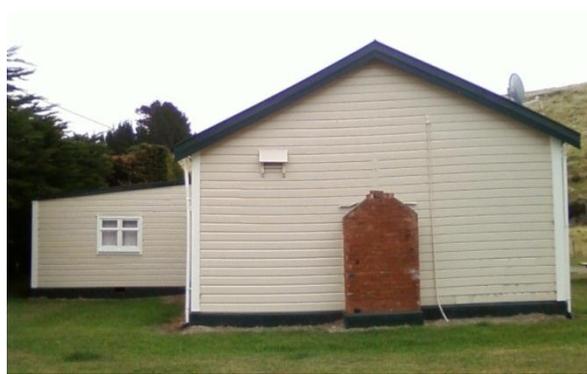
Southern elevation of Kaituna Hall. Note partial deconstruction of chimney.

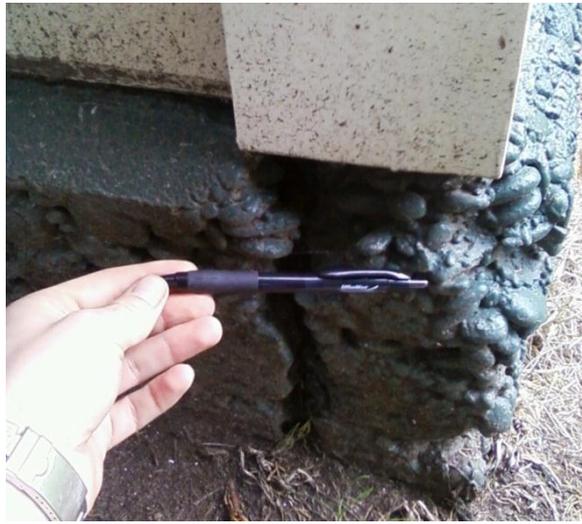
The crack in the perimeter foundation is likely due to the use of poor quality concrete when the structure was built. The crack is not thought to be seismic related as the crack has previously been painted indicating that it has existed for some time; in addition there is a lack of damage to the structure in the vicinity of the crack which would indicate movement due to seismic action.

Cracking in concrete perimeter foundation (existing). Note poor quality of concrete.

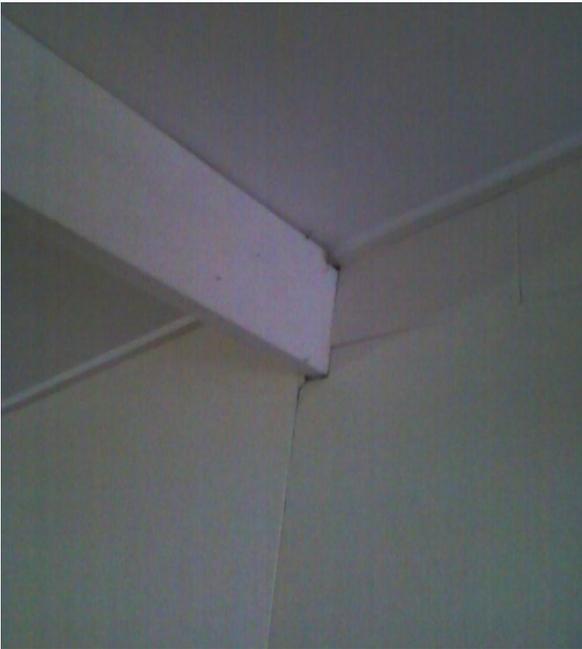
There was only minor cosmetic damage observed to the Kaituna Hall as a result of seismic actions. This is expected as buildings of this nature are flexible and have high inherent ductility. Additionally the timber sarking and weatherboards used for wall linings allow the building to move to some extent without damage to the linings.

Minor damage to internal linings in the extension.

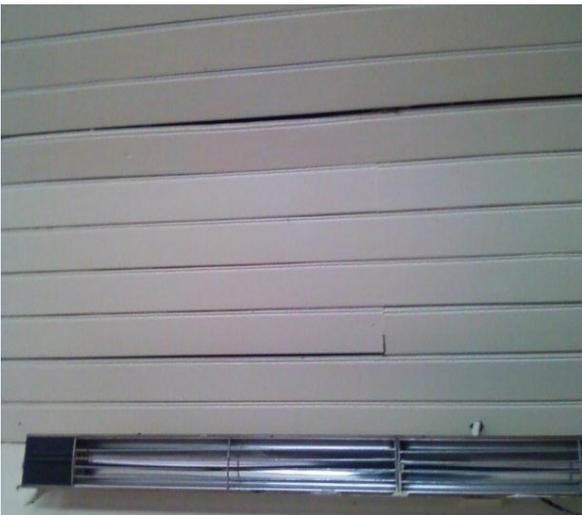
Warping and separation of sarking boards in the main hall.

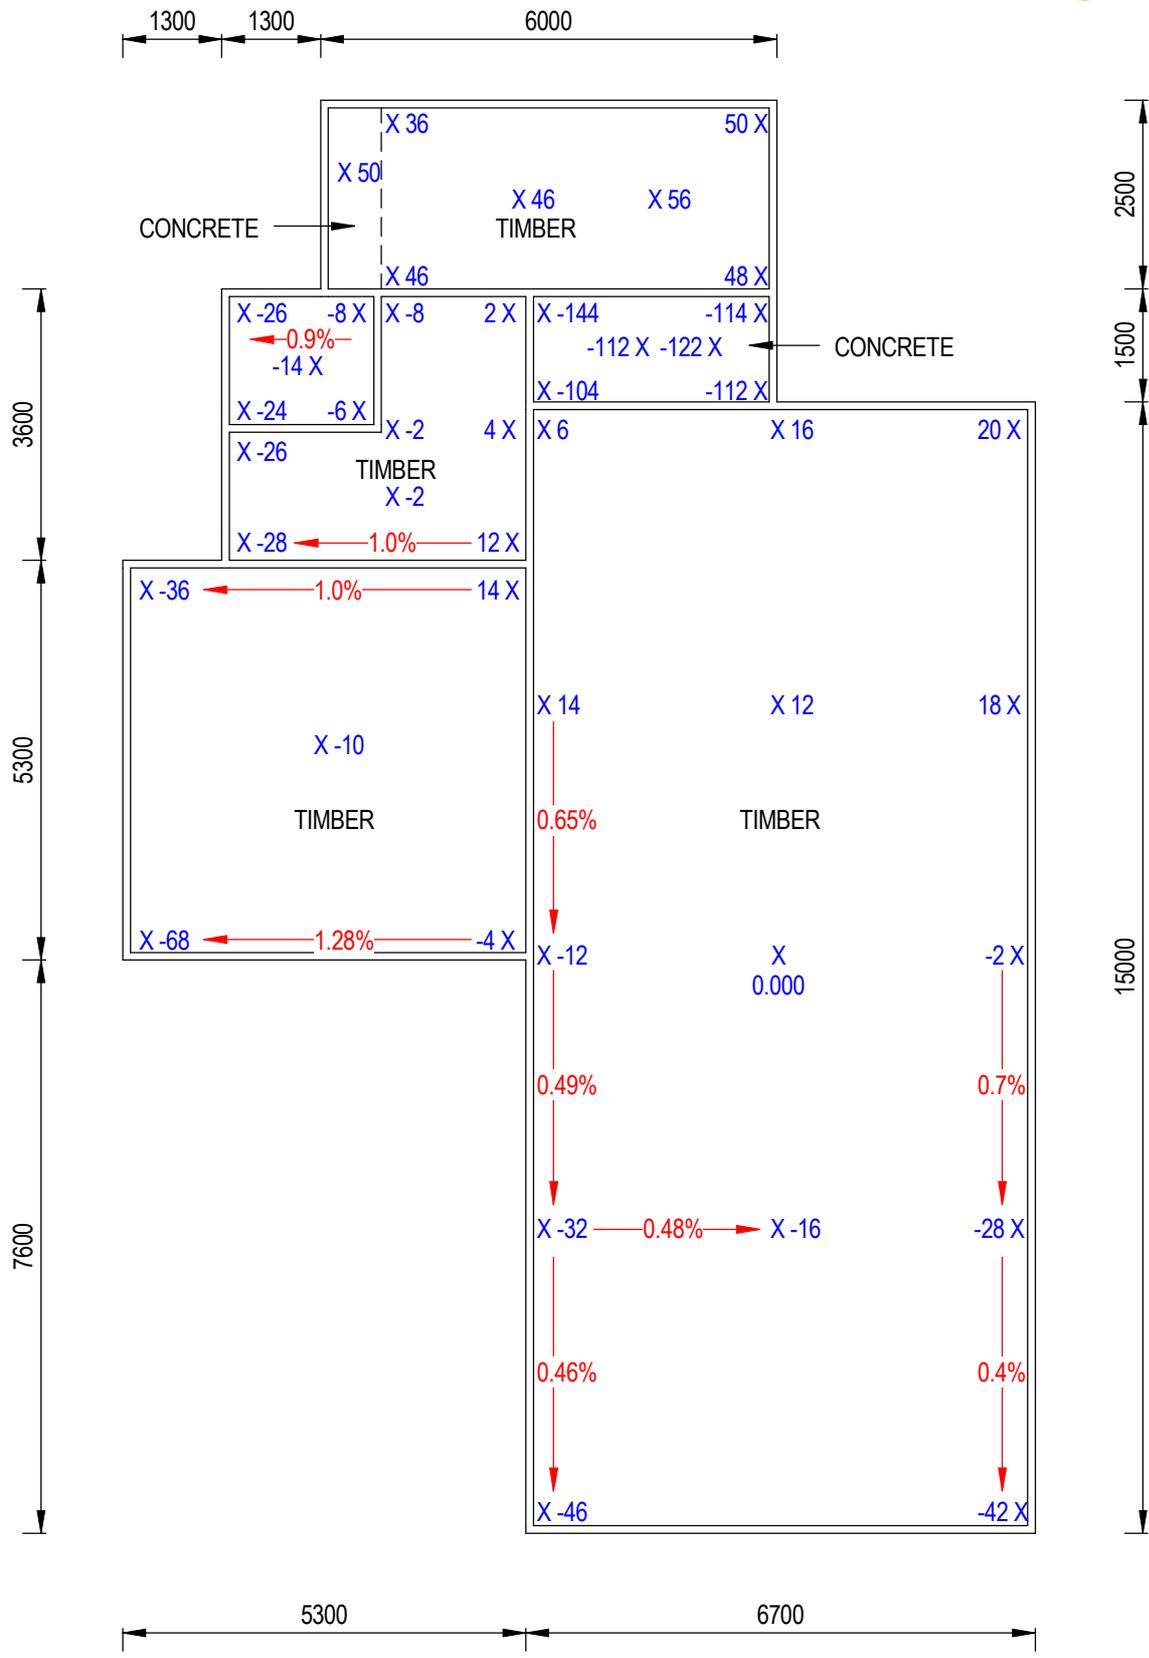
PROJECT
KAITUNA HALL
2543 CHRISTCHURCH AKAROA ROAD
TITLE
LEVEL SURVEY

The floor levels for the Kaituna Hall were found to be outside the recommended tolerances with slopes of up to 1.28% and a variation of 124mm over the floor plan. The floor slopes are most significant in the extension. While it is difficult to determine whether the variations in level are due to age related settlement or earthquake induced settlement it is likely that they are due at least in part to consolidation of the ground during recent earthquakes.

The land below the Kaituna Hall is zoned as Port Hills and Banks Peninsula and as such is not expected to be prone to liquefaction and settlement. Additionally there is no local evidence of settlement and liquefaction in the surrounding land. However the floor **levels survey carried out within Kaituna Hall found that the floor levels were significantly outside of the recommended tolerances**. As such releveling of some areas of the building is recommended.
