**Kaumatua Place
Housing Complex
PRO 0417**

**Detailed Engineering Evaluation
Quantitative Assessment Report**

Date: February 2014
Reference: 6-QC367.00
Status: Final

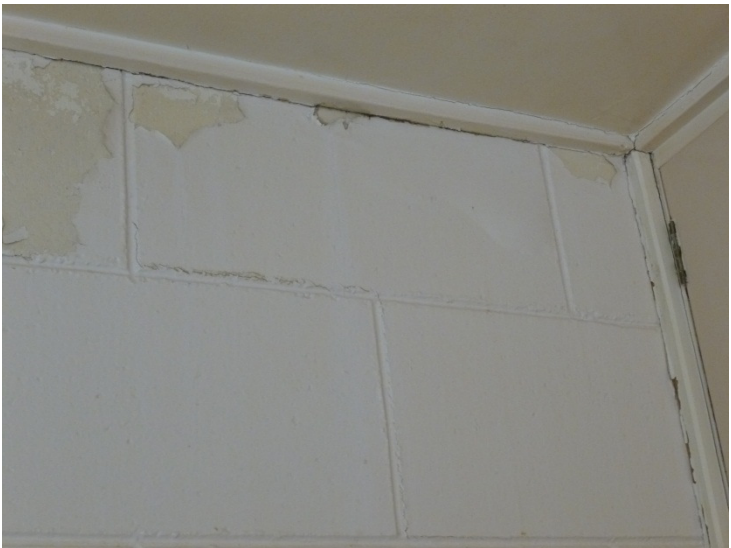
<p>18.</p>	<p>Stepped cracking through paint in Unit 1</p>

Loose bricks in situ were observed on Units 5 and 7 (photo 22). Cracking and settlement was observed in the path surrounding Block B. A minor crack was observed between the veneer and the firewall on Unit 6/5 (photo 23). Stepped cracking was observed in the Unit 2 firewall (photo 18).

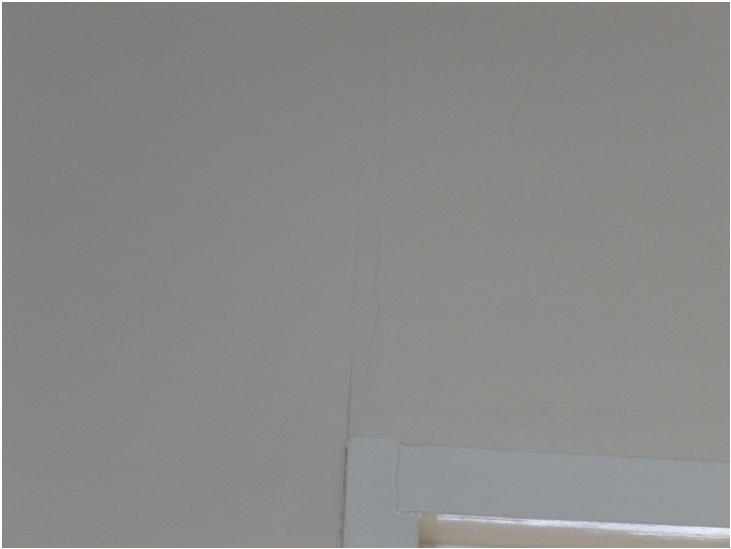
19.	Typical cracking above doorways

Minor cracking in the plasterboard was observed in all units, typically above doorways, windows and at the rooflines (photos 19-21). This damage was deemed minor and not to affect the lateral-resistance structure.
