**Leslie Park Toilets
PRK 1572 BLDG 001 EQ2**

Detailed Engineering Evaluation

Quantitative Assessment Report

Date: November 2012
Reference: 6-QUCC1.82
Status: Final

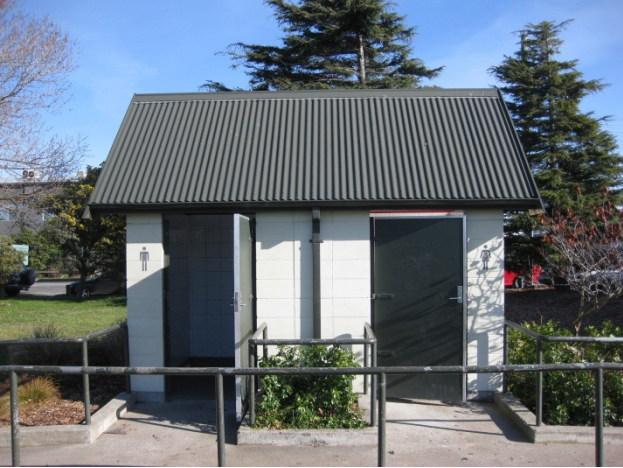
Site Name		
No.	Item description	Photo
General		
1.	Northern view of building

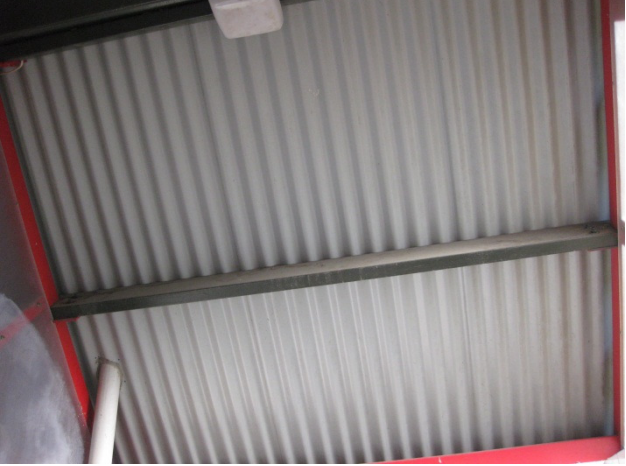
3.	Southern view of building	  A photograph showing the southern view of a small, single-story building with a dark grey corrugated metal roof and light-colored walls. A green bush is in the foreground, and a grassy area is visible in the background.
4.	RHS trusses with 100x50 purlins spanning between

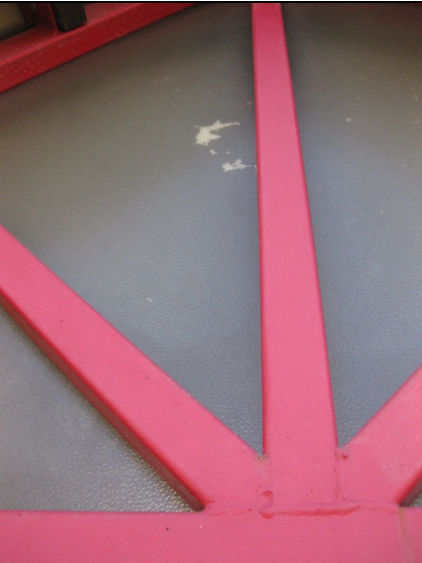
6.	Welded RHS end frame

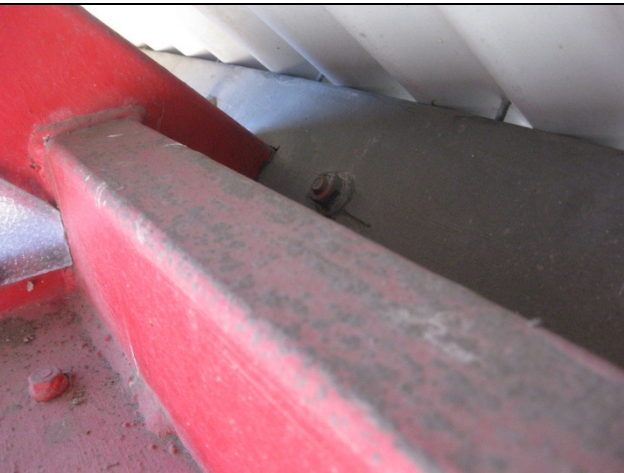
7.	Wall roof junction

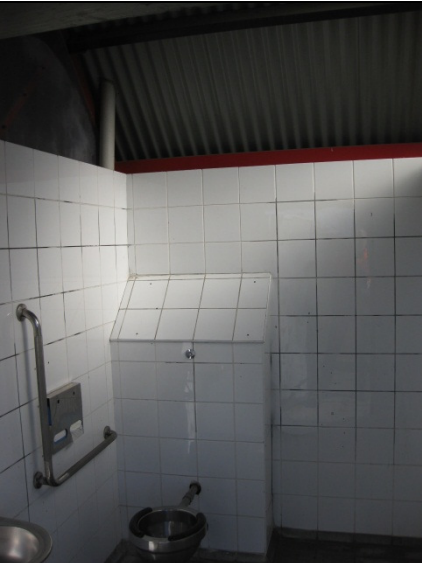
8.	Tiles lining internal walls
