CHRISTCHURCH CITY COUNCIL
PRK_0227_BLDG_007 EQ2
Linwood Nursery – Glasshouses (×5)
320 Linwood Ave, Linwood

QUALITATIVE ASSESSMENT REPORT

- Rev C
- 23 May 2013

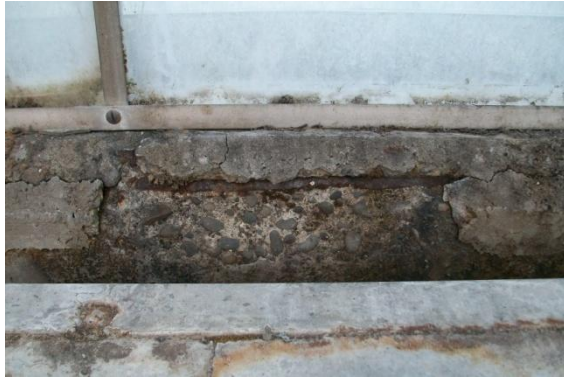
- 1) Spalling was found at the top of the longitudinal walls of a number of the glasshouses. In some locations the reinforcement was exposed (see Photo 5). Spalling was found at the following locations:

Photo 5: Typical spalling found at the top of the longitudinal concrete walls

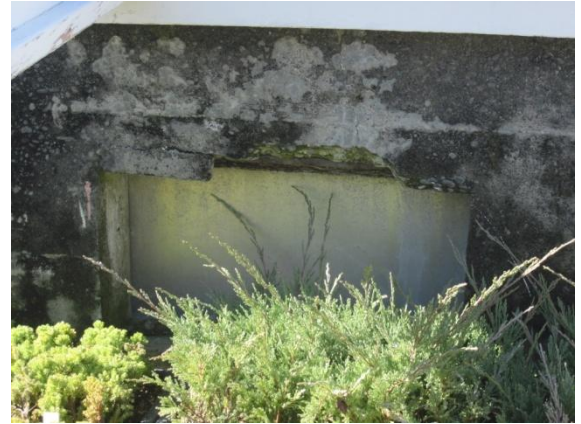
- a. exterior of the western wall of Glasshouse A, adjacent to a vent, half way along the wall (see Photo 6). This damage is likely to have been caused by the recent earthquakes.

Photo 6: Spalling found adjacent to a vent, half way along the western wall of Glasshouse A

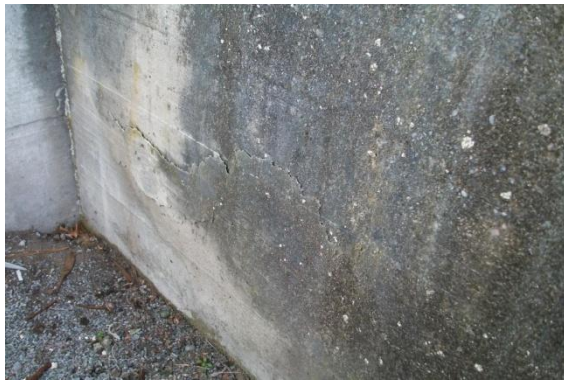
Photo 7: Spalling found at the southern end of the eastern wall of Glasshouse B

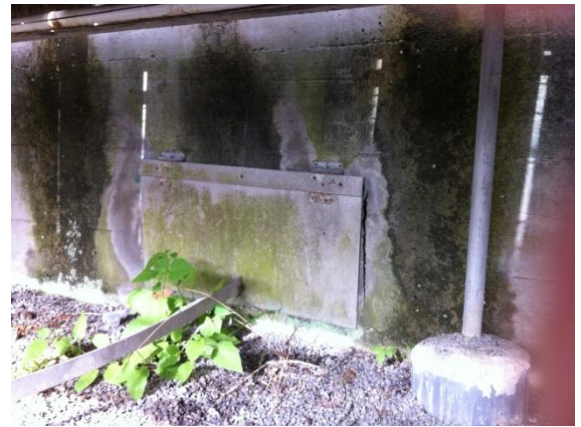
Photo 8: Spalling found adjacent to a vent half way along the eastern wall of Glasshouse C

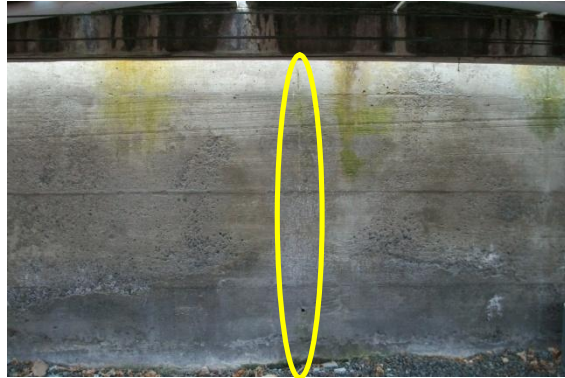
- 3) Regular vertical cracking was found in the longitudinal walls of Glasshouse A, C and E (see Photo 9). The cracks were up to 0.5mm in width and spaced at approximately 1m centres. Some additional vertical cracking was observed adjacent to vents in the walls (see Photo 10).

Photo 9: Typical vertical cracking found in the longitudinal walls of Glasshouses A, C and E

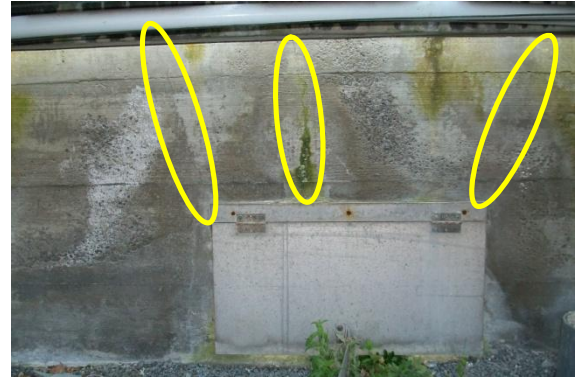
Photo 10: Typical vertical cracking found adjacent to vents in the longitudinal walls of Glasshouses A, C and E

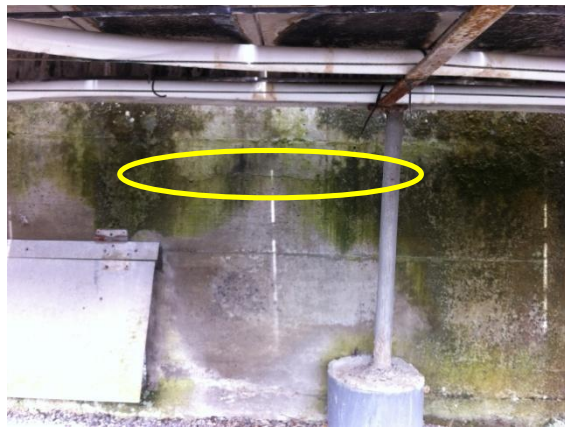
- 4) Horizontal cracking, located approximately 350mm from the top of the wall, was found at the north end of the east wall of Glasshouse B (see Photo 11). The cracking was approximately 0.5mm in width.

Photo 11: Horizontal cracking located approximately 350mm from the top of the eastern wall of Glasshouse B

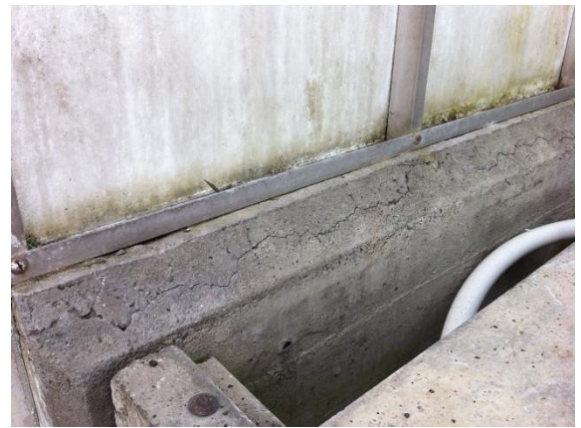
Photo 12: Typical cracking and spalling found at the top of the northern wall of Glasshouse A and D

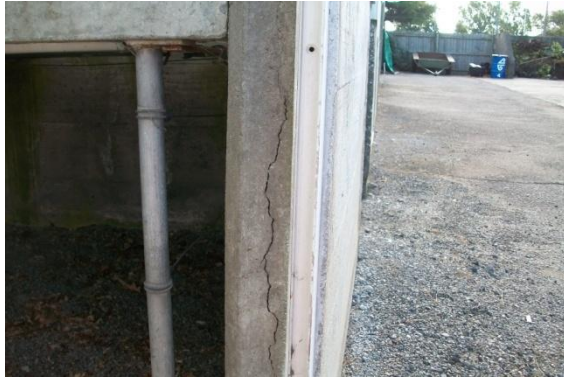
Photo 13: Typical spalling found on the vertical edge of the northern wall, adjacent to the door in Glasshouse B, C and E

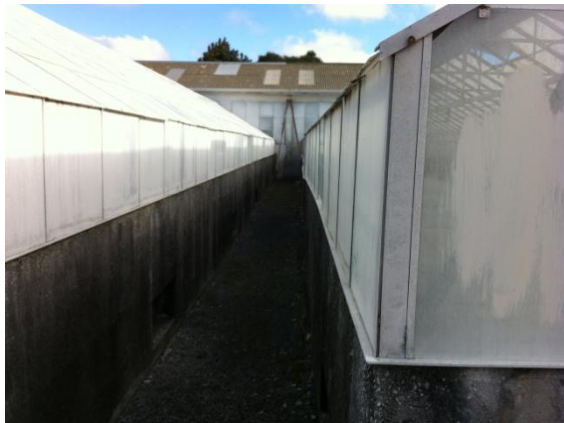
these locations were missing or had corroded and sheared. Corrosion of the fixings is expected to have occurred prior to the recent earthquakes, however shearing of the bolts and lateral movement of the aluminium structure is likely to have happened in the recent earthquakes.

Photo 15: Lateral displacement mid-way along the east side of Glasshouse C

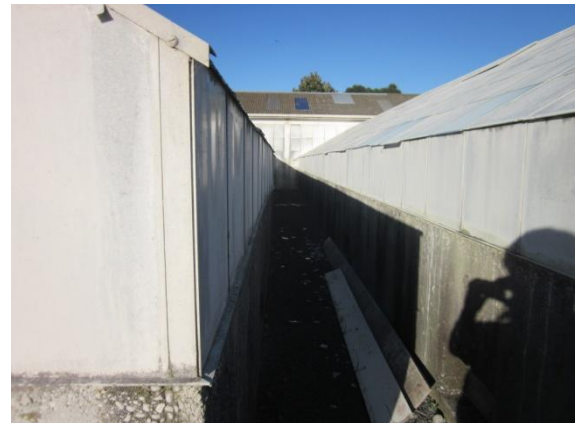
Photo 16: Lateral displacement mid-way along the west side of Glasshouse E

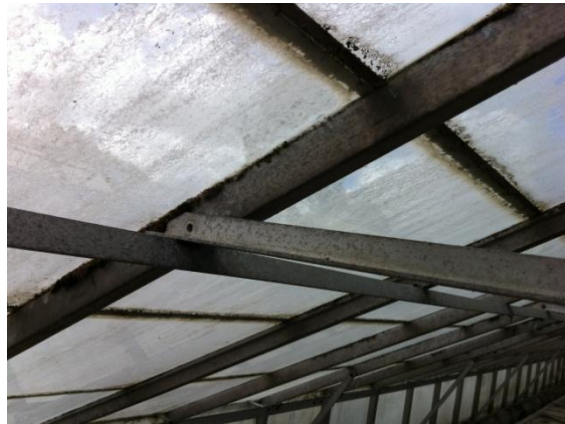
Photo 17: Bolt missing at an aluminium frame connection, mid-way along the east side of Glasshouse D

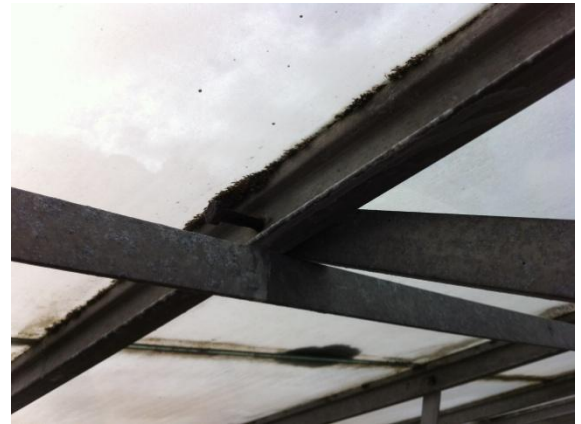
Photo 18: A loose bolt at an aluminium frame connection, mid-way along the west side of Glasshouse C

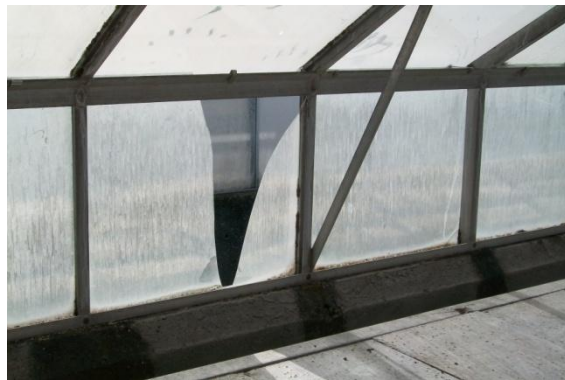
- 8) One broken pane of glass was observed at the south end of Glasshouse B, on the west side of the structure, and at the north end of Glasshouse E (see Photo 19). This is likely to have occurred in the recent earthquakes.
- 9) Some glass panes in Glasshouse A had slipped, allowing weather to penetrate the roof of the structure (see Photo 20). This is likely to have occurred in the recent earthquakes.
- 10) Concrete troughs are located in the south west corner of Glasshouse C, in the place of the concrete decking (see Photo 21). The troughs have significant cracking and spalling along the eastern edge (see Photo 22).

Photo 19: Broken glass pane at the south end of Glasshouse B

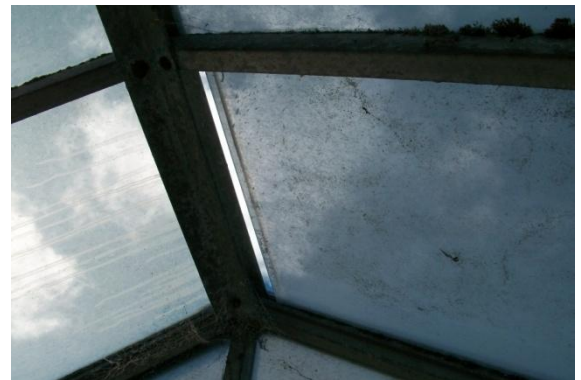
Photo 20: Glass pane which has shifted in Glasshouse A

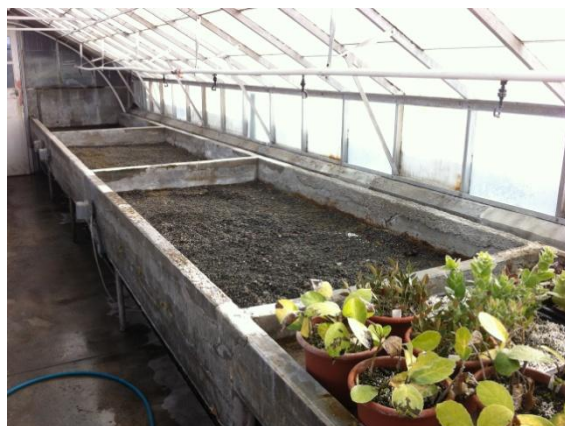
Photo 21: Concrete troughs at the south end of Glasshouse C

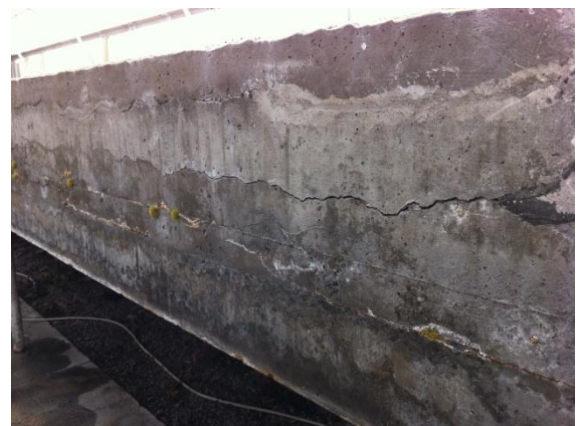
Photo 22: Detail of cracking to the sides of the concrete troughs in Glasshouse C
