Little Akaloa Community Hall
BU 3590-001 EQ2
Detailed Engineering Evaluation
Quantitative Report

Detailed Engineering Evaluation Quantitative Report

Date: 10 October 2012
Reference: 6-QUCCC.71
Status: Final V2

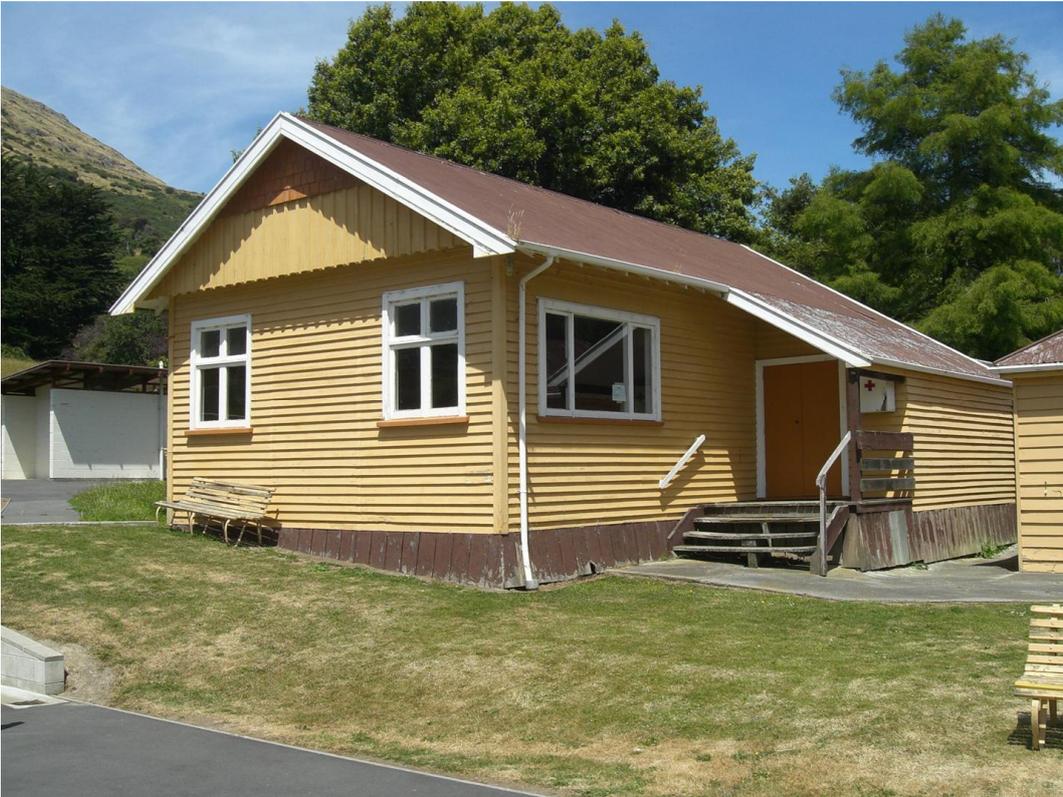
Photo 1: View of the north east corner of the building

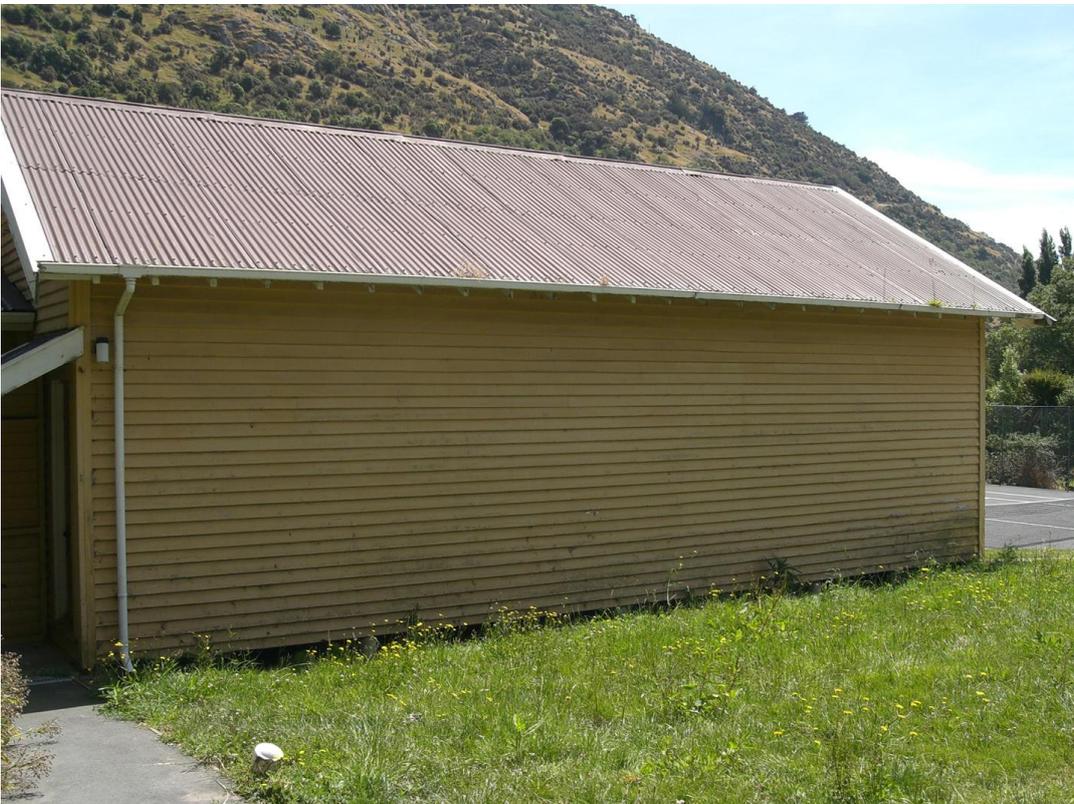
Photo 2: The south perimeter wall

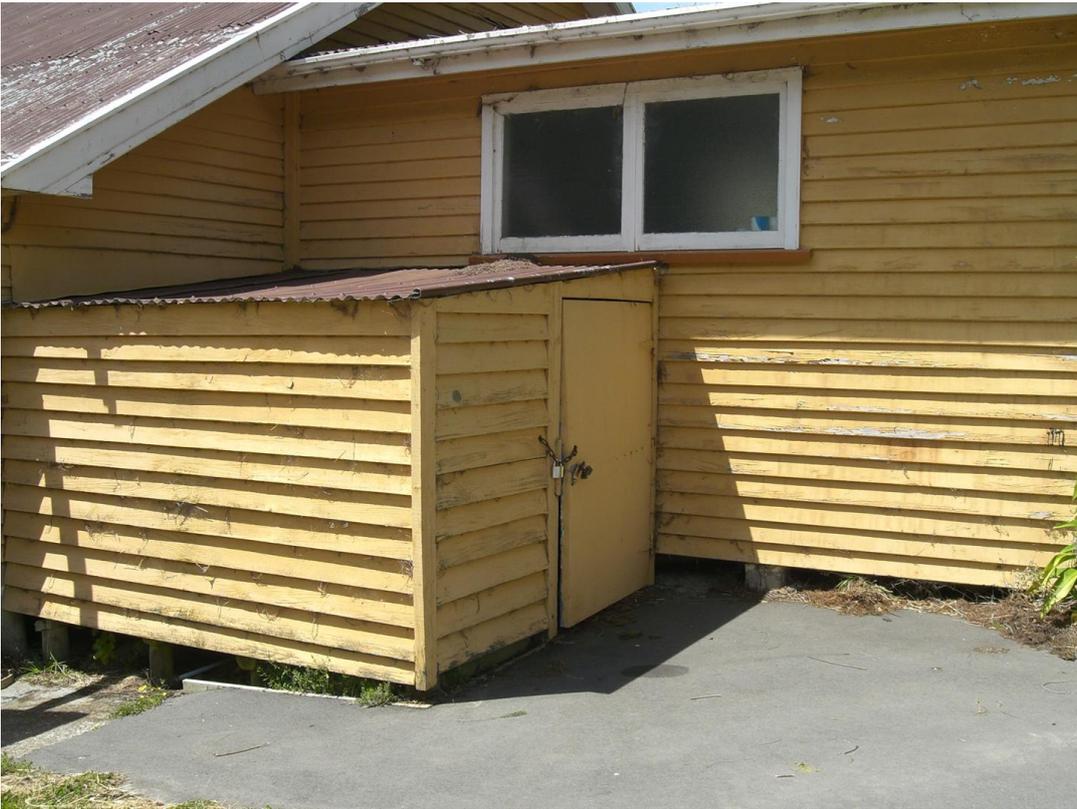
Photo 3: The exterior of the storage area and kitchen area at the north west end of the building

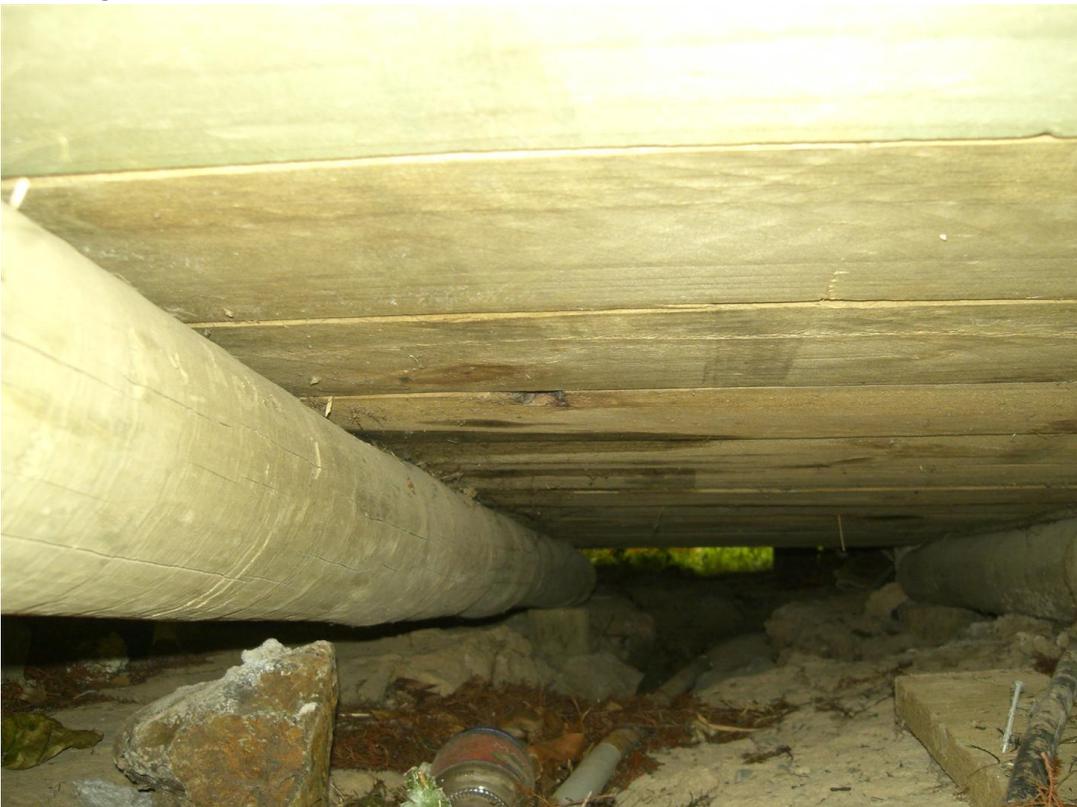
There was no sign of subfloor bracing or hold down connections between the piles and bearers.

- a) Lack of subfloor bracing - the building sits on concrete pile and timber pile foundations and there is no sign of subfloor bracing, such as cantilever piles, braced piles, anchor piles or perimeter foundation walls.

Photo 4: View of the subfloor under the storage area

- (a) Strengthening options be developed for increasing the seismic capacity of the building to at least 67% NBS.
- (b) It is recommended that the CCC review the on-going occupancy of this building.

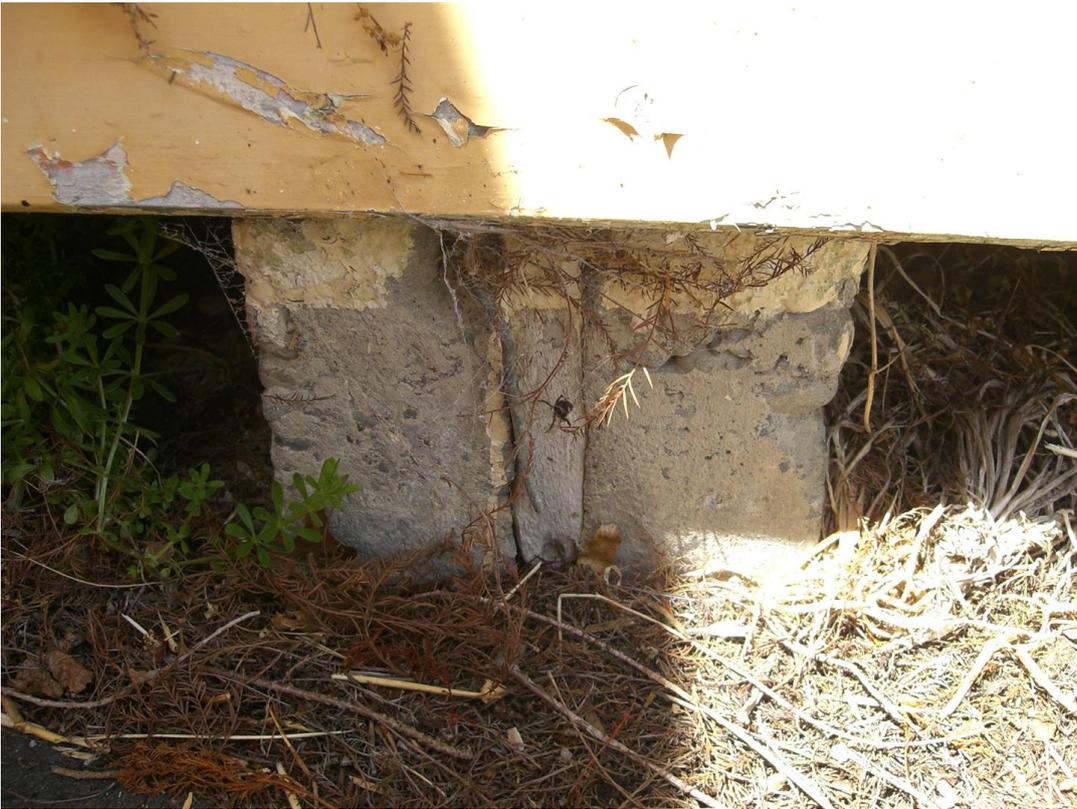
Photo 5: View of a concrete pile under the kitchen area of the building

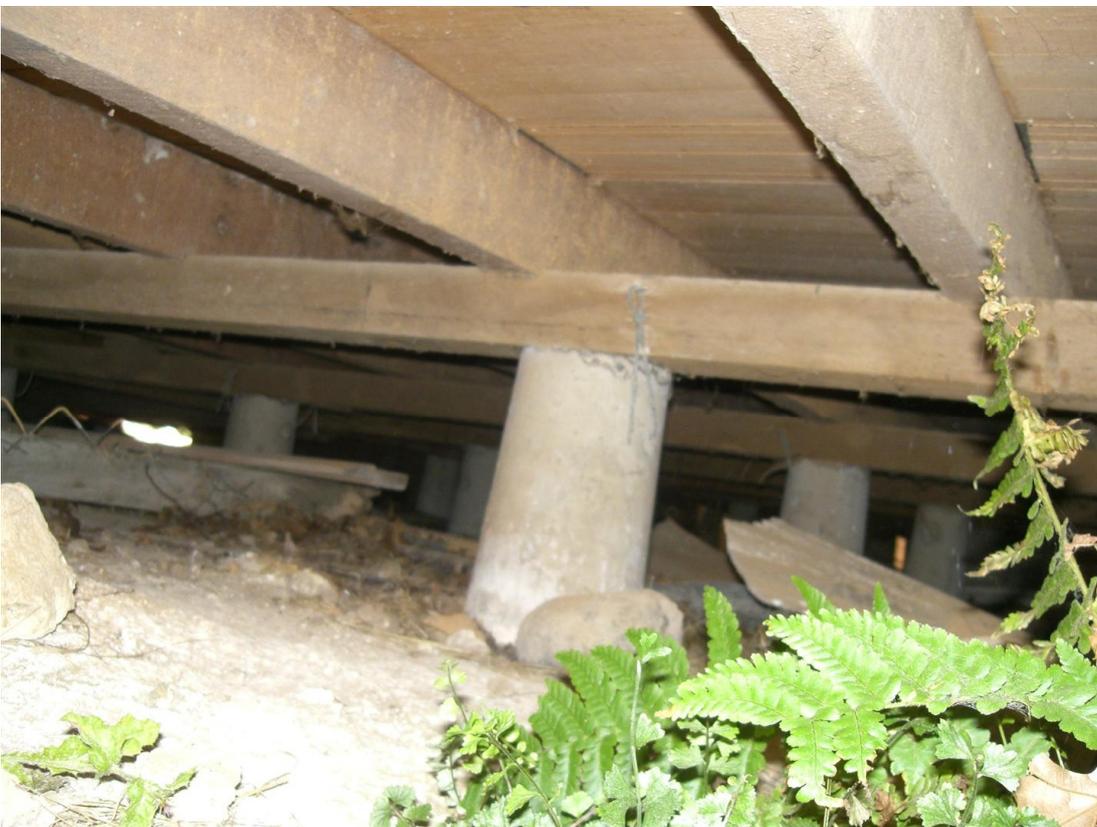
Photo 6: View of the subfloor under the main hall

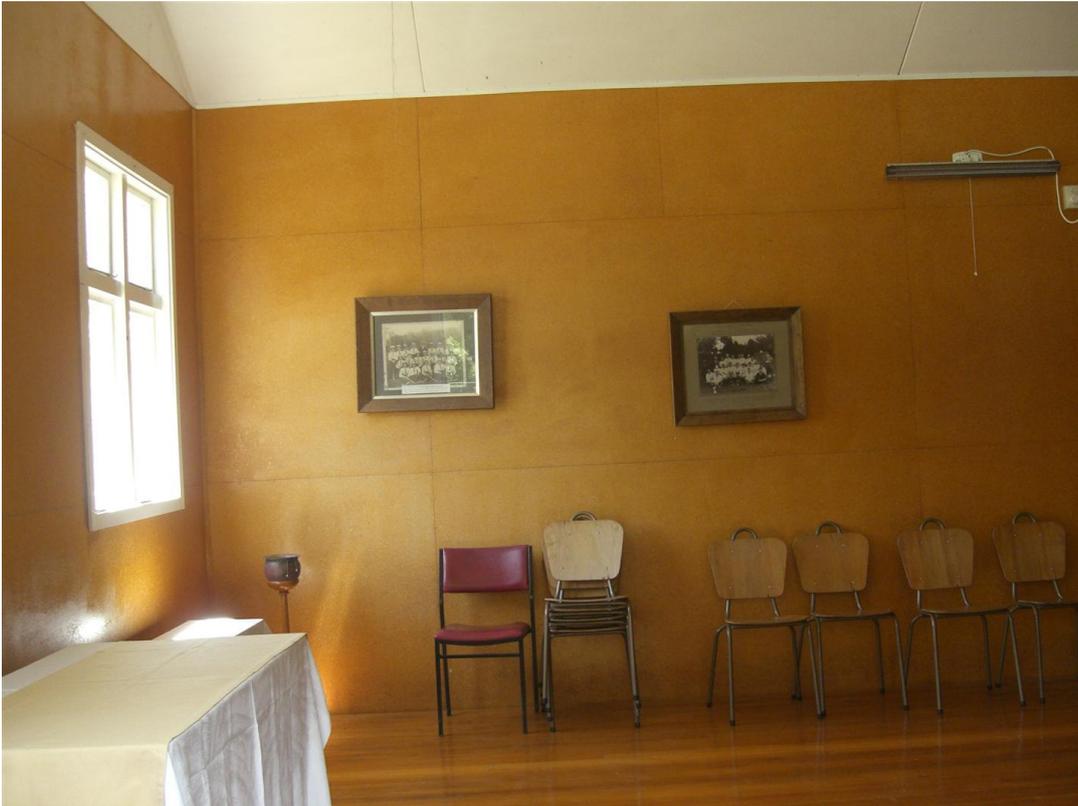
Photo 7: View of the interior face of the south wall in the main hall

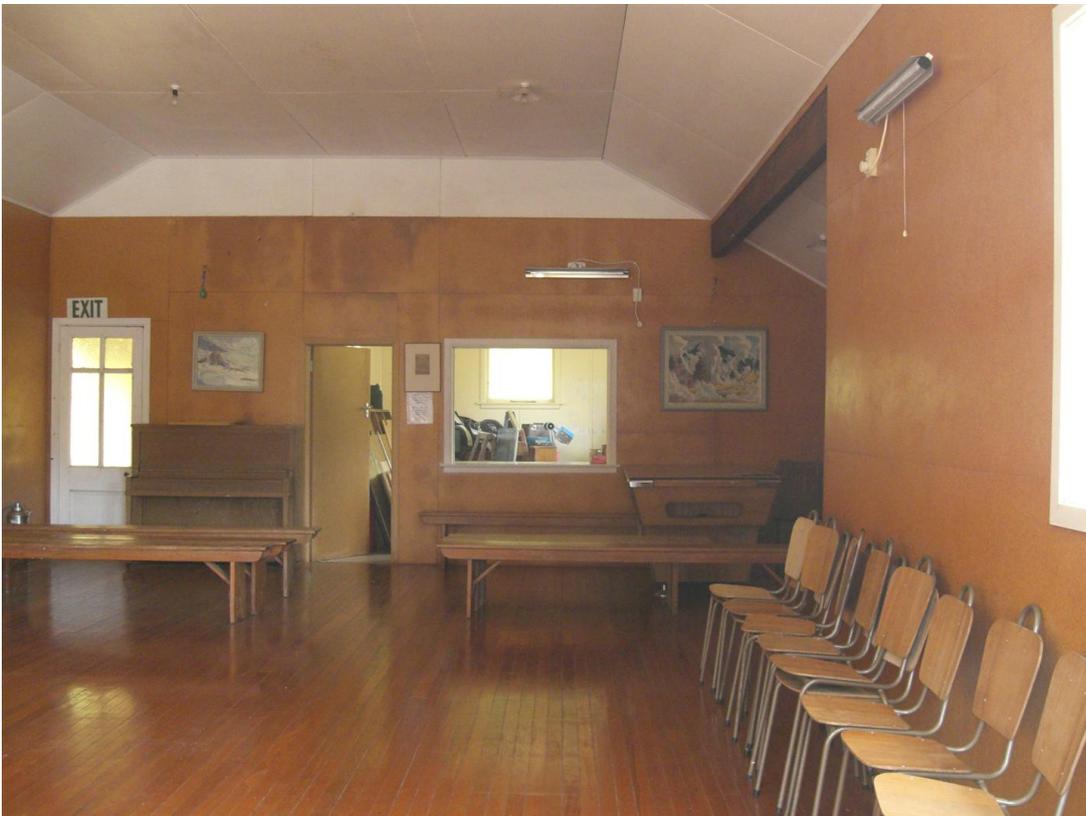
Photo 8: View to the west end of the main hall

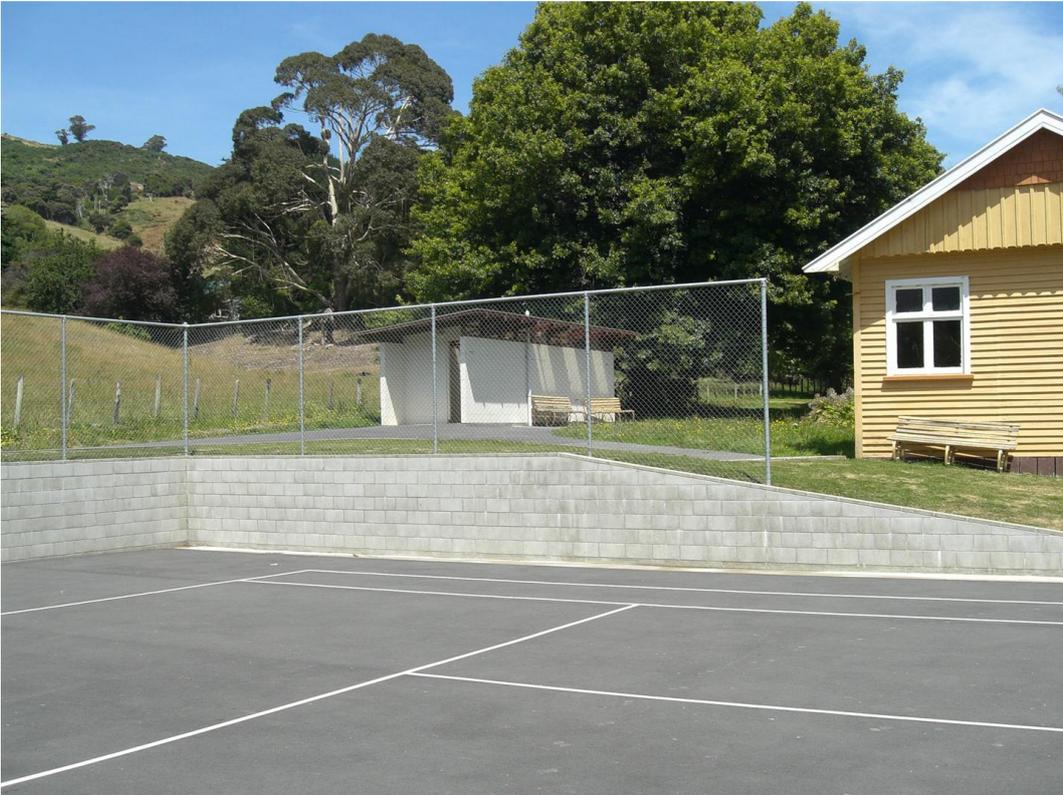
The existing foundations appear to have performed satisfactorily in the recent seismic events. No liquefaction has been observed on site. The paved tennis courts and the surrounding cantilever block wall appear to be in good condition, indicating that no ground deformation has occurred. The pavement between the Community Hall and Club Rooms does not appear to have settled due to the earthquakes and is likely to have been constructed with a fall to aid surface water run-off. Based on site observations, no further geotechnical investigations are recommended.

Photo 9: Concrete cantilevered wall on the east side of the hall
