Little Akaloa Toilets
Quantitative Engineering
Evaluation

Reference: 237794

Prepared for:
Christchurch City Council

Date: 23 September 2013

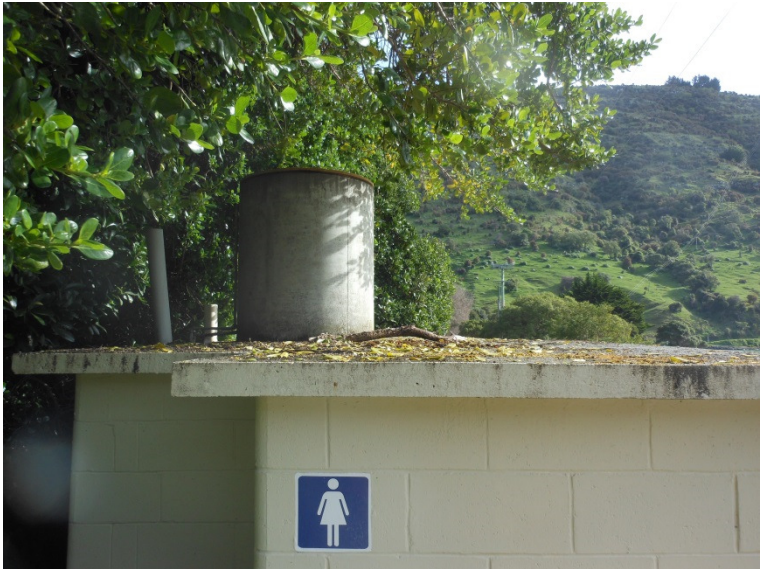
View on top of concrete roof showing water tank from southern side of building.

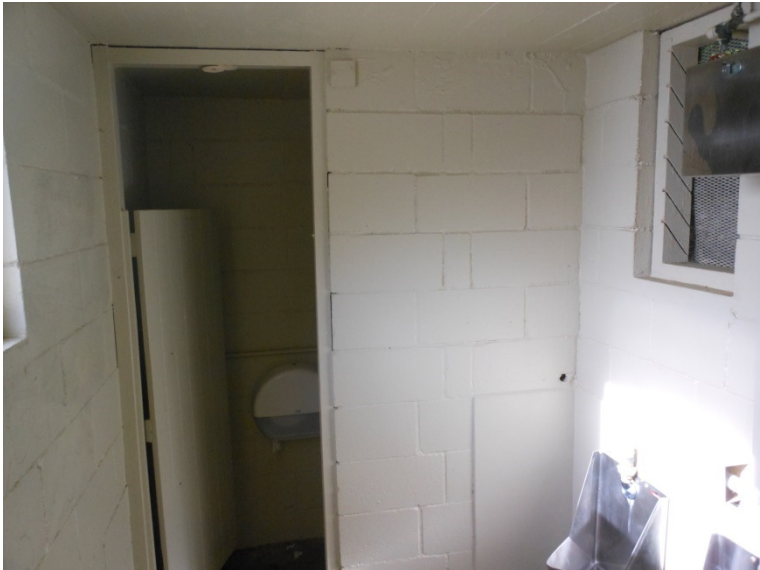
General view from inside the building.

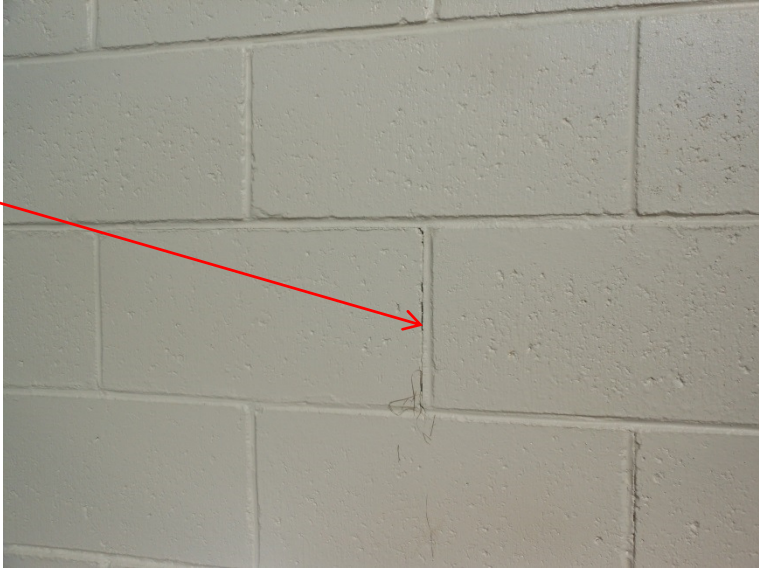
- Minor step cracking in the blockwork wall mortar joints at the northern end of the building; and
- Minor cracking in the floor slab. Most of these appear to be shrinkage cracking that would have been pre-existing.

<p>Minor step cracking in the blockwork wall mortar joints in the northern corner of the building.</p>

Cracking to the blockwork wall mortar joints should be raked out and repointed.

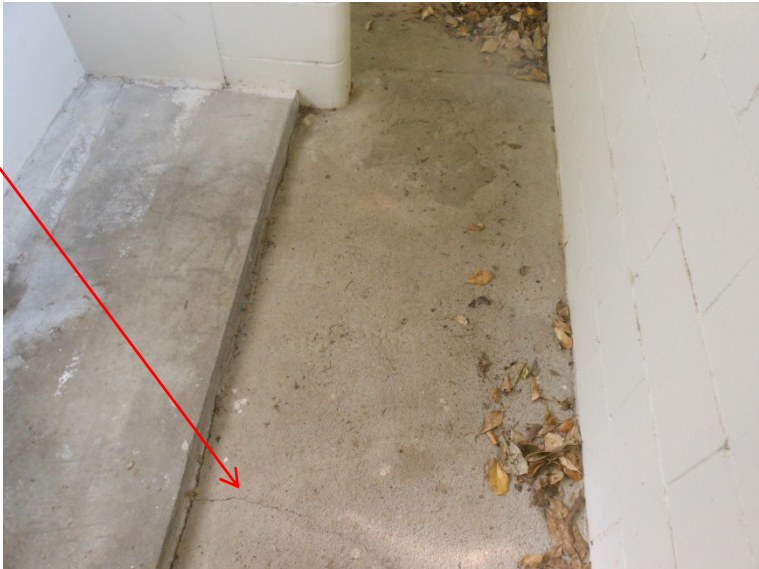
<p>Minor cracking in the slab-on-grade foundation. This appears to be pre-existing.</p>

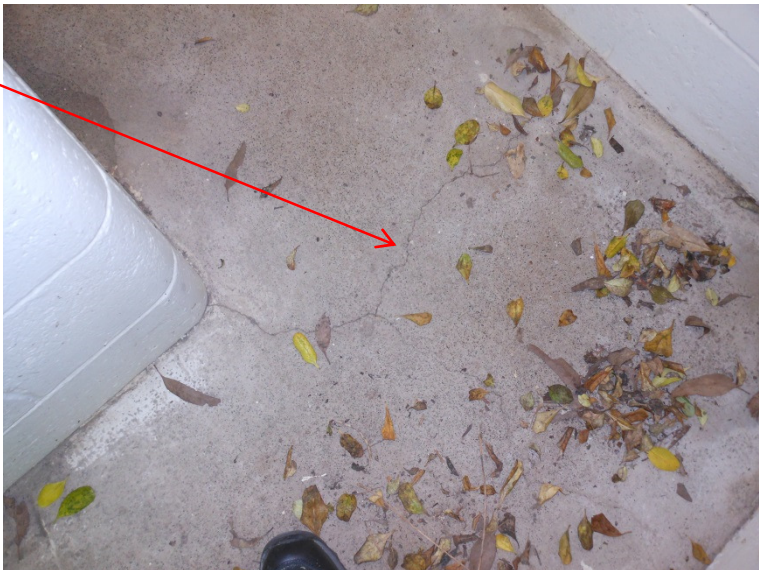
<p>Minor cracking in the slab-on-grade foundation. This appears to be pre-existing.</p>
